M.T. TZ GLORY

TECHNICAL REPORT

No.: CJPG-JS-22-KY-468

TECHNICAL REPORT of MT TZ GLORY

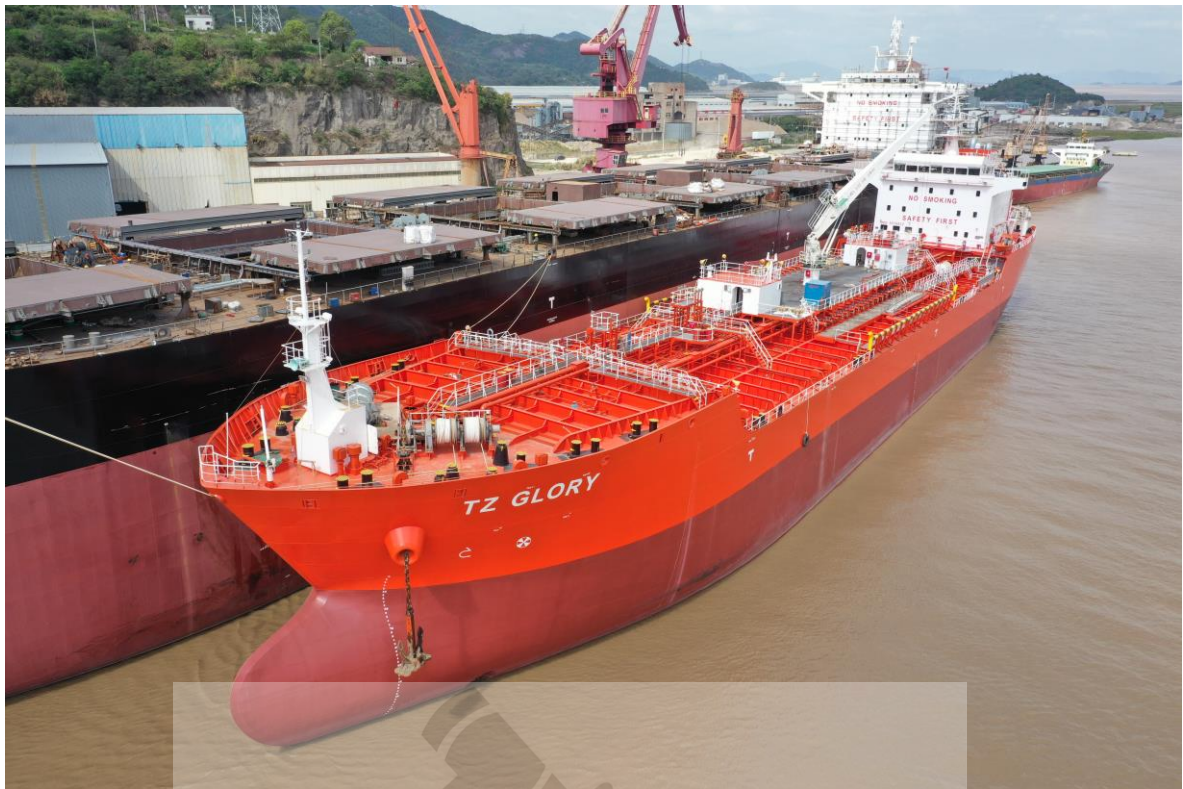
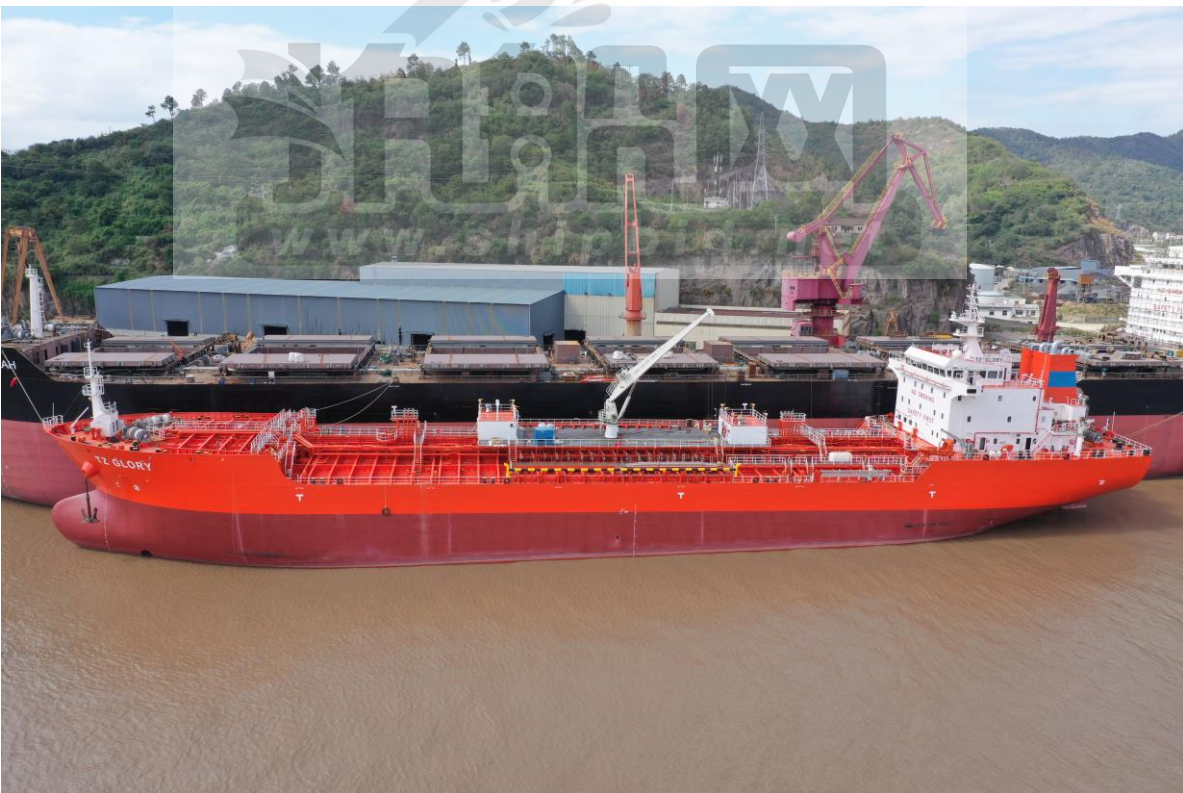
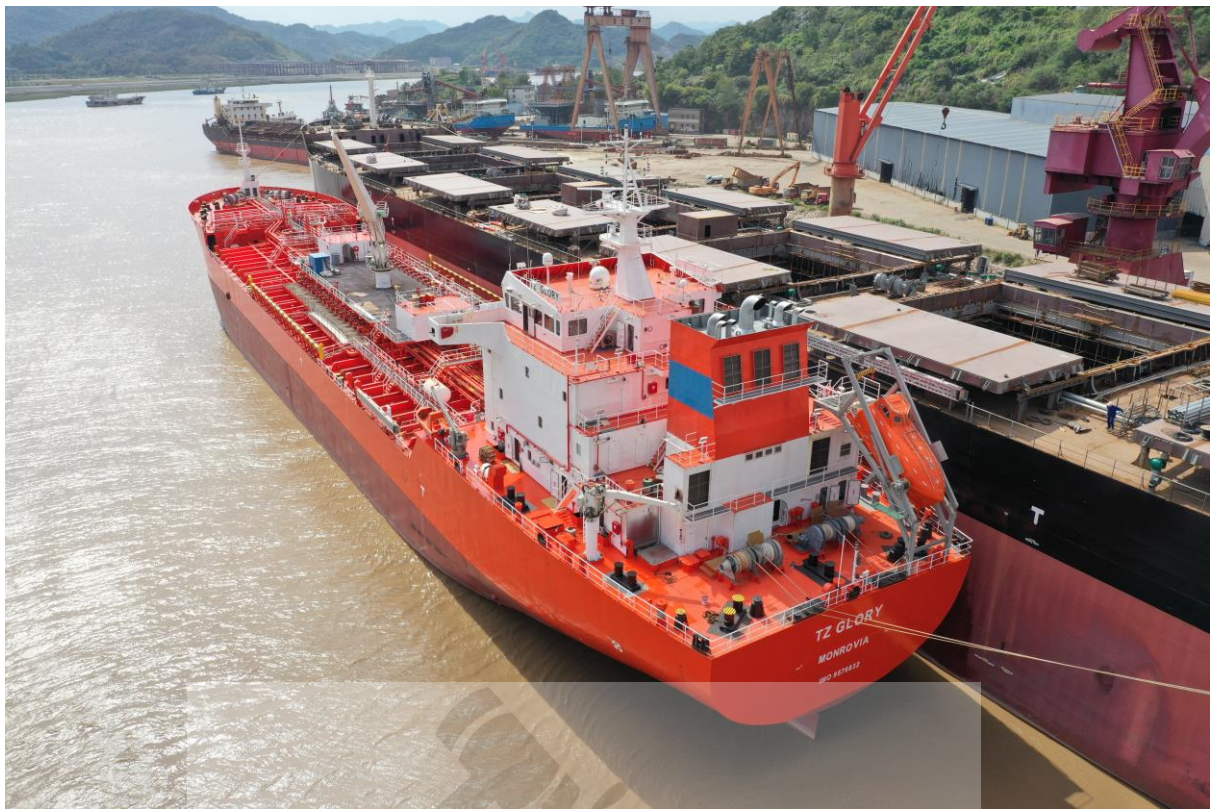
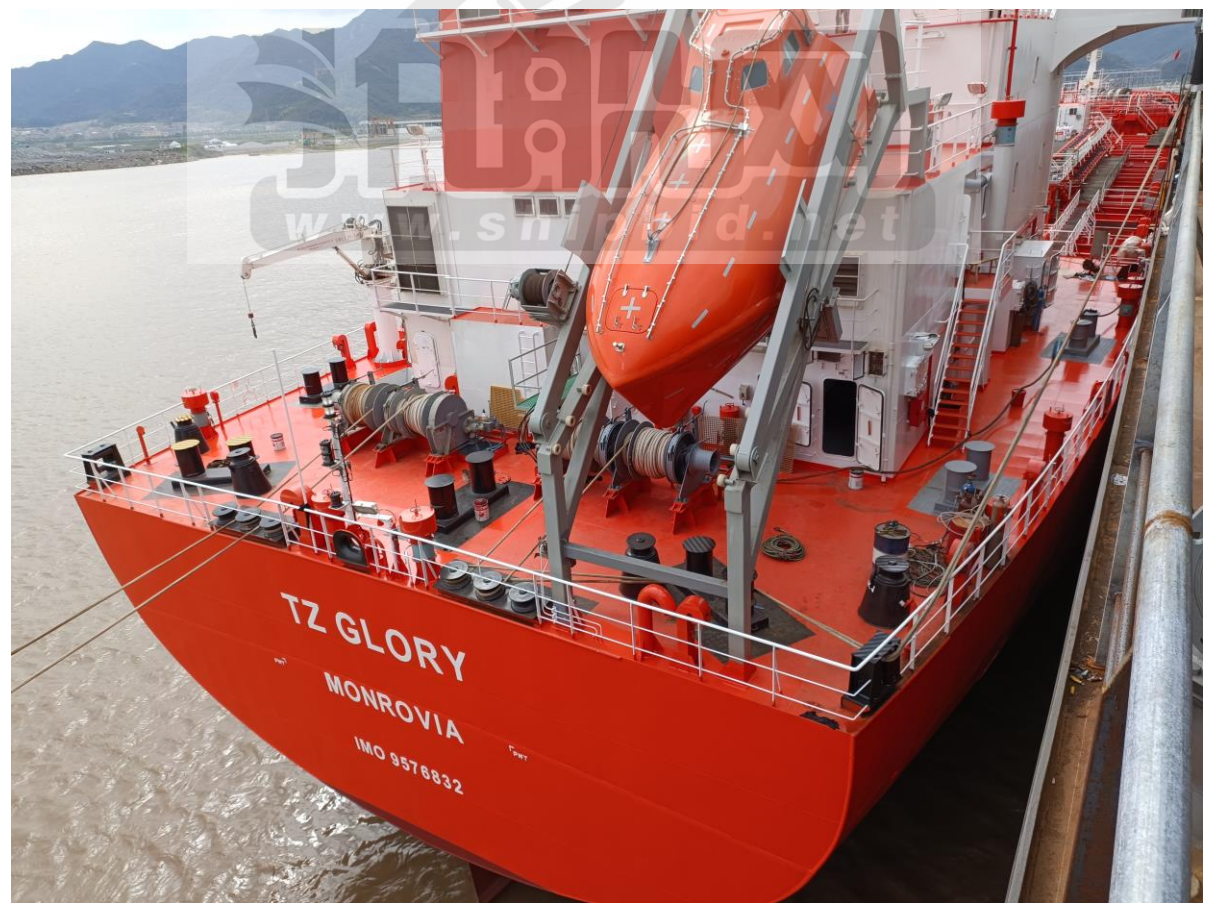
The ship's name, port of registry, load line, tank boundary, tug and other marks on the shell plate were found clear and full painted. The welding seams were found to be good and smooth. The rudder blade and rudder post above the water line were found complete in structure, and the coating at the coupling flange of rudder carrier was found intact, basically without corrosion. The condition of hull under water is unknown.

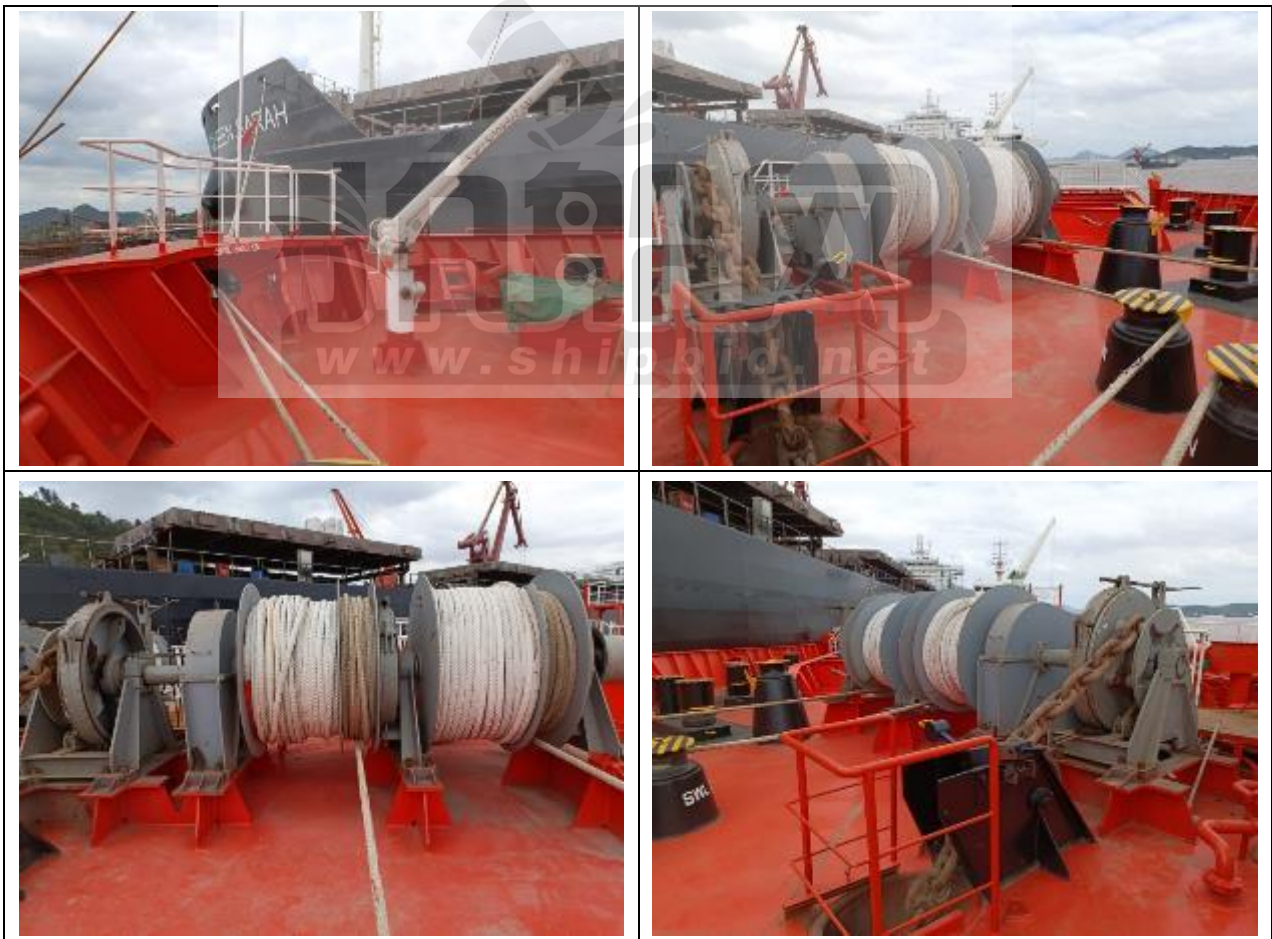
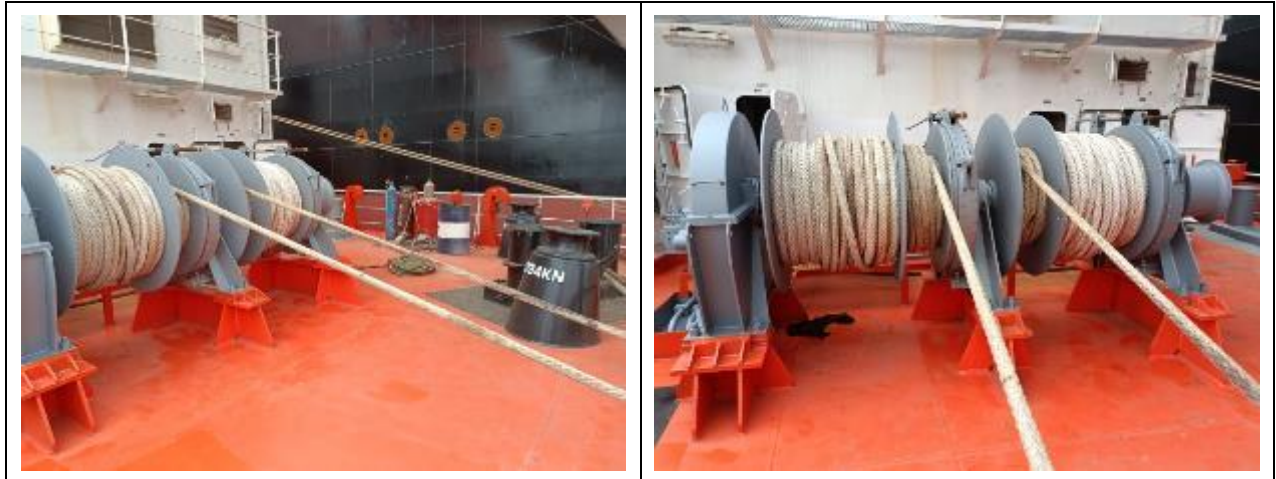
The coating on the forecastle and poop deck was found completely attached, and the coating of the deck bollards and small hatch cover was found basically complete with local damage.

2 sets of windlasses were installed on the forecastle deck, and no obvious corrosion was found on the windlass body, but local slight corrosion was found at the lever chain stopper and the hydraulic pipeline connection. The foundation of windlass was found complete, and the coating of the reinforcing brackets was found complete without obvious corrosion. The anchor chain was found rusted without significant thinning.

2 sets of winches were installed on the aft main deck. The coating of the winch body was found basically complete, and the foundation was slightly rusted.

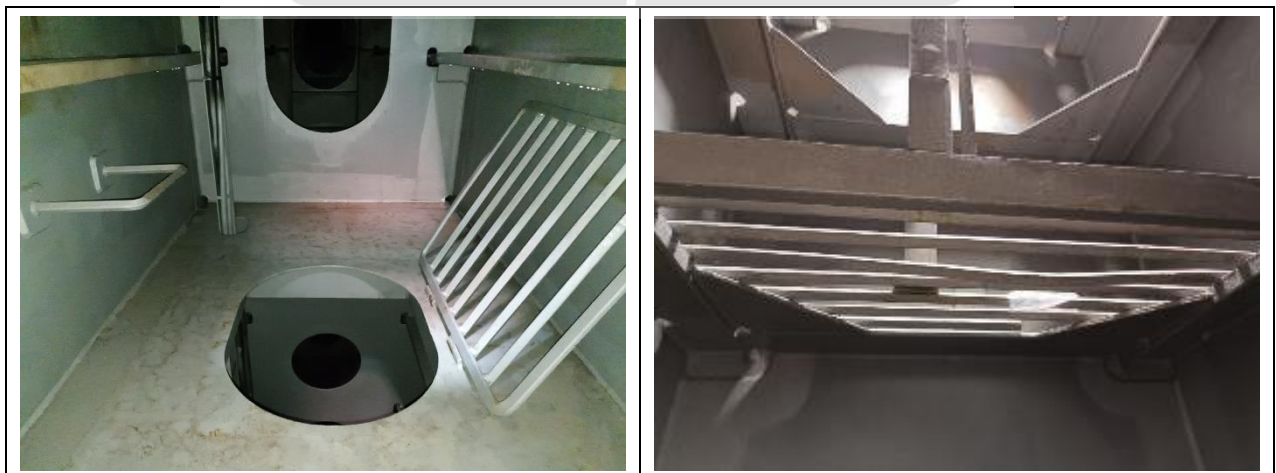
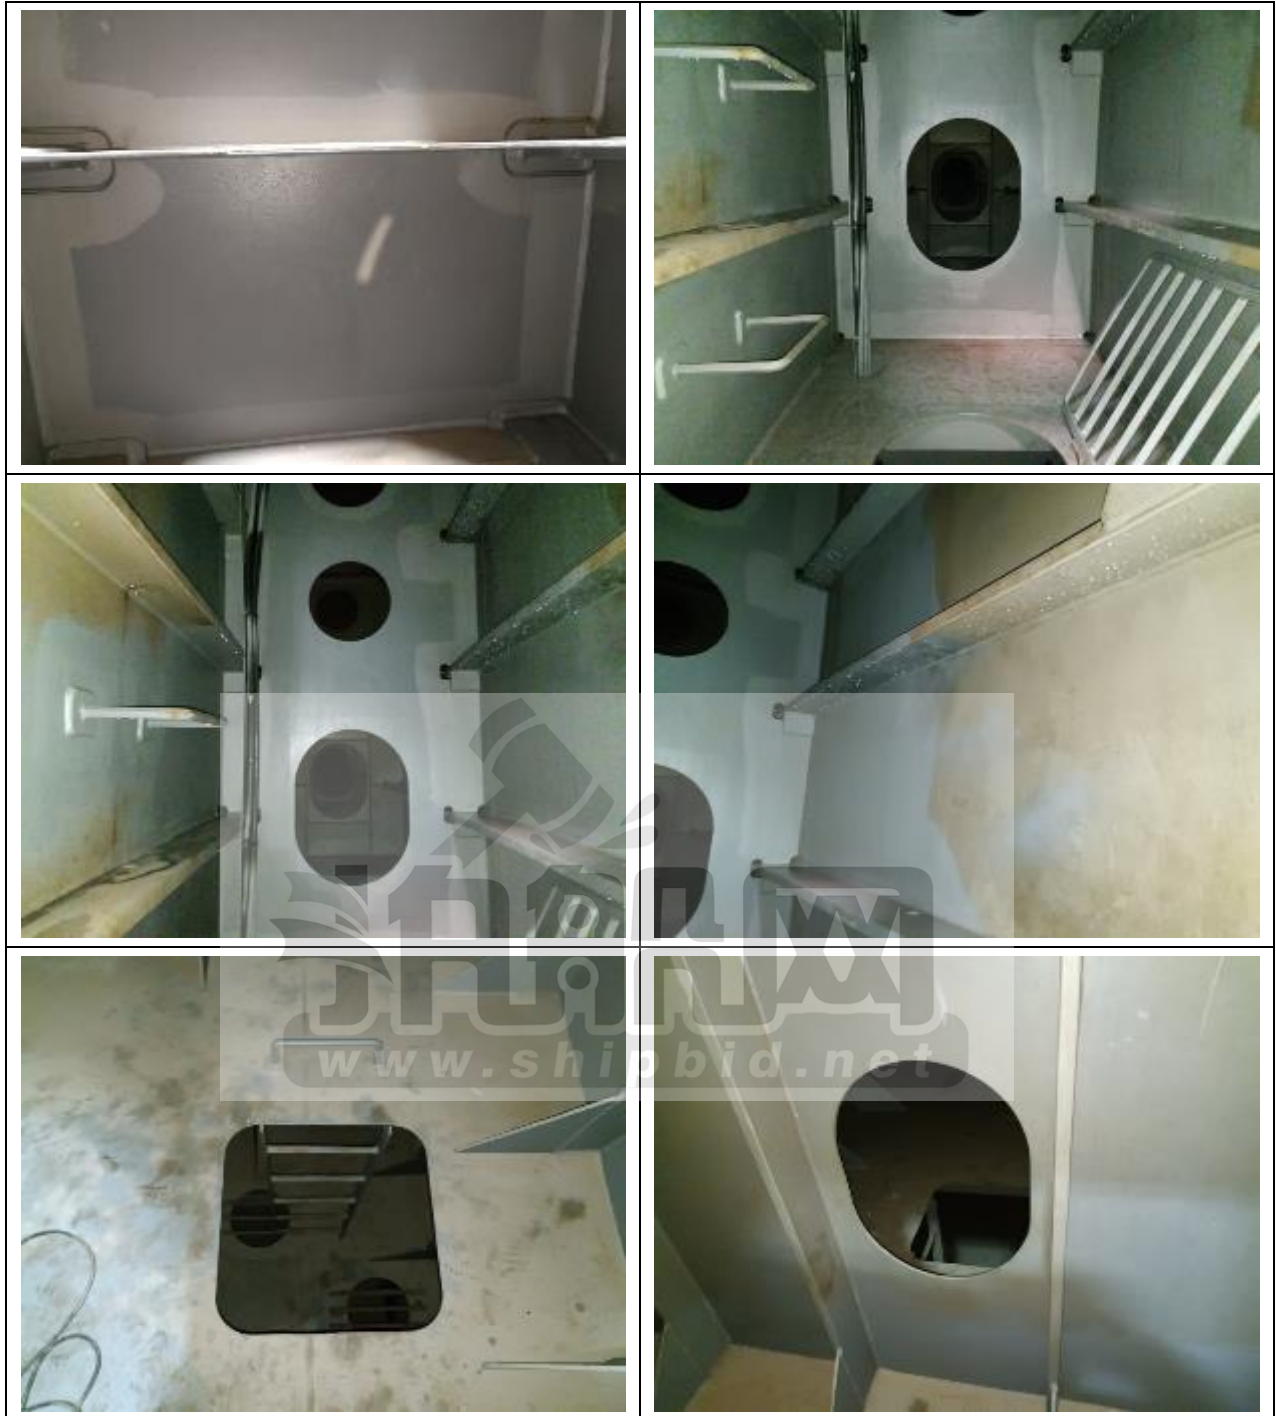
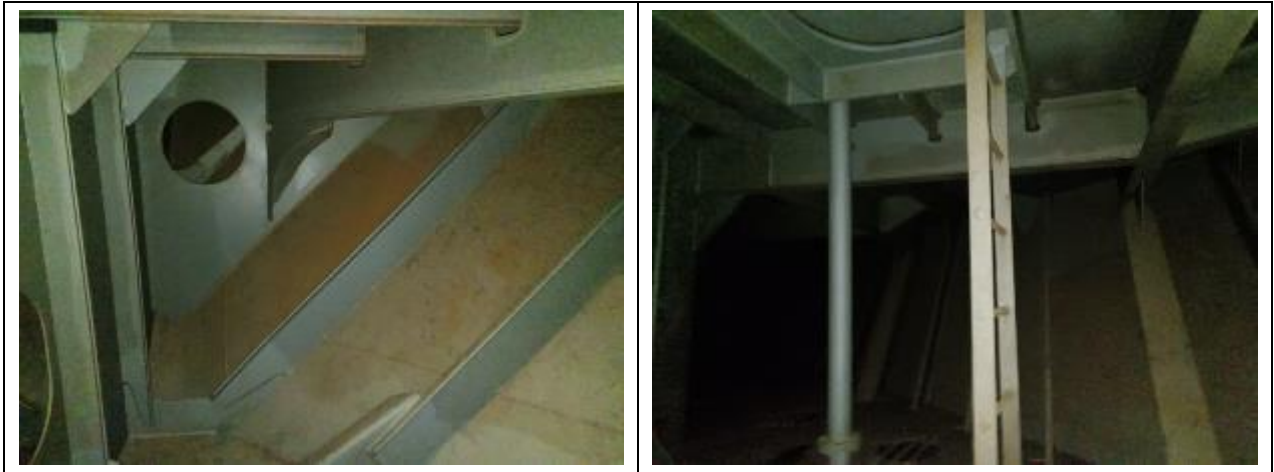
There were 12 ballast tanks (NO.1-6, P&S) with 2 ballast pumps in mid-section: model SB200-3, capacity 400m³/h/set. The frame structure, platform in the side ballast tank were found complete with partial slightly rusted.

The interior structure of the forepeak tank was found complete without deformation and cracks, and the coating was found basically intact without obvious corrosion.

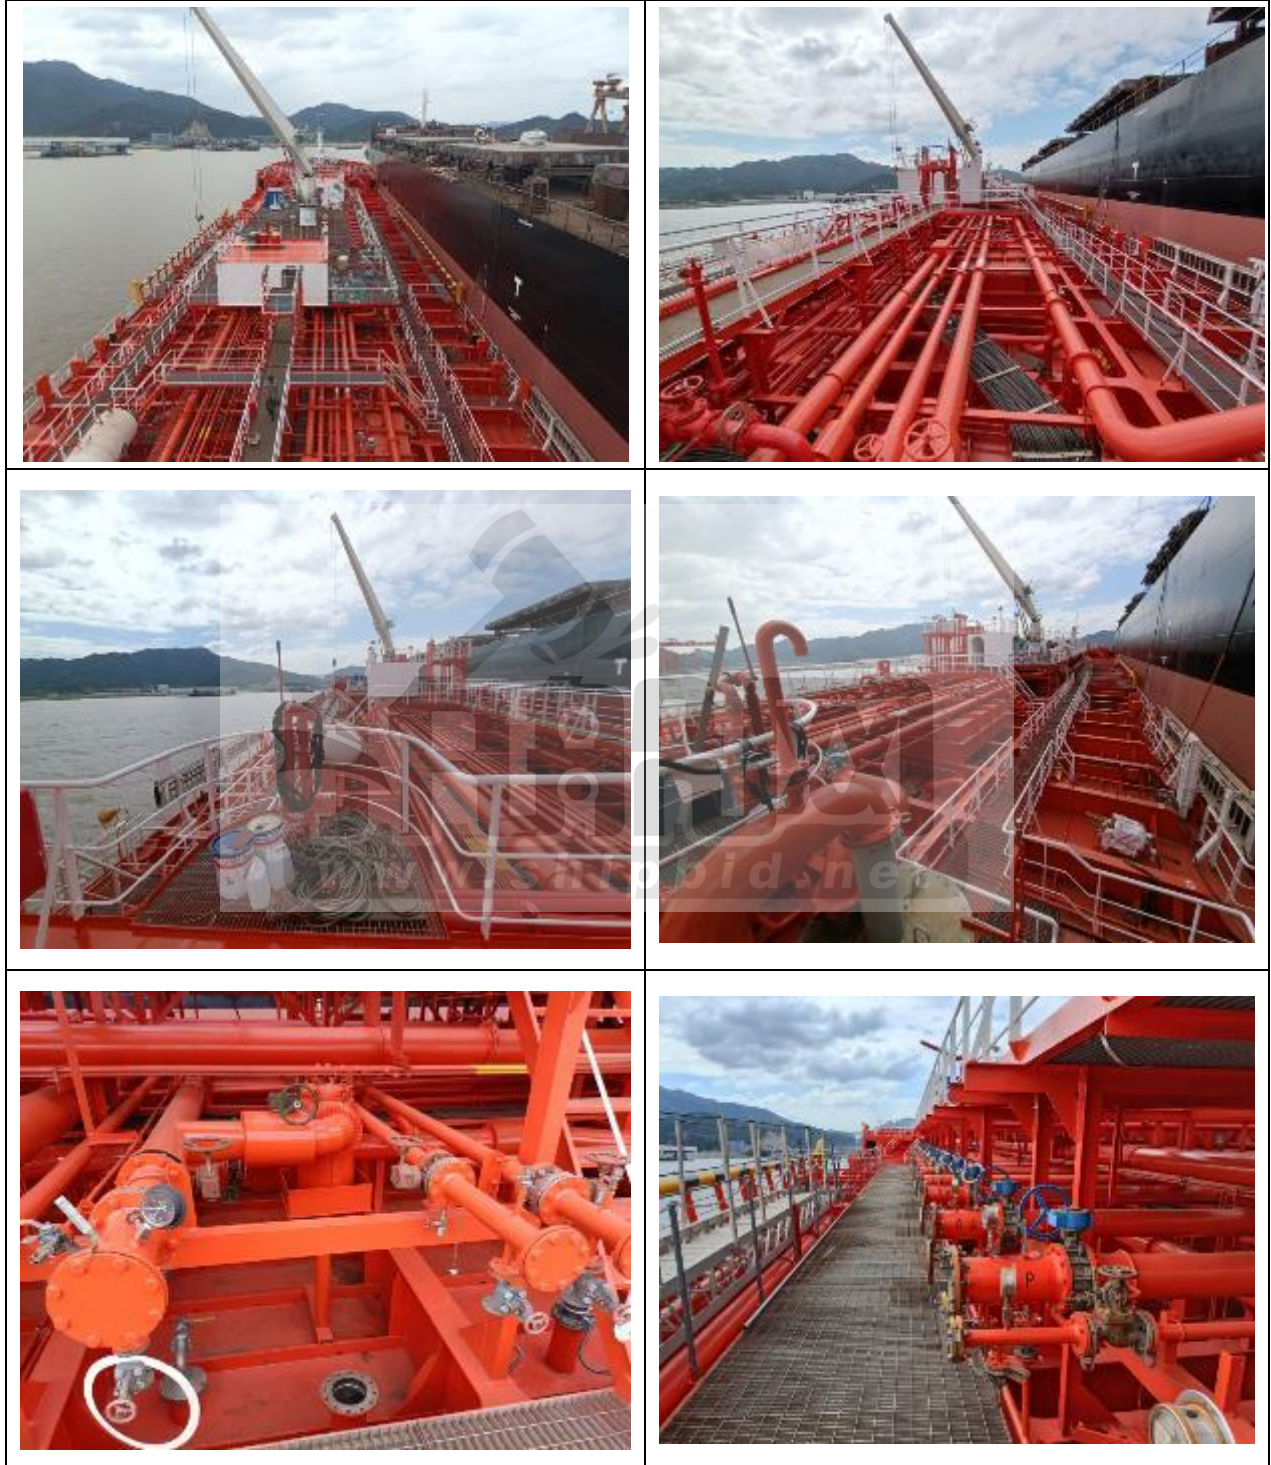
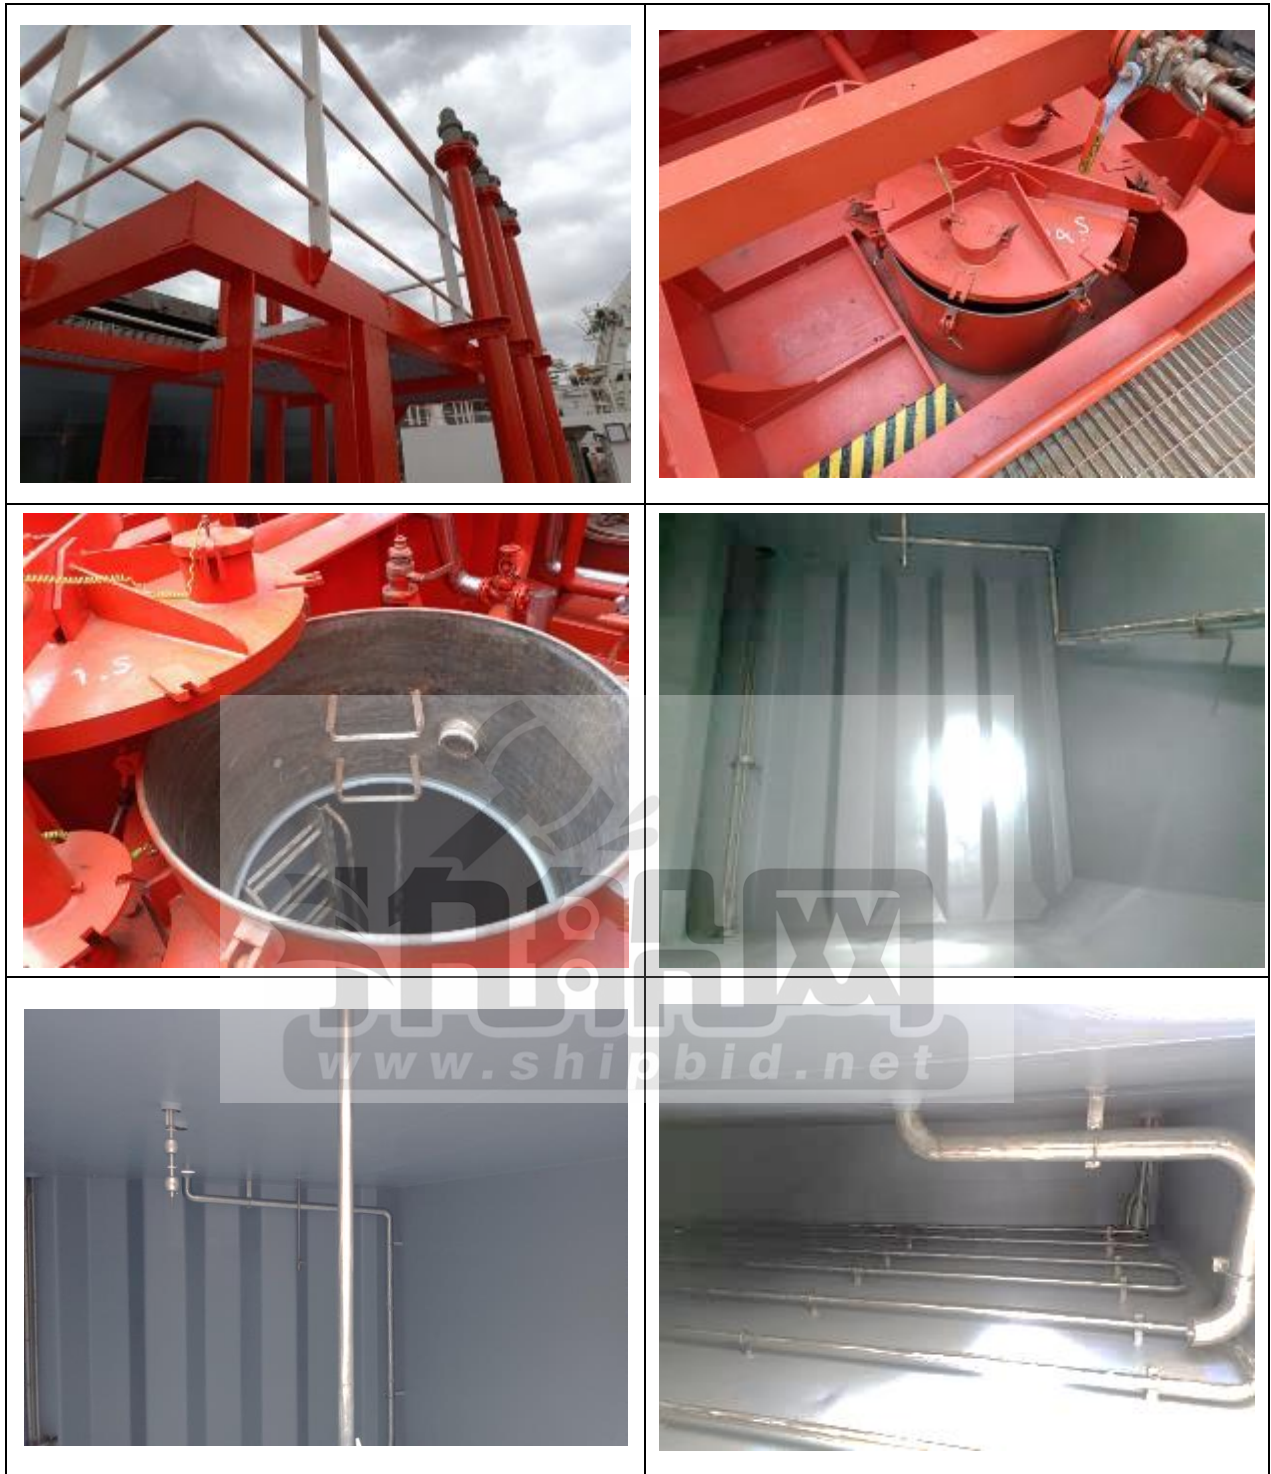
The coating of the flying passage was found basically complete, the grille and railings were intact. There was no obvious corrosion on the cargo tank cover, and the opening / closing mechanism of the tank cover was found flexible without obvious corrosion.

The coating of the deck frames in the cargo tank area was found complete. The deck frames were attached by double-sides continuous welds. The longitudinal and strong beams were found complete without obvious corrosion, deformation and cracks.

The coating of the deck pipeline was found basically intact, and without obvious corrosion on the nozzle flange. The PV vent valves of the cargo tank were found complete without obvious corrosion.

During inspection, except for NO.1 cargo tank (S) and NO 6 cargo tank (S) where were unable to enter, the other rest of the cargo tanks were carried out a general survey. The epoxy coating surface in the tank was found basically complete without damage or aged. The ladder,

temperature monitoring and liquid level monitoring pipelines were all made of stainless steel, with relatively good appearance. As informed by the ship staff, partial touch-up has been done recently.

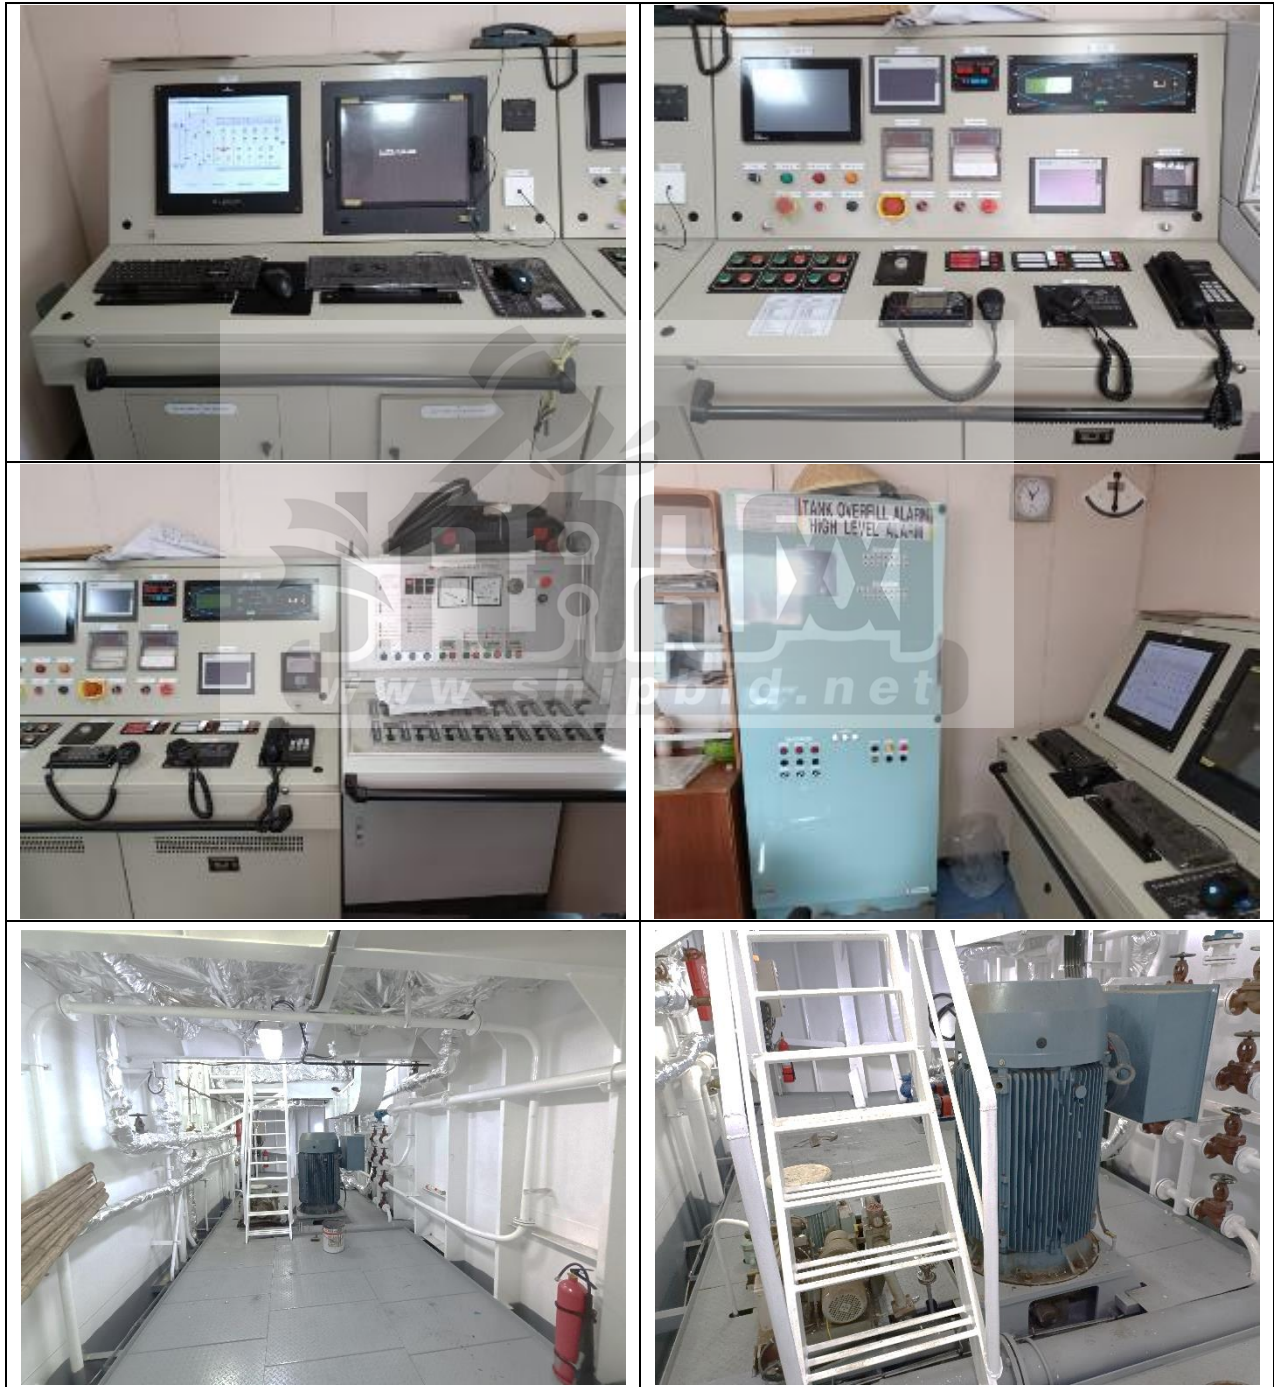
During the inspection, the monitoring screen was found in working condition, and all monitoring data and parameters were clear and complete.

The ship is equipped with a set of FRAMO hydraulic valve control station on the main deck, and the drive motor is ABB. The appearance of the equipment was found in good condition, and no obvious corrosion on the hydraulic pipeline, and the fireproof insulation laying was found complete without obvious damage.

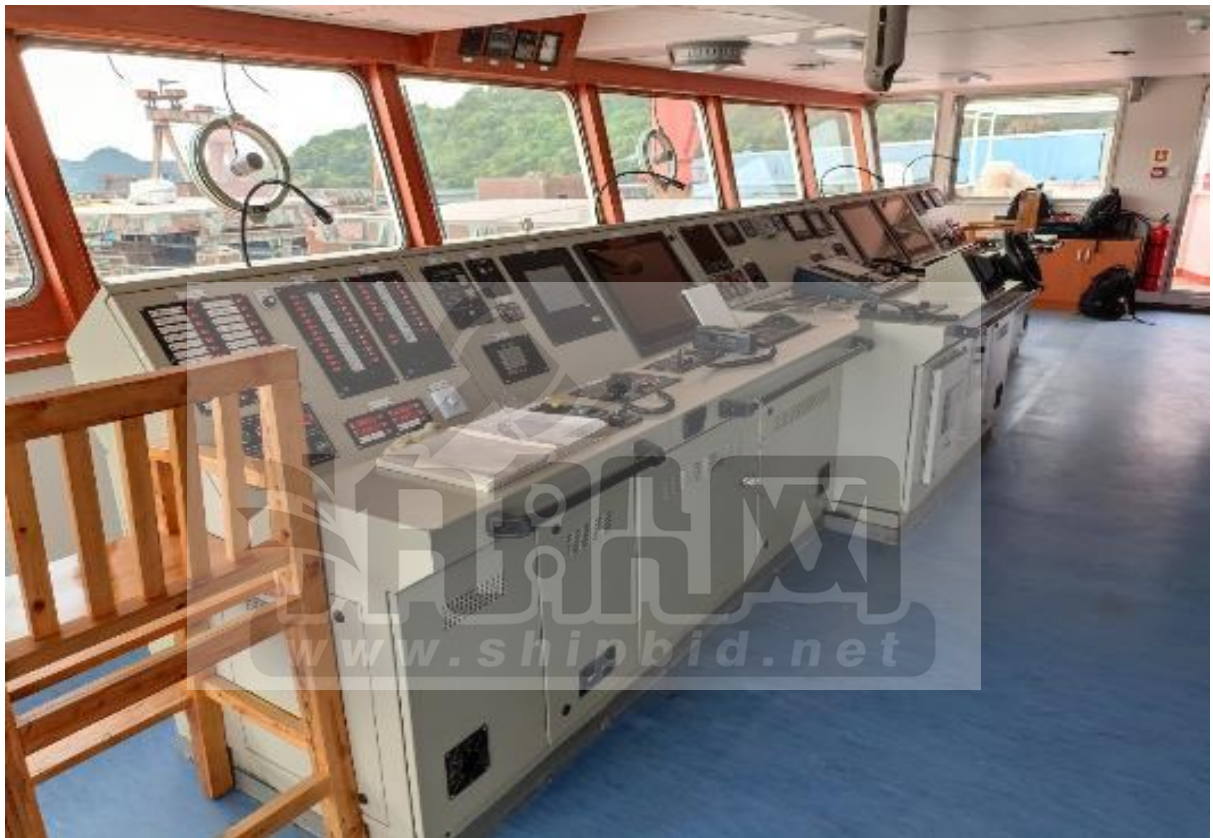
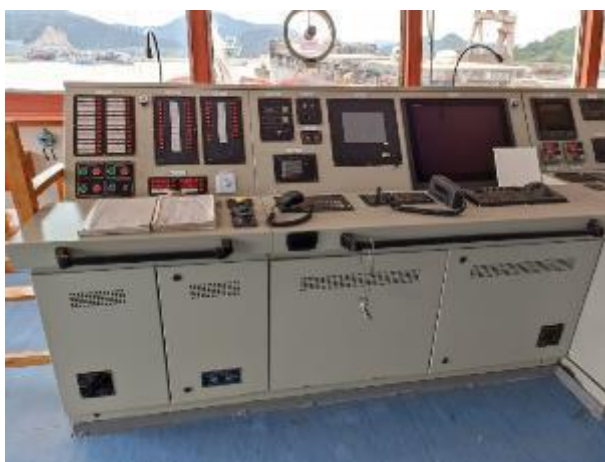
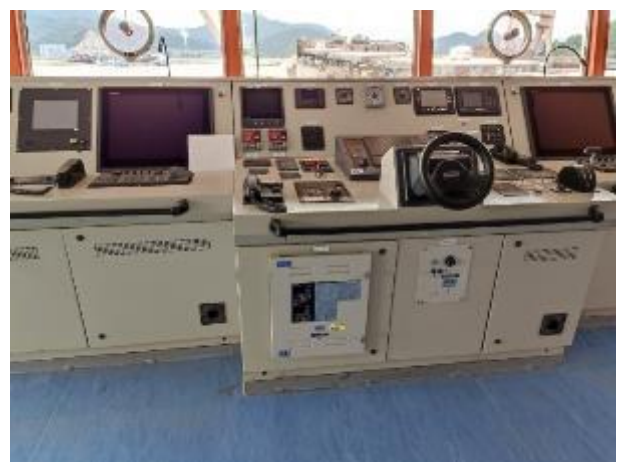
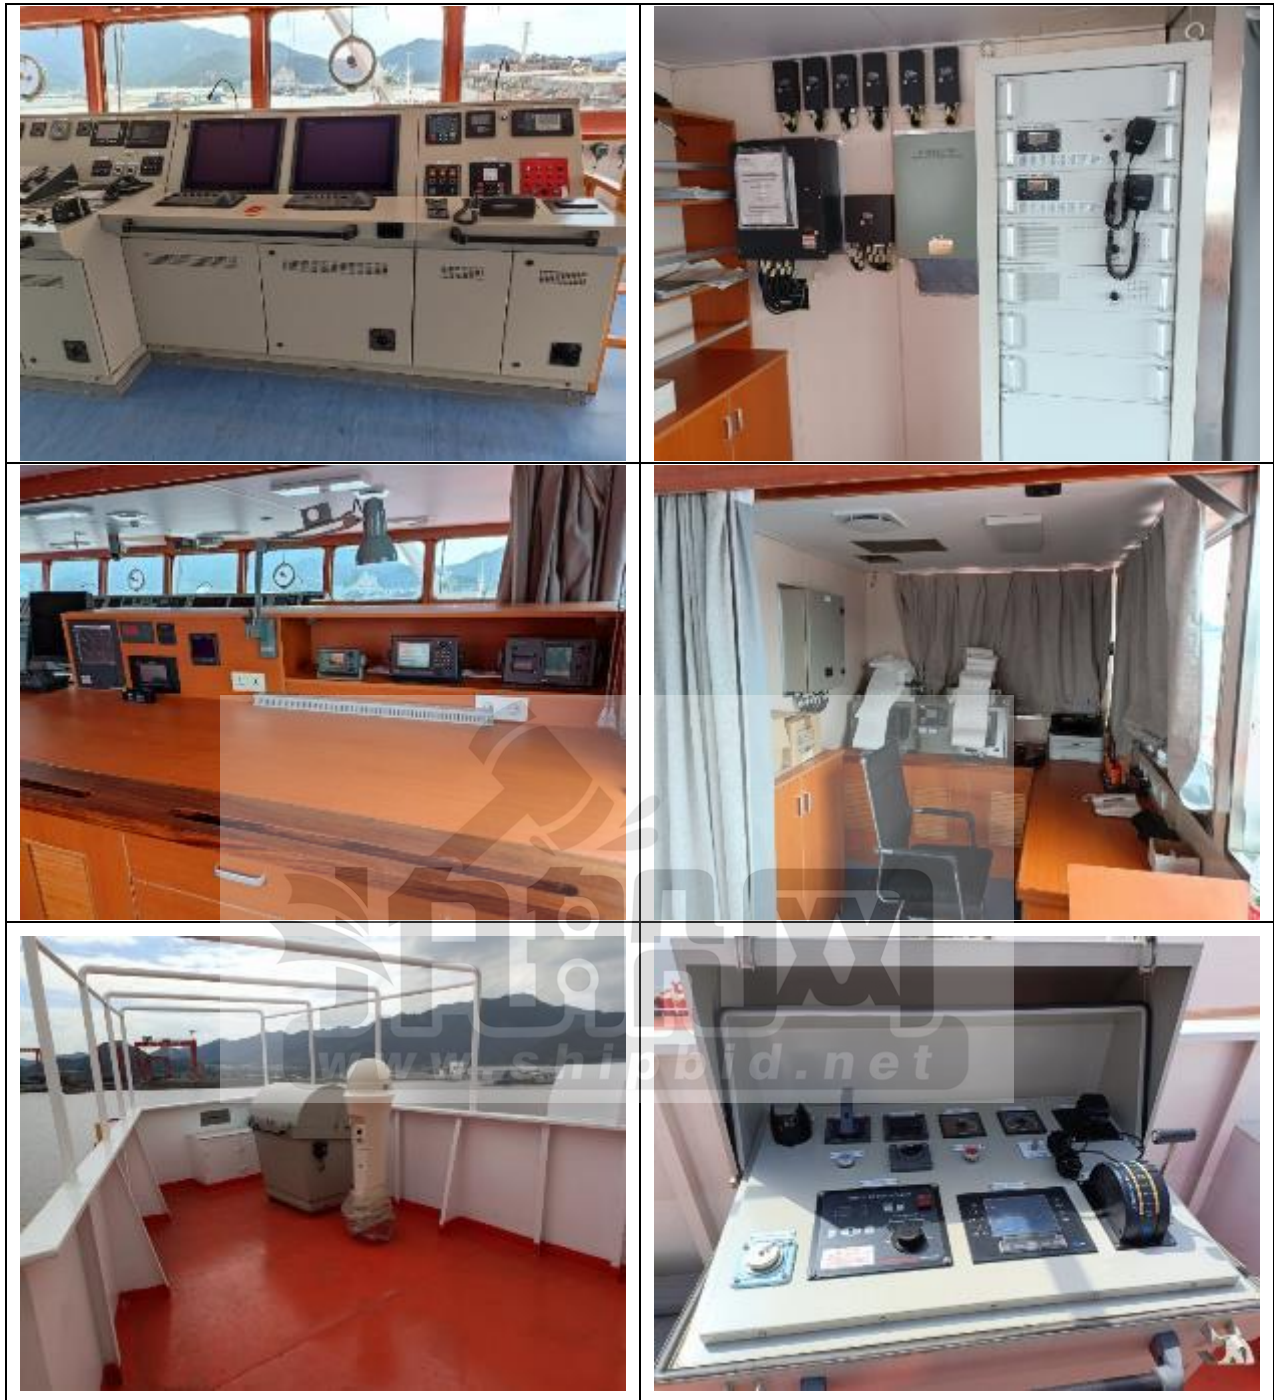
The cleanliness of wheelhouse was found in good condition, and no obvious damage on the insulation laying and decoration facilities. The bridge equipment was found complete with good appearance. The wheelhouse is equipped with chart, navigation books, national flags, and information such as oil pollution emergency plan deployment tables. 2 sets of azimuth compasses were equipped outside the wheelhouse.

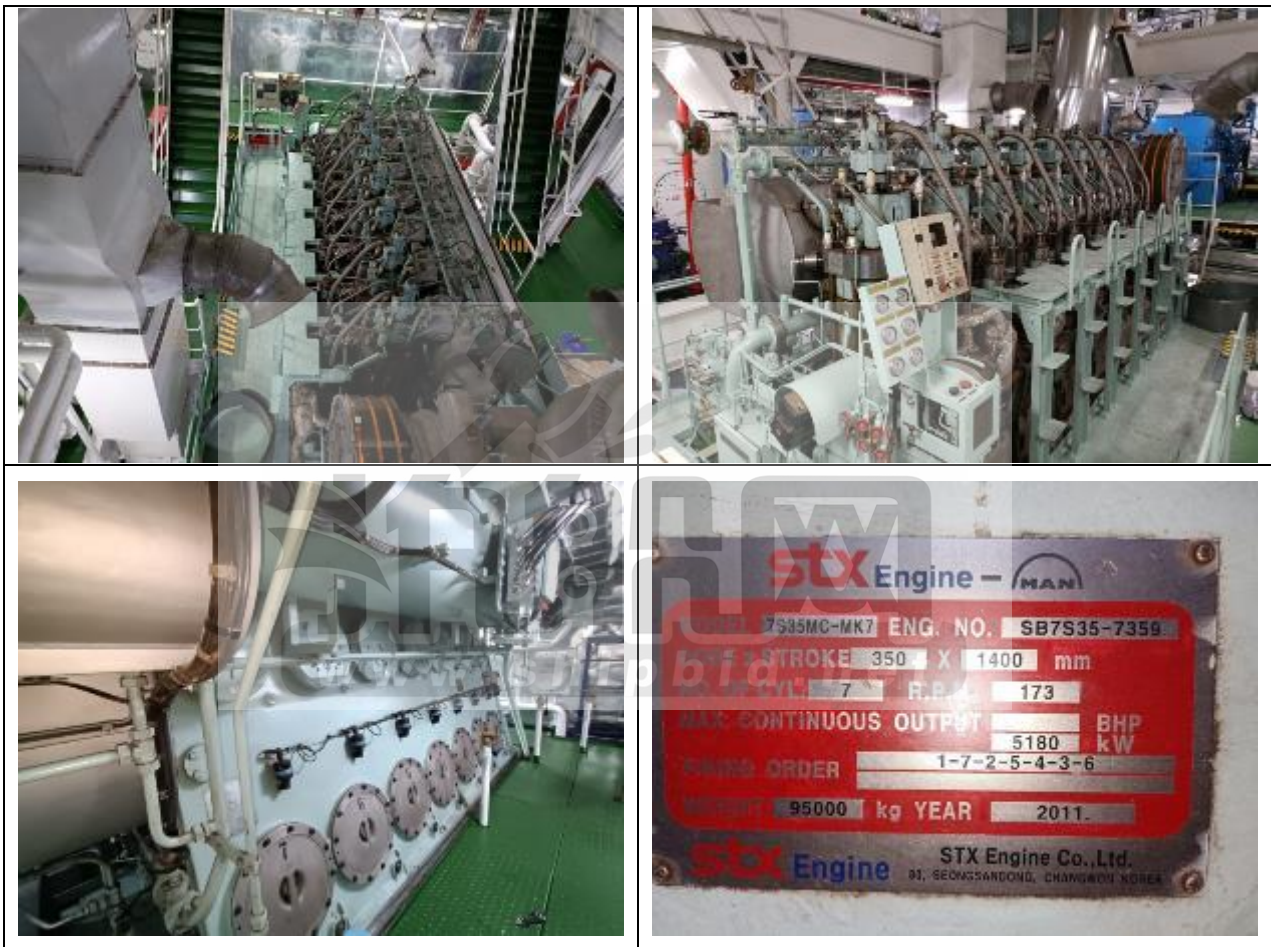
The surface coating of the main engine was found basically complete, no obvious leakage was observed, partial pipelines were found slightly rusted, and the nameplates were found complete and clear. The main engine was built in 2011.

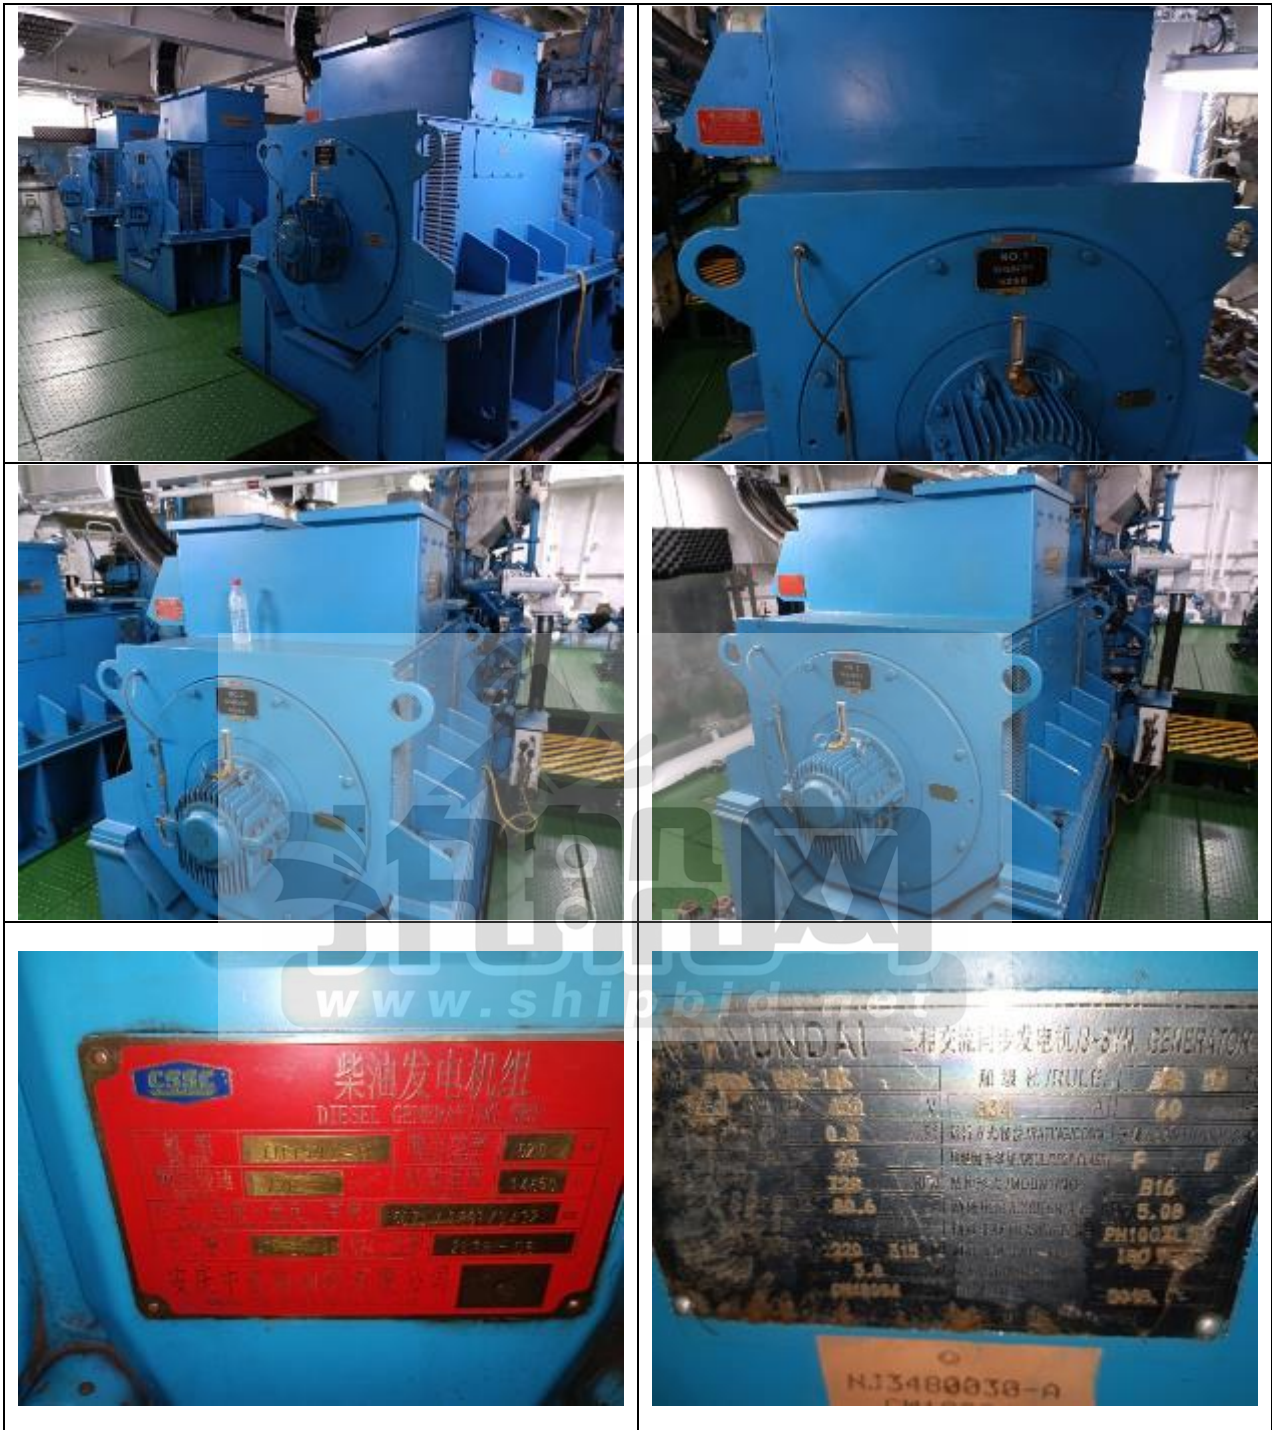
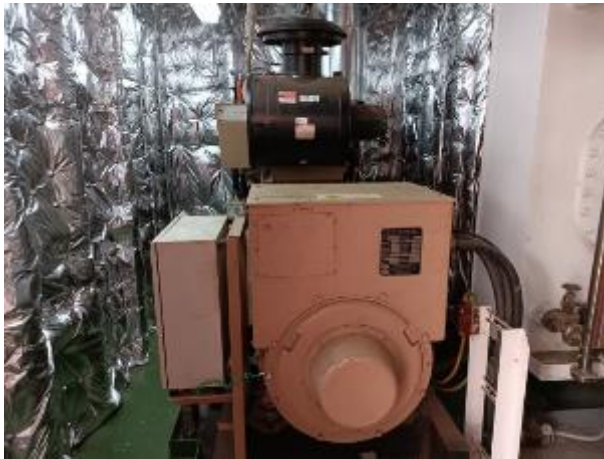
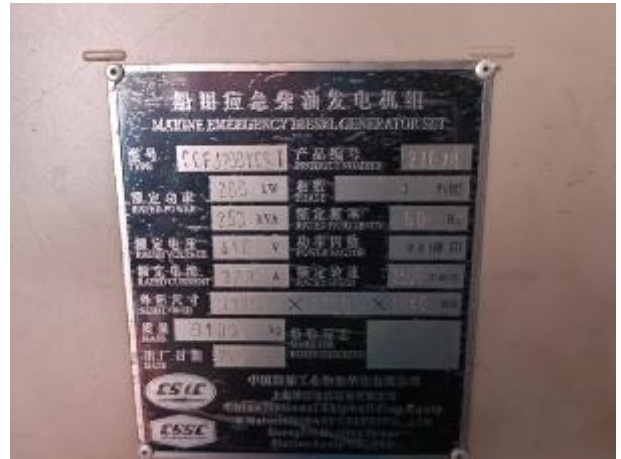
The coating of main generator was found basically complete without obvious oil stain on the foundation. No obvious damage was found on the cable, and the nameplate was identified clearly.

The watertight door of the emergency generator room was found complete in structure, the indoor fire insulation was laid in place, the generator set was found normal in appearance,

and the nameplate was identified clearly.
