M.T. TZ GLORY

TECHNICAL REPORT

No.: CJPG-JS-22-KY-468

TECHNICAL REPORT of MT TZ GLORY

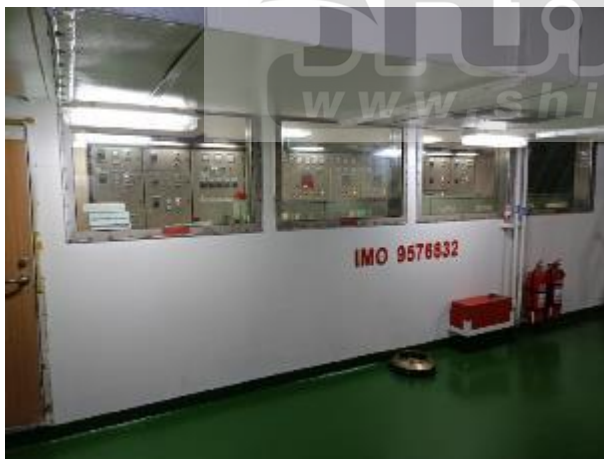
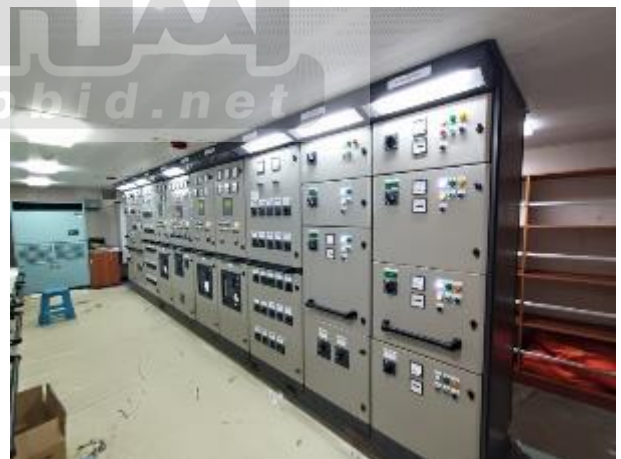
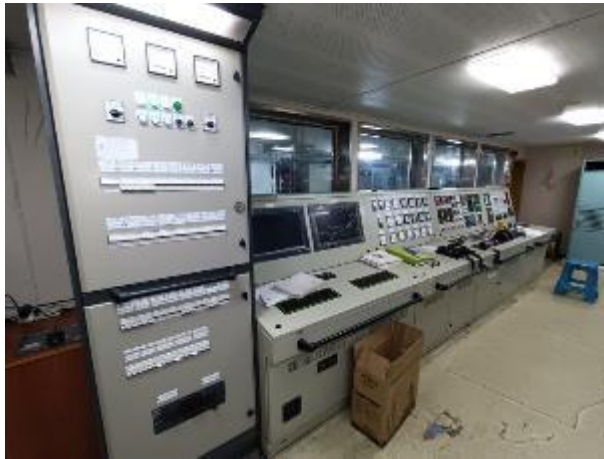
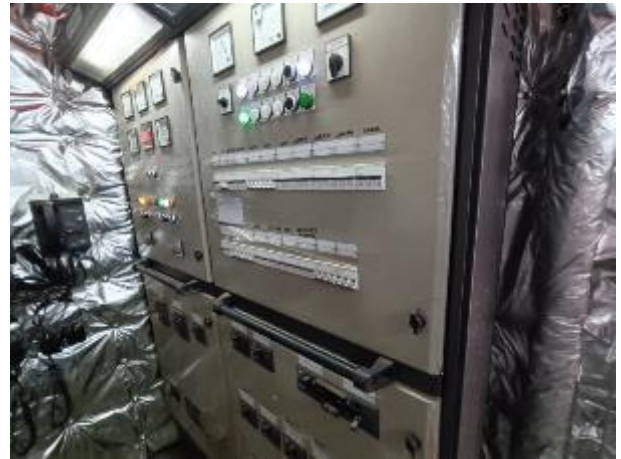
The self-closing door of the engine control room and the indoor fire insulation laying were found basically complete. The console and main switchboard were located in the house. The structure in the room was found complete with good appearance. The appearance of the monitoring instrument was found normal, the indicator lights and button protection devices were basically complete without damage.

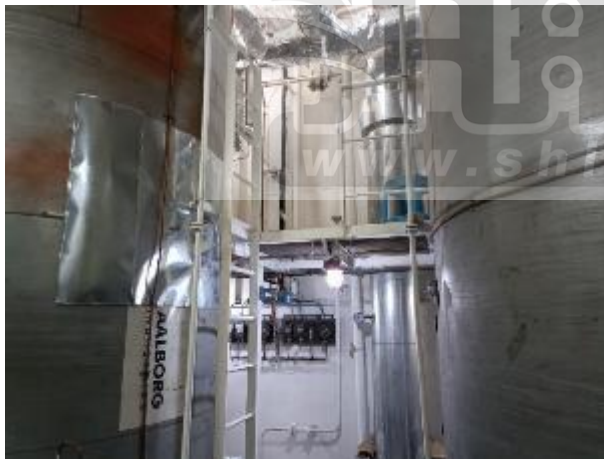
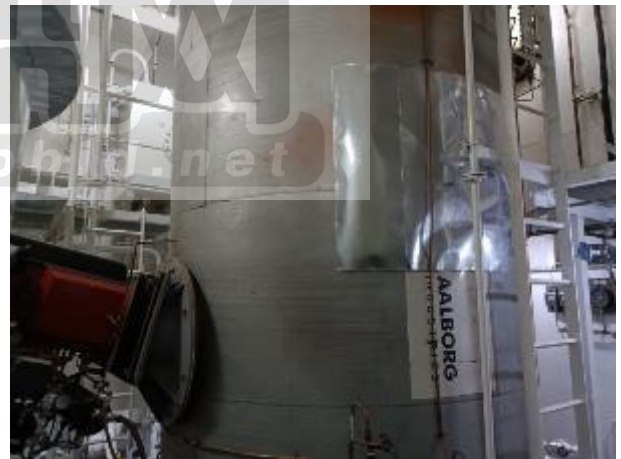
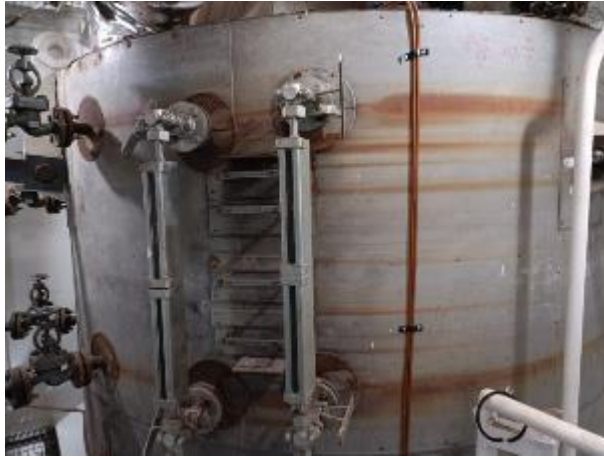
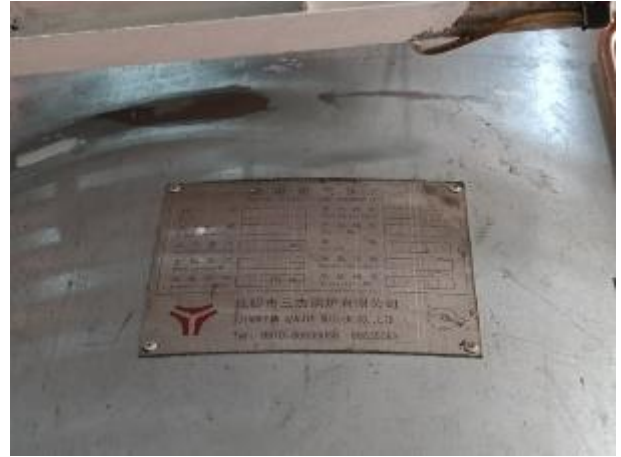
The ship is equipped with 2 sets exhaust gas combined boilers for fuel oil heating and daily use. The boiler body was found complete in the structure without obvious corrosion. The insulation laying of the boiler air duct and exhaust pipe was found no obvious damage, and the nameplate was identified clearly.

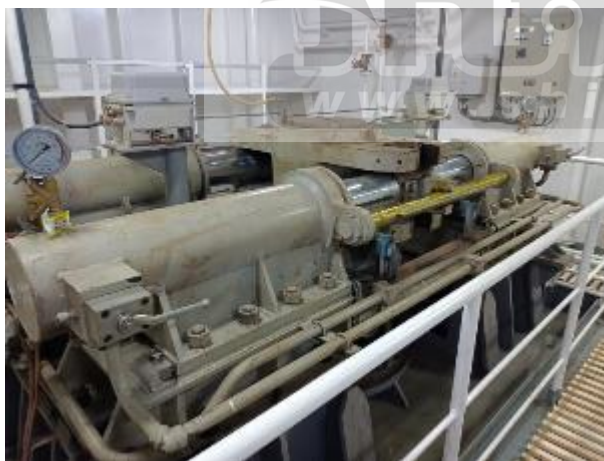
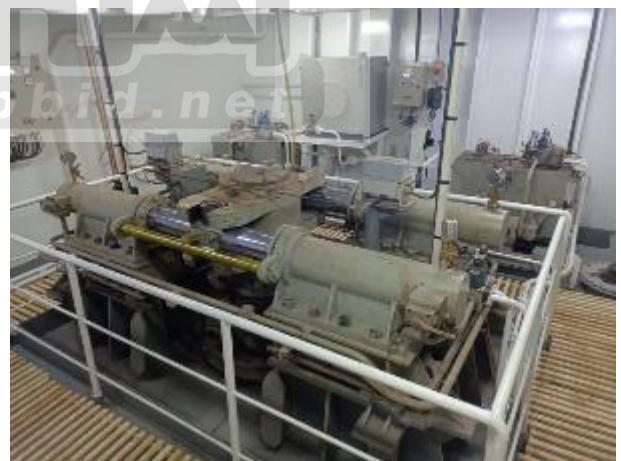
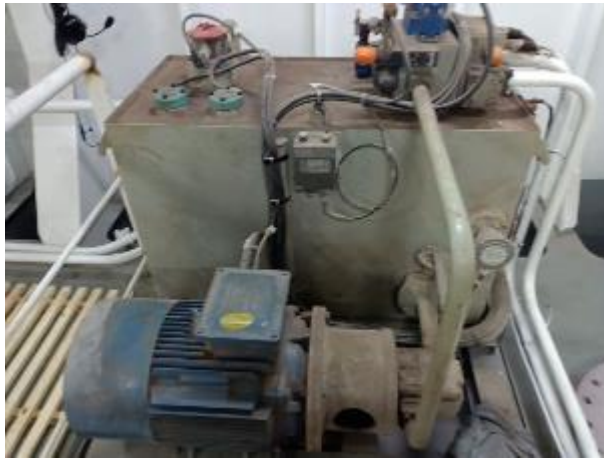
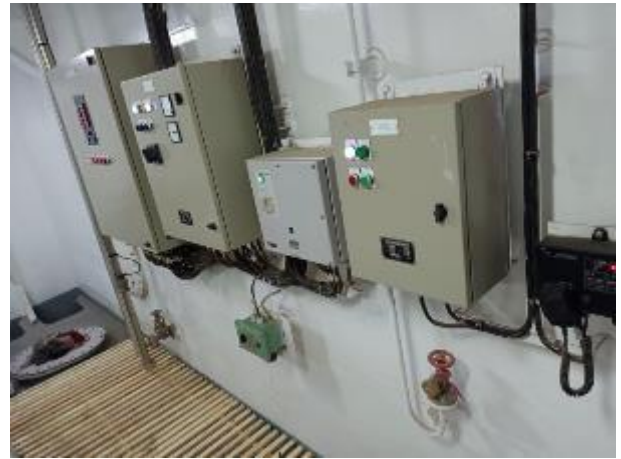
The protective railings in the steering gear room were found complete, the liquid level gauge of the hydraulic oil tank was at the normal oil level. The rudder angle indicator has been calibrated with the rudder angle indicator on the bridge. The coating of steering gear was found to be in good condition, and oil cylinder was free from obvious leakage.

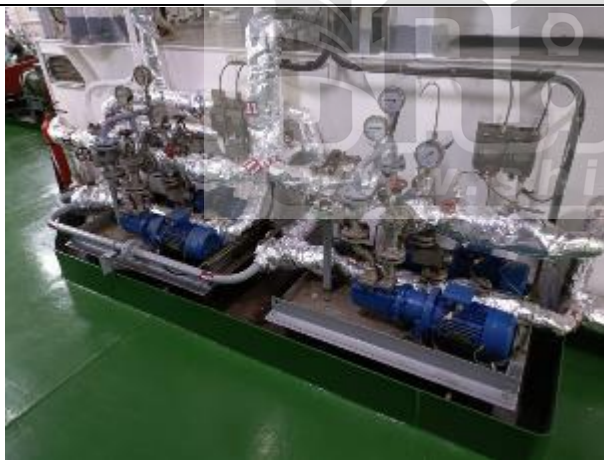
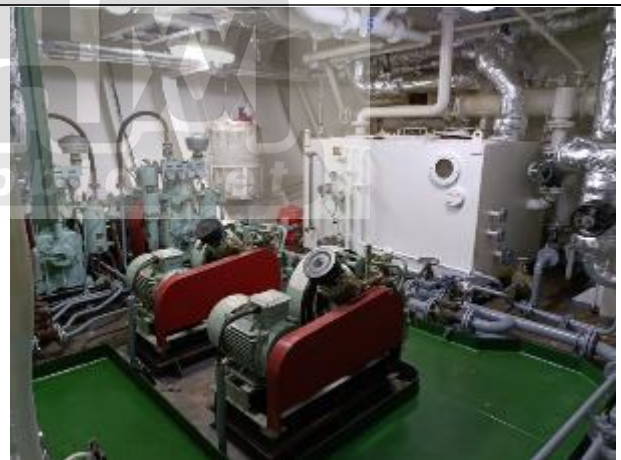
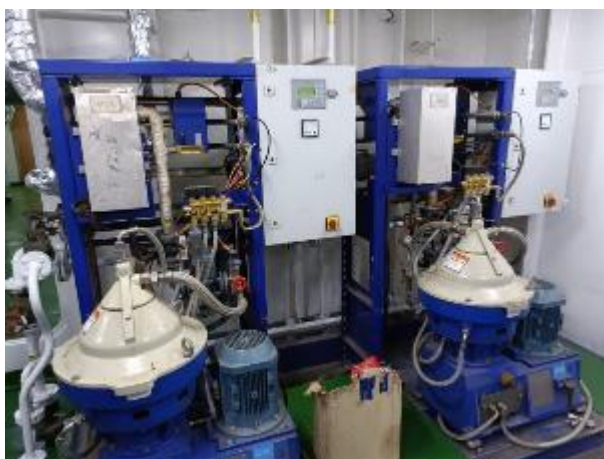
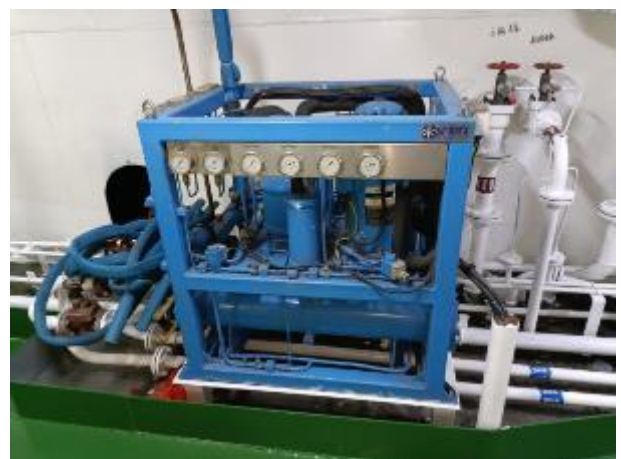
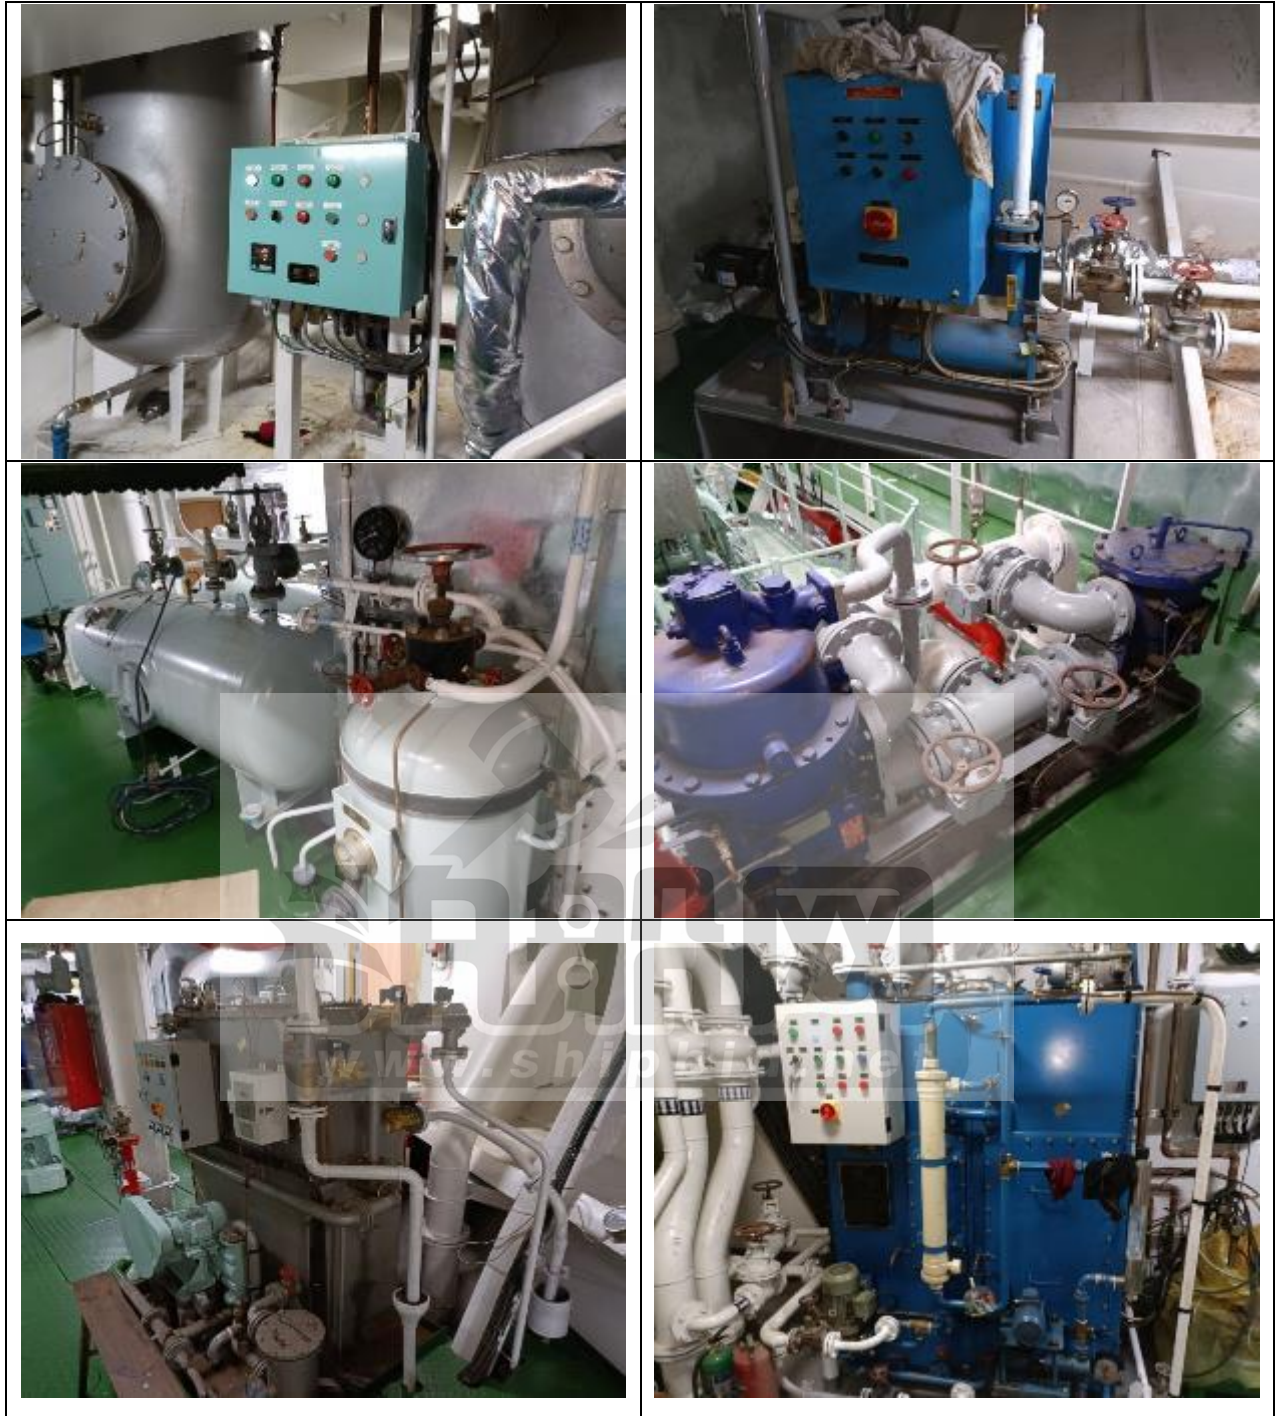
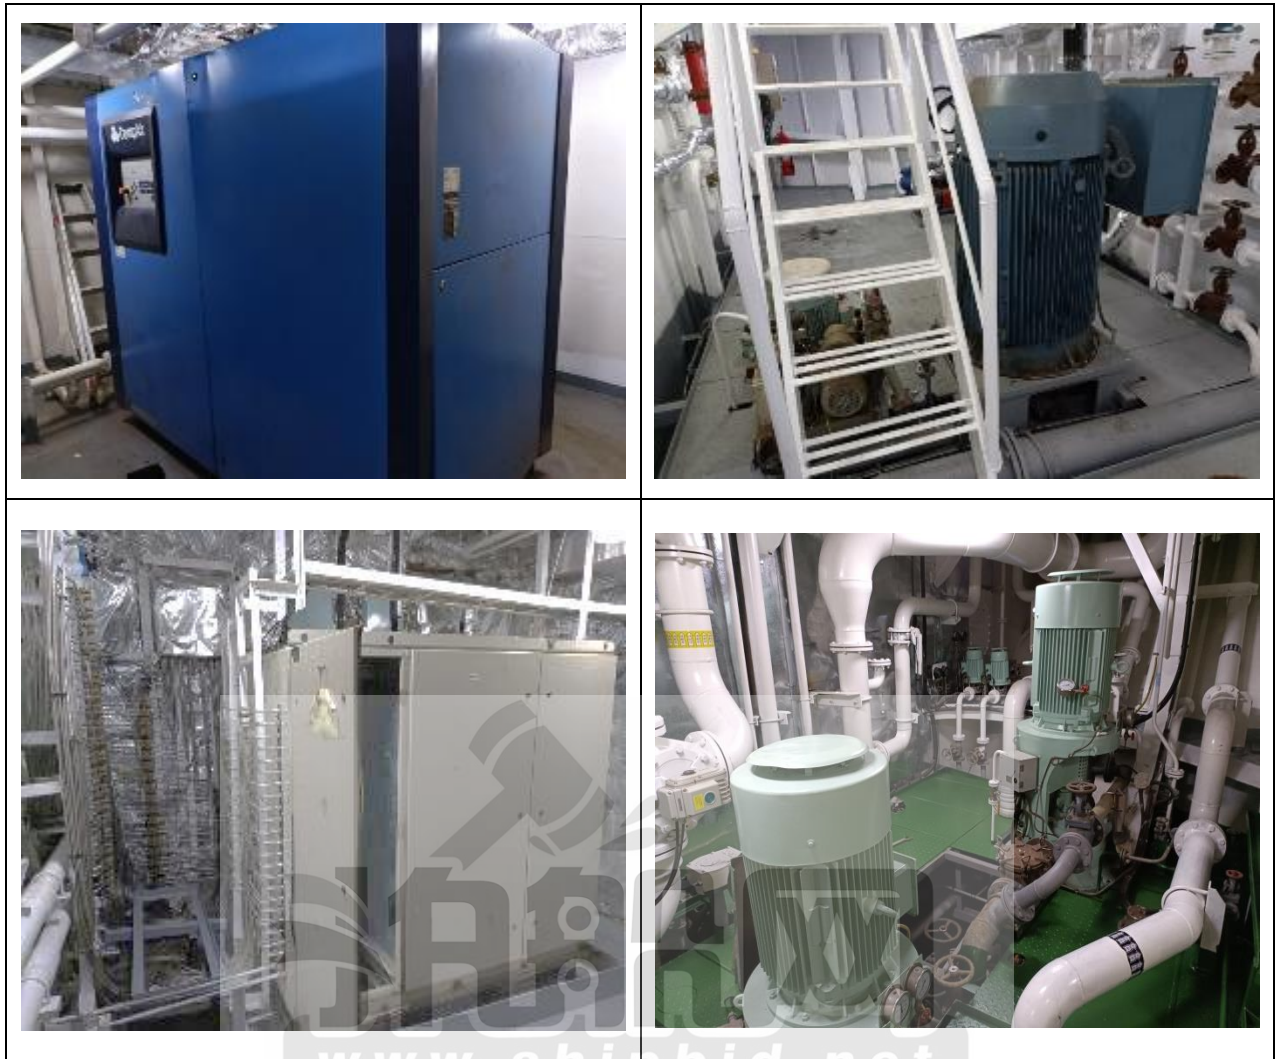
The engine room is equipped with air compressor, air reservoir, fuel conditioning module, oil separator, oil-water separator, sewage treatment plant, various pumps and motors, etc. No obvious abnormality was found in the appearance, without oil stain.

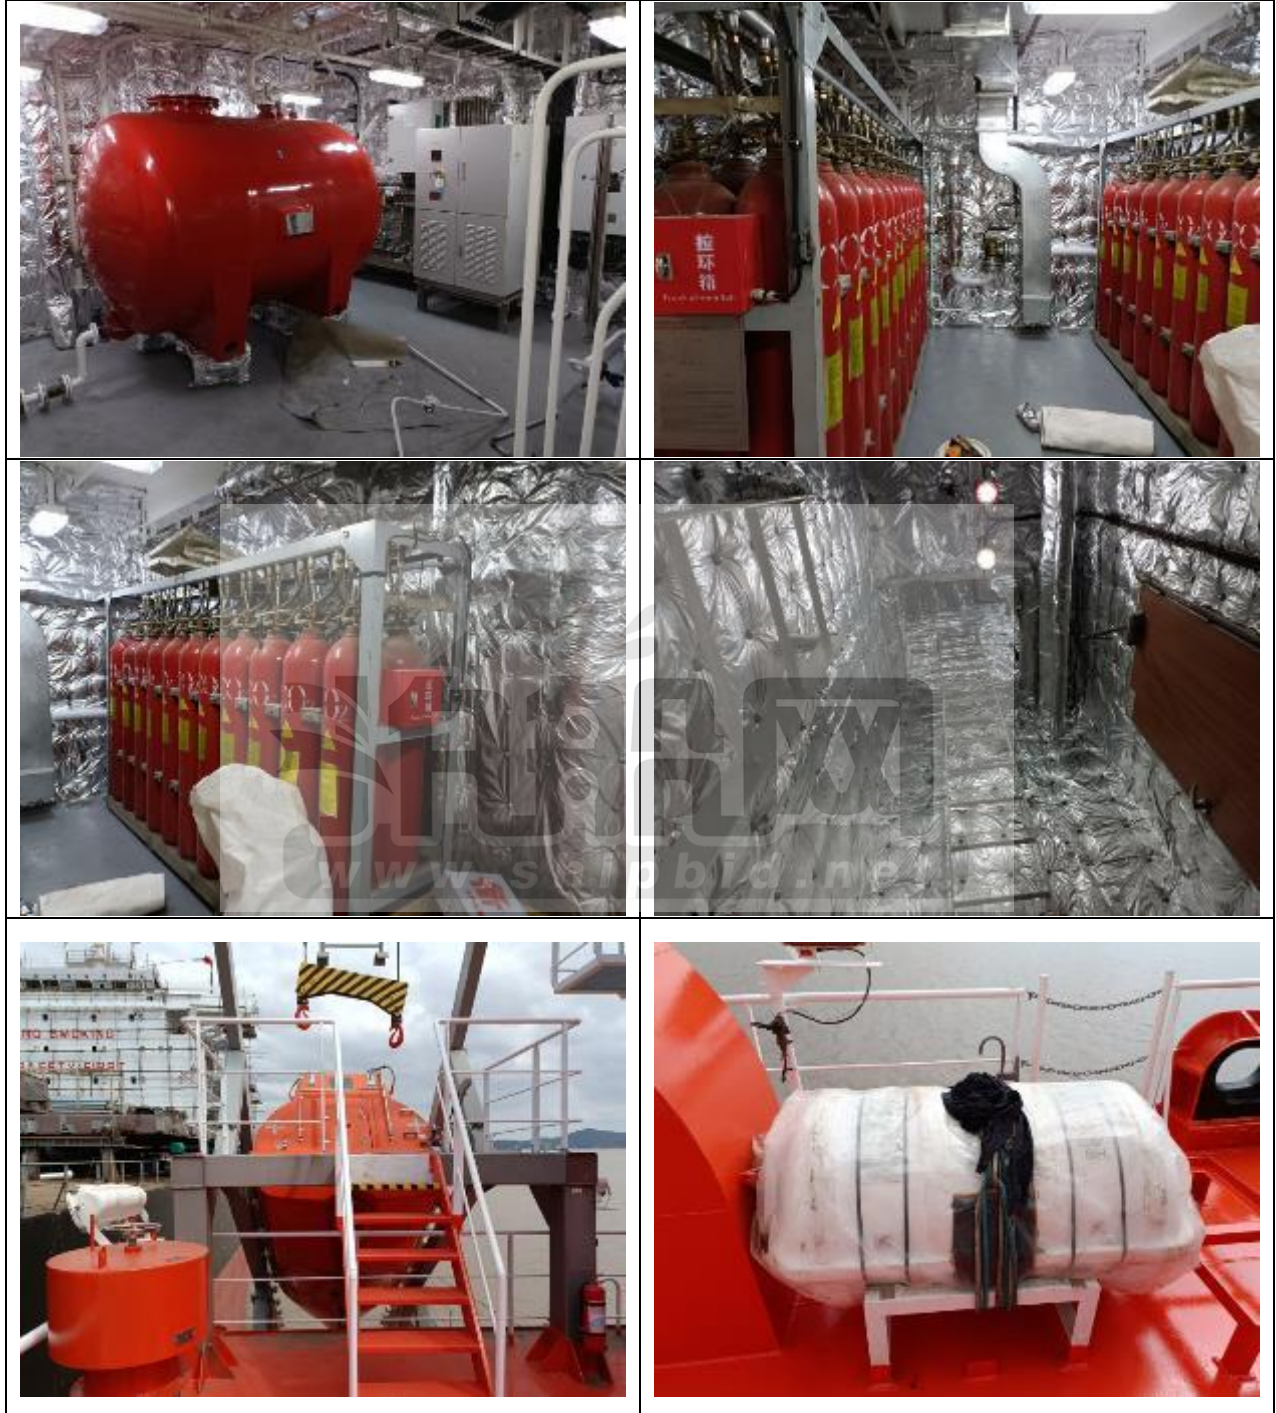
The fire insulation of foam room was found laid in place, and the foam generator and pipeline were found basically free of corrosion. The inspection marks were found complete.

The weather tight door of CO2 room was found complete, and the indoor fire insulation was laid in place. The release valve and pipeline of CO2 bottle were found free of obvious corrosion. The appearance of the release control cabinet was found to be in good condition and the operation instruction and inspection marks were found complete.

The fire insulation of the emergency passage in the engine room was found laid in place without damage. The appearance of the self-closing door was normal, and the life ladder in

the channel was found complete and in good condition.

The ship was equipped with one lifeboat at the stern, without obvious crack and damage on the hull external.
