TECHNICAL REPORT

编号: CJPG-JS-23-KY-199

Place of Inspection: Panzhi Island, Zhoushan Port

Technical Report of MV “PU HUI 2”

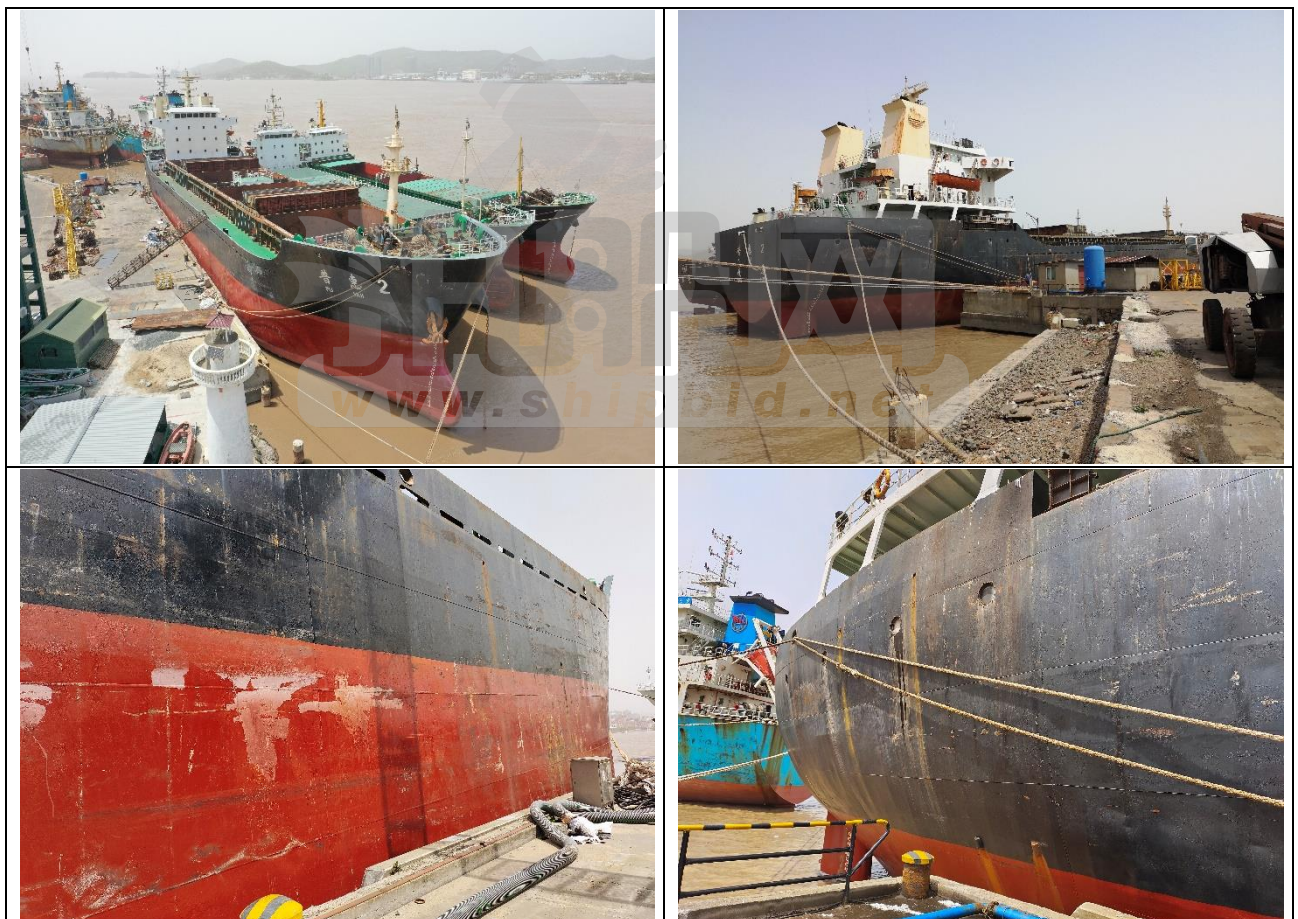
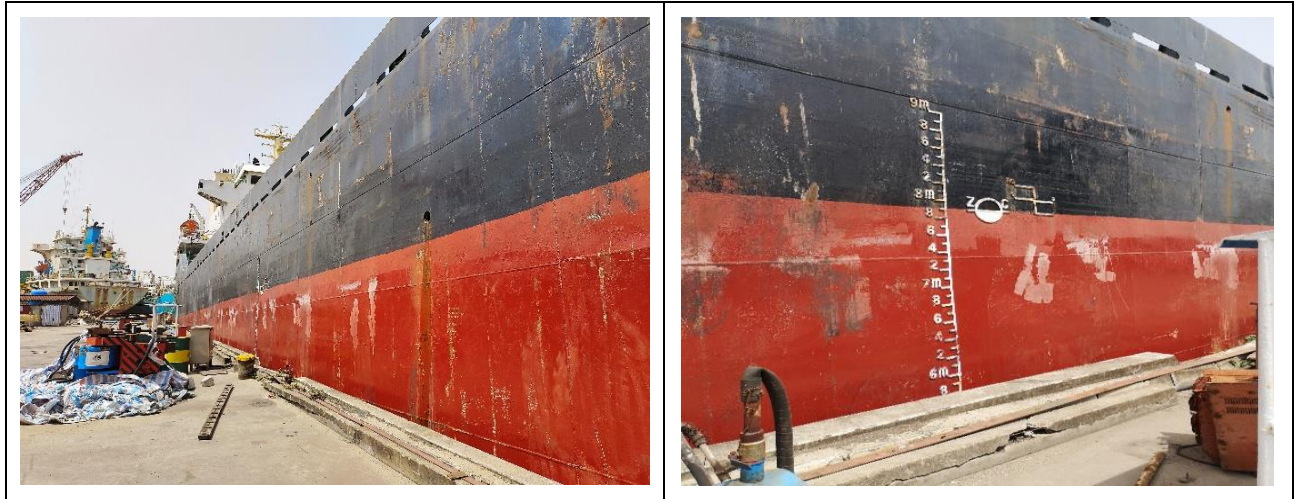
The condition of exposed shell plate was found in generally good condition, with significant scratches on the bow and stern shell plates. The draft marks, ship's name, load line above the waterline was clear and complete. The condition of underwater shell was unknown.

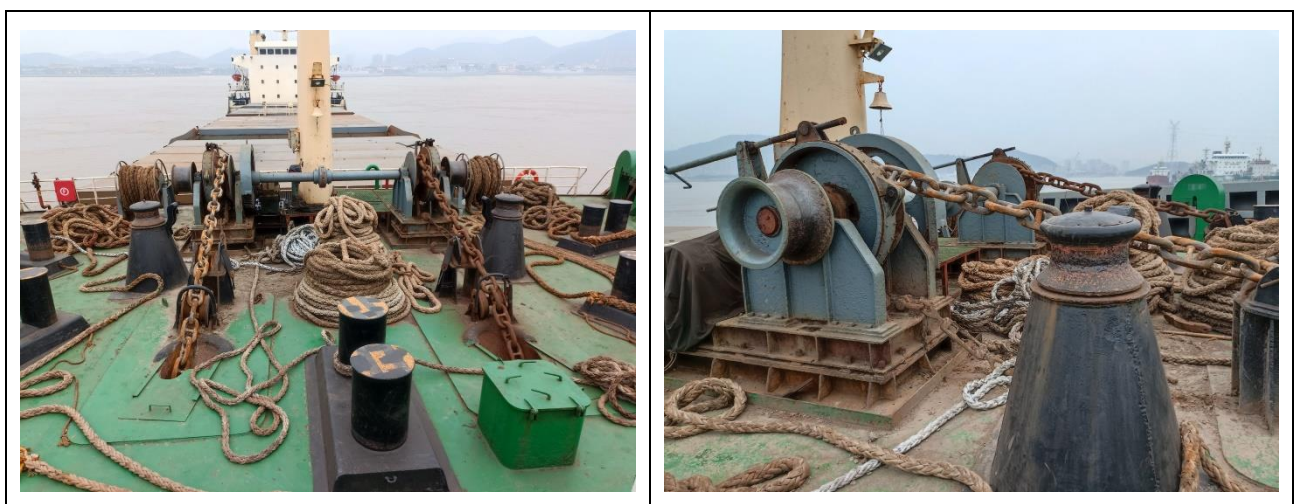
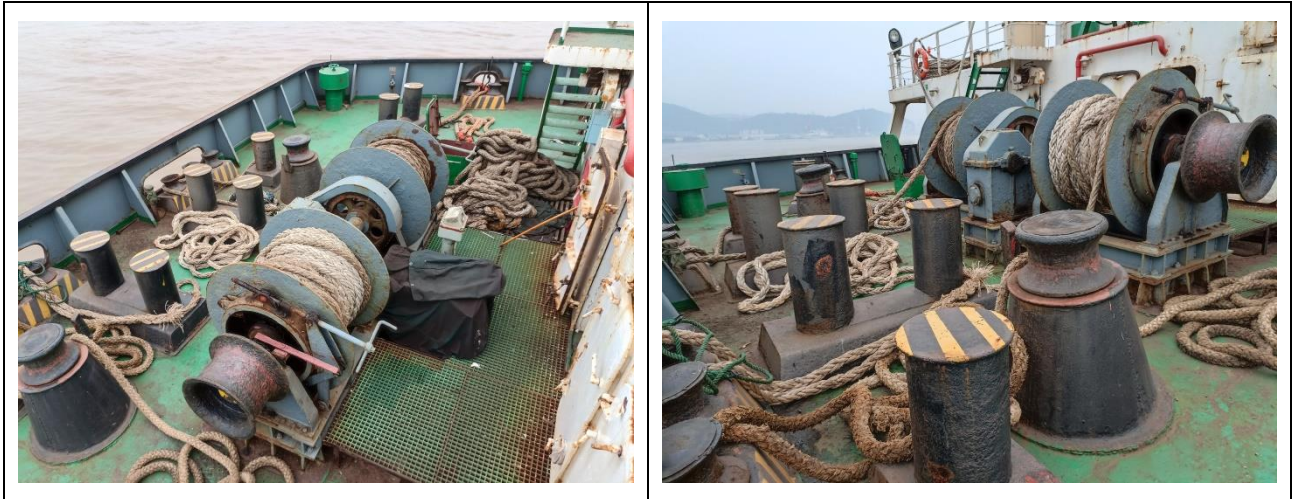
The paint condition of the forecastle deck was found basically intact, and local corrosion on the bulwark. No obvious deformation was found on the bulwark bracket, but rust damage on the steps of the ladder leading to the forecastle deck.

The body structure of the hydraulic windlass was found basically intact, with local coatings damaged and the foundation significantly corroded; The body structure of mooring equipment was found complete, with common condition on coating.

2 sets winches were installed on the main deck aft, with complete body and base structures and localized rusting. The paint condition of the fairlead pile and fairlead hole was found general, with local wear and tear.

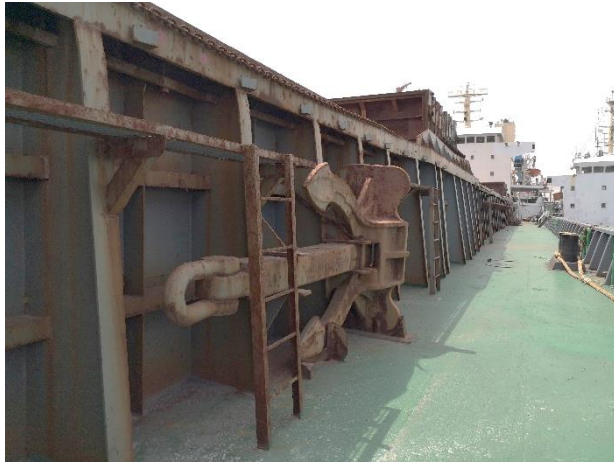
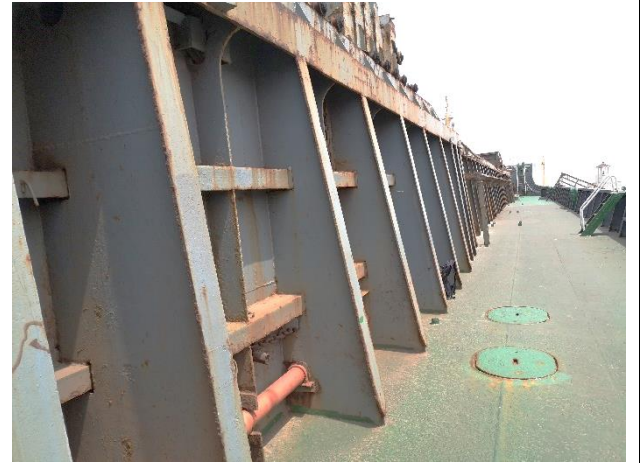
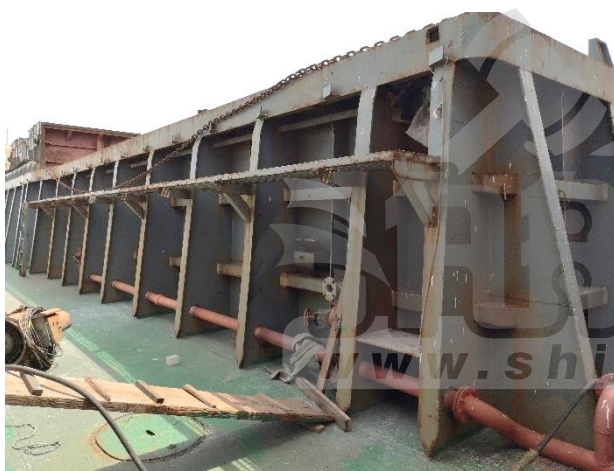
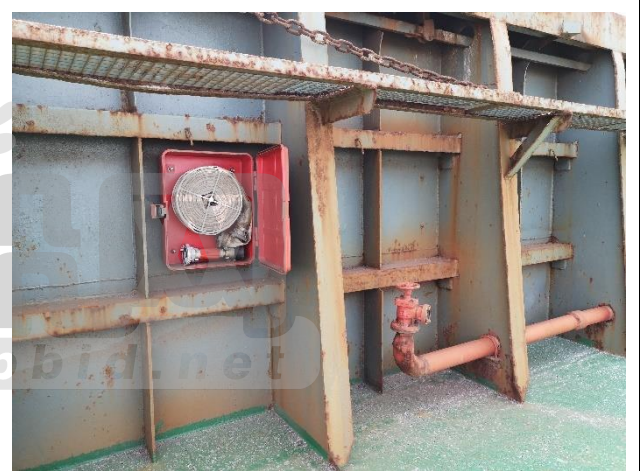
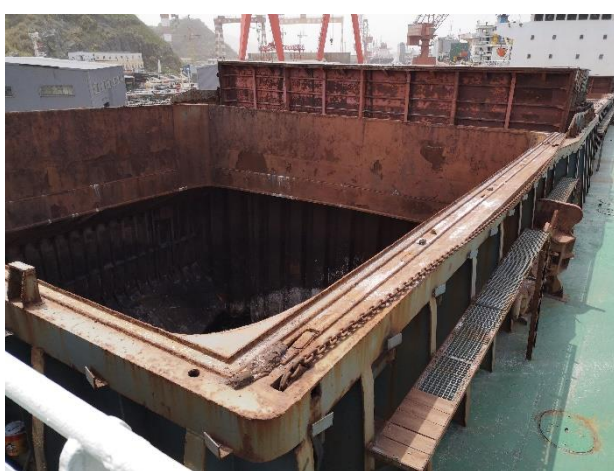
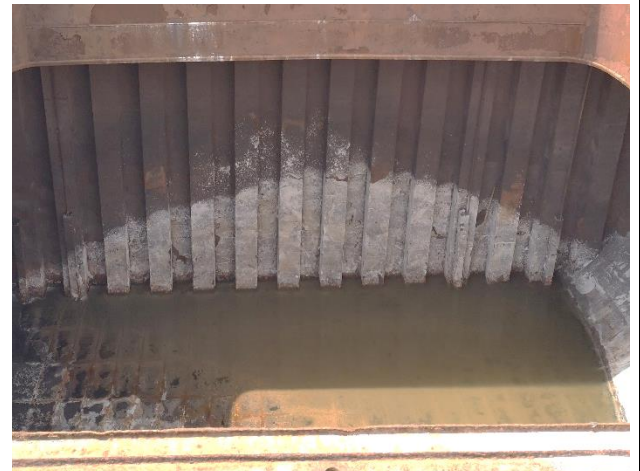
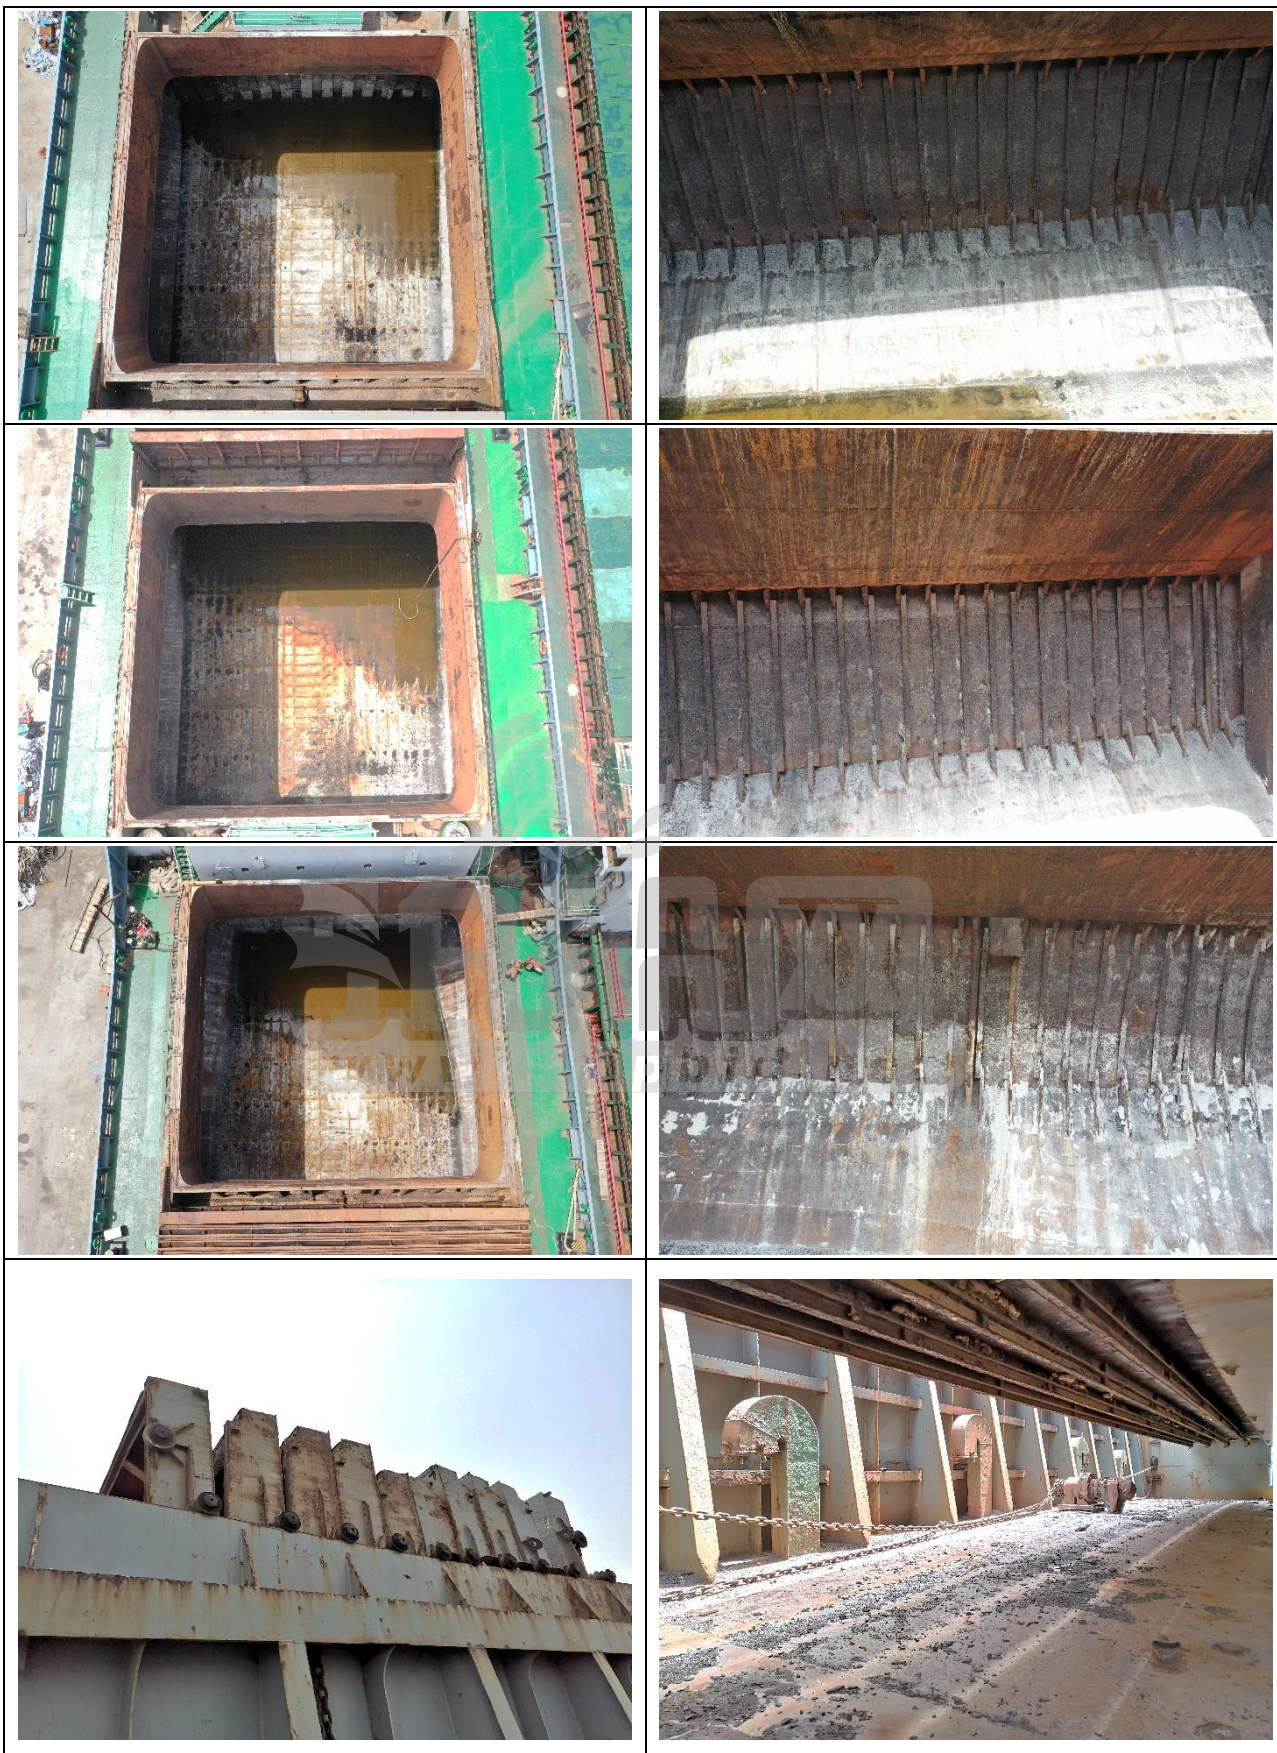
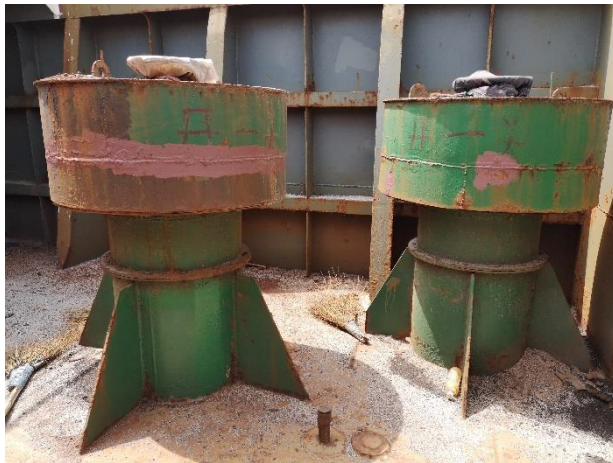
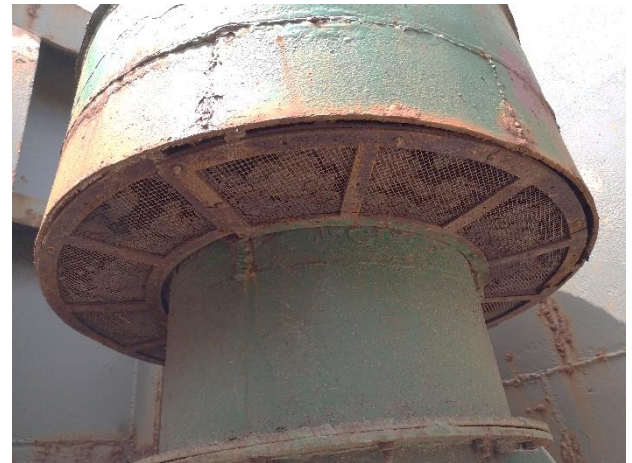
The main deck was found rust, with basically intact paint. One spare anchor was found on the port side of the No.1 hatch coaming. No deformation or damage was found on the bulwark. The edge of the deck manhole cover was found rusted, with intact bolts.

The stiffeners of hatch coaming were found slightly rusted. No deformation or significant crack was found at the toe end. The welding seams were also found slightly rusted. No significant crack was found at the corners of the cargo hatch, and the corrosion was found on the top plate and sealing track groove. The drain holes were not blocked or damaged.

A large area of corrosion was found inside the cargo hold, and the paint of No. 1 hatch coaming and watertight transverse bulkhead was found damaged in multiple areas. No significant deformation was found on the frame structure in the cargo hold, but significant corrosion on the welding seam of the toe; The obvious depression was found on the tank top plate, but no significant damage. The ladder in NO.4 cargo hold was found deformed and damaged, with the steps missing.

The top plate of the hatch cover was found extensively corroded, but no cracking or deformation on the reinforcement structure. The sealing strip groove was found rusted and damaged, with the watertight sealing strips missing. No significant deformation was found on the rollers.

The vent pipes on the main deck between the cargo holds were found corroded in multiple places, and the watertight cover was rusted and thinned, with intact locks. The connecting

flange of the mechanical ventilation duct was found rusted, and the bolts were basically intact, the handwheel switch was found blocked, and the ventilation duct baffle was damaged.

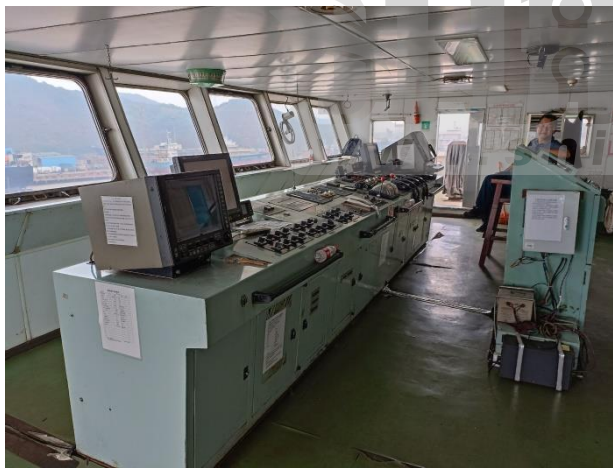
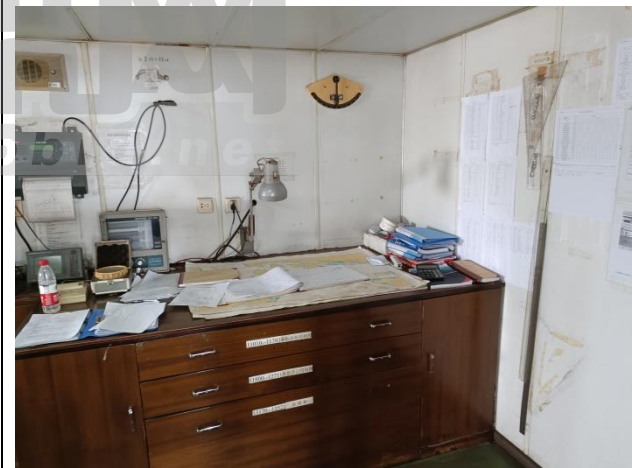
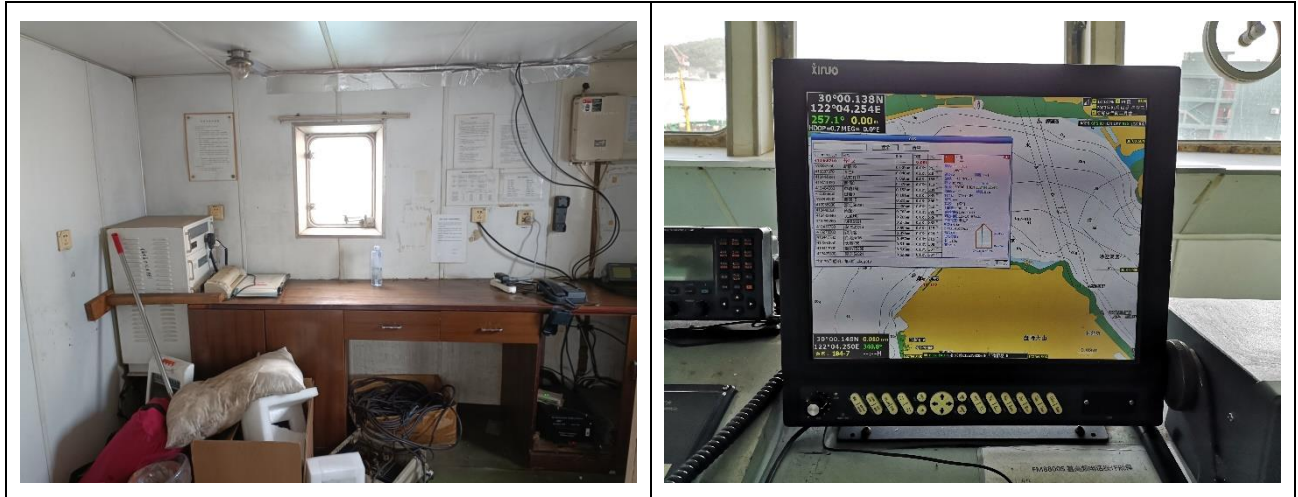
The cleanliness of the wheelhouse was found in general condition, with complete flooring, steel doors, windows and complete communication equipment.

This ship is equipped with IF, VHF, electronic chart, AIS, GPS, gyro compass, magnetic compass, echo sounder, radar, etc. The appearance of the equipment was found normal and the surface cleanliness was general.

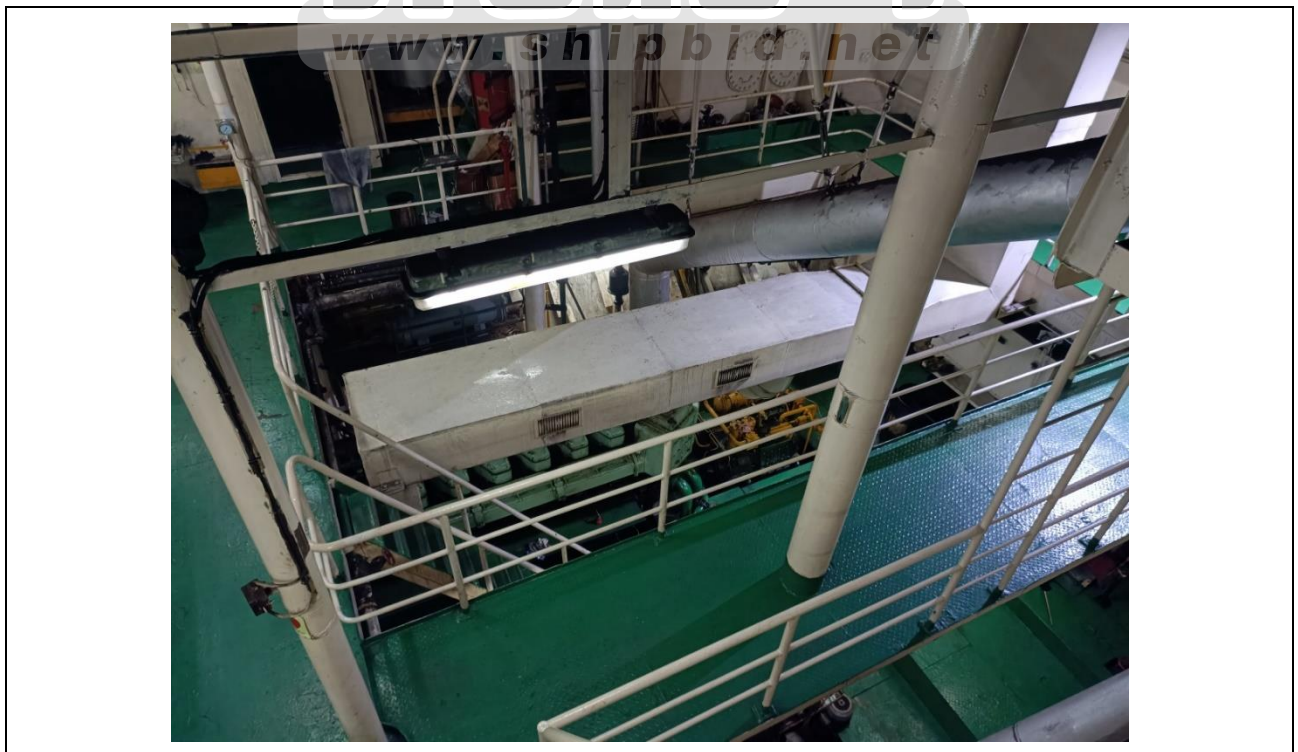
The structure in the engine room was found complete with good condition coating. The cleanliness in the engine room was found in general good condition, with no significant oil stains attached. The arrangement of facilities such as stairs, railings, and checkered plates was found complete. The cable layout on the top was found neat, the paint on the top was found intact with no obvious rust. The coating on the pump valve and other equipment on the bilge was found rusted and damaged.

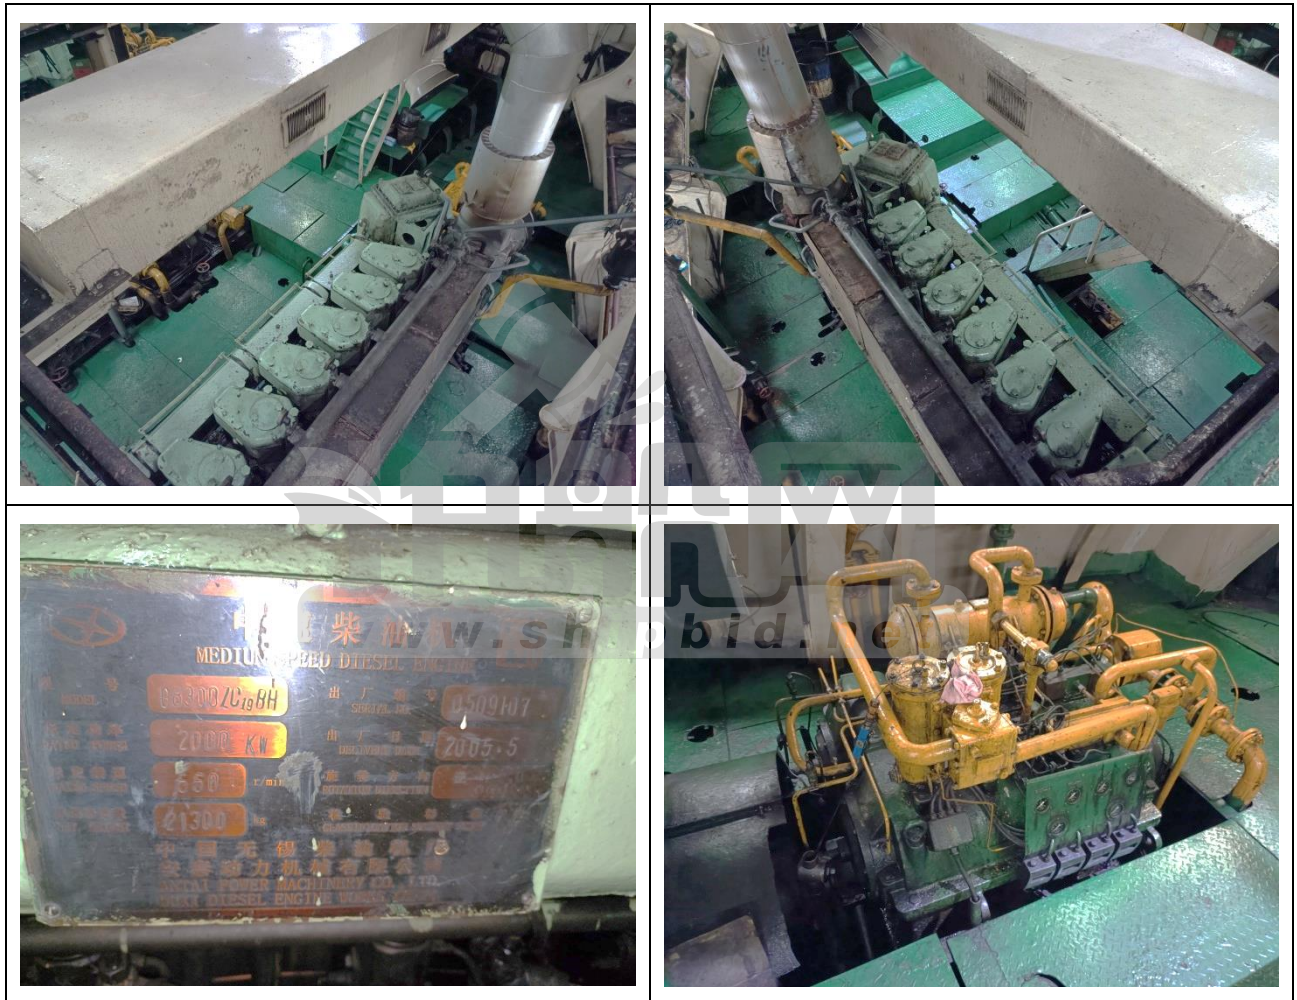
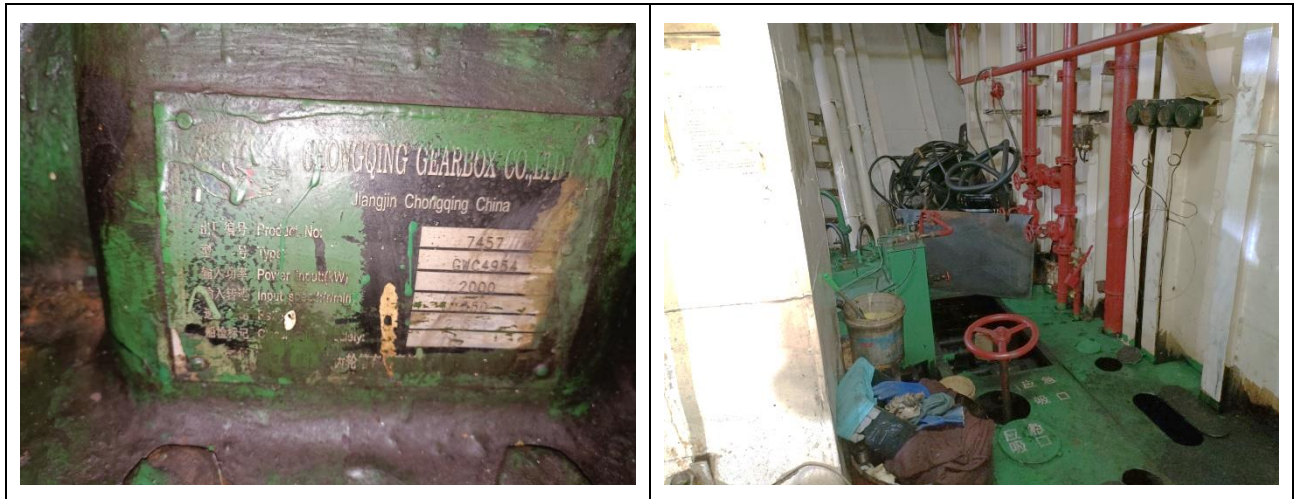
The nameplate of the diesel was found clear, and significant oil stains was found on the chassis. The local coating cracks were found on the surface of the diesel, and no obvious rust on the components and pipeline system.

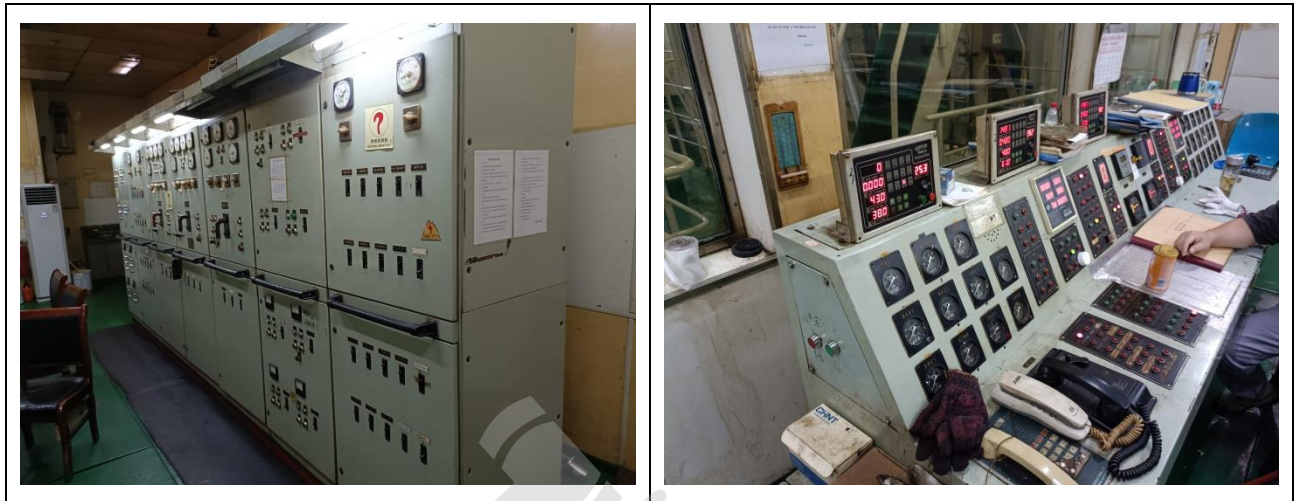
This ship is equipped with a control console and main distribution board in engine control room. The indoor structure was found complete and tidy; The appearance of the monitoring instrument was normal; all indicator lights and button protection devices were found basically complete.

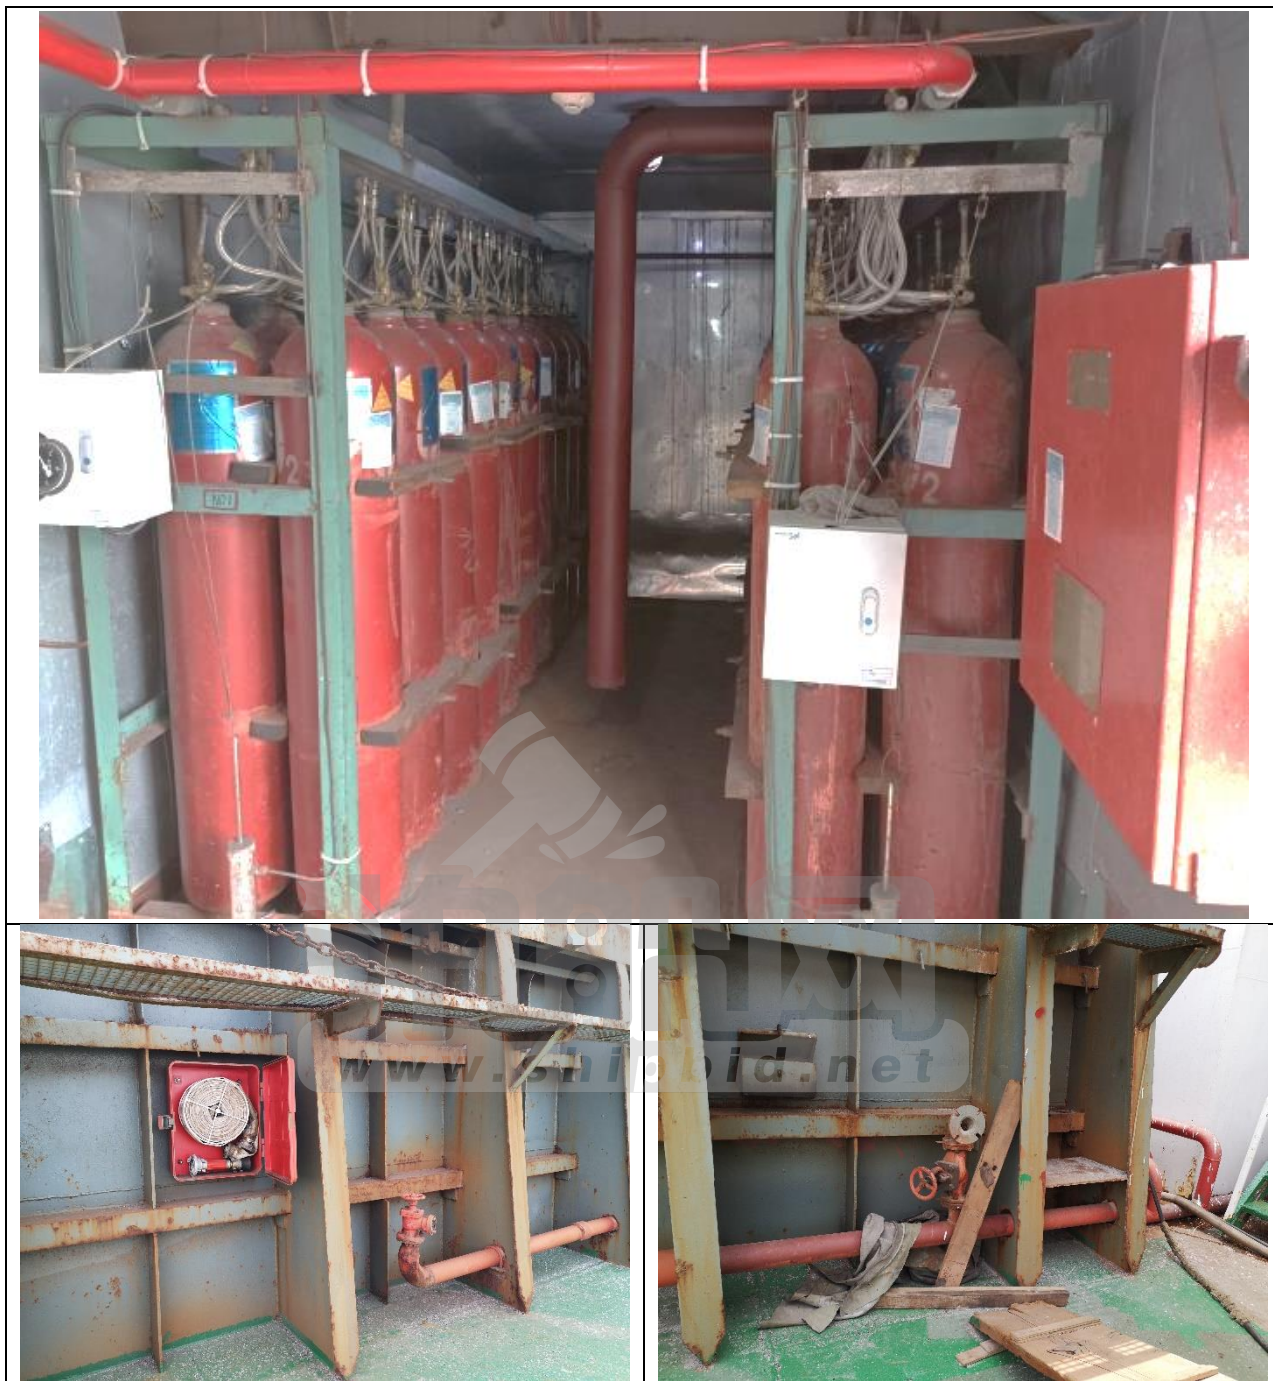
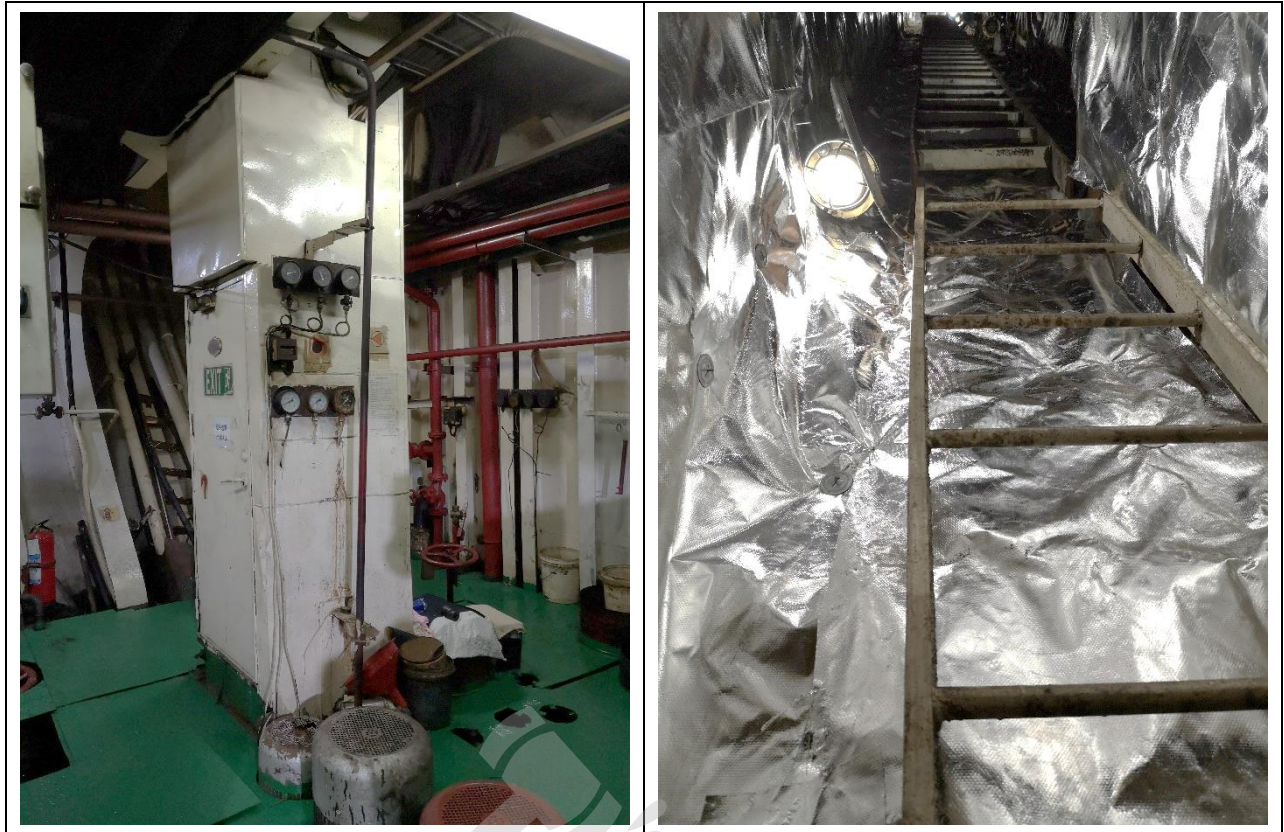
The ship is equipped with a CO2 fire extinguishing system, and the indoor fire insulation was found basically in place. No significant corrosion was found on the steel cylinder release valve.

The paint of the deck fire pipeline was found basically intact, with locally corroded on interface flange. The hose box was found complete and undamaged, and the appearance of the fire hose and connector was intact.

The self-closing door of the emergency passage in the engine room was found in a normally closed state, the self-closing device can work normally, and the lighting in the passage was found normal. The structure of the life-saving ladder was found complete, but no lifeline was found. The local cracks were found on the surface layer of the fire separation.

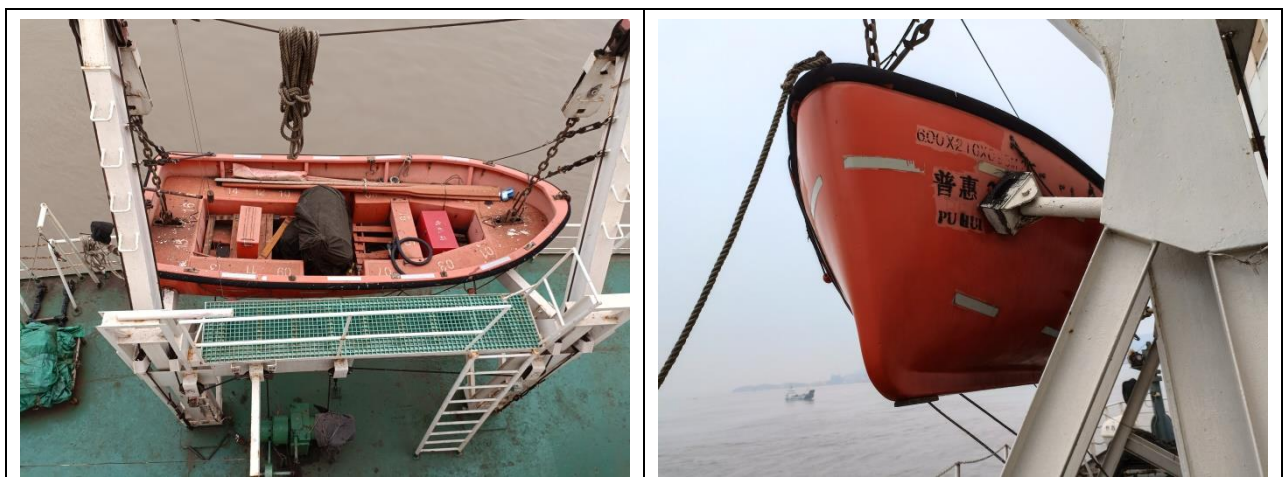
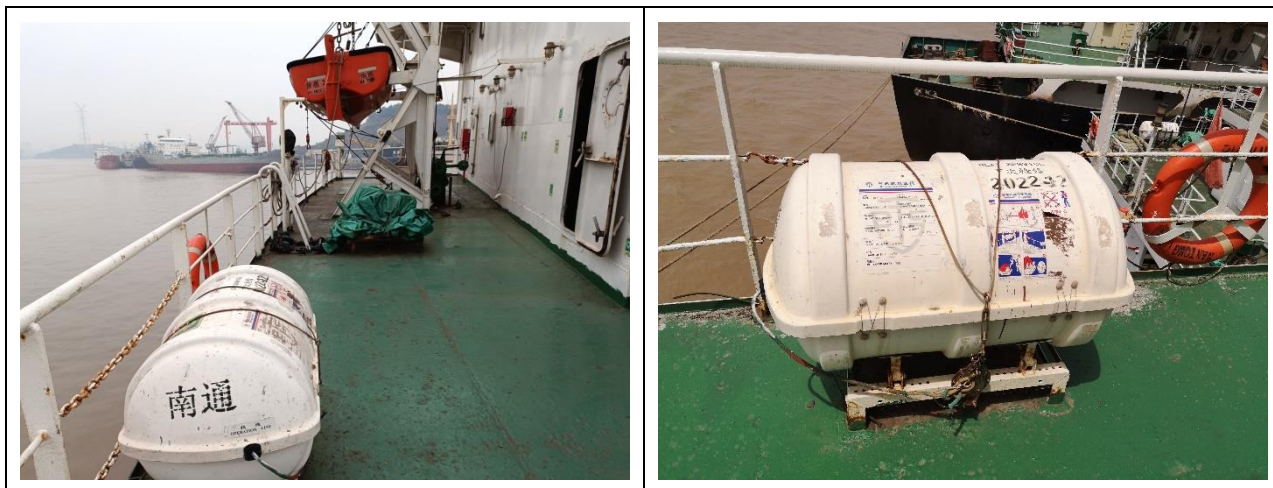
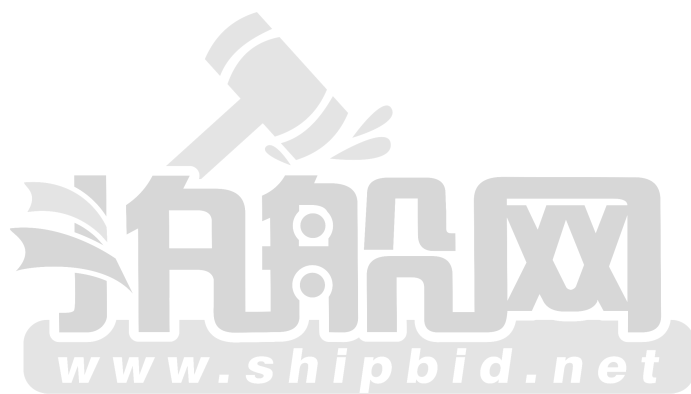
The ship is equipped with two open type motorized lifeboats, with no significant cracking or damage to the hull appearance. The arrangement of the facilities inside the boat was found complete, and the appearance of the equipment was found general condition. The boat frame was found local corrosion with overall general condition.

The ship is equipped with two inflatable liferafts with a capacity of 20 people and one inflatable liferaft with a capacity of 6 people. The liferaft release device was found complete, and the inspection mark is that it has expired in December 2022.
