TECHNICAL REPORT

编号: CJPG-JS-23-KY-236

Place of Inspection: Tianjin, China

Technical Report of MV "HAI XING CHUANG XIN"

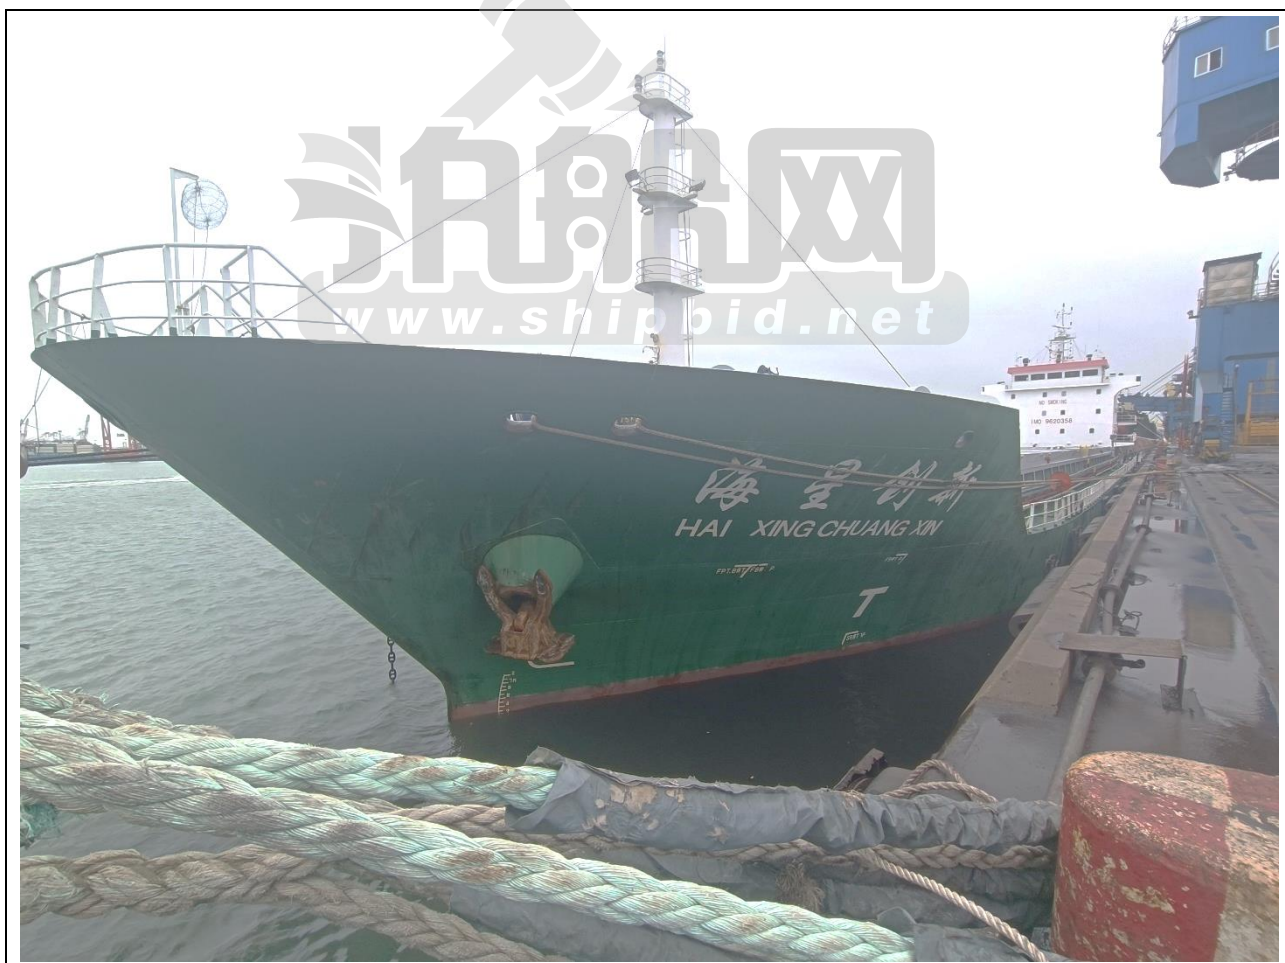
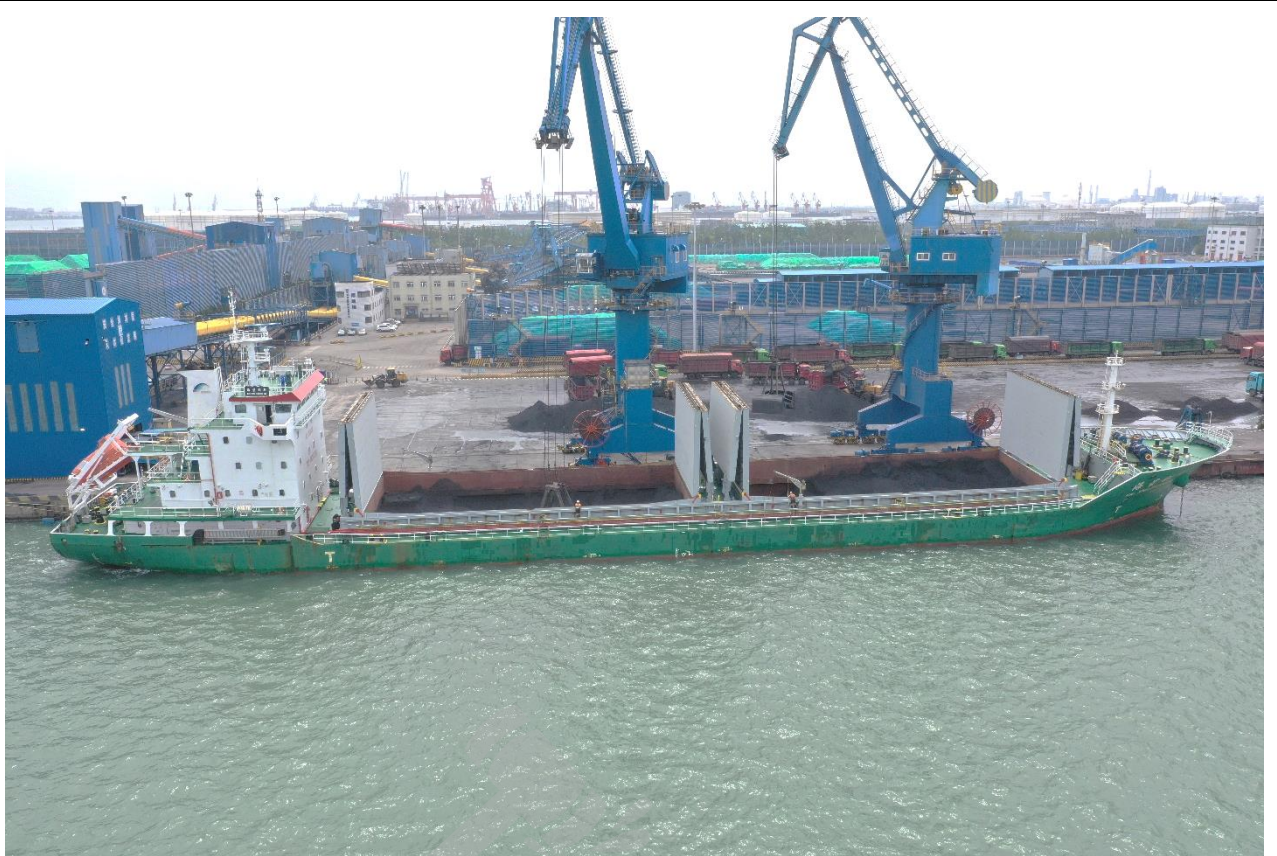
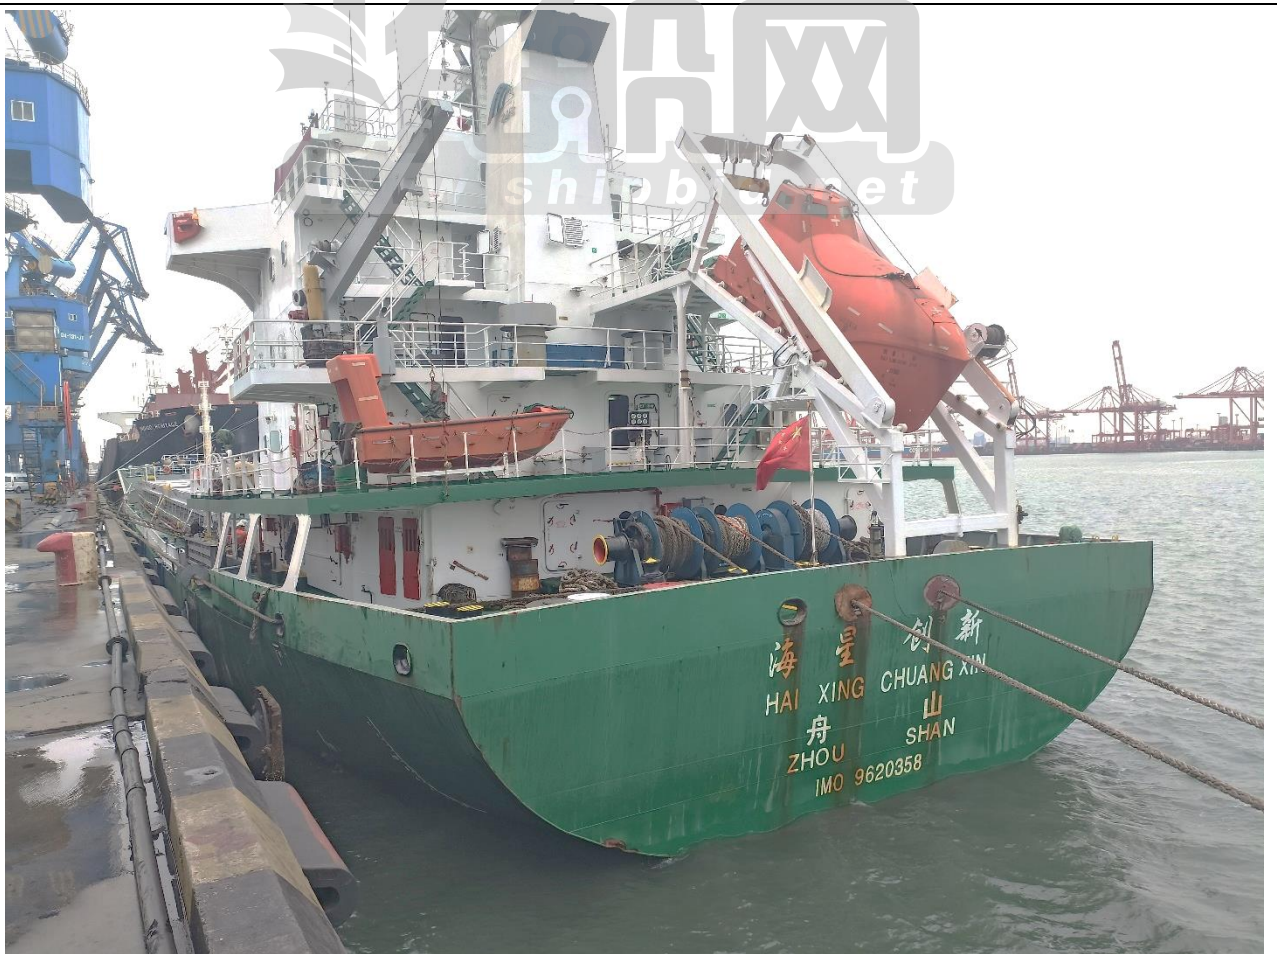
6.1 Hull Structure Condition

The condition of exposed shell plate was found in generally good condition. The draft marks, ship's name and IMO number was found clear and complete. The condition of underwater shell was unknown.

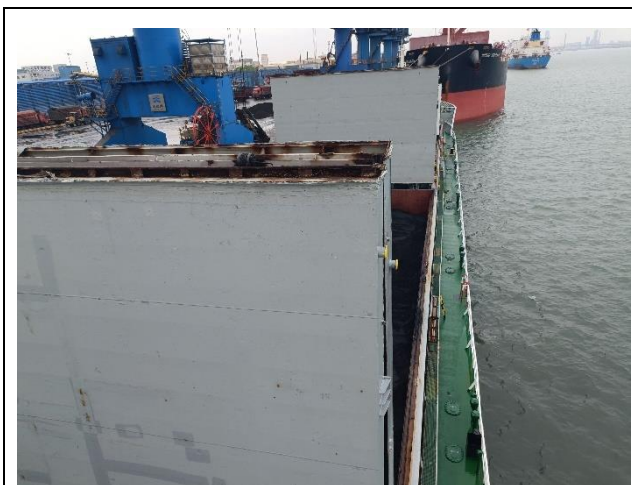
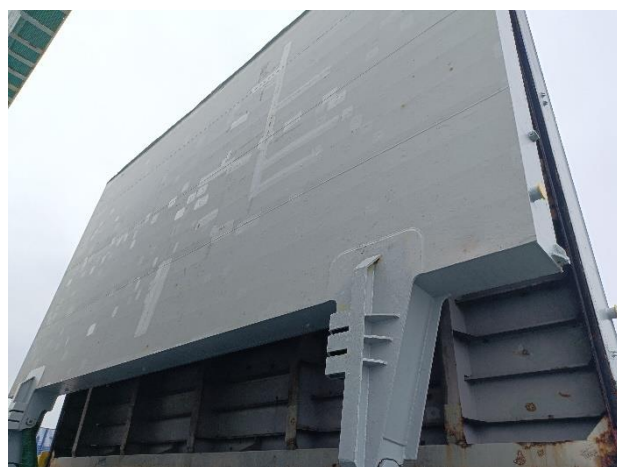
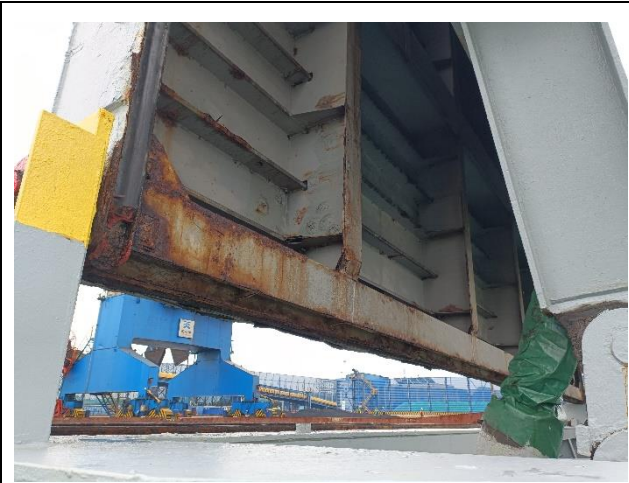
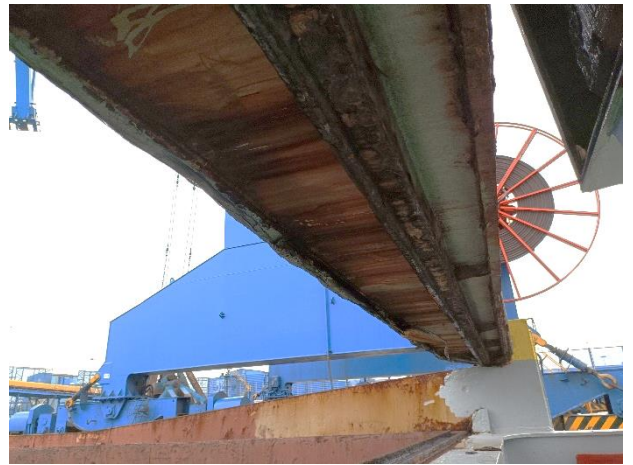
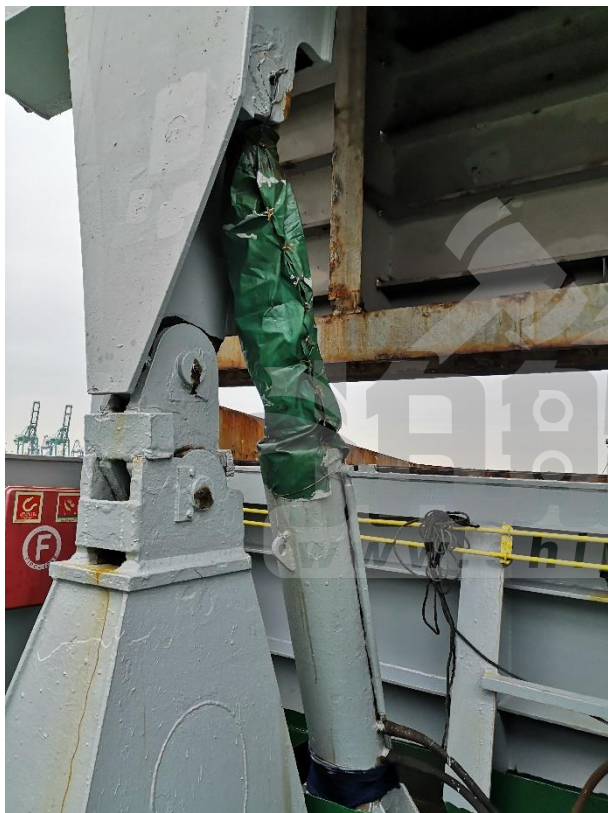
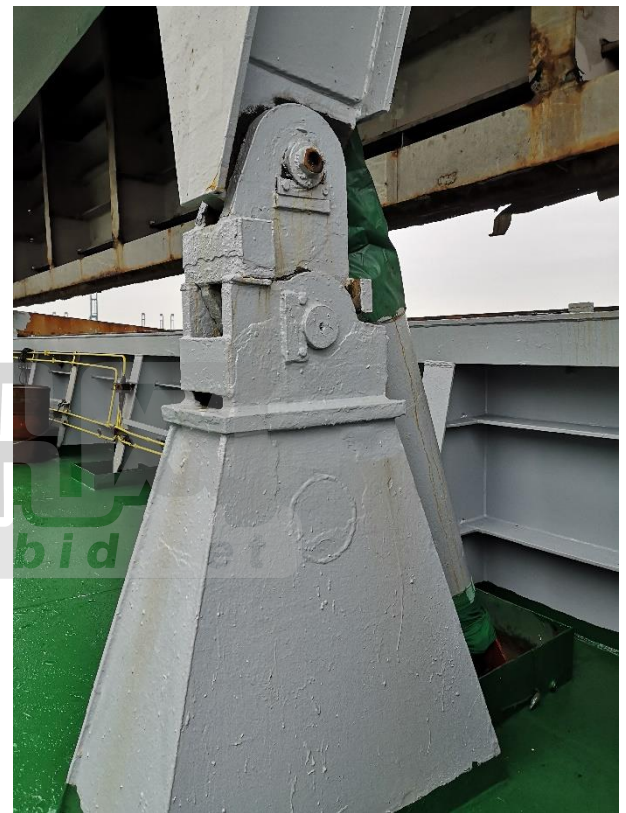
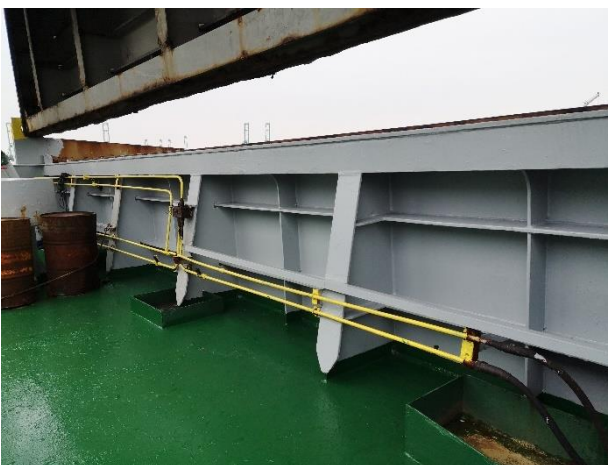
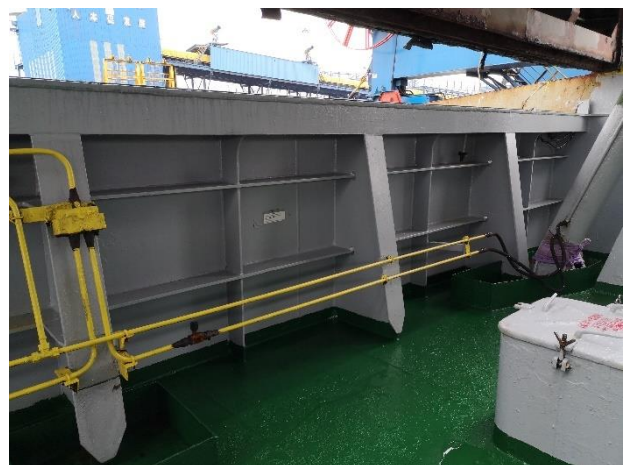
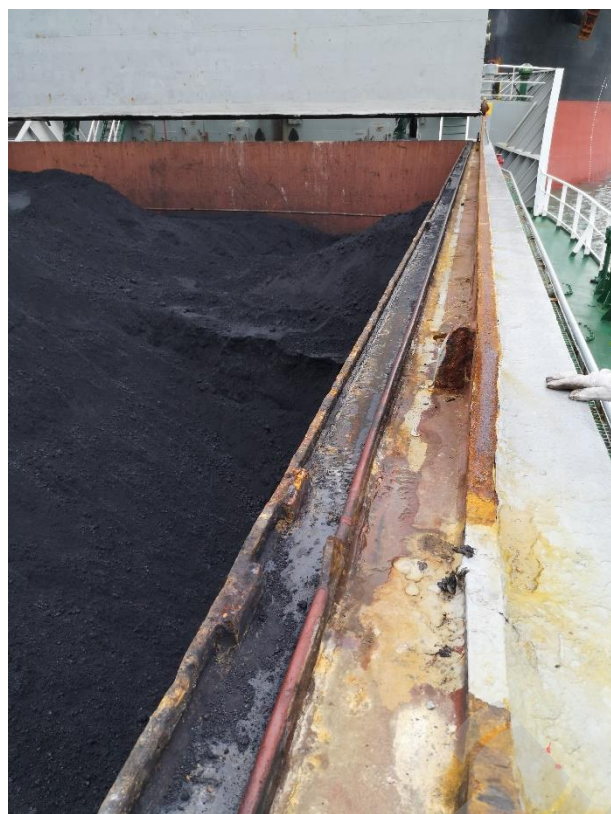
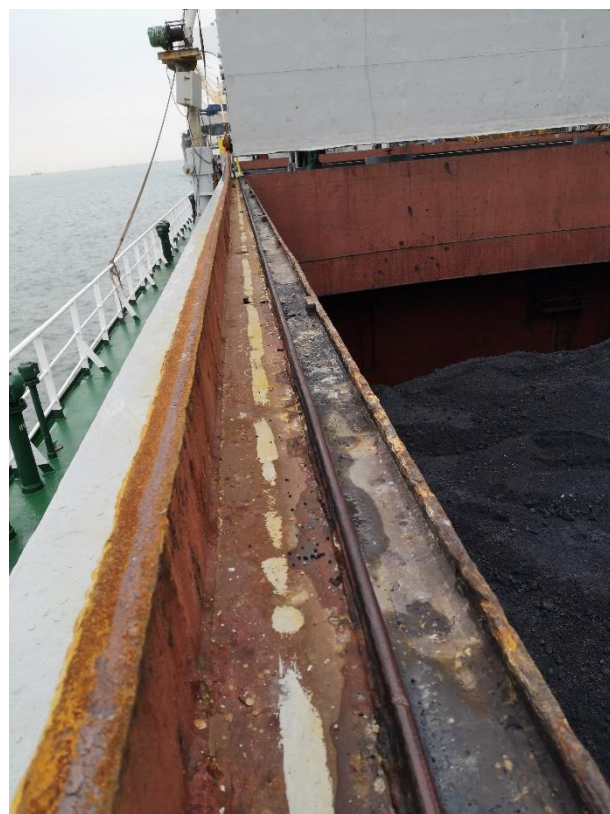
6.2 Cargo Holds

The ship has 2 cargo holds with double bottom and double hull, and equipped with folding hatch cover. No significant corrosion was found on the top plate of hatch cover, but the edges of the reinforcement stiffeners were found corroded. The watertight adhesive strip groove was found rust and thinning. The fastening wedge and wedge ear of the hatch cover were found slightly rusted. The hydraulic cylinder is equipped with a protective cloth cover, and the hydraulic cylinder support was found free of rust and no significant leakage in the hydraulic pipeline.

The hatch corner structure was found intact, and the rust mark was found on the pressure strips and water guide channel on the top plate of the hatch coaming.

The welding condition of the hatch coaming was found in generally good condition, and the rust was found on the local welding seam of the reinforced bracket. The faceplate of the reinforced bracket was welded to the deck with a chamfer, without significant rust

At the time of the inspection, the ship was unloading, and the visible coating on the bulkhead of the cargo hold was found basically intact, and no deformation on the access ladder.

The fire pipelines around the hatch coaming were found well painted, and the fire hydrants were arranged intact and undamaged. The paint of the cargo hold ventilation pipe was found intact, the fireproof net was complete, and the fire damper handwheel was found no significantly blocked.

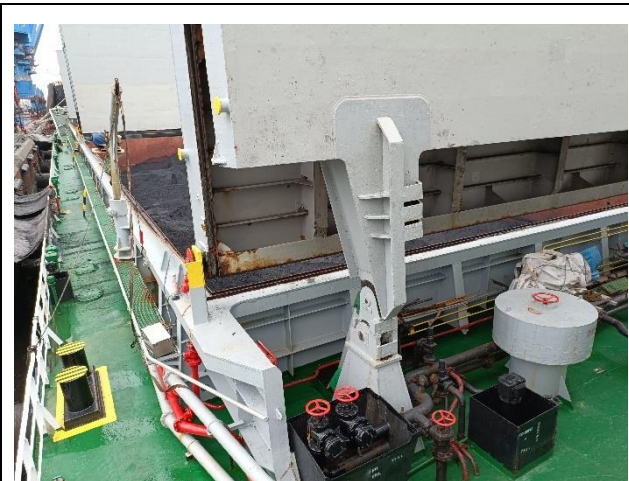
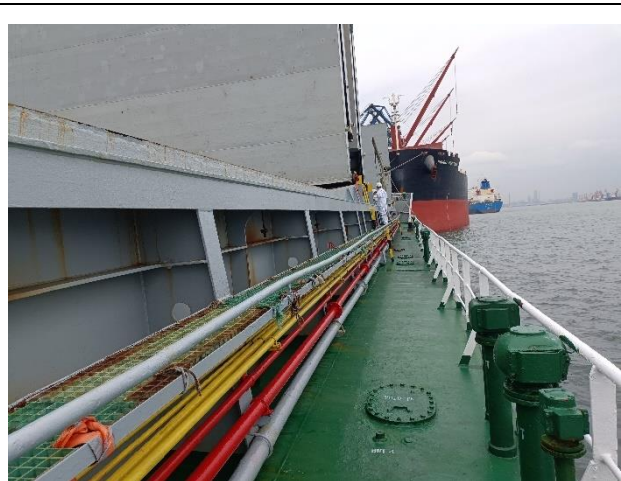
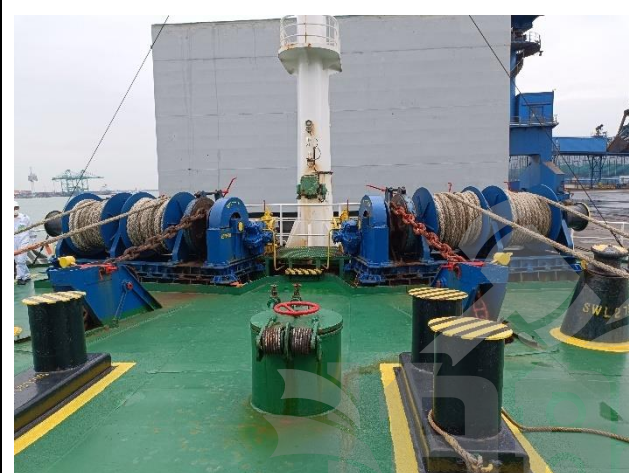
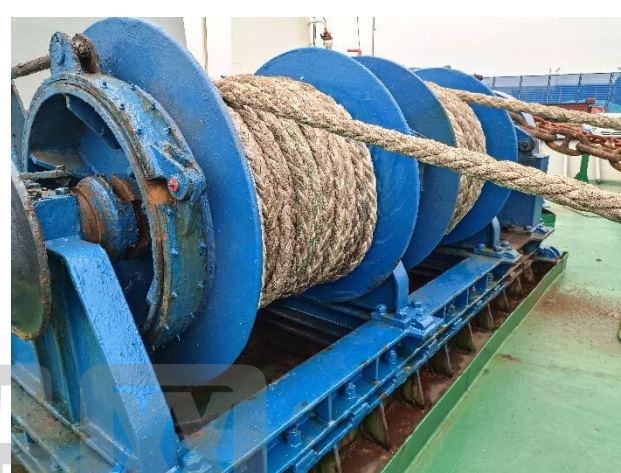
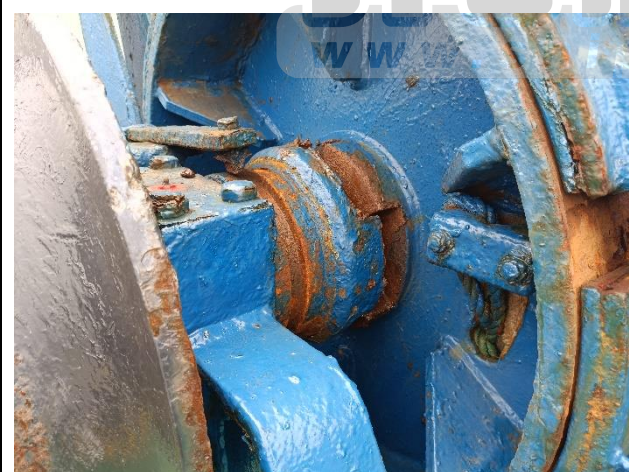
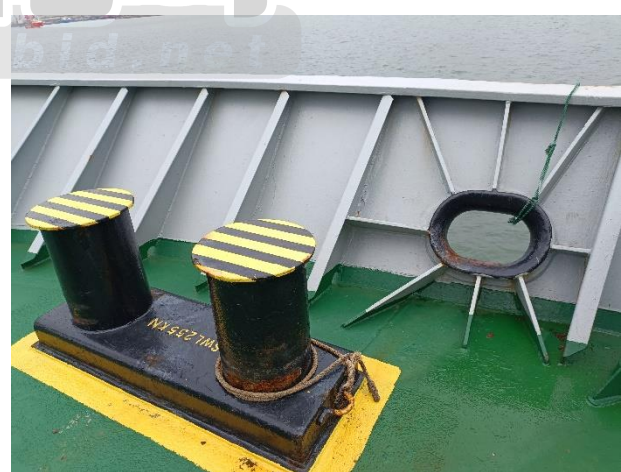
6.3 Main Deck and Deck Machinery

The condition of the main deck was found generally good, and the paint was basically intact. No rust was found on the manhole covers on both sides of the deck.

The condition of the forecastle deck was found to be general, without significant damaged on paint and deformation on the bulwark bracket. The body structure of the two windlasses were found basically intact, with paint damaged on the local of base. The structure of mooring equipment such as bollard was found complete, with basically intact coating.

There is 1 set winch installed on the main deck aft, and the paint was found basically intact. The bracket of the base was found significant rust. No significant corrosion or thinning was found on the guide pulley, without significant breakage on the rope.

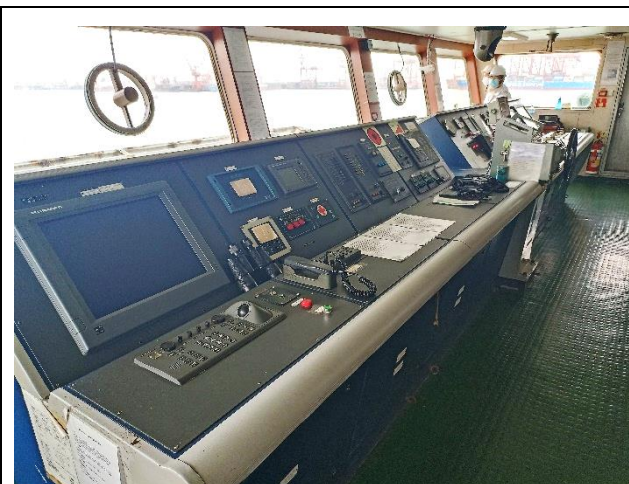
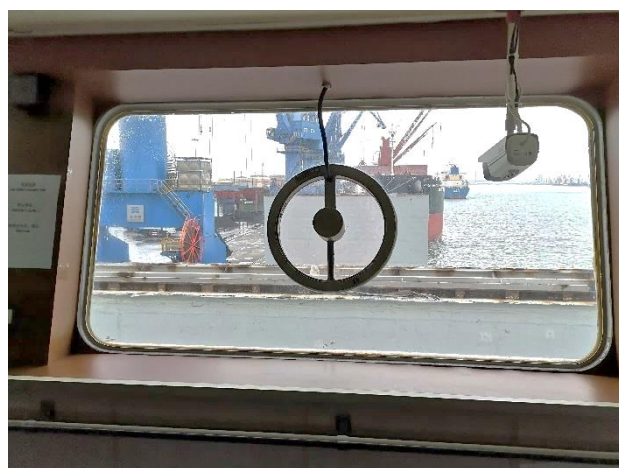
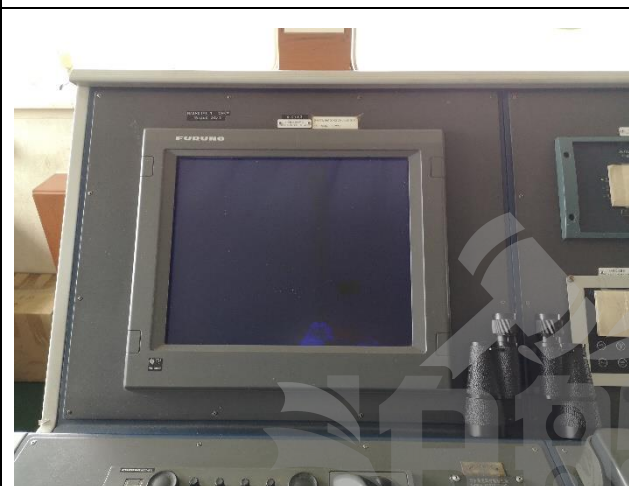
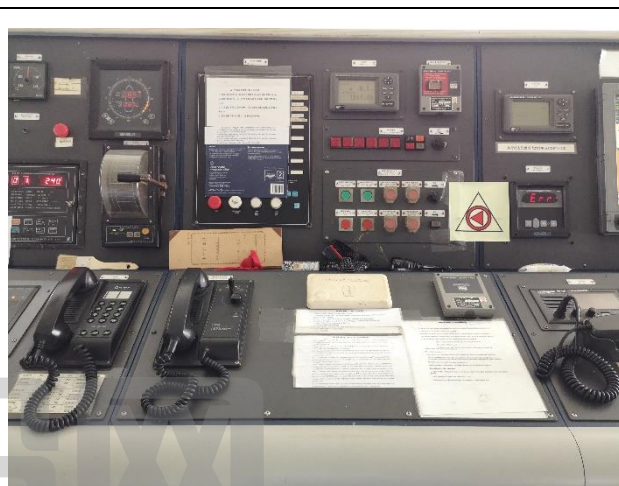
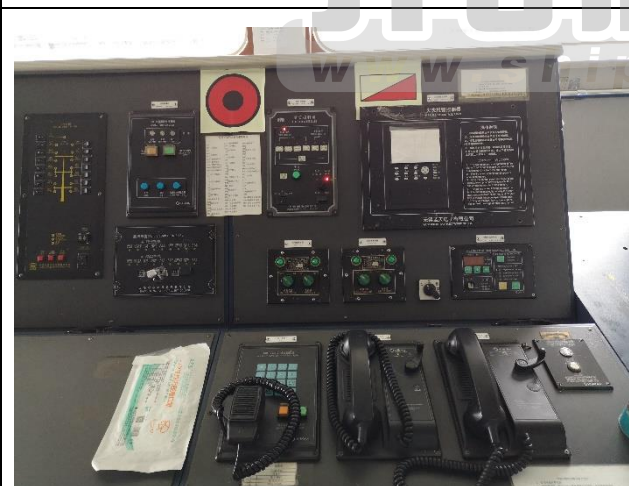
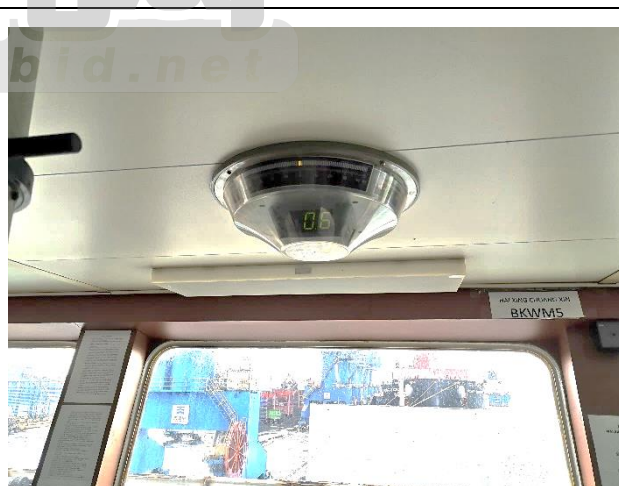
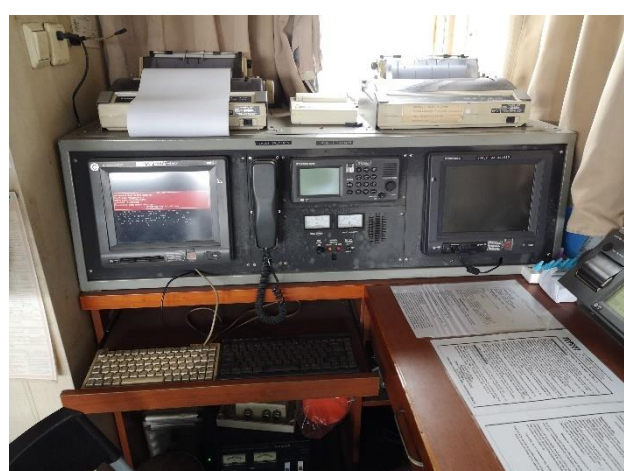
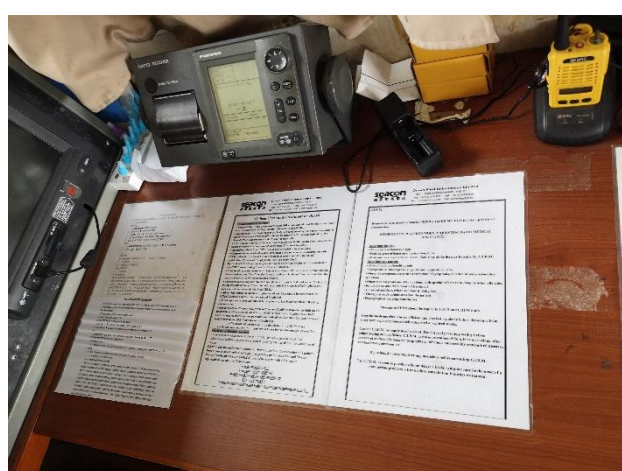
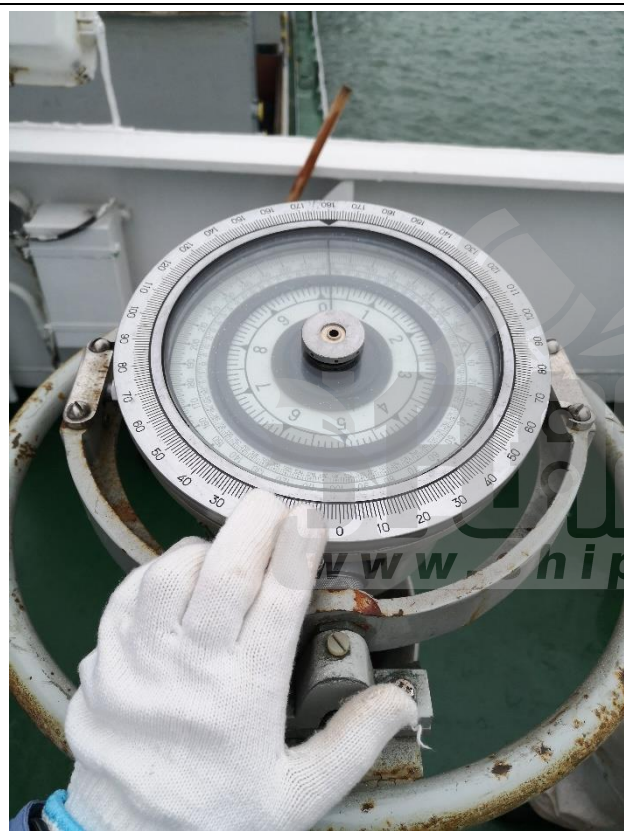
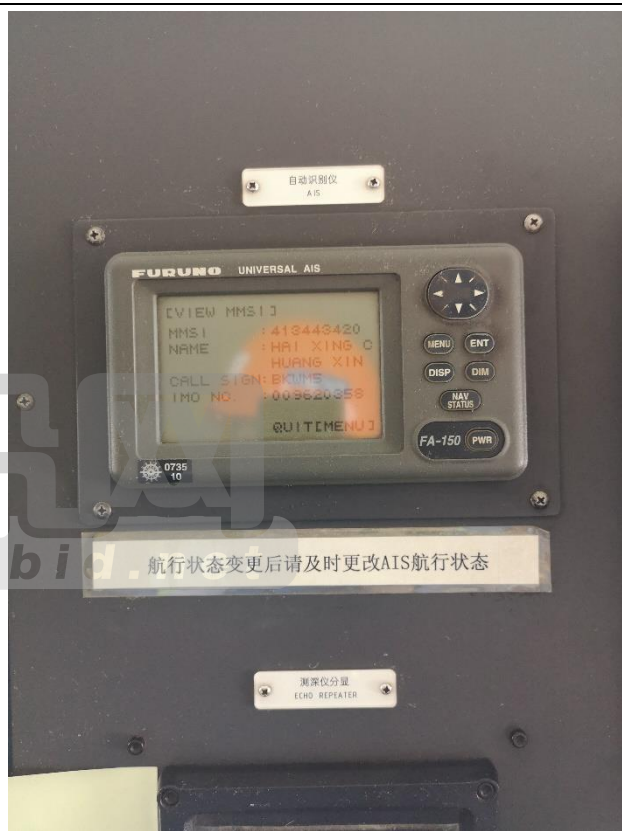
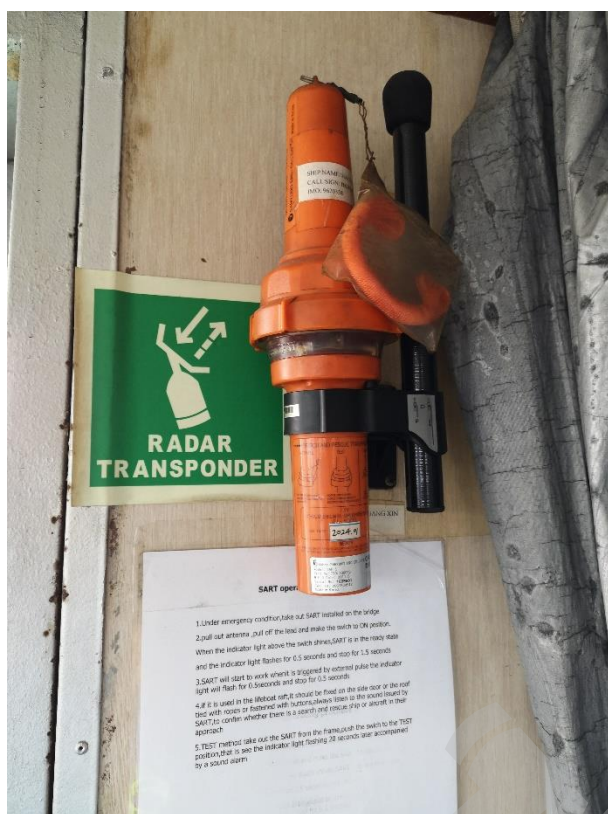
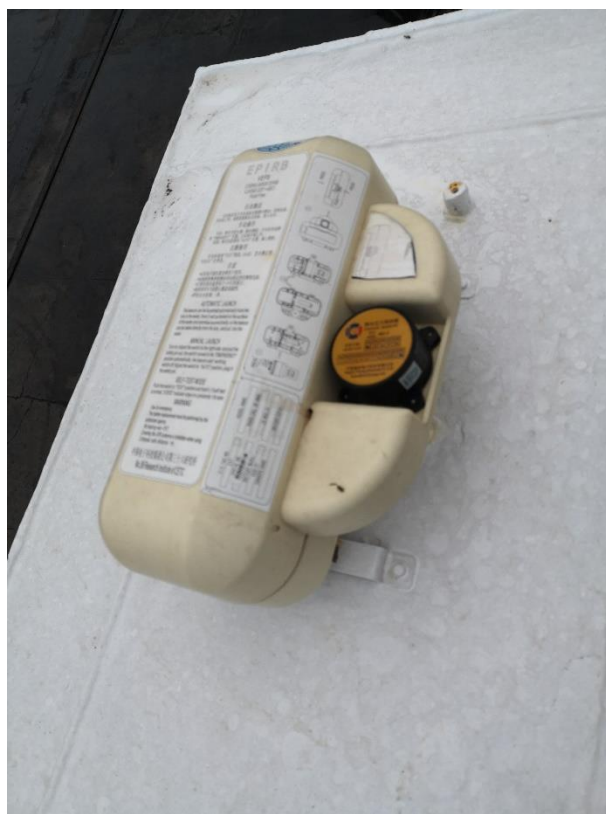
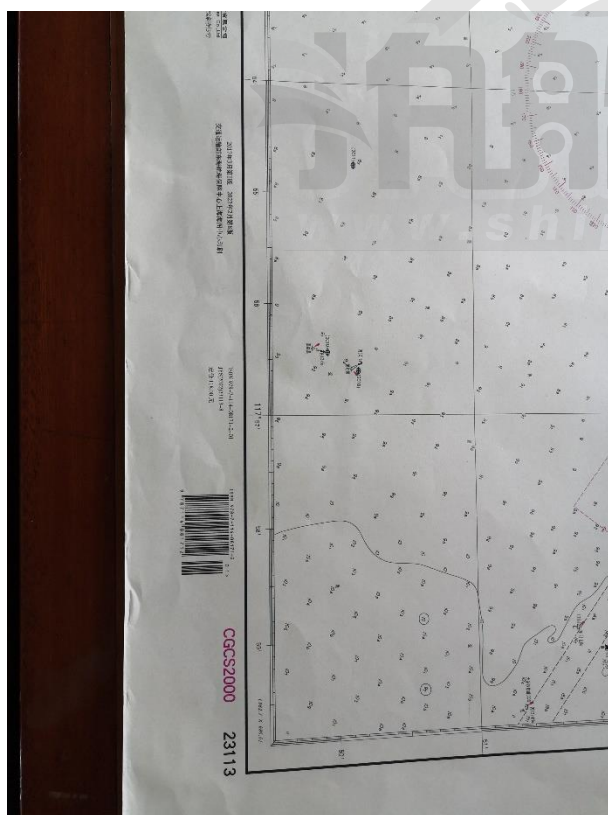
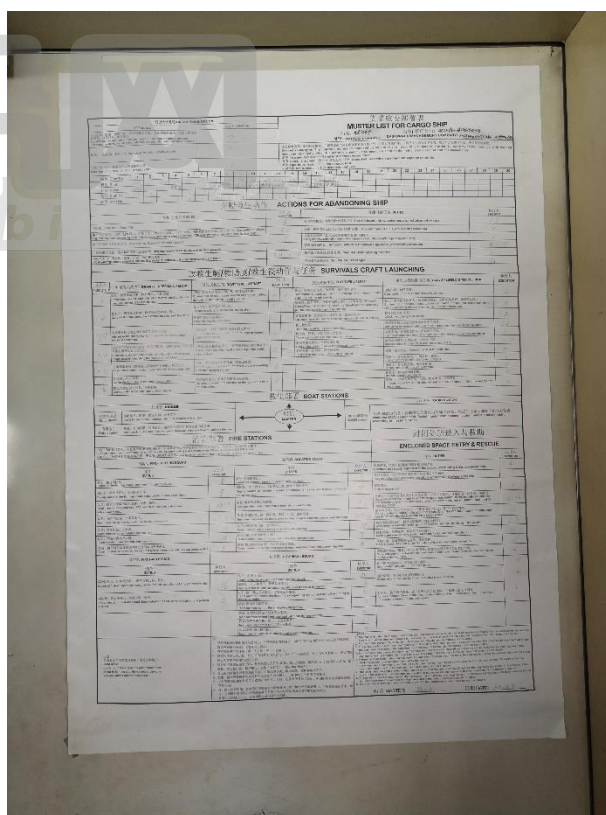
6.4 Bridge Equipment

The fire insulation material and PVC floor in the wheel house were found intact and undamaged. The water tightness of the front window was intact, with the good appearance.

The door frame of the wheel house was found no deformed, with slightly rusted on the bottom sliding groove, and there was jamming when moving the door.

The appearance of the signal light control panel, alarm, fire monitoring screen, and other equipment on the bridge console was found intact, and the communication and navigation equipment were configured according to the certificate requirement.

The compass repeaters on both sides of the bridge deck was found no bubbles, and the heading angle was consistent with the steering compass.

The AIS data was found displayed normally, and the IMO number, MMSI number and other identity information are correct.

The radar transponders were found to be installed on the both sides of the bridge console as required, and operating instruction was posted nearby.

The emergency radio position indicator was located on the compass deck, with intact water tightness of the shell and operating instructions. The hydrostatic release device was found within the validity period.

The navigation files on the ship were found basically the latest version, including chart and contingency deployment table

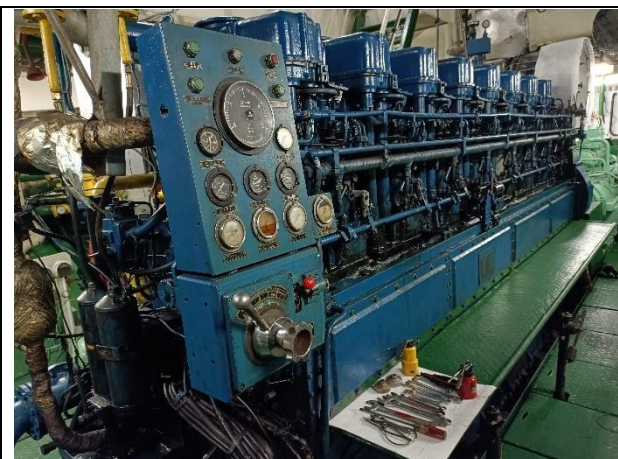
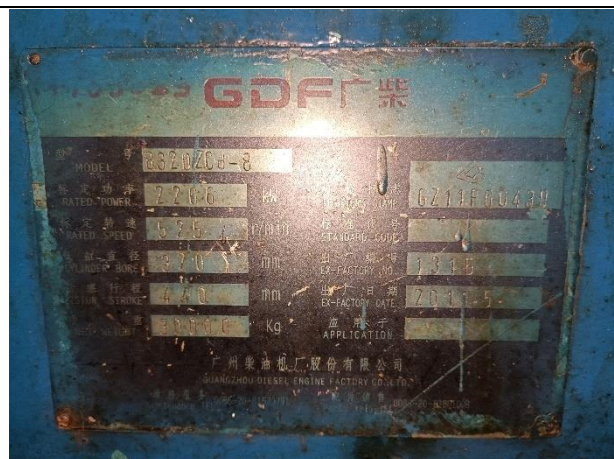
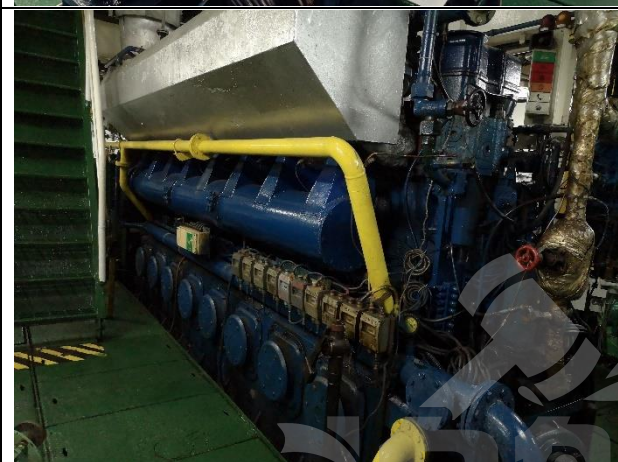
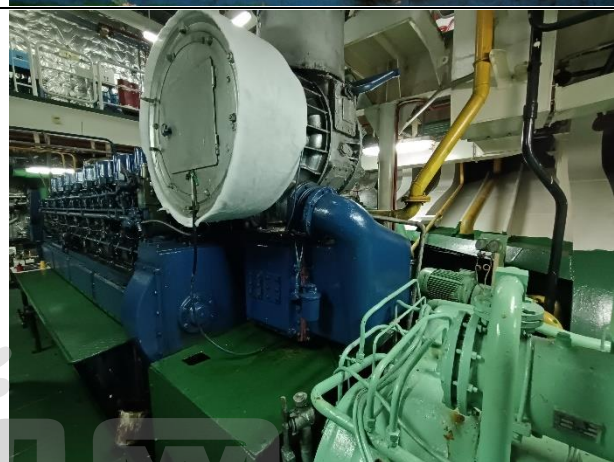
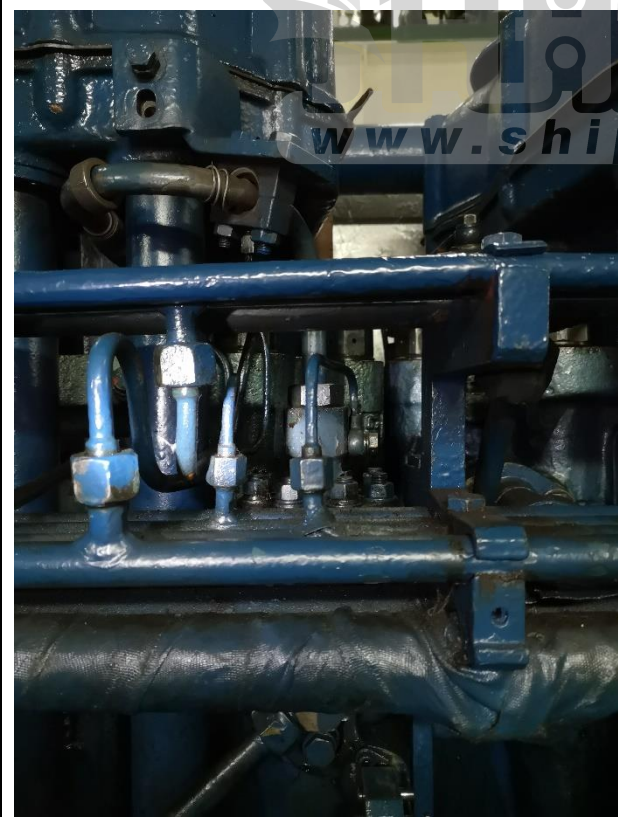
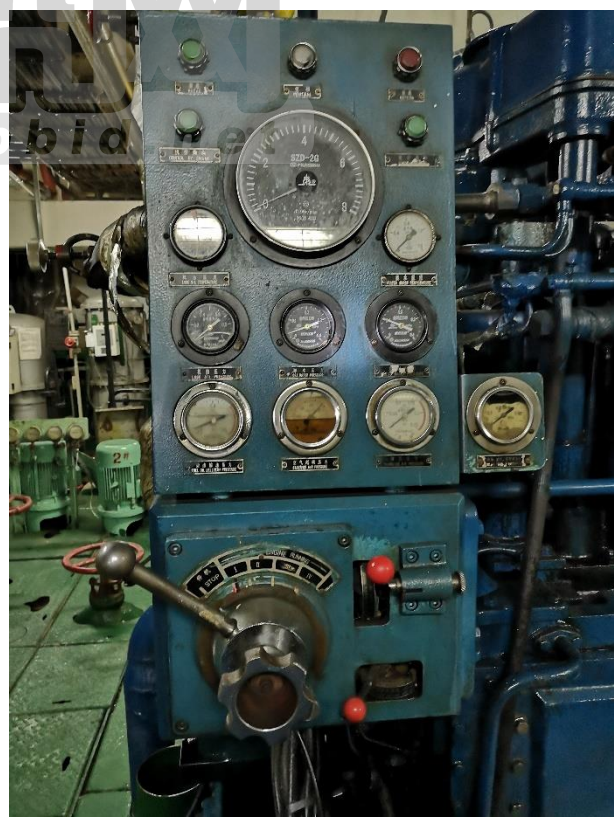
6.5.1 Main Engine

The appearance of the M/E was found to be generally good, without significant loosening of the oil and water pipeline joints. The binding material for the exhaust pipe was found basically complete.

The nameplate of the M/E was found complete, and the control instrument was basically intact and no obvious damaged on the dial plate.

The manual transmission device, fuel leakage alarm, low oil pressure alarm, etc. were found installed next to the M/E.

A small amount of oil stains was found on the chassis of the M/E, and the residual oil channel pipe was found to be connected to an external oil drum, not reached the residual oil tank.

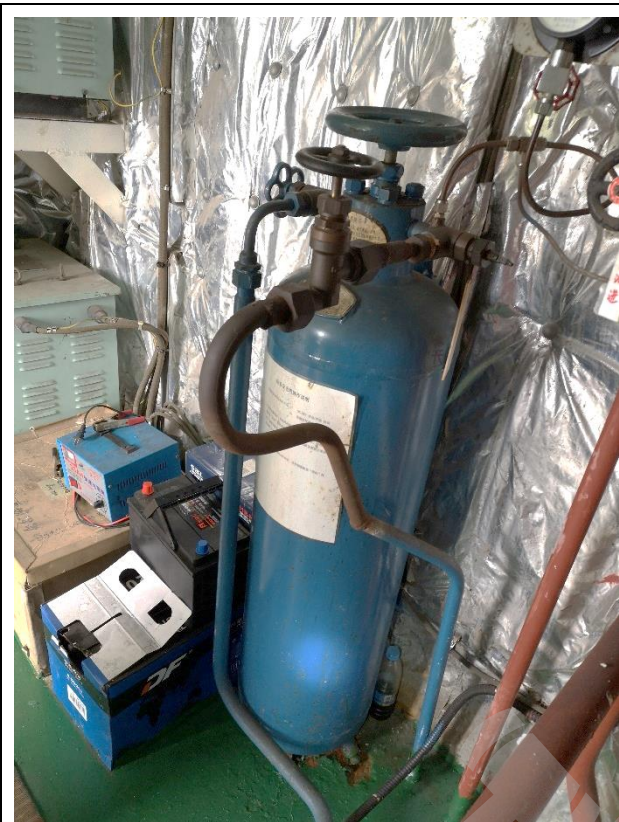
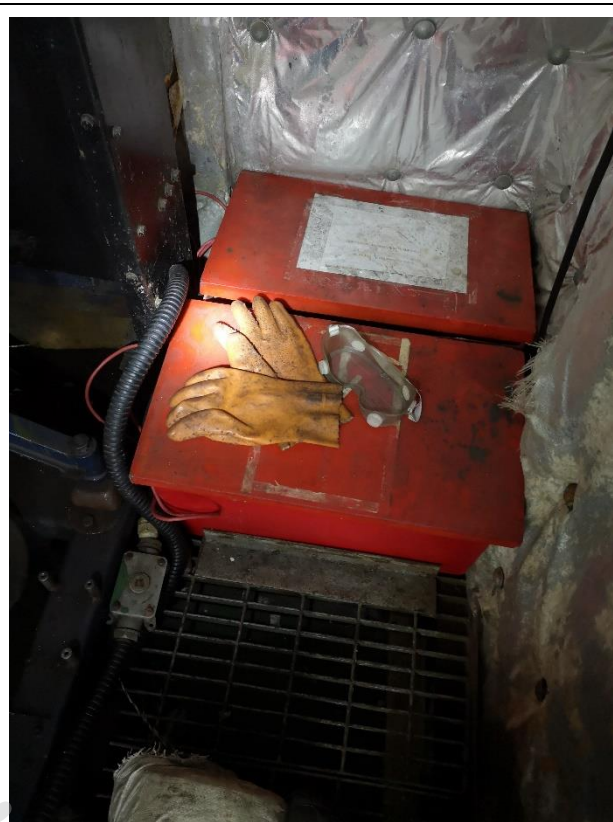
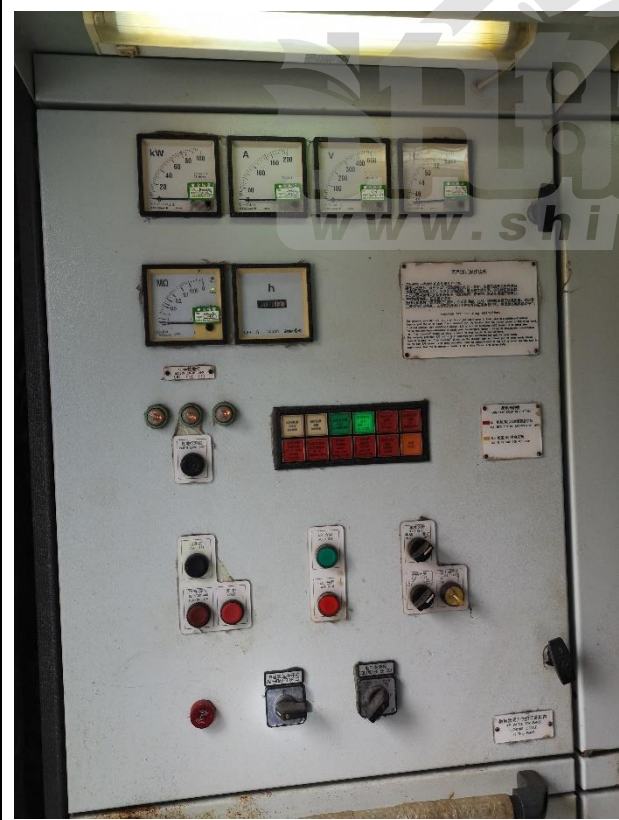
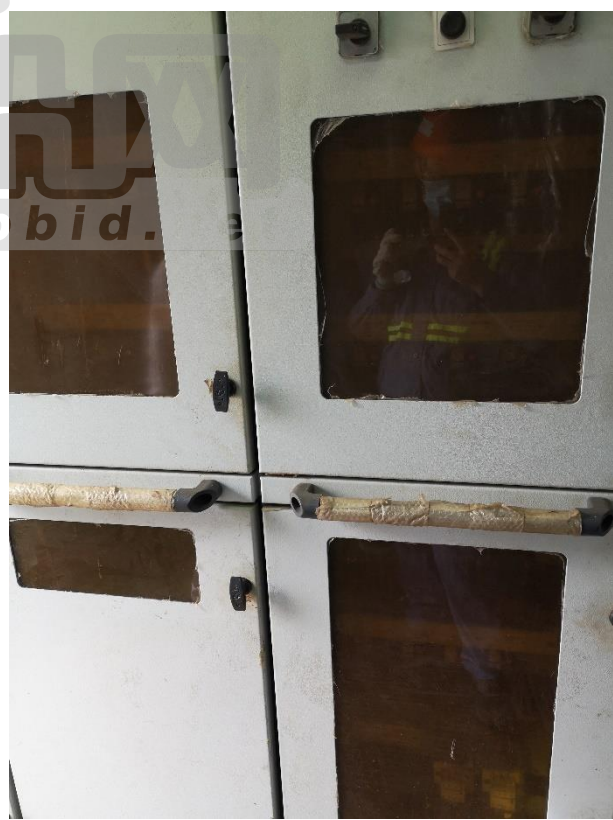
• Emergency Generator

The emergency generator room's weathertight door and frame were found no significantly rusted, with no aged or deformed on the adhesive strip. The ventilation grille and bolts were found intact.

The indoor lighting of the emergency generator was found intact, the fireproof laying material was found complete, without fixing nails missing.

The appearance of the emergency generator was found clean, the liquid level in the fuel tank was found normal, and the quick closing valve was found no significantly rusted.

The auxiliary engine of the emergency generator adopts two starting modes as required, namely air bottle and storage battery, with the storage battery being replaced on November 3rd, 2021.

The emergency switchboard was found to be in a normally open state, with no abnormalities in the appearance of the switch, indicator light, and instrument.
