TECHNICAL REPORT

编号: CJPG-JS-23-KY-236

Place of Inspection: Tianjin, China

Technical Report of MV "HAI XING CHUANG XIN"

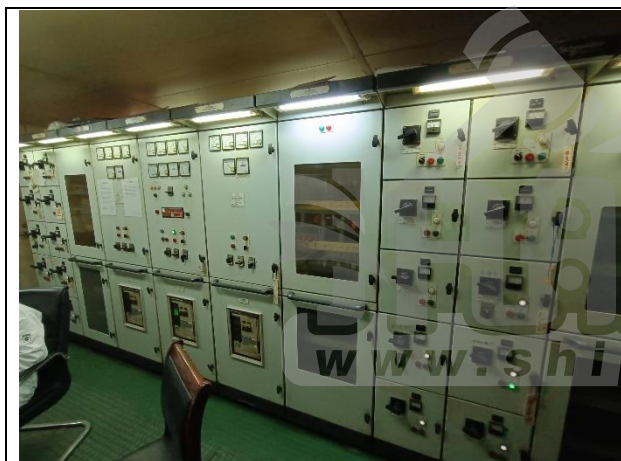
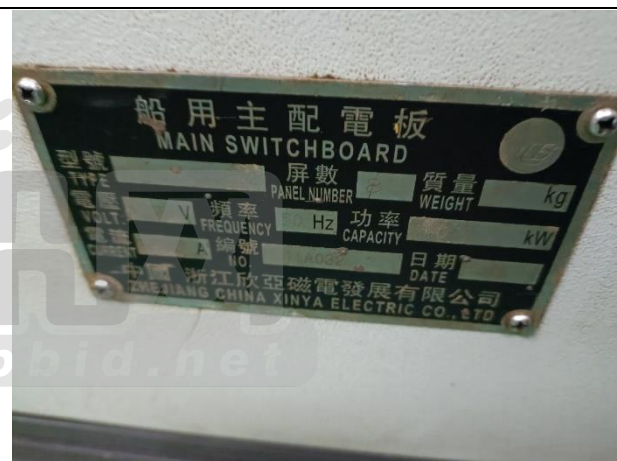
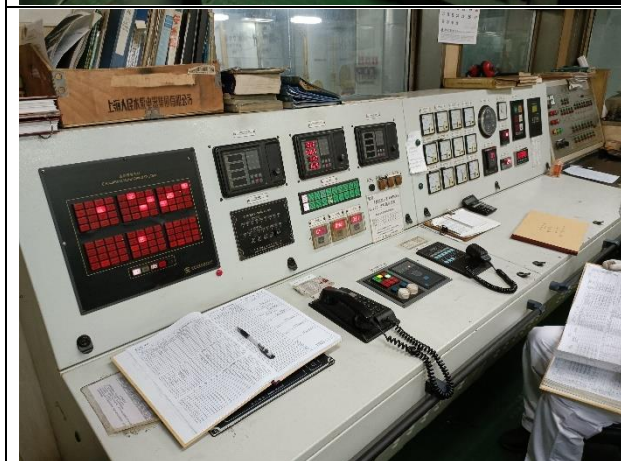
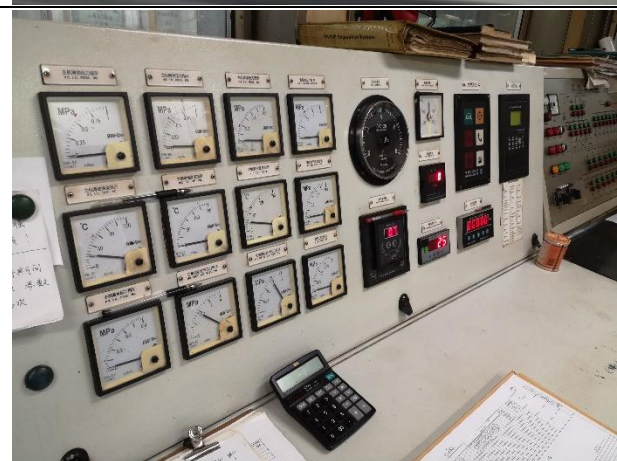
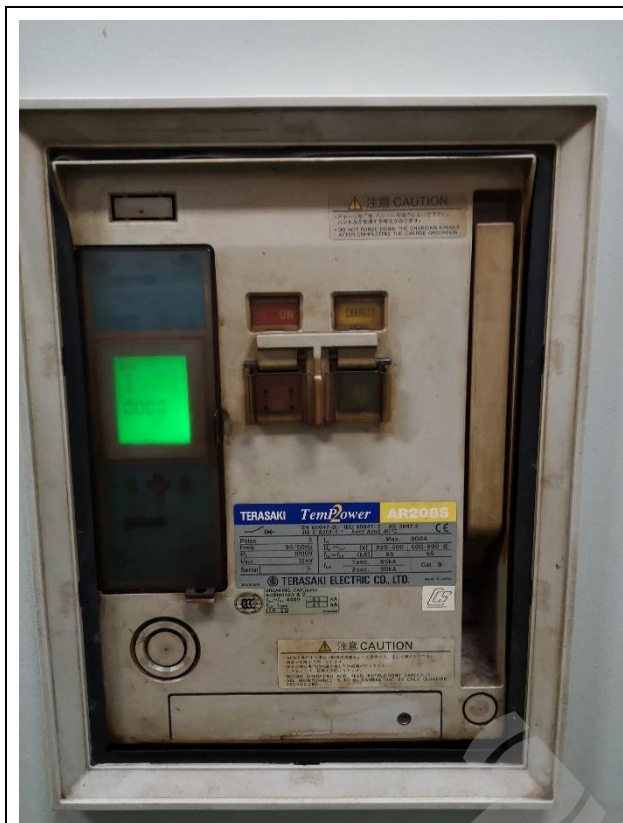
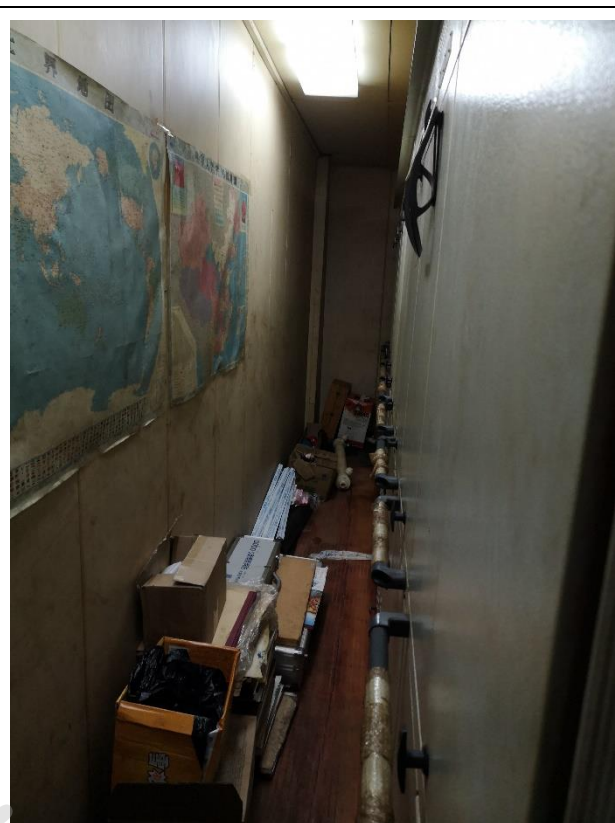
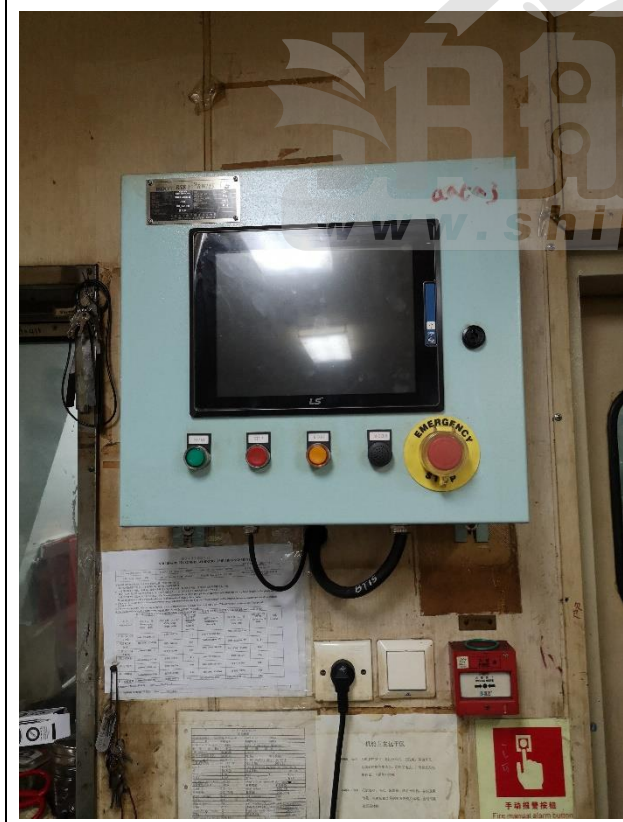
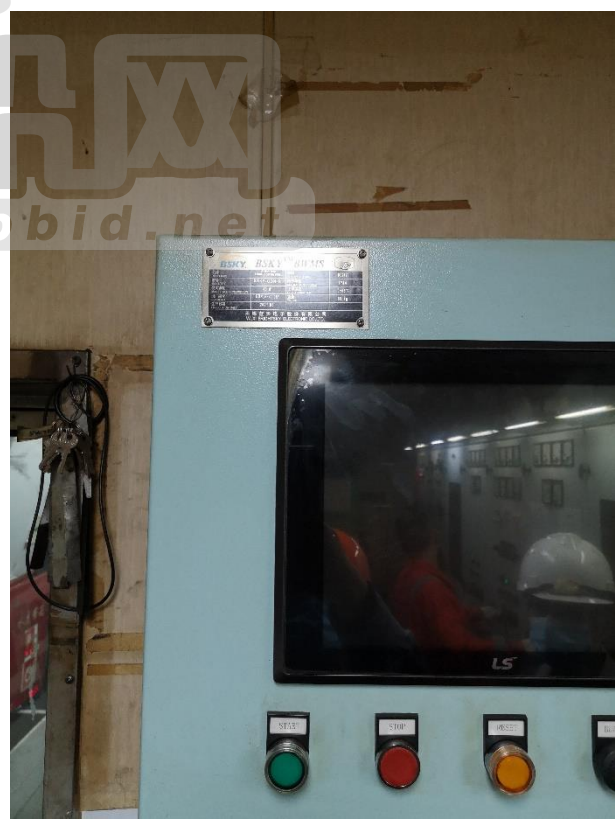
● Engine Control Room

The self-closing door, indoor lighting fixtures, and fire insulation laying of the engine control room were found in good condition.

The ship was equipped with 8 main distribution screens which produced by Zhejiang Xinya Electric Development Co., Ltd, and the brand of main switch is TERASAKI.

The appearance of each switch, indicator light, and instrument on the main distribution board was found normal.

The alarm lights and monitoring instrument panel on the engine control console were found in real-time monitoring status, and the rudder angle indicator was consistent with the bridge console.

The remote control device of the ballast water management system was set in the engine control room, and the appearance was found normal.

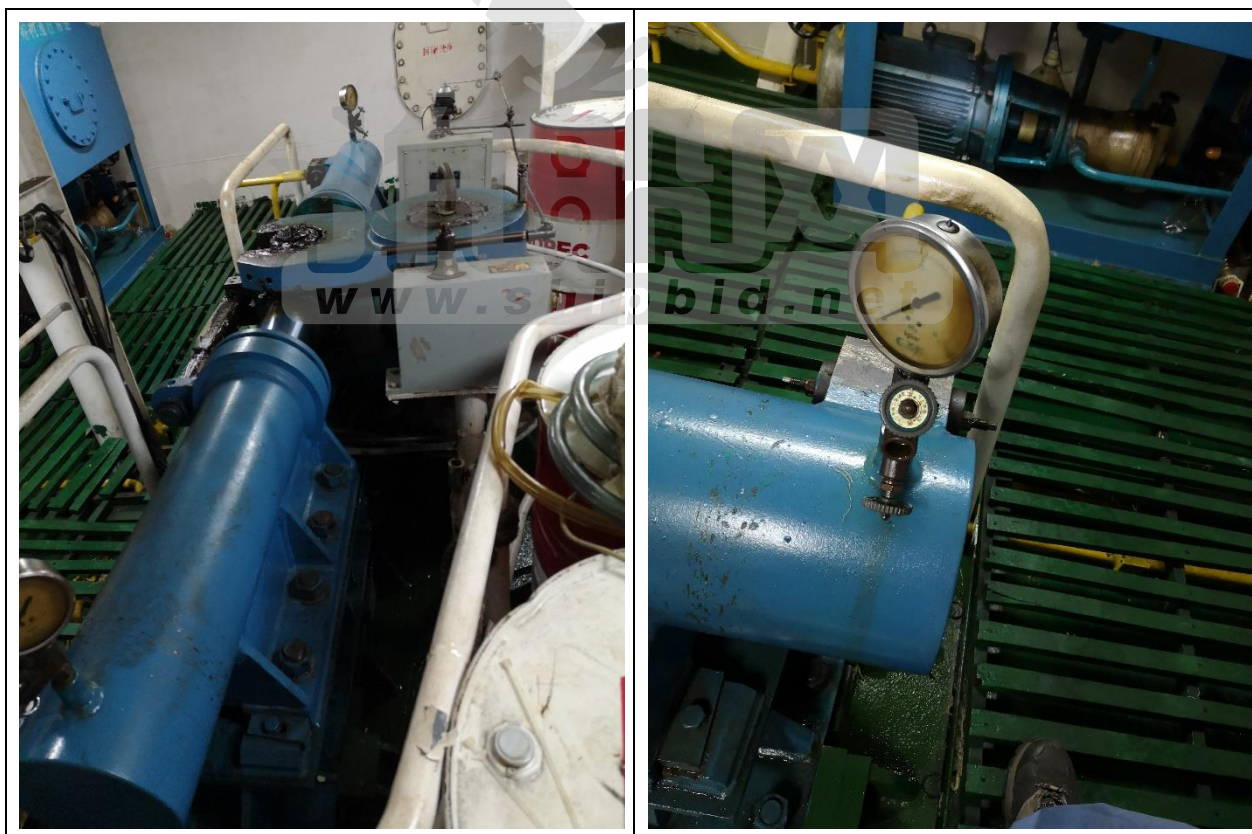
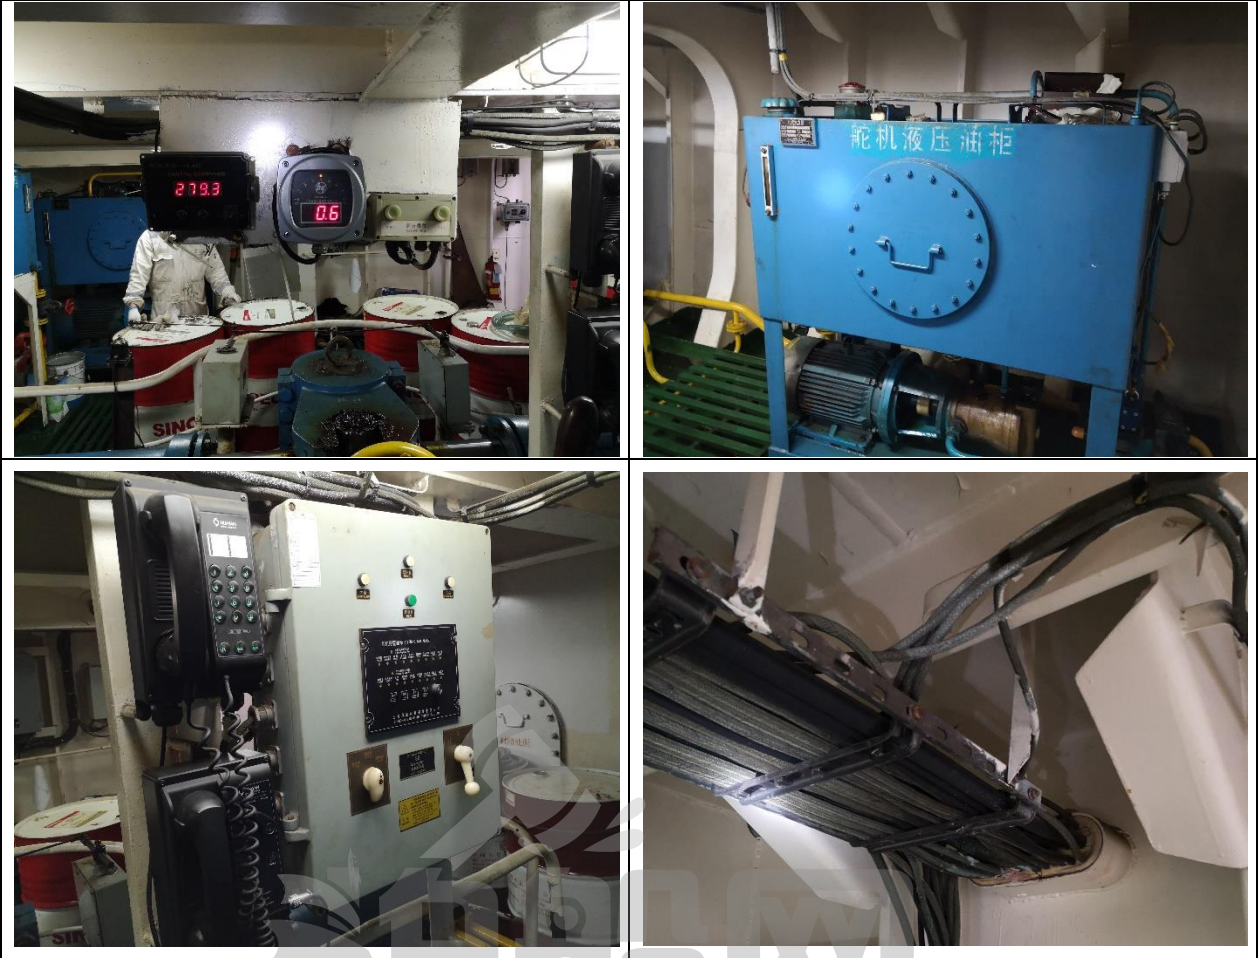
● Steering Gear Room

A small amount of oil stains was found in the steering gear room, the floor was equipped with anti slip wooden grilles, and protective railings were installed nearby.

One set of manual emergency steering devices and one set of electrical emergency steering devices were installed next to the steer gear, and the liquid level of the two sets of hydraulic oil tanks was at a high level.

The rudder carrier seat was found no significant oil leakage, with no rust on base bolts. There are relief valves and pressure gauges installed at both ends of the oil cylinder, and the pressure gauge is in a zero state.

The reading of the rudder angle indicator was consistent with that of the bridge console, and the reading of the digital compass was also consistent with that of the bridge console.

The cables inside the room were found to be neatly arranged and all were sealed with fillers.

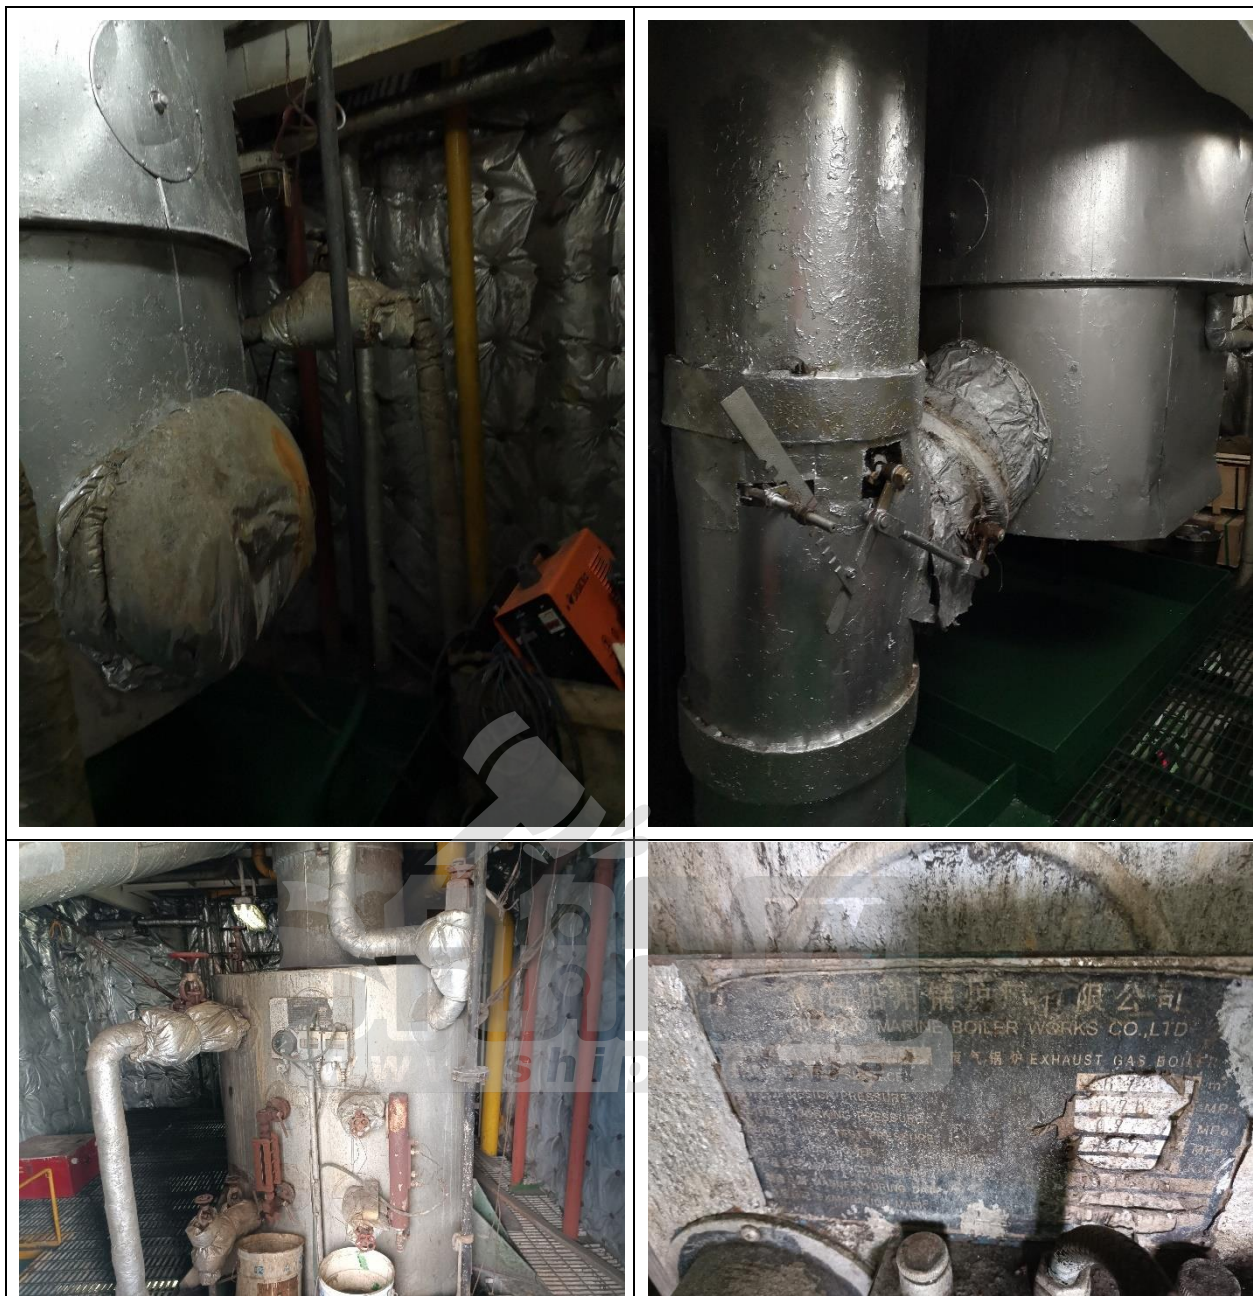
● Exhaust gas boiler

The exterior of the boiler body, exhaust pipes, and steam pipes were found all insulated and wrapped without obvious damage.

The boiler valve components were found no significant signs of water leakage, and the water supply pipeline has no significant leakage.

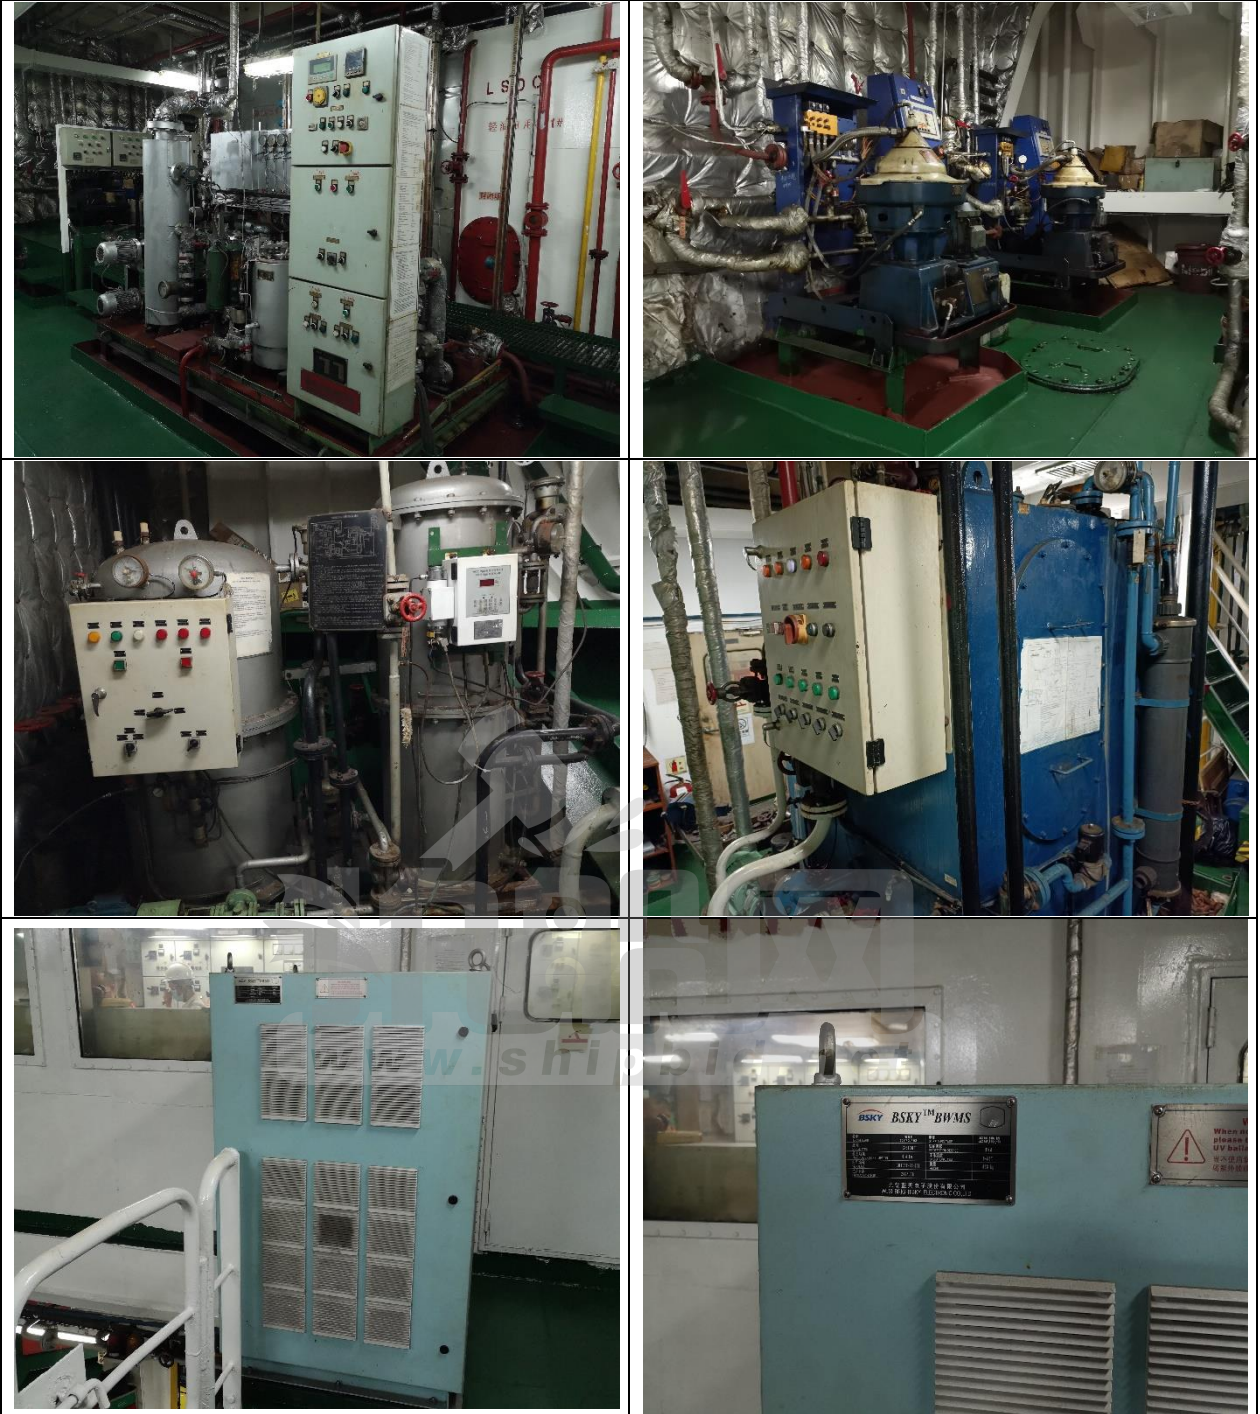
● Anti-pollution equipment

The engine room is equipped with a fuel oil purifier and fuel oil supply unit, with a small amount of oil stains on the equipment chassis, and no significant corrosion or leakage in the pipelines.

The engine room is equipped with a domestic sewage tank and treatment device, and the pipelines and valves were found to be free of rust. The appearance of the control box and emission monitoring alarm was found normal.

The engine room is equipped with electrical control unit of ballast water management device, which is a brand of Wuxi BSKY.

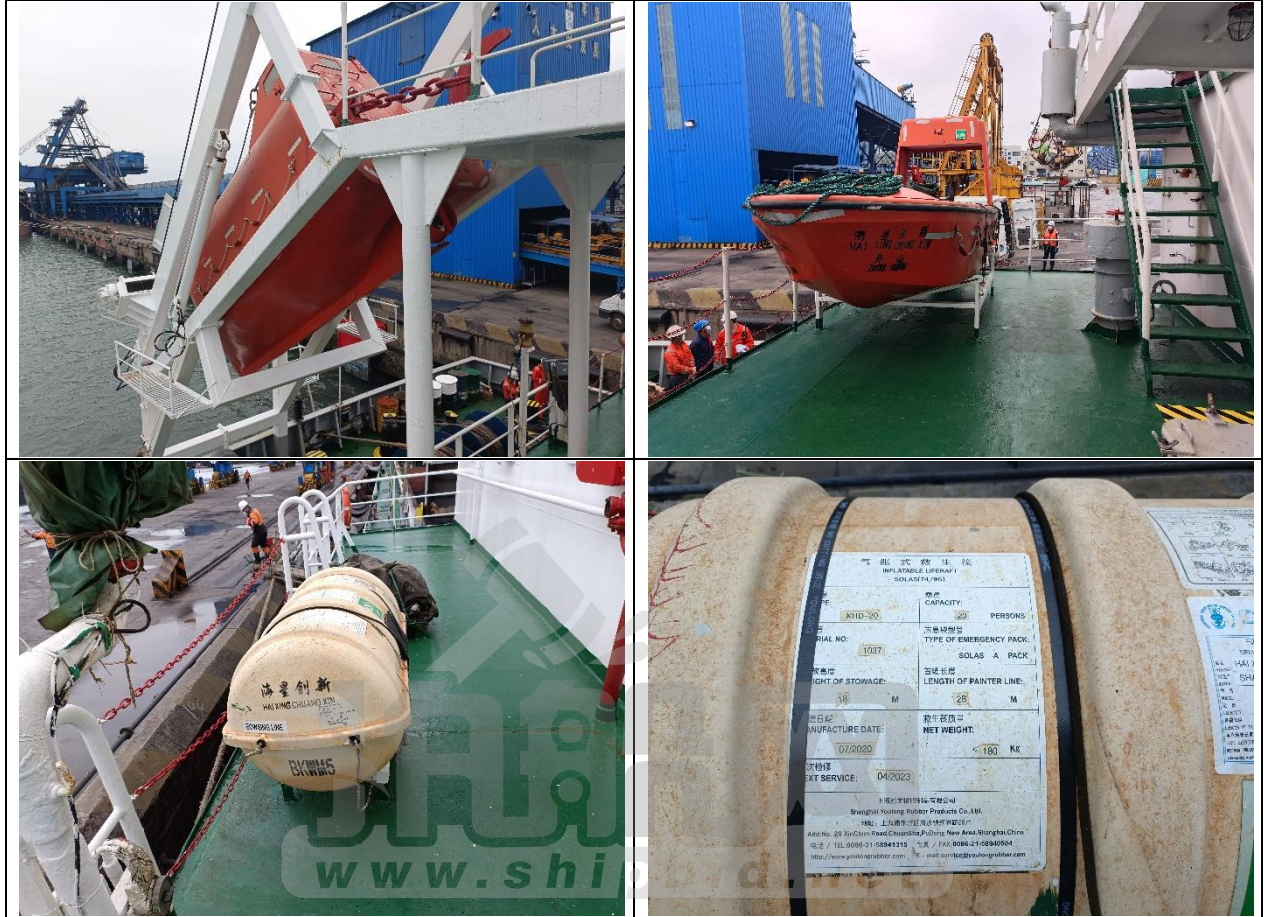
6.6.1 Life-saving equipment

The ship is equipped with one fully enclosed lifeboat with a capacity of 20 people. The appearance of the lifeboat was found no cracked, with complete the thruster facilities, and the keel plate at the bottom of the lifeboat was found no damaged.

The roller groove of the lifeboat frame was found no significant rust or thinning, and the lifting roller and

release hook was found no rust.

The ship is equipped with one inflatable life raft with a capacity of 20 people on the port and starboard sides. The release device of the life raft was found complete and in overall good condition.

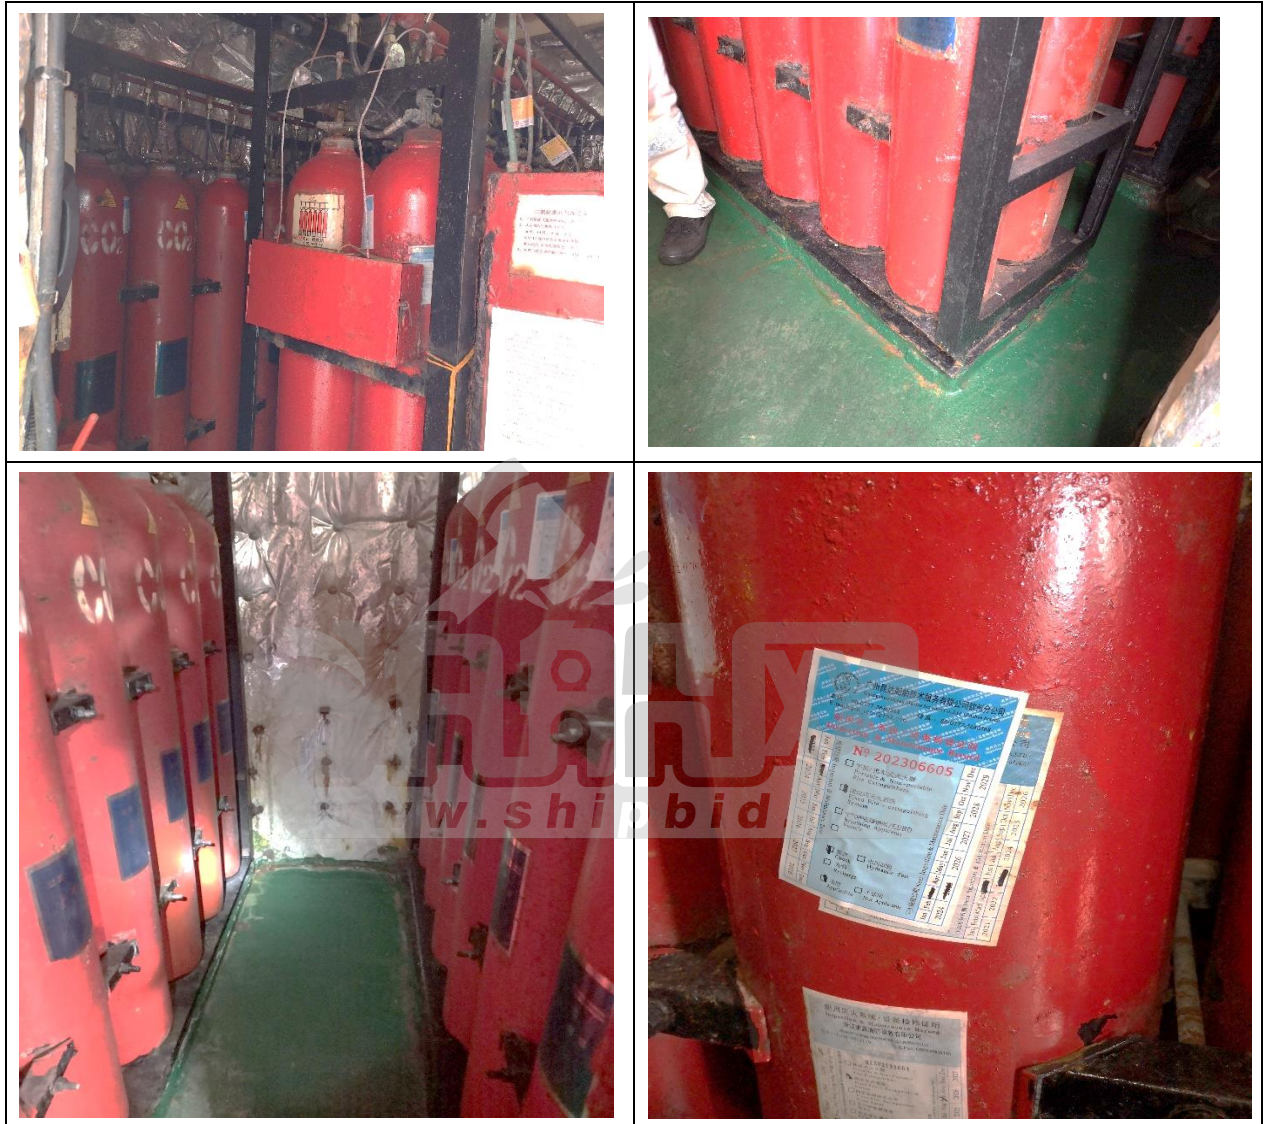
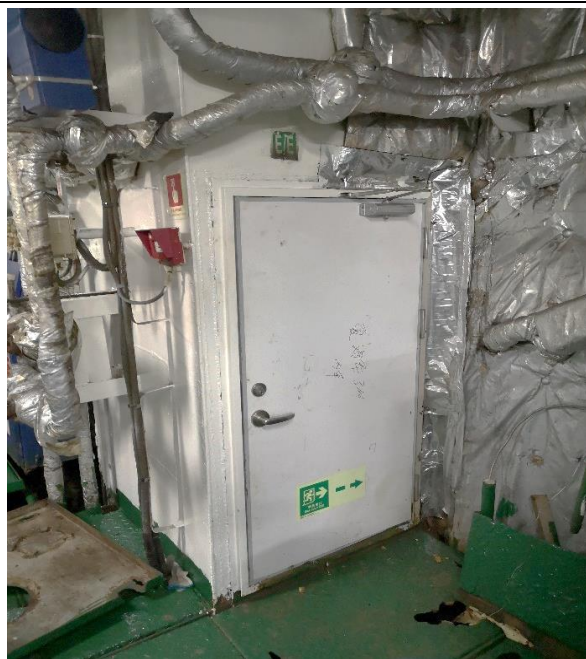
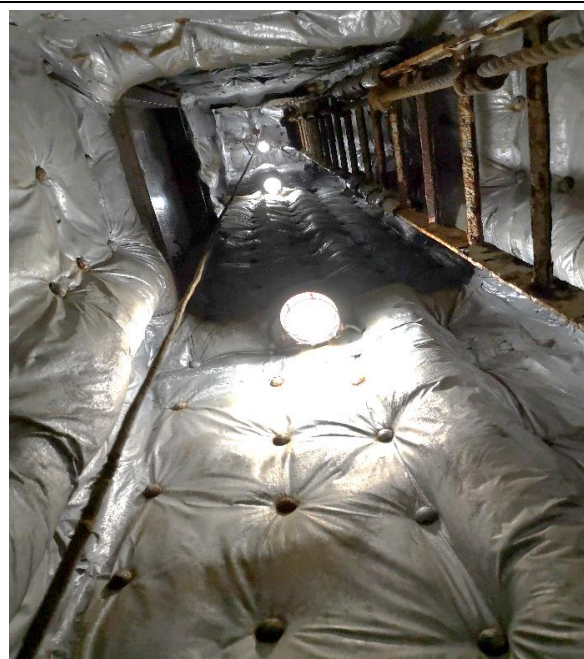
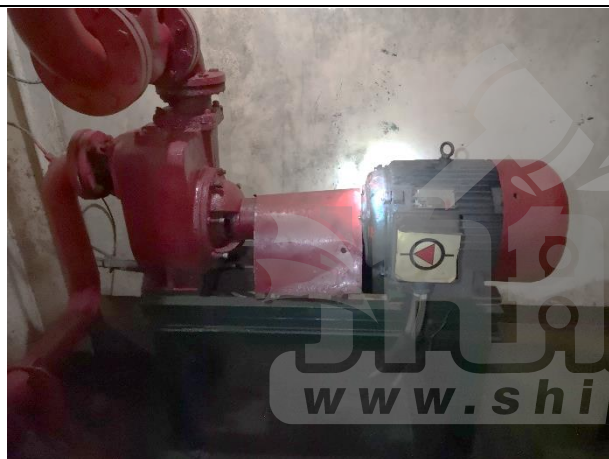
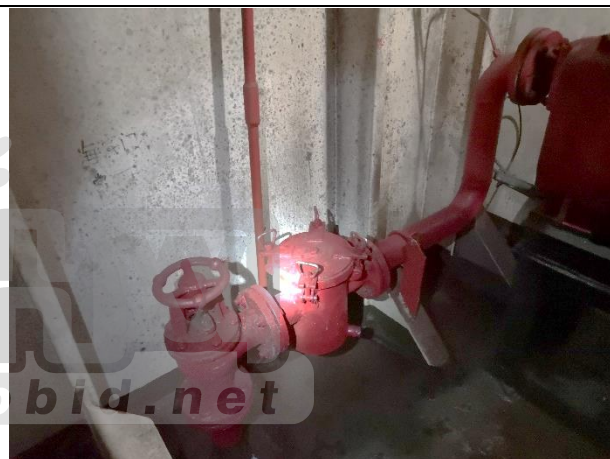
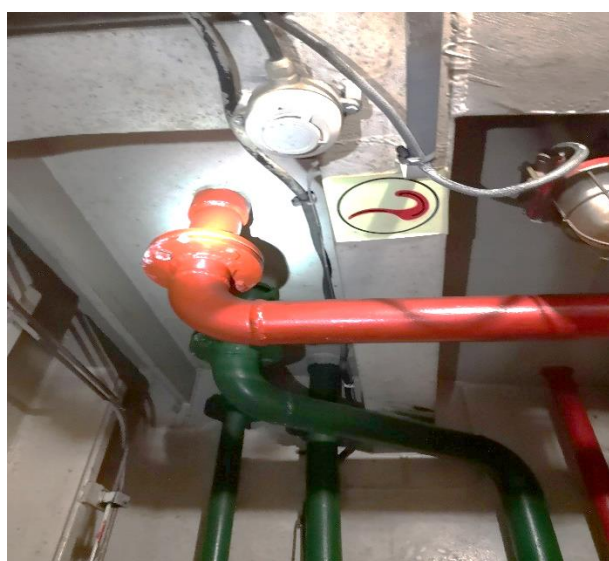
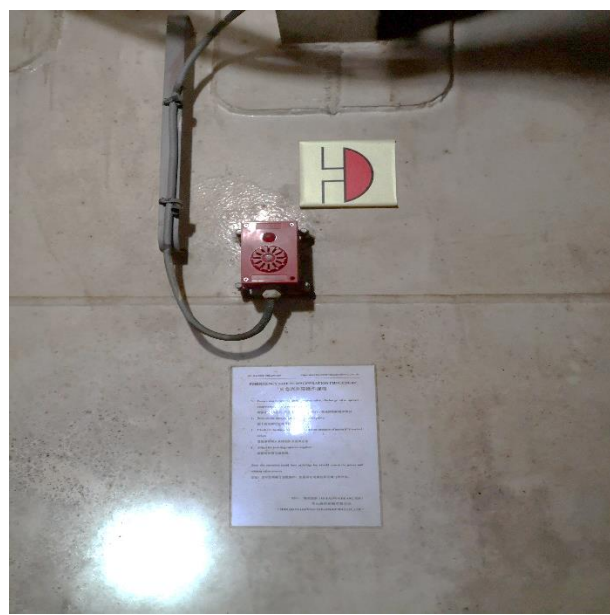
6.6.2 Fire-fighting equipment

A small amount of rust was found on the sealing strip groove and door frame weld of the CO2 room of this ship. The indoor fire protection laying was found complete, with no rust on the release valve and bottom of the cylinder. The inspection mark shows the last inspection was in March 2023, and the next inspection will be in March 2025.

The self-closing door of the emergency passage in the engine room was found in a normally closed state, the self-closing device could work normally, the fire separation outside the passage was found complete, and the life ropes and ladders inside the passage were fully equipped, and the overall condition was found good.

The emergency fire pump is located in the bow fire pump room, the paint of pump body was found

basically intact, the starter motor shell was found no significantly rusted, and the pipeline and valve parts were completely painted. The operating procedures was found posted indoor, and the smoke detectors and explosion-proof lights were in good condition and appearance.
