TECHNICAL REPORT

Number: CJPG-JS-23-K Y-285

XING XIANG 7

Inspection Place: Zhoushan Jinzhou Shipyard

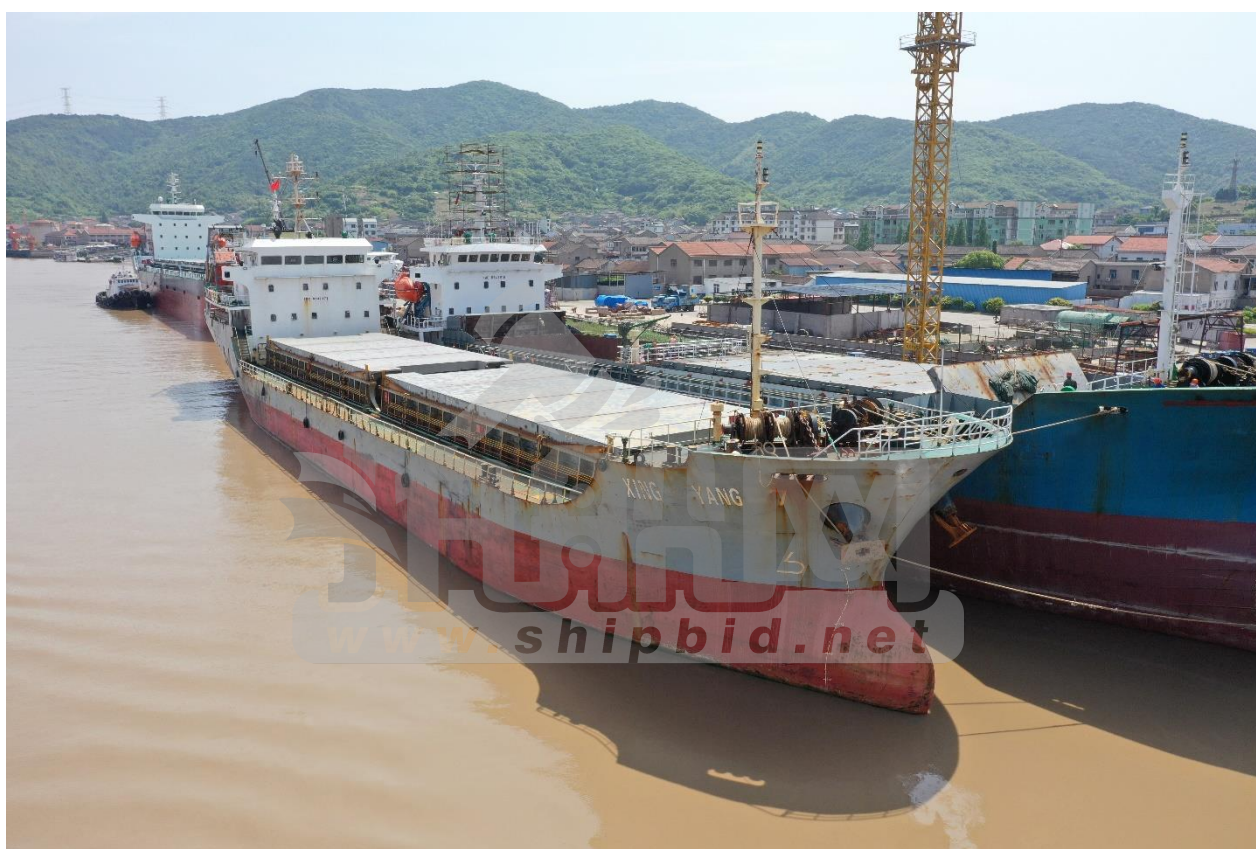
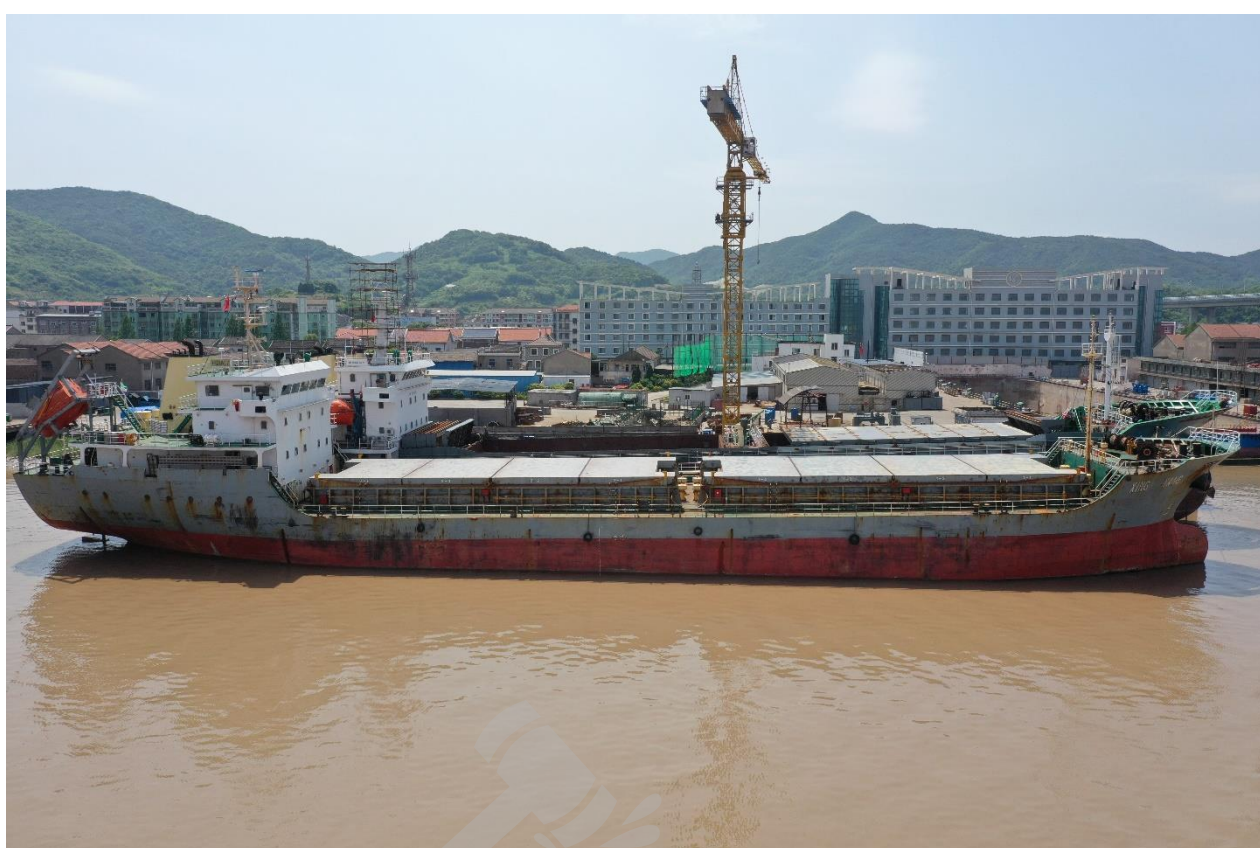
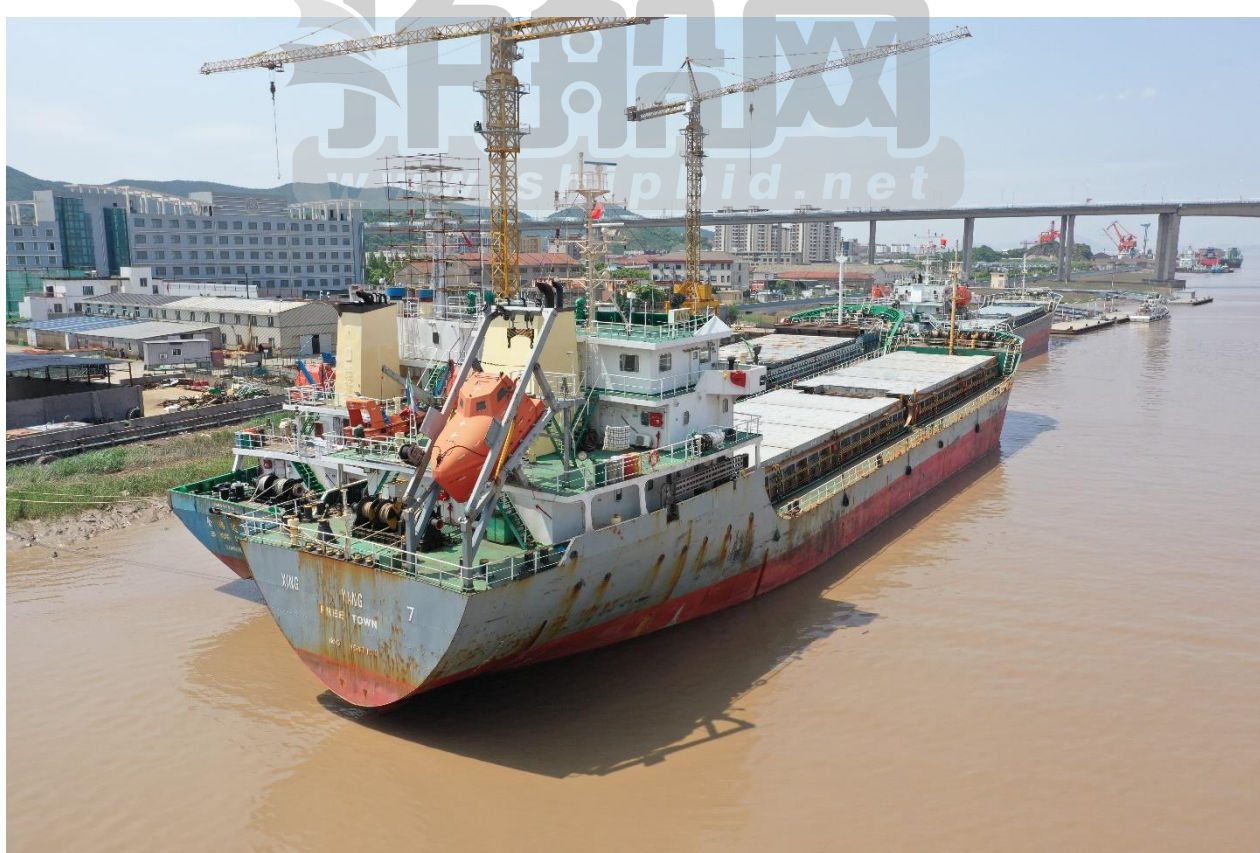
The painting condition of shell plate was found basically general, without obvious corrosion. The draft marks, ship's name, IMO number above the waterline were found clearly and full painted. The bow and stern bulwark was found general condition, with deformation on the side railing.

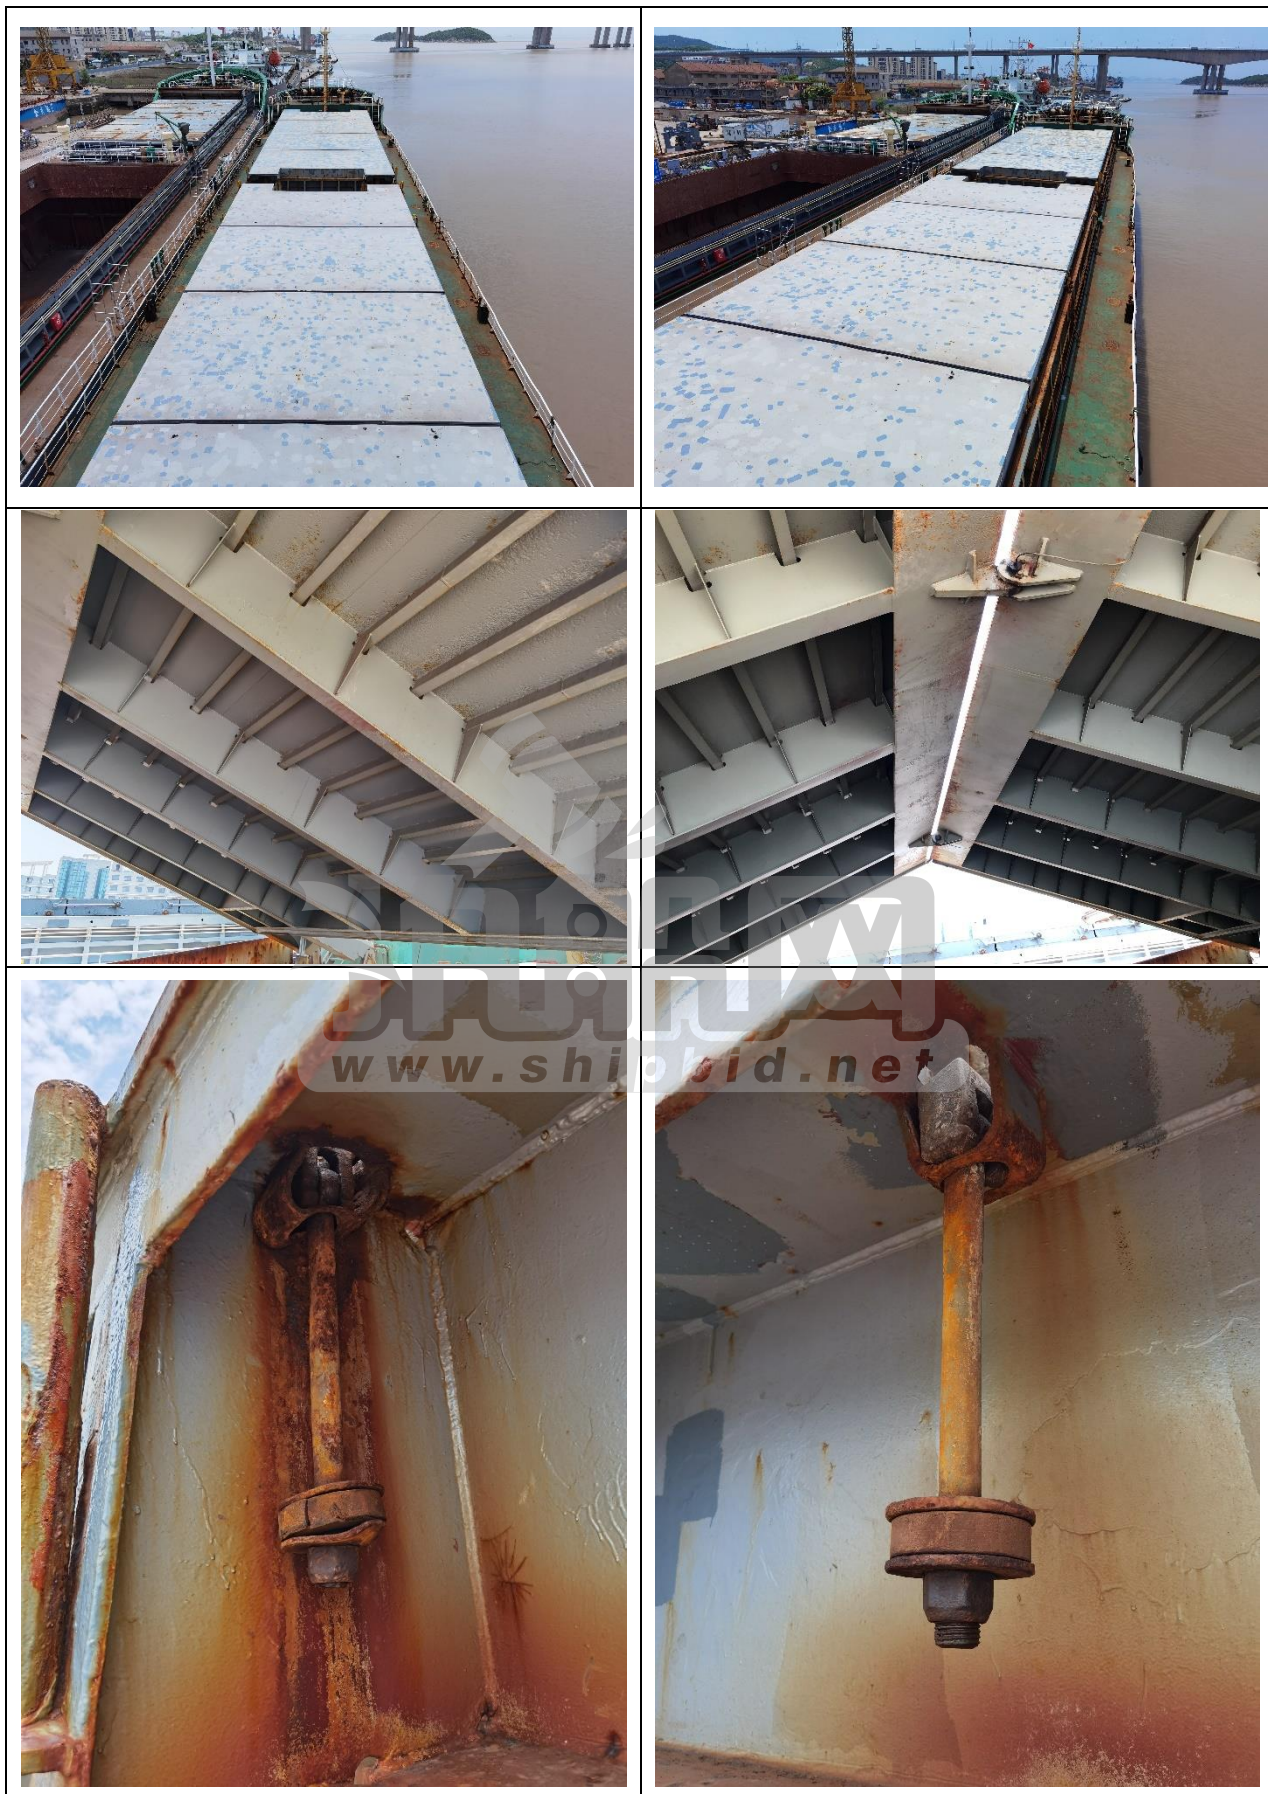
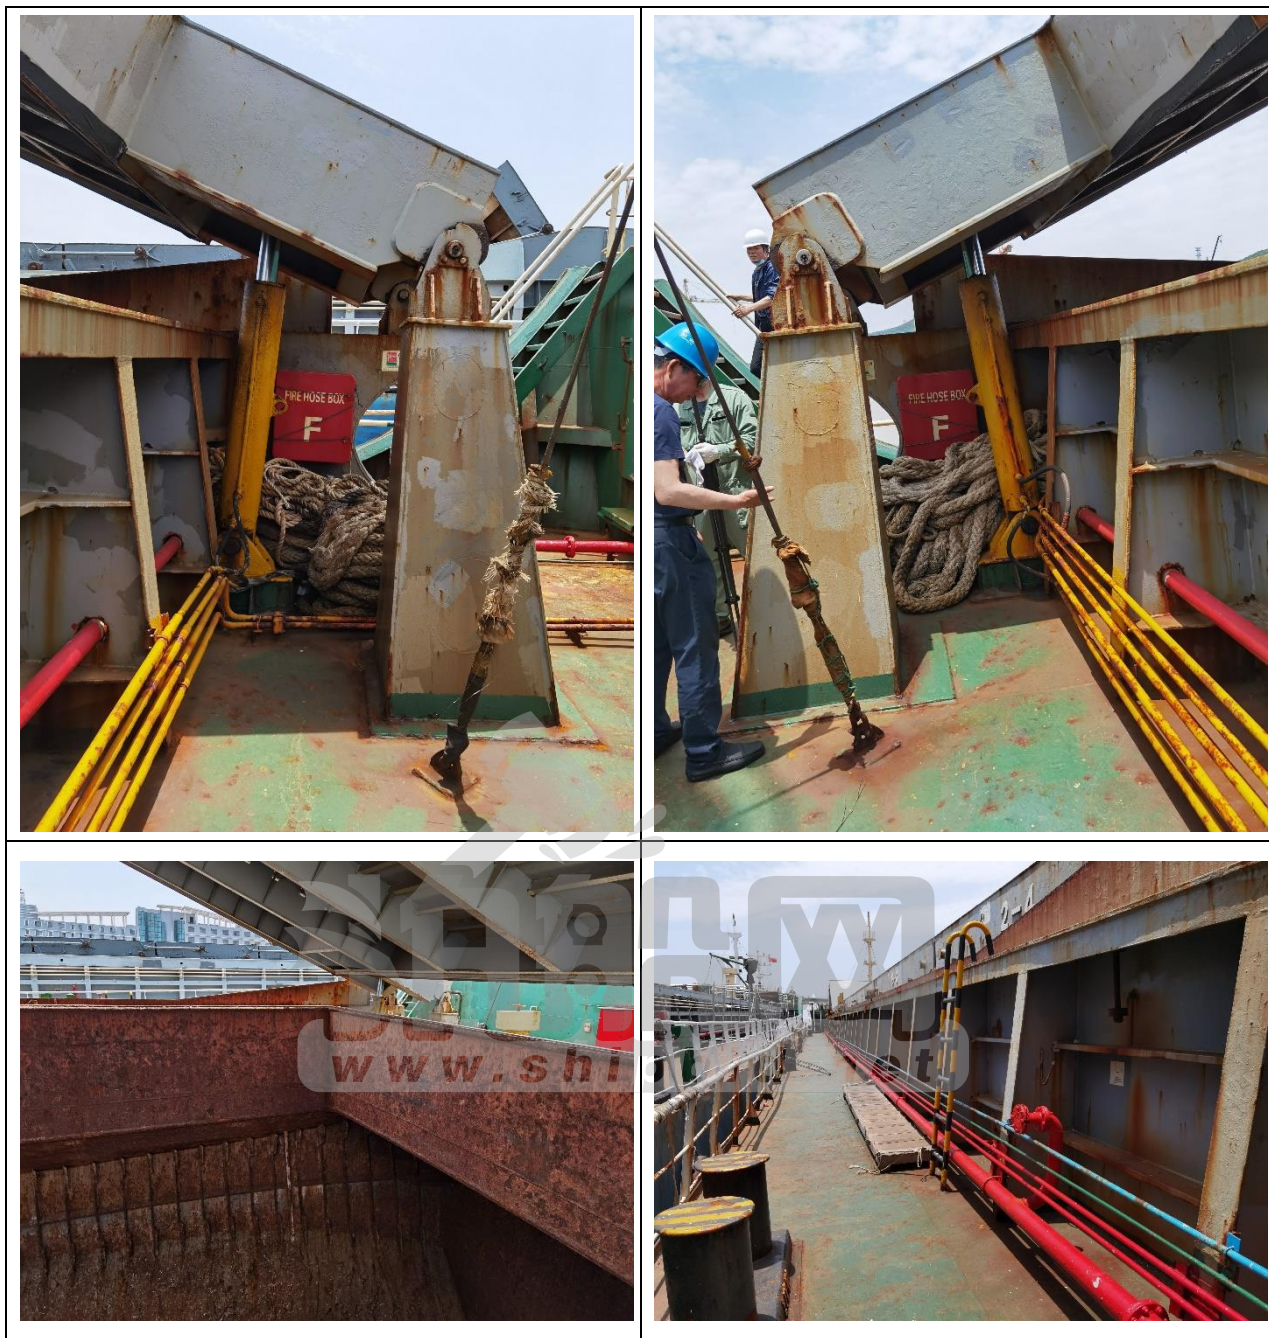
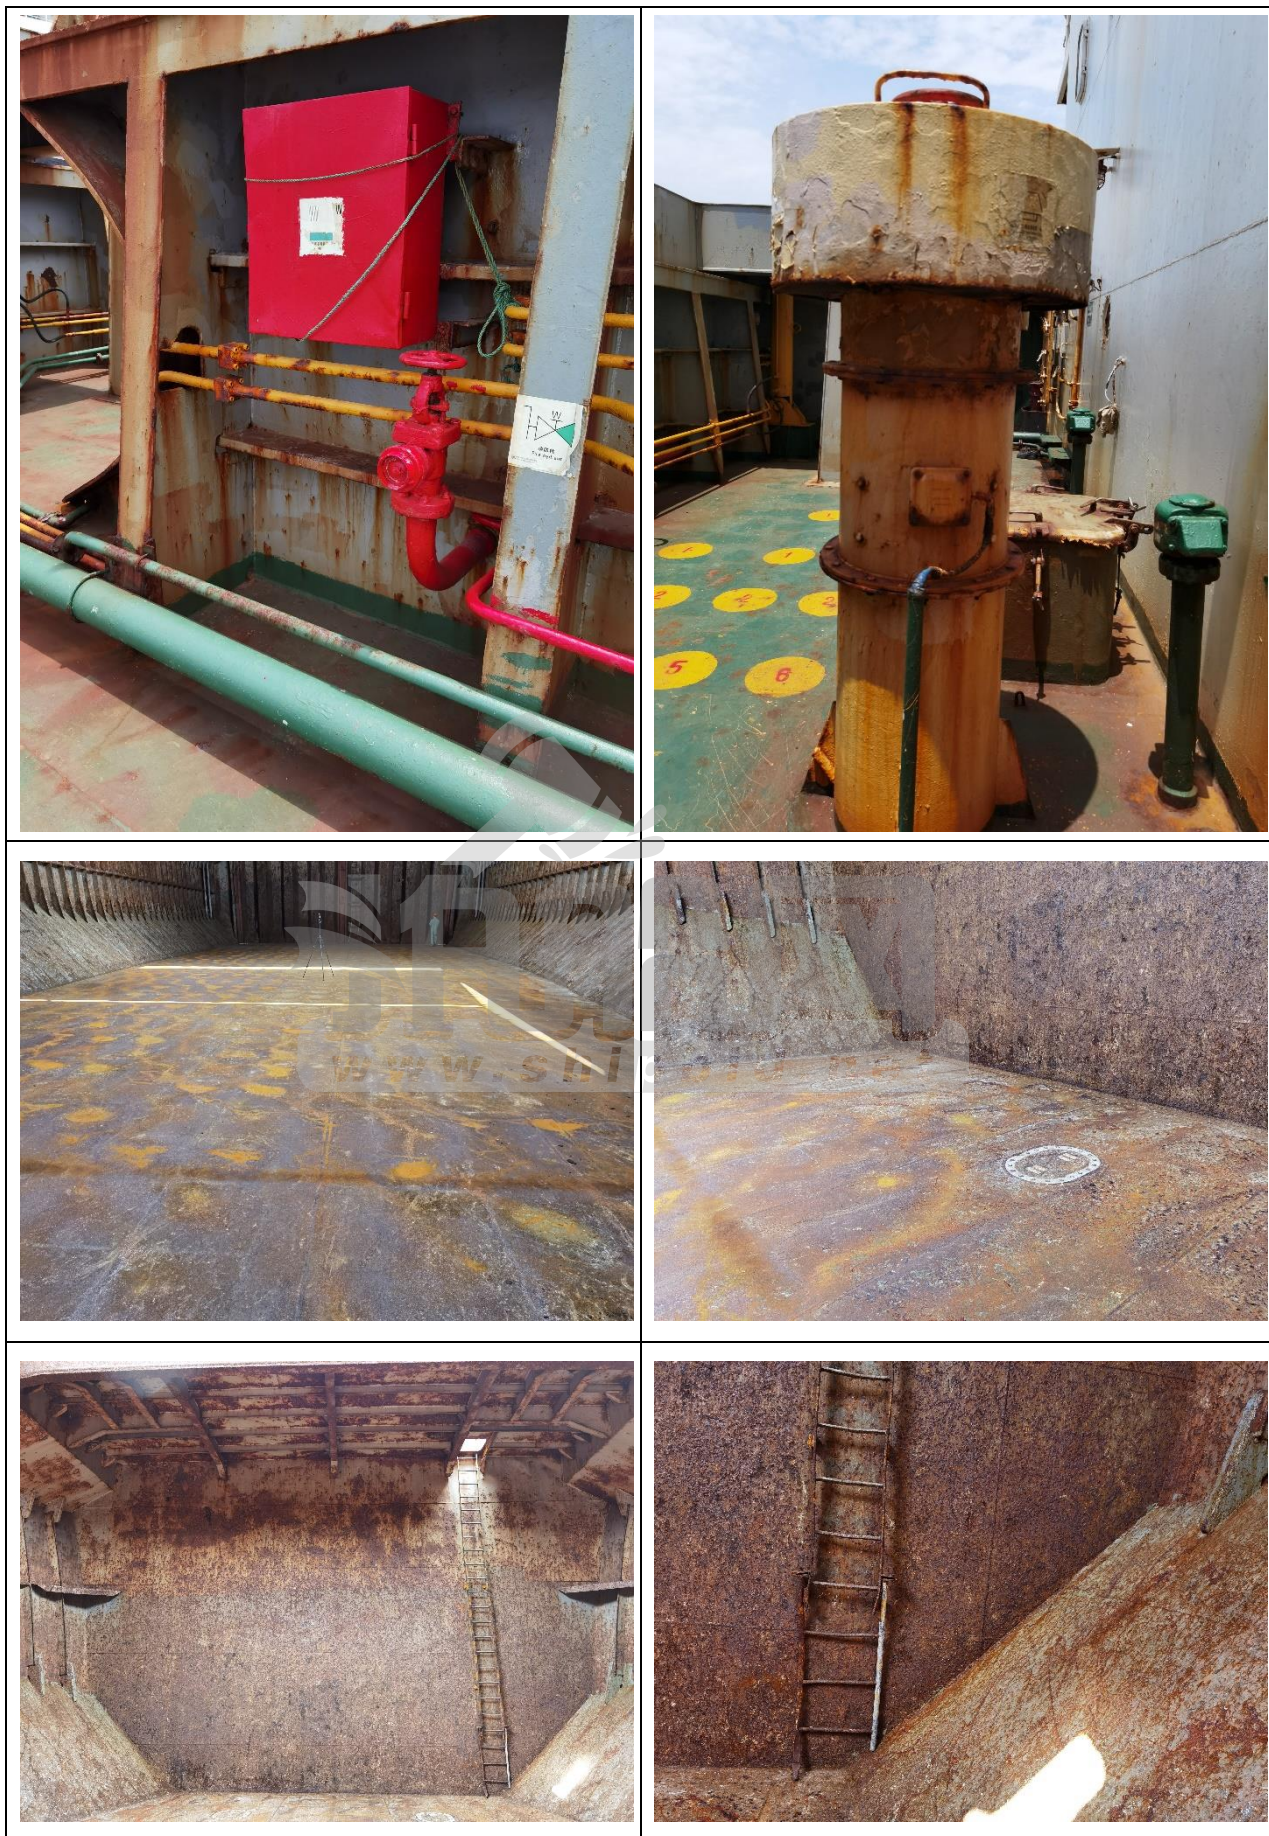
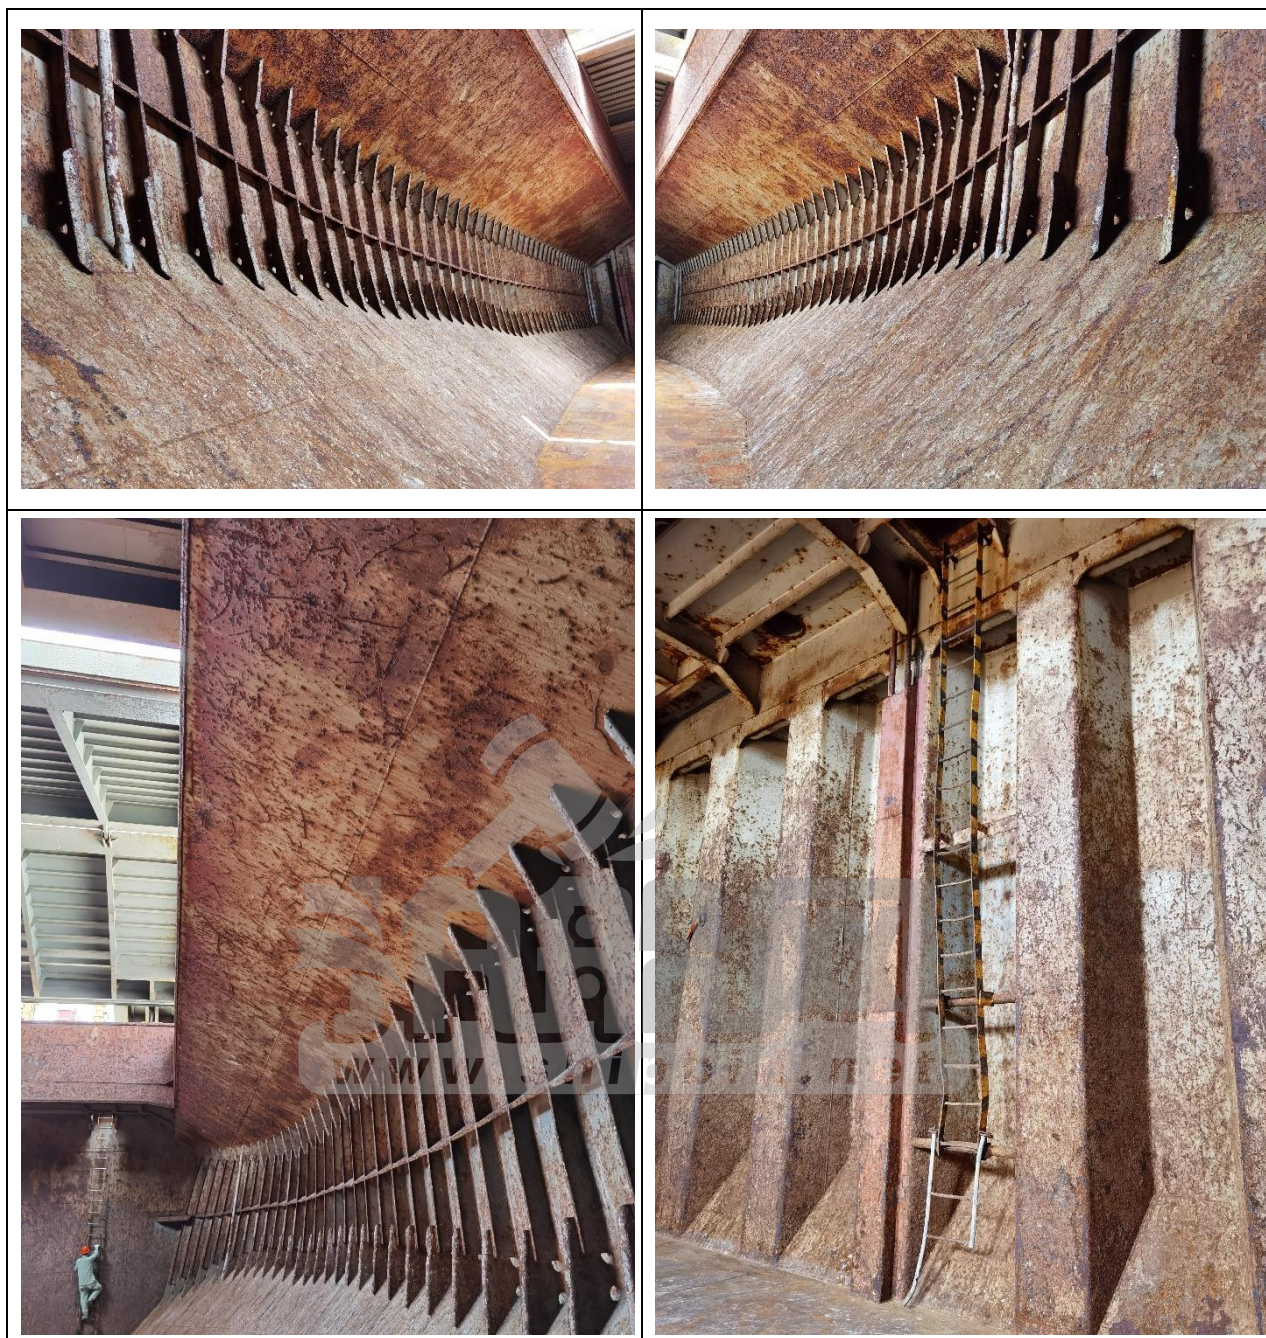
The ship has 2 cargo holds with double bottom and single hull, the hatch cover is hydraulic folding type. The flatness of the top plate of hatch cover was found general good, with spot repaint mark. The reinforcement structure and rubber strip groove of the hatch cover were found to be free of significantly corroded, and without significantly aged on the rubber strip.

The fastening wedge and wedge ear of the hatch cover were found deformed and significantly corroded. No rust was found on the hydraulic cylinder support and no significant leakage in the hydraulic pipeline.

The corner structure of the hatch was found significant corrosion, and the hatch cover strip and guide channel on the top plate of hatch coaming was found corrosion, with no significant deformation of the structure.

The side of the hatch wall facing the cargo hold was found extensive rust, and the edge of the bracket was found corroded. No significant corrosion or crack was found on the welding seam between the bracket toe and the main deck.

The painting condition of the fire pipeline around the hatch coaming was found in good condition, the fire hydrant layout was found basically complete, and the lock catch of the hose box was found missed. The ventilation pipe and hood of the cargo hold was found significantly corroded.

During the inspection, the NO.1 cargo hold was opened for inspection. The flatness of the inner bottom plate and the slop plate of the bottom side tank was found good; No significant deformation was found on the watertight bulkheads, and the entry ladder at the bulkheads was found deformed and broken on the lower part. The longitudinal on both sides is bulb bar, and no significant deformation on the toe end of bracket.

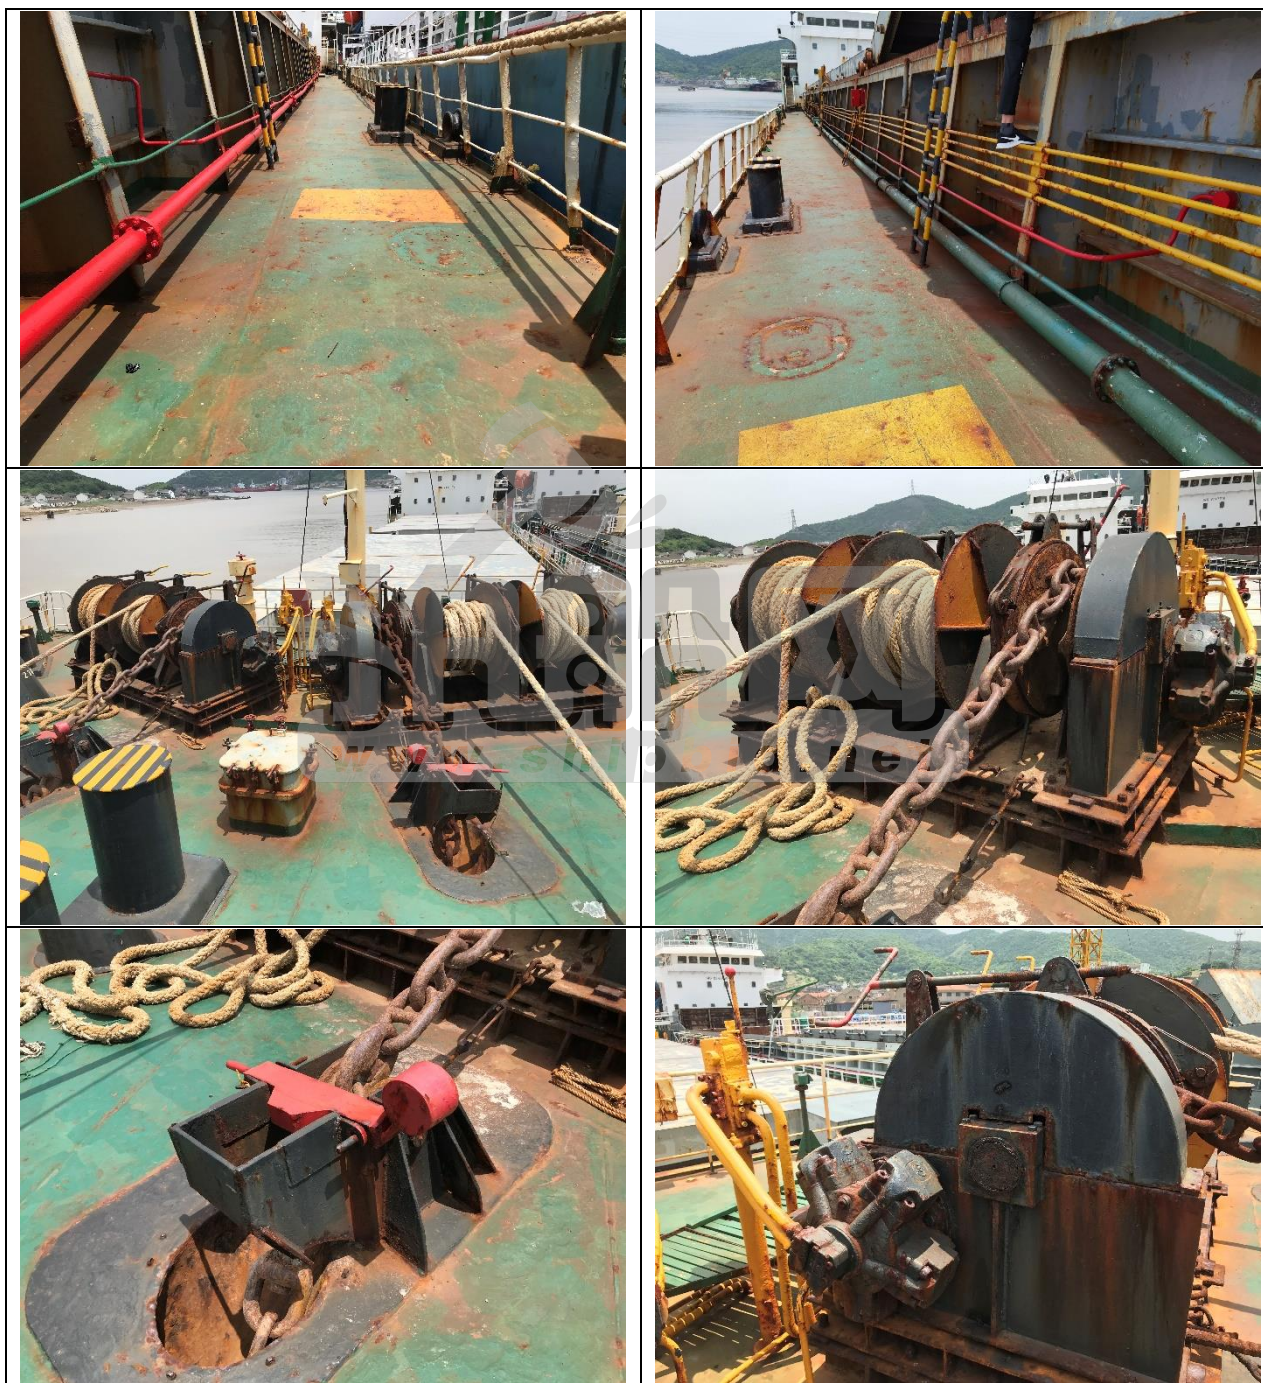
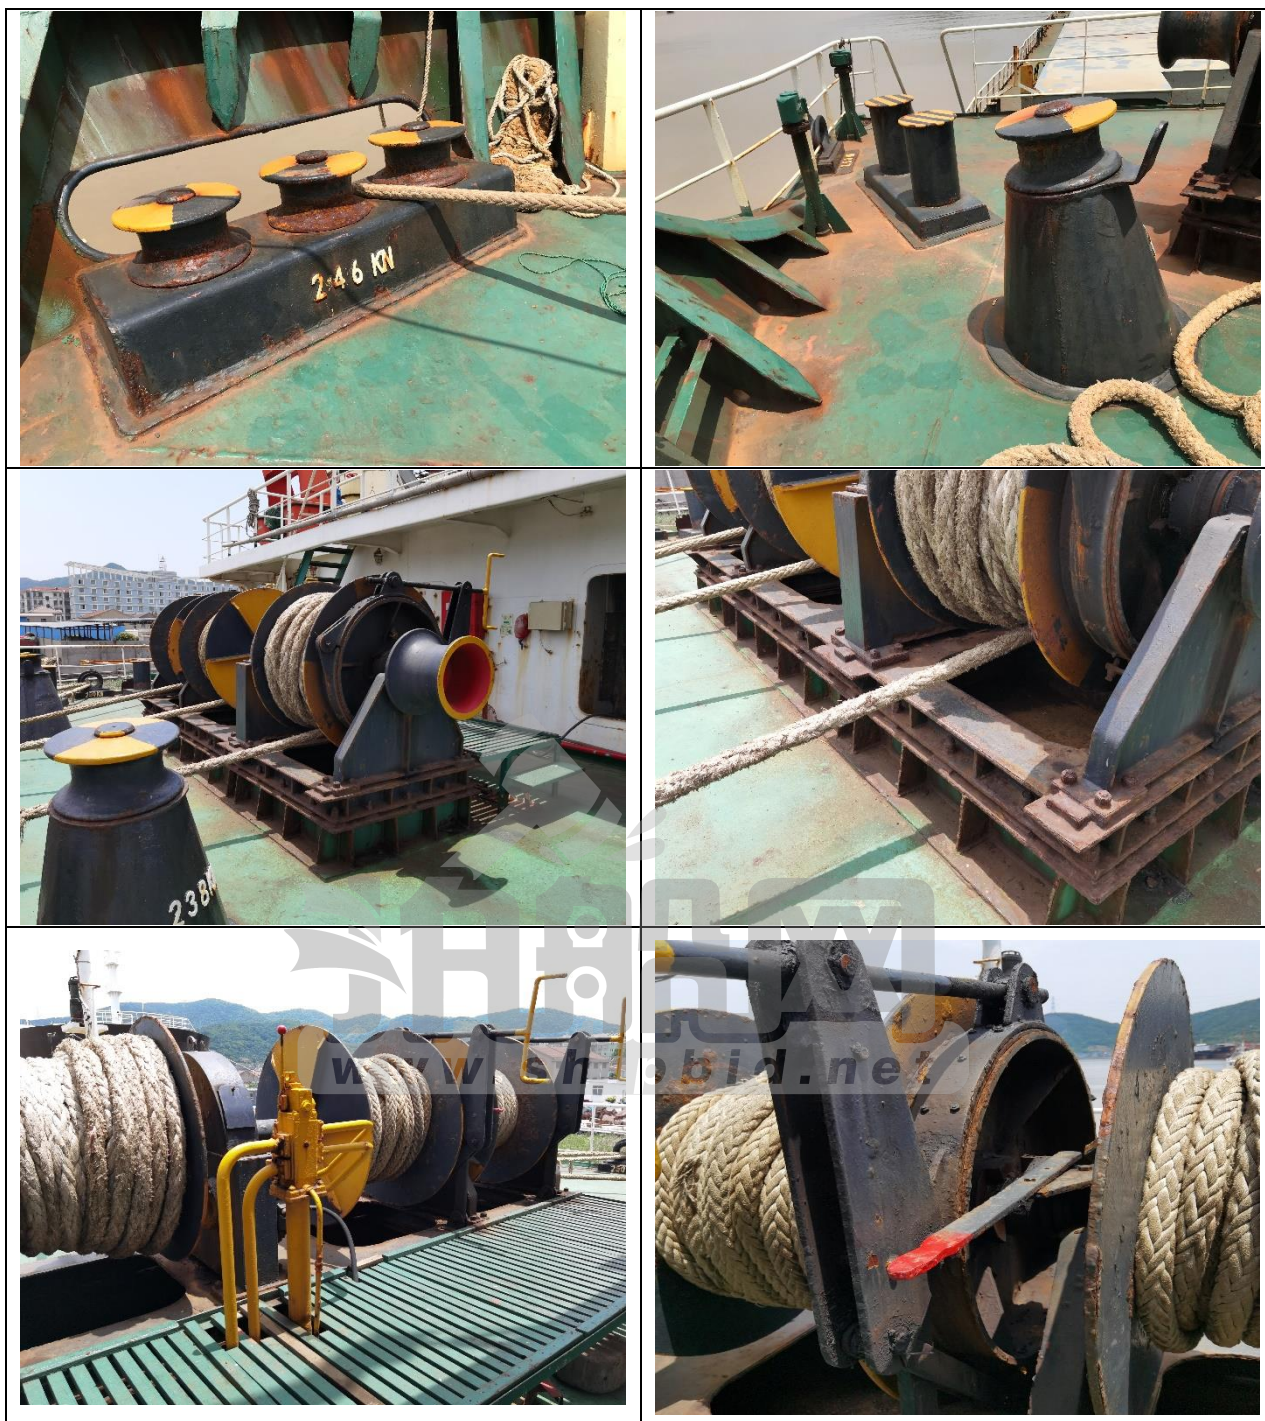
The overall condition of the main deck was found general good, and the watertight manhole covers on the left and right sides of the main deck were found severely corroded.

The overall condition of the forecastle deck was found general good, without significant paint damaged. The structure of the two windlass were found complete, with significant rust on the windlass base, but no structural thinning. The brake wheels were found significant rust. The surface of mooring components such as chain stoppers, bollard,

and guide rollers was found slightly worn.

One set winch was installed on the main deck aft, and the body paint was found basically intact, and without obvious structural thinning on the base bracket. No significant corrosion or thinning on the guide pulley, and no significant breakage of the mooring rope.

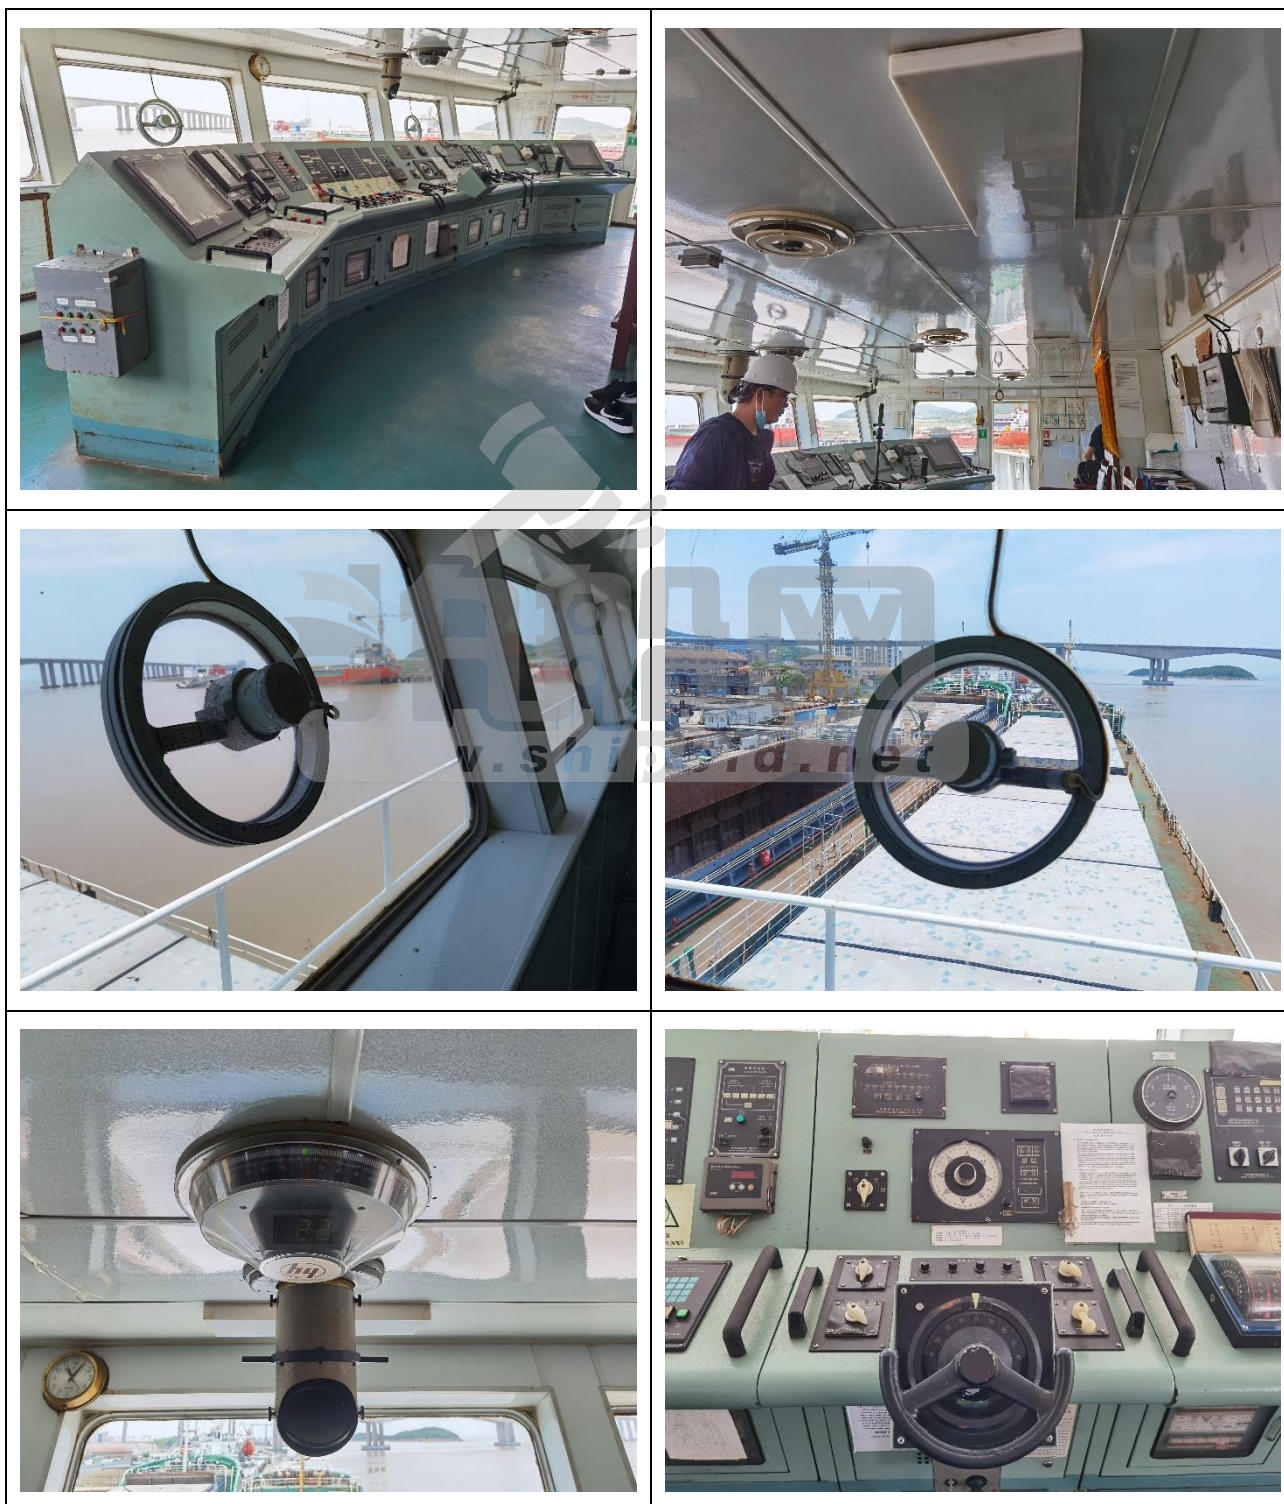
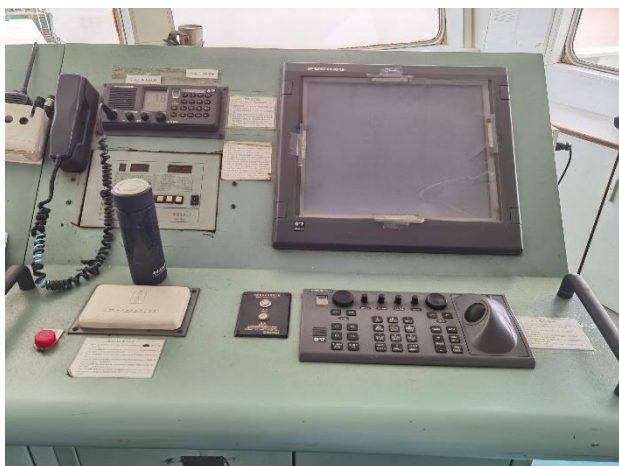
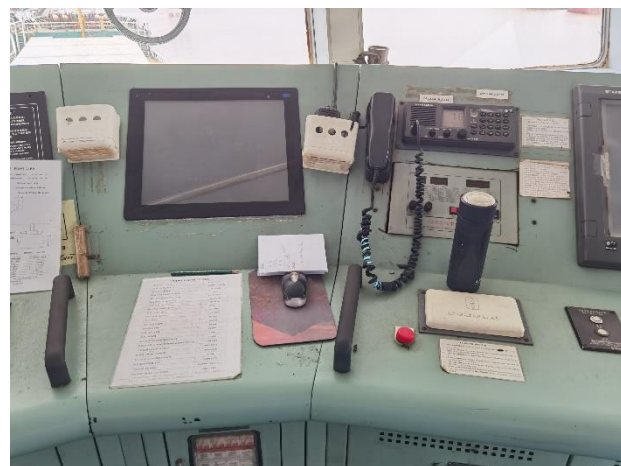
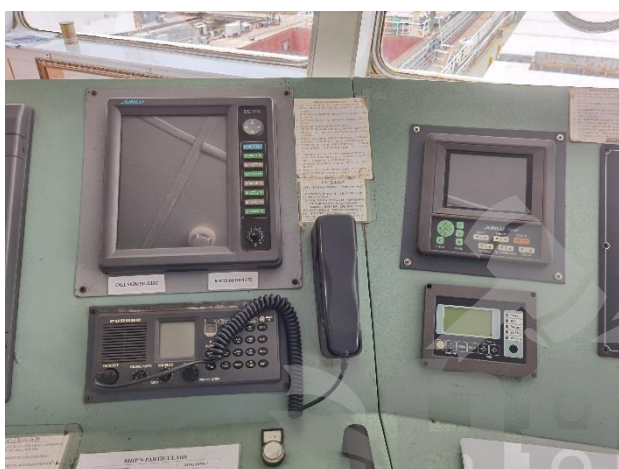
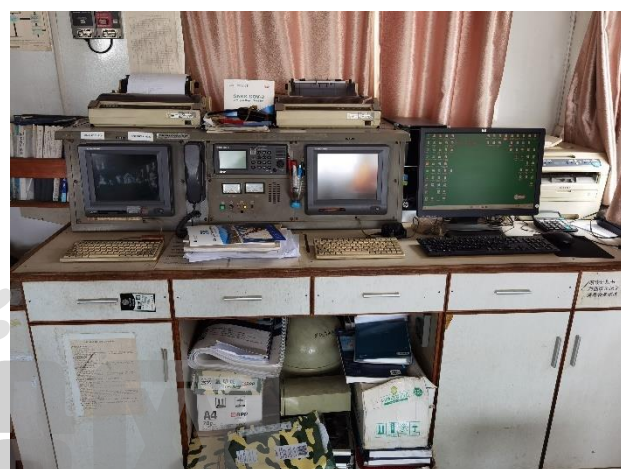
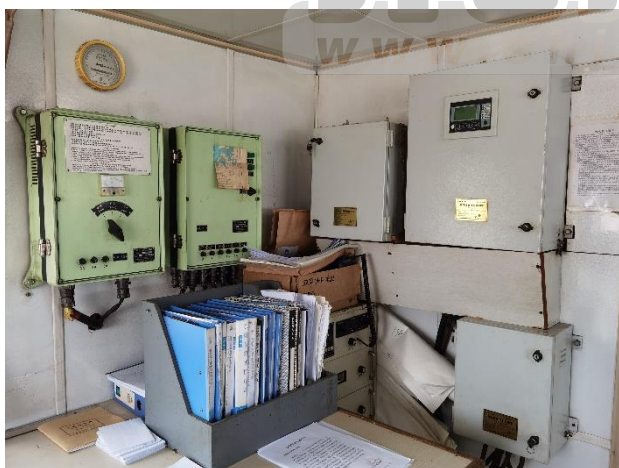
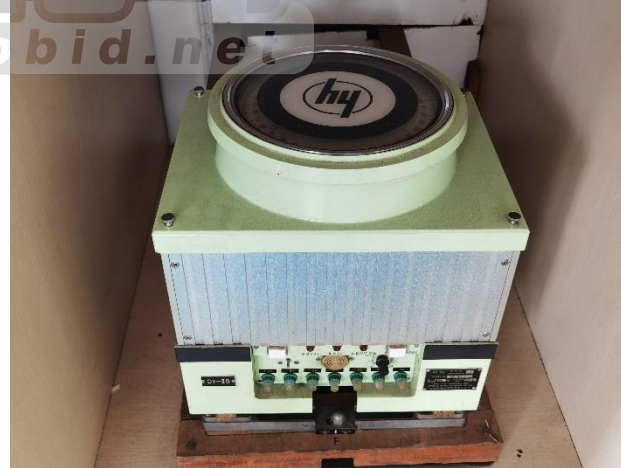
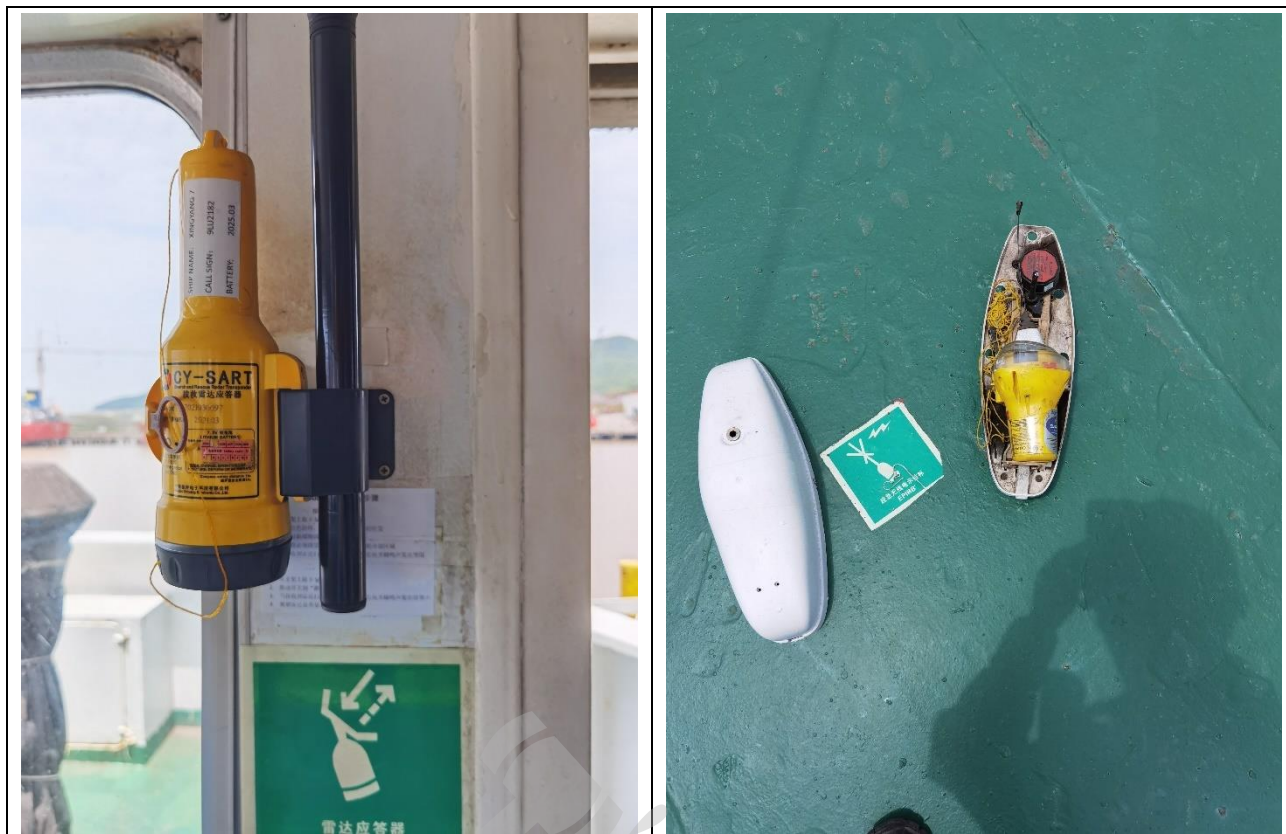
The insulation ceiling of the wheelhouse was found in good condition. The water tightness of the front window was intact, and the appearance of the rotating window was found intact. The radar's brand is FURUNO, and the gyro compass and autopilot is Shanghai Marine Instruments. This ship's is equipped with a communication station C. According to the owner's info, GMDSS and medium/high frequency equipment were all available.

The battery of the starboard radar responder on the bridge is valid until March 2025, and the port radar responder was found missed.

An emergency radio position indicator is located on the compass deck, and the water tightness of the outer shell was found intact. The inspection of the hydrostatic release device is valid until January 2024.
