TECHNICAL REPORT

Number: CJPG-JS-23-K Y-285

XING XIANG 7

Inspection Place: Zhoushan Jinzhou Shipyard

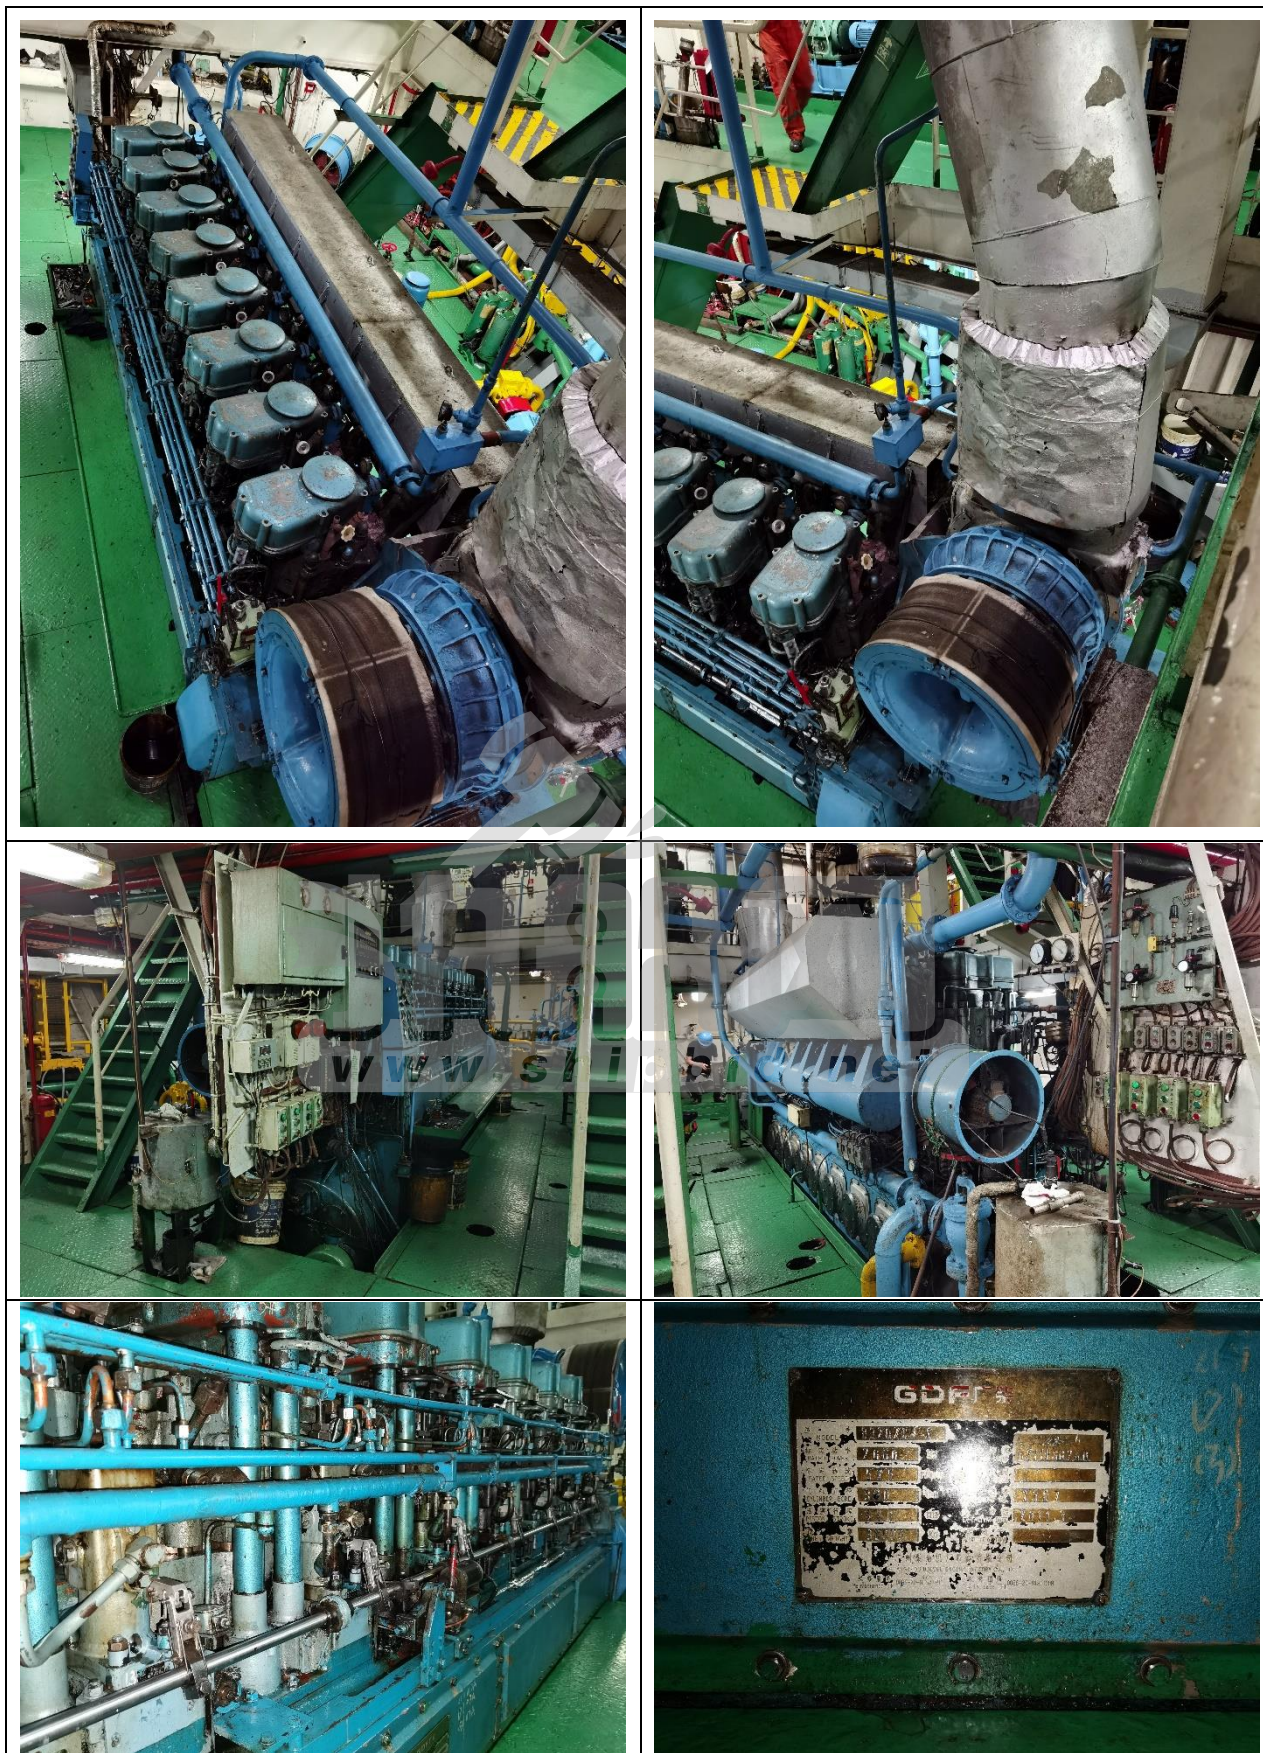
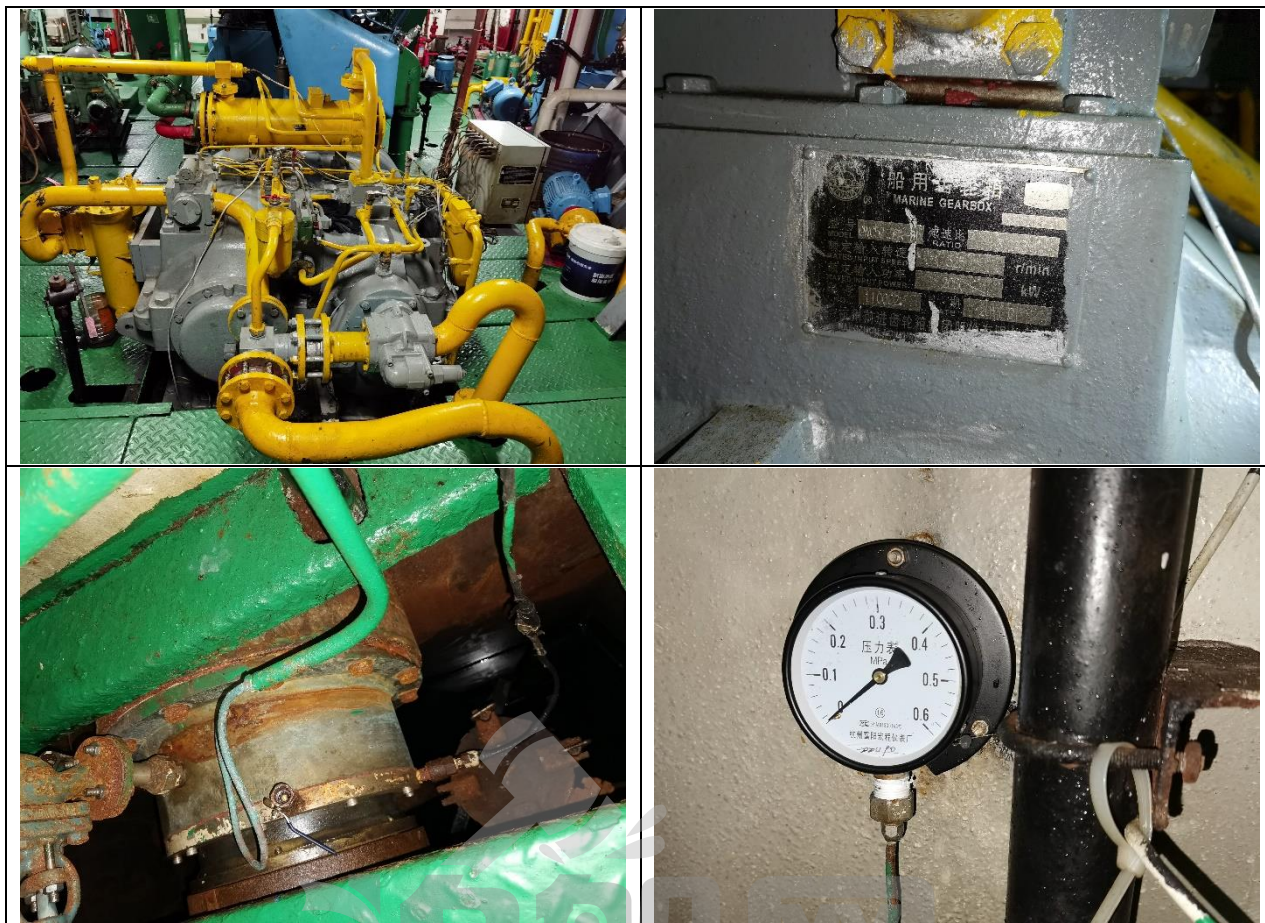
The appearance of the main engine was found clean and tidy, and no significant loosening of the oil and water pipeline joints.

The appearance of the main engine turbocharger was found intact, and the binding laying for the exhaust pipe was basically complete.

The nameplate of the main engine was found complete, the control instruments beside the machine were basically complete, without significantly damaged on the dial.

A small amount of oil stains was found on the chassis of the main engine, and the residual oil channel pipe of the main engine was connected to an external oil drum, not reached to the residual oil tank.

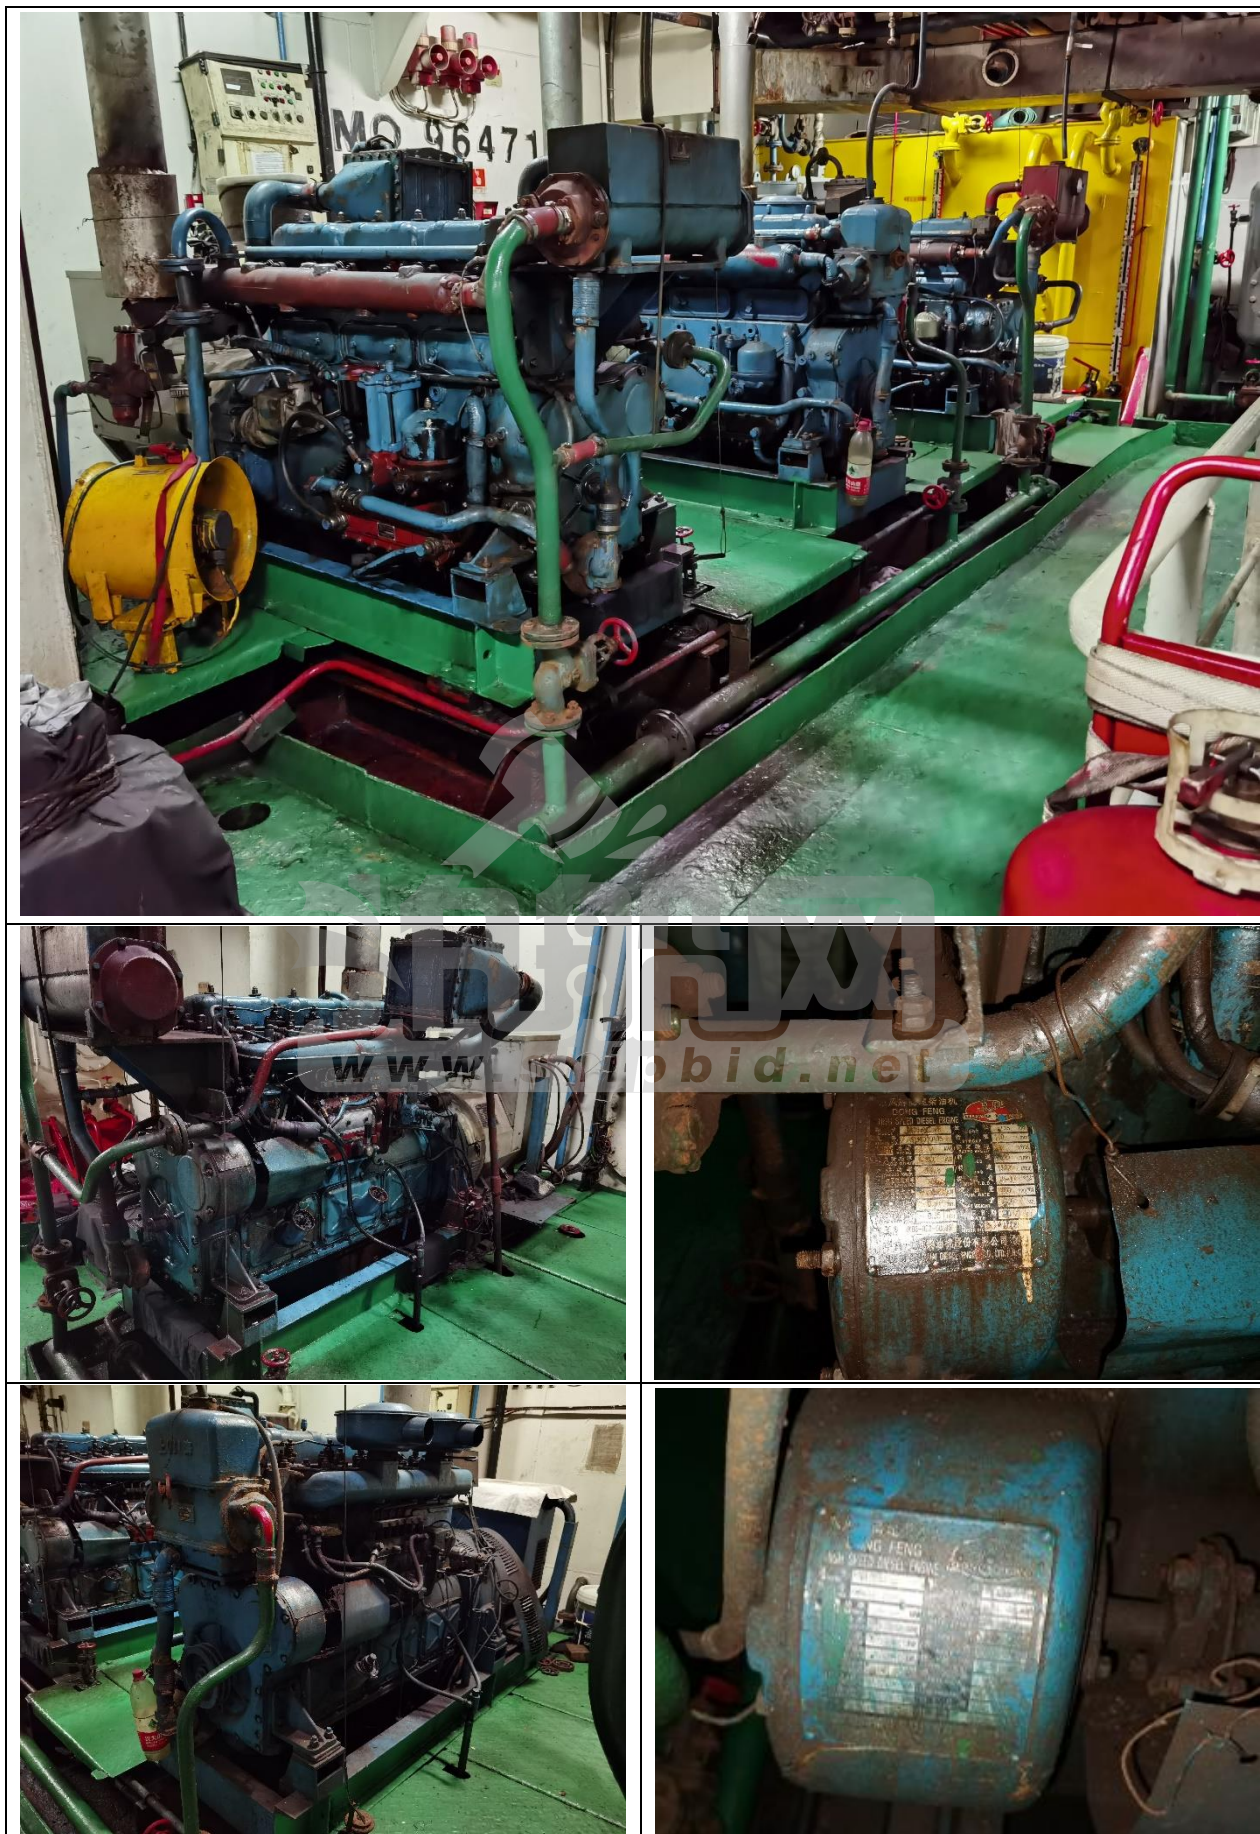
This ship is equipped with 2 sets main generators and 1 set harbor generator in the engine room, and the overall appearance of the generator sets were found general, with no significant oil stains on the chassis. The body paint was found intact, and rust on the pipelines and components.

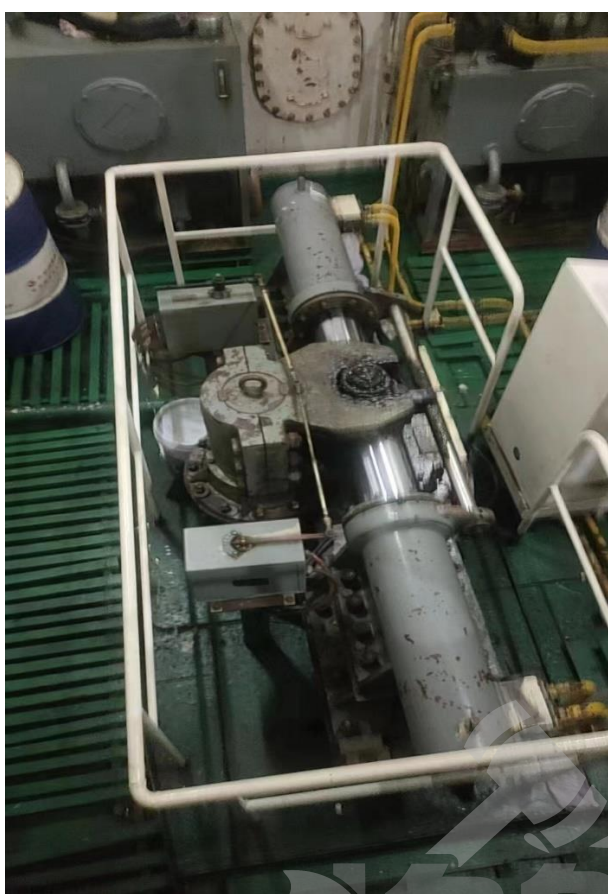
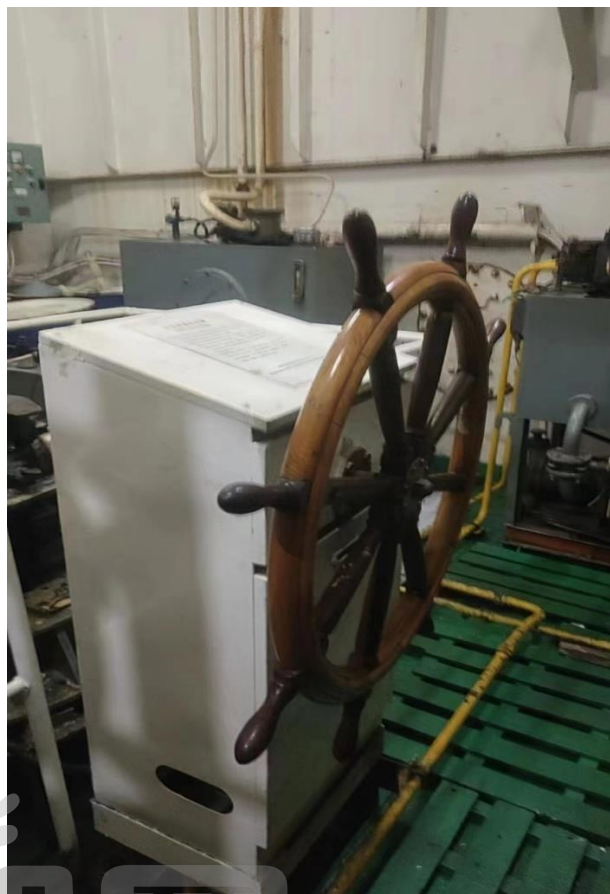
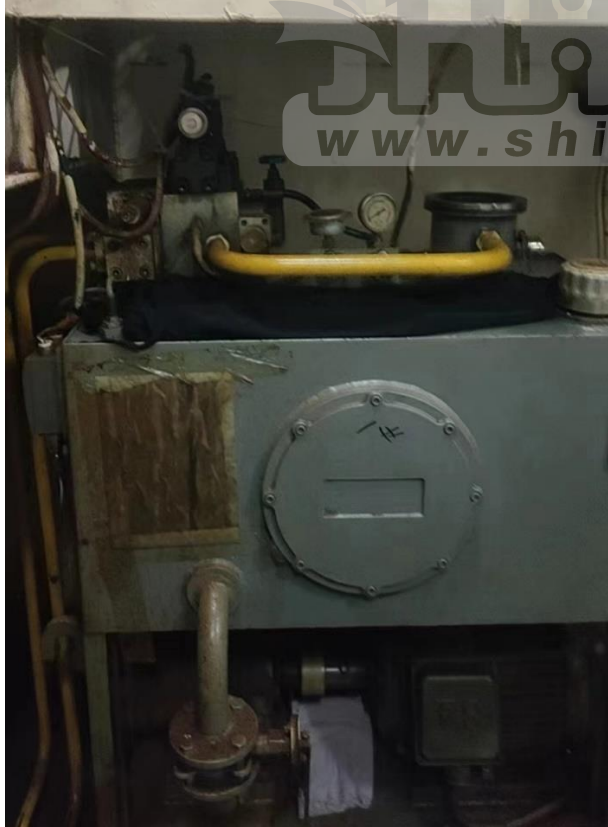
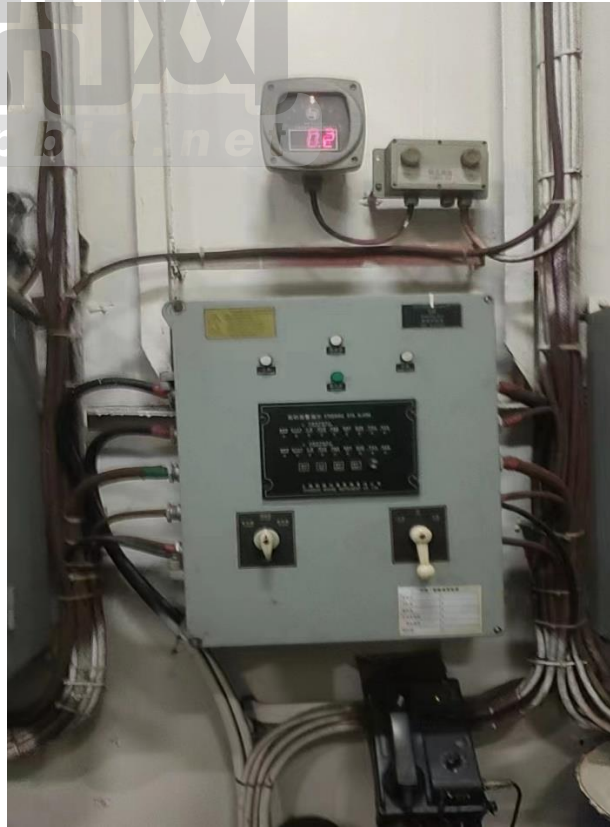
A small amount of oil stains was found in the steering gear room, the floor was complete with anti slip wooden grilles, and the protective railings was installed nearby the machine. Two sets of manual emergency steering devices and electrical emergency steering devices were installed next to the machine, and the liquid level of the two sets of hydraulic oil tanks was found at normal level.

No significant oil leakage was found on the upper rudder bearing seat, without corrosion on the base bolts. The reading shown on the rudder angle indicator and the compass reading on the bridge was found basically same.

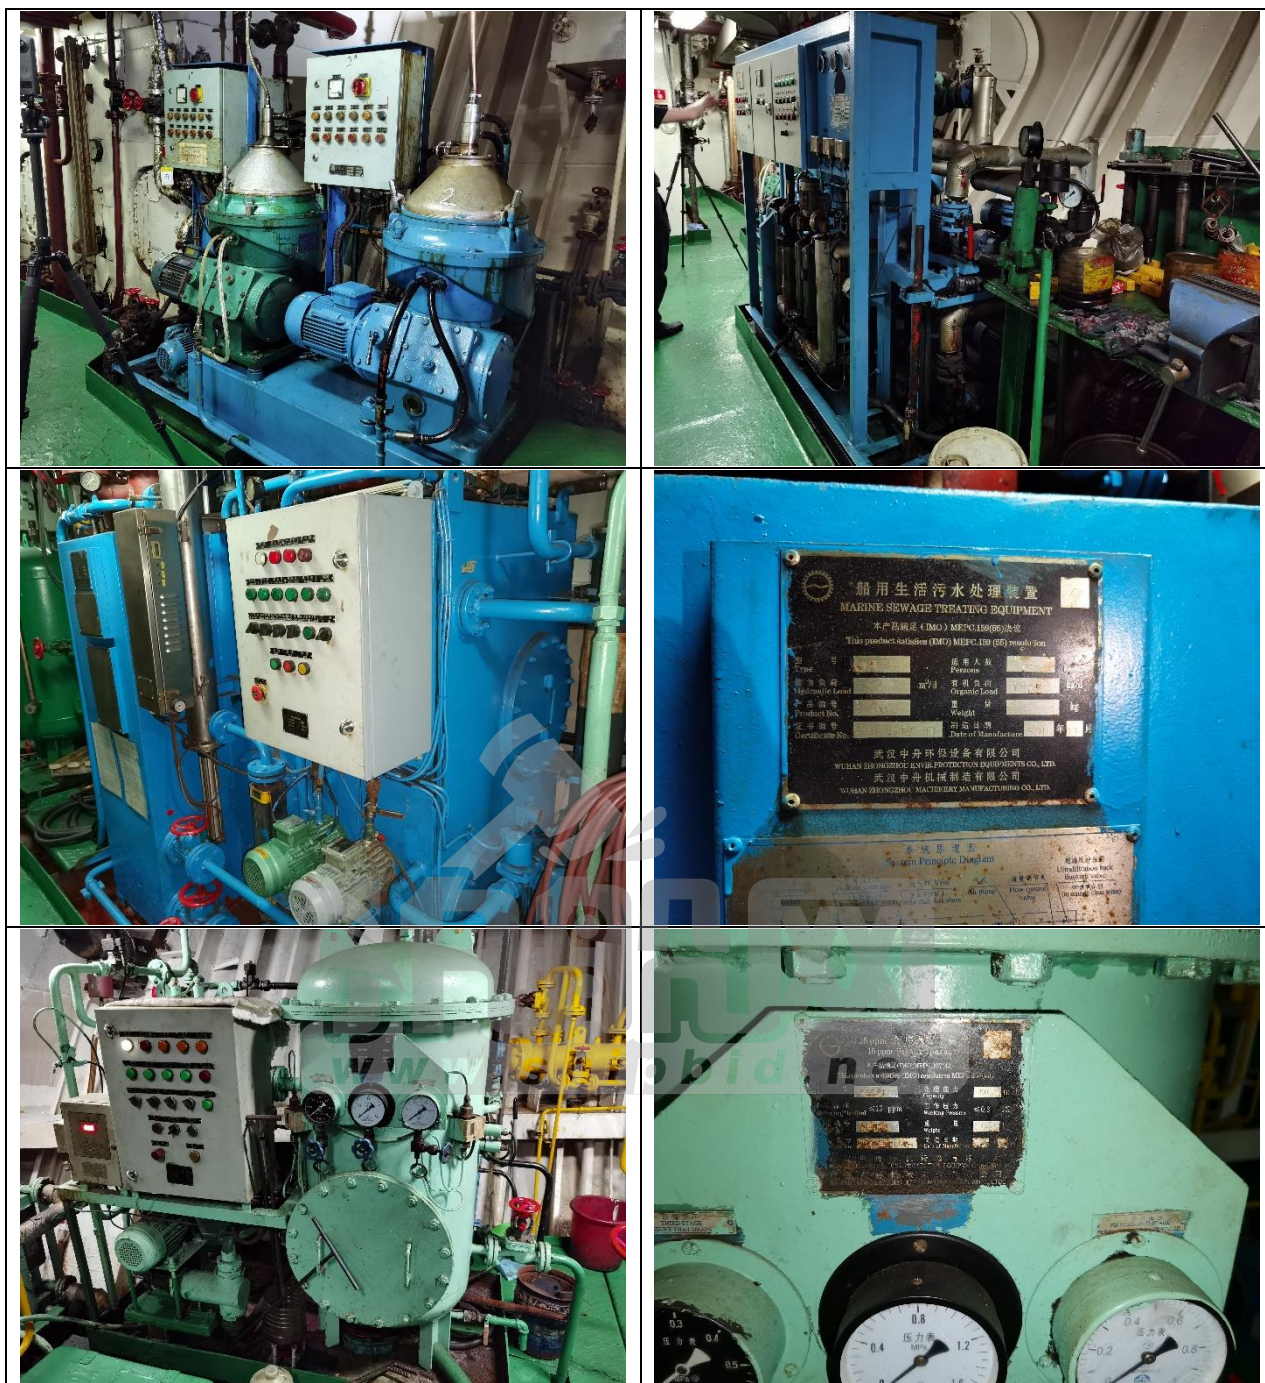
This ship is equipped with a oil purifier and fuel supply unit, with a small amount of oil stains on the equipment chassis, and no significant corrosion or leakage in the pipelines.

This ship is equipped with a domestic sewage treatment device and a bilge water separator. The pipelines and valves were found to be free of rust, and the appearance of the control box and emission monitoring alarm was normal.

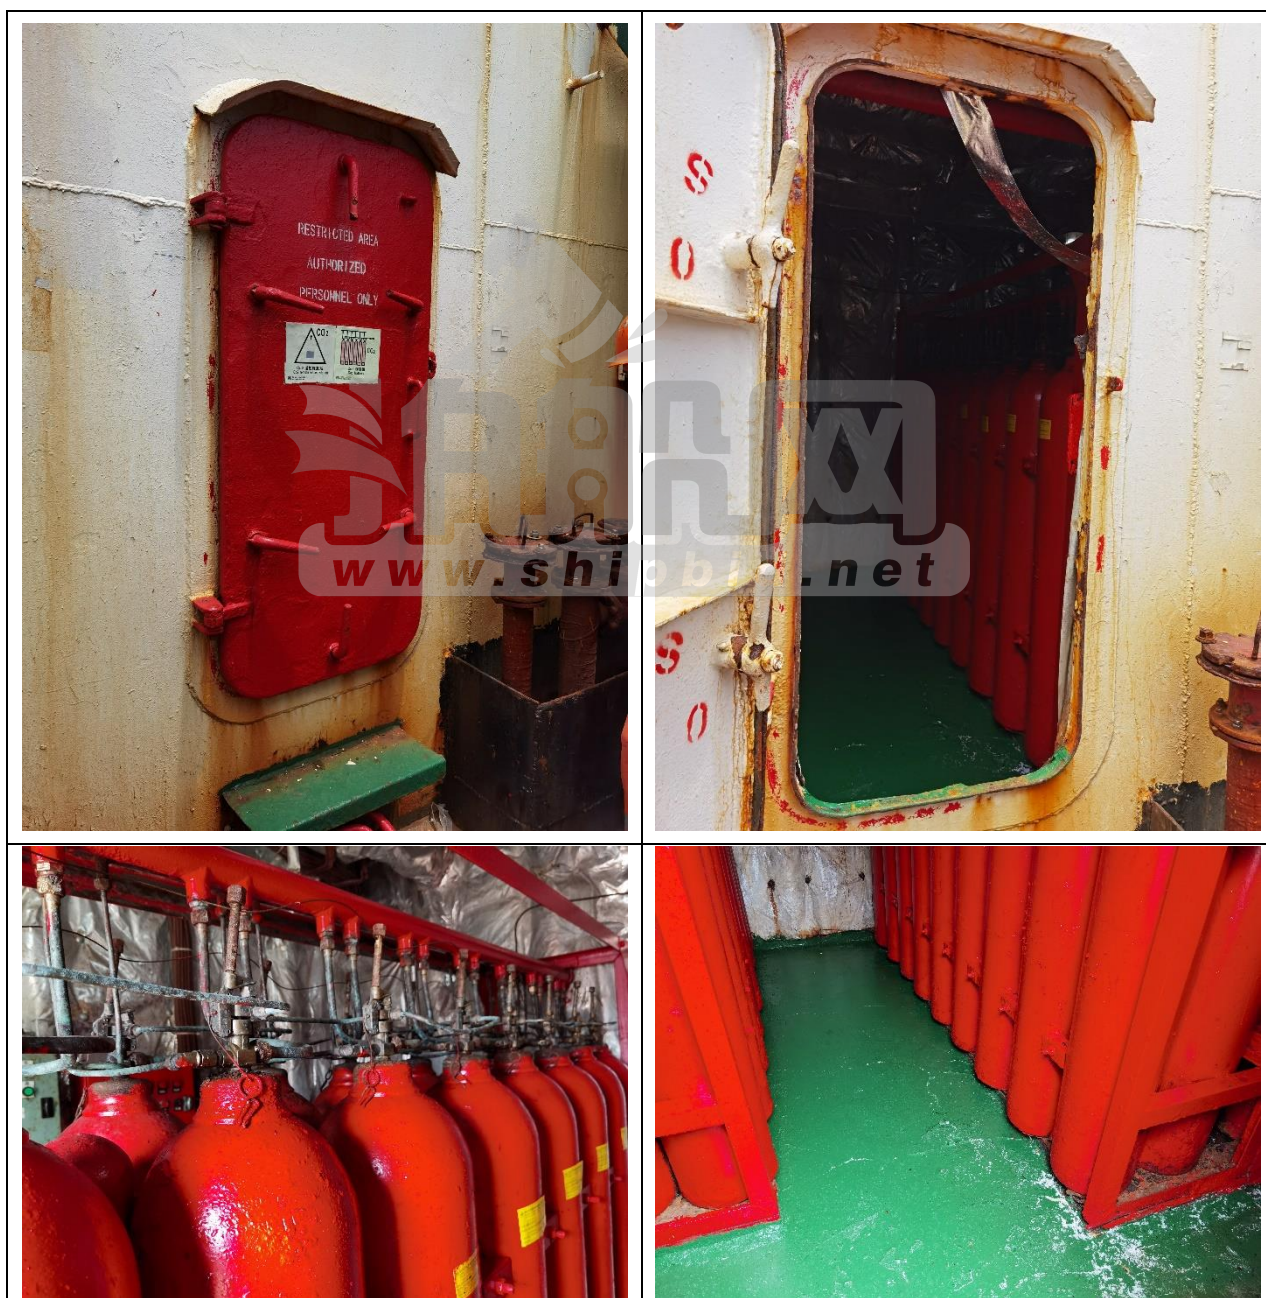
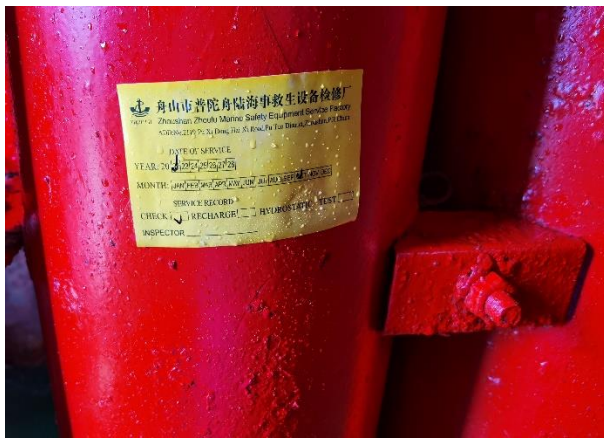
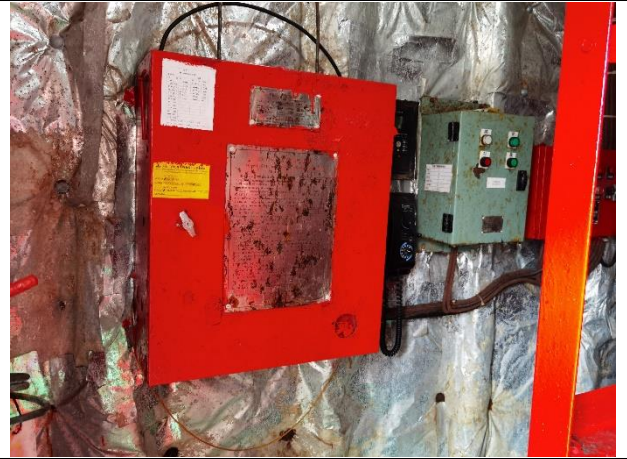
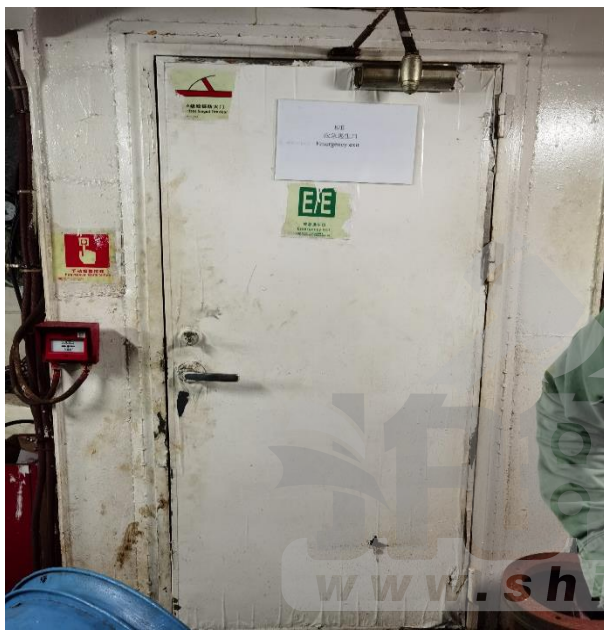
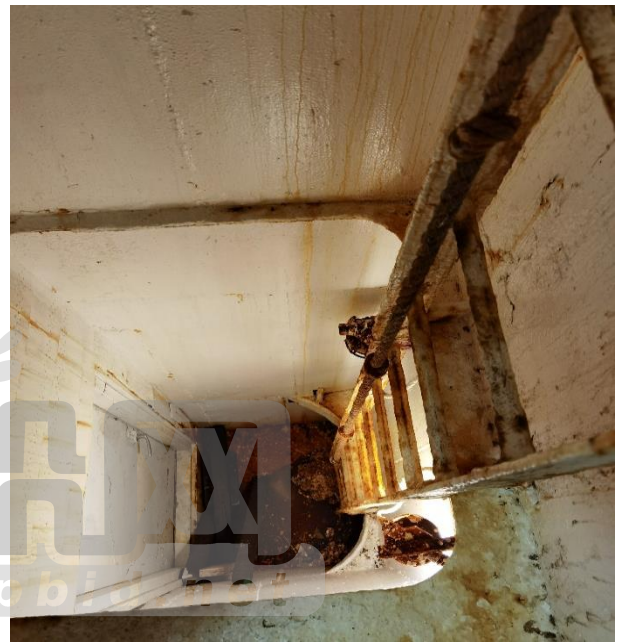
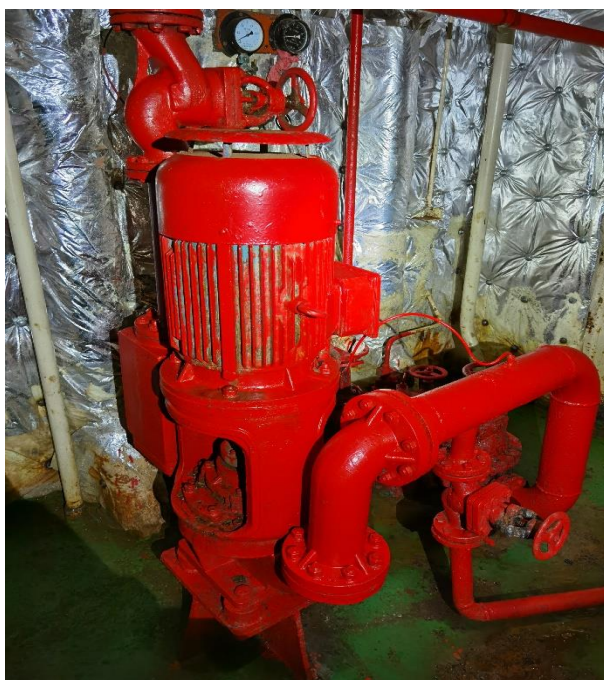
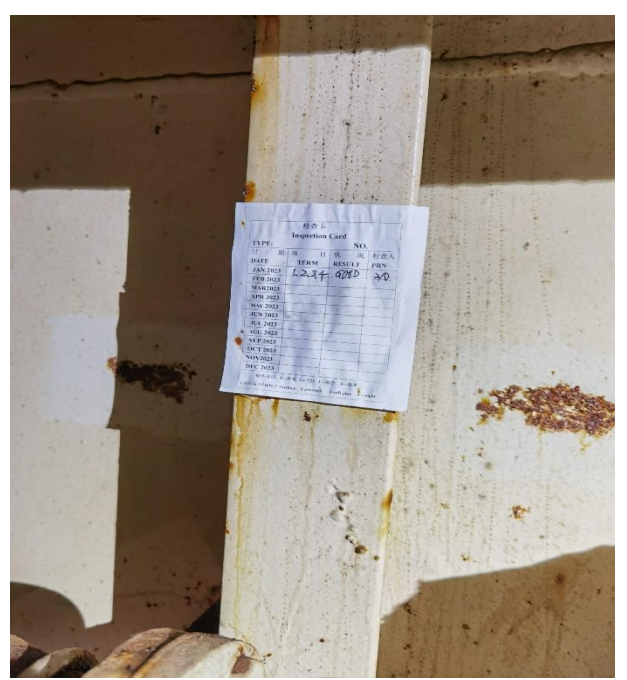
A small amount of rust was found on the sealing strip groove and door frame of the CO2 room, and the indoor fire protection was found complete. The CO2 cylinder release valve and the bottom of the cylinder were found to be free of corrosion, and the safety

pin has been pulled out and is in an instant usable stat. The CO2 cylinder inspection marks were found complete, and the last maintenance was in October 2022.

The self-closing door of the emergency passage in the engine room was found in a normally closed state, and the opening and closing of the self-closing device were normal. Lifelines and ladders in the passage were found fully equipped.

The emergency fire pump is located in the bow fire pump compartment, with complete paint on the pump body, no significant rust on the starting motor casing, and complete paint on the pipelines and valves. The last inspection date was January 2023.
