TECHNICAL REPORT

编号: CJPG-JS-23-KY-309

XING HAI HUA 728

Technical Report of MV "XING HAI HUA 728"

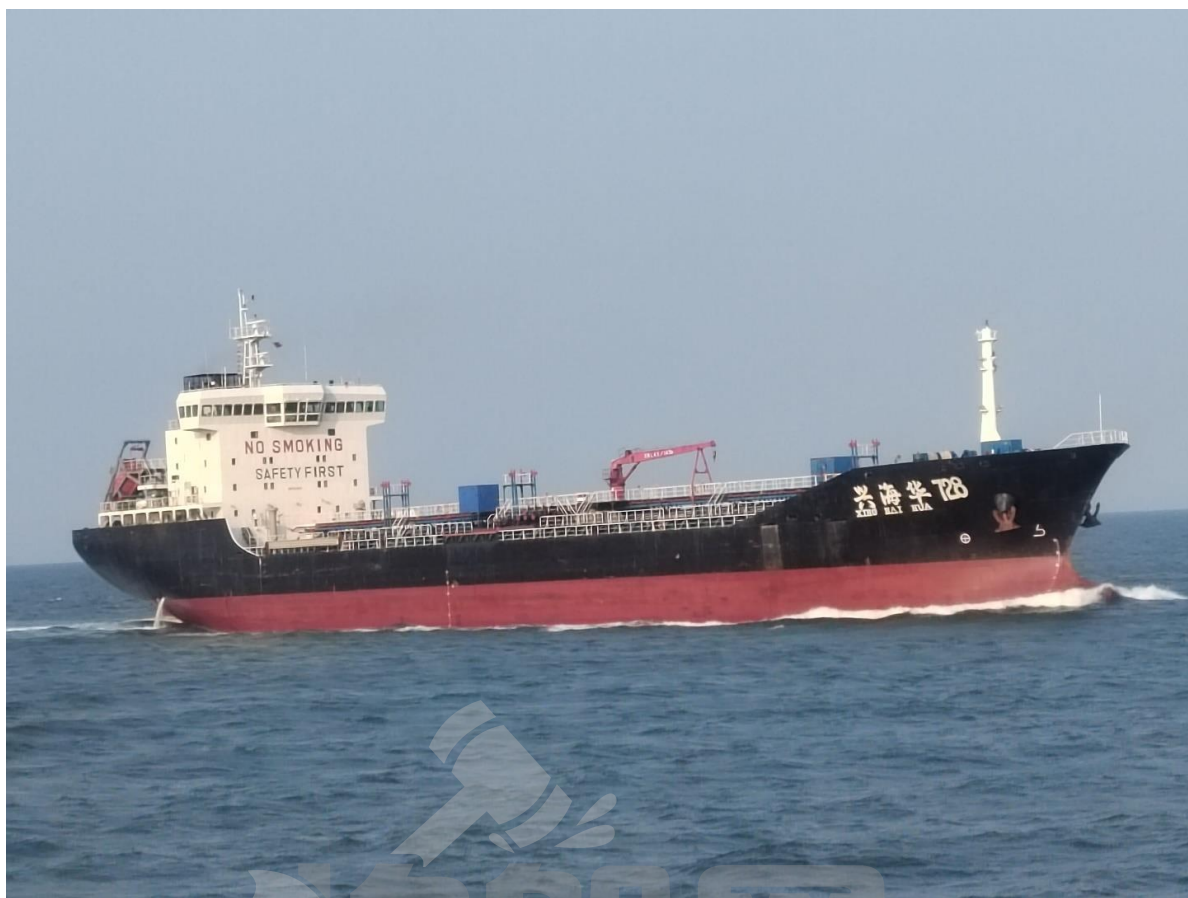
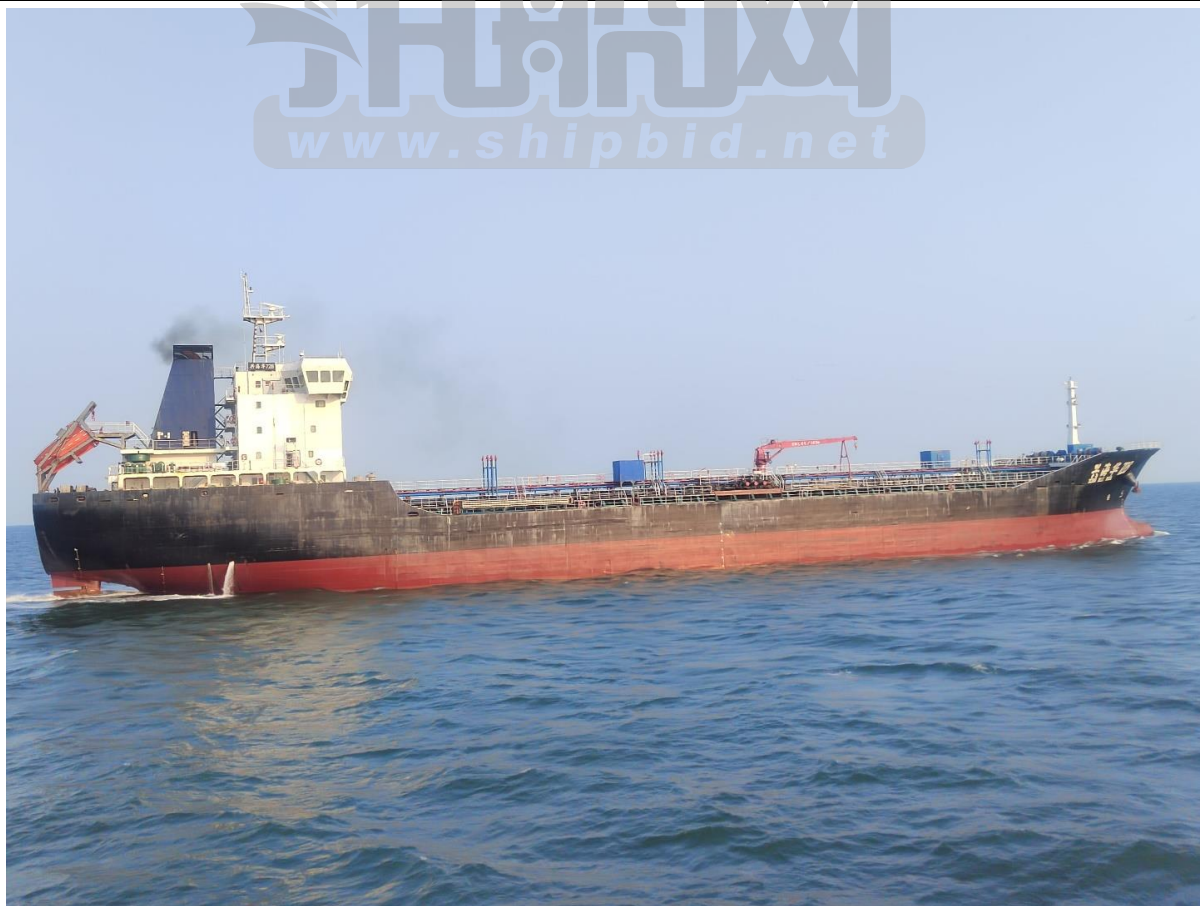
6.1 Hull Structure Condition

The paint of the shell plate was found basically complete, and the ship's name, port of registry, load line and draft mark were found clear and full painted.

The overall condition of the shell plate was found general good, without significant corrosion.

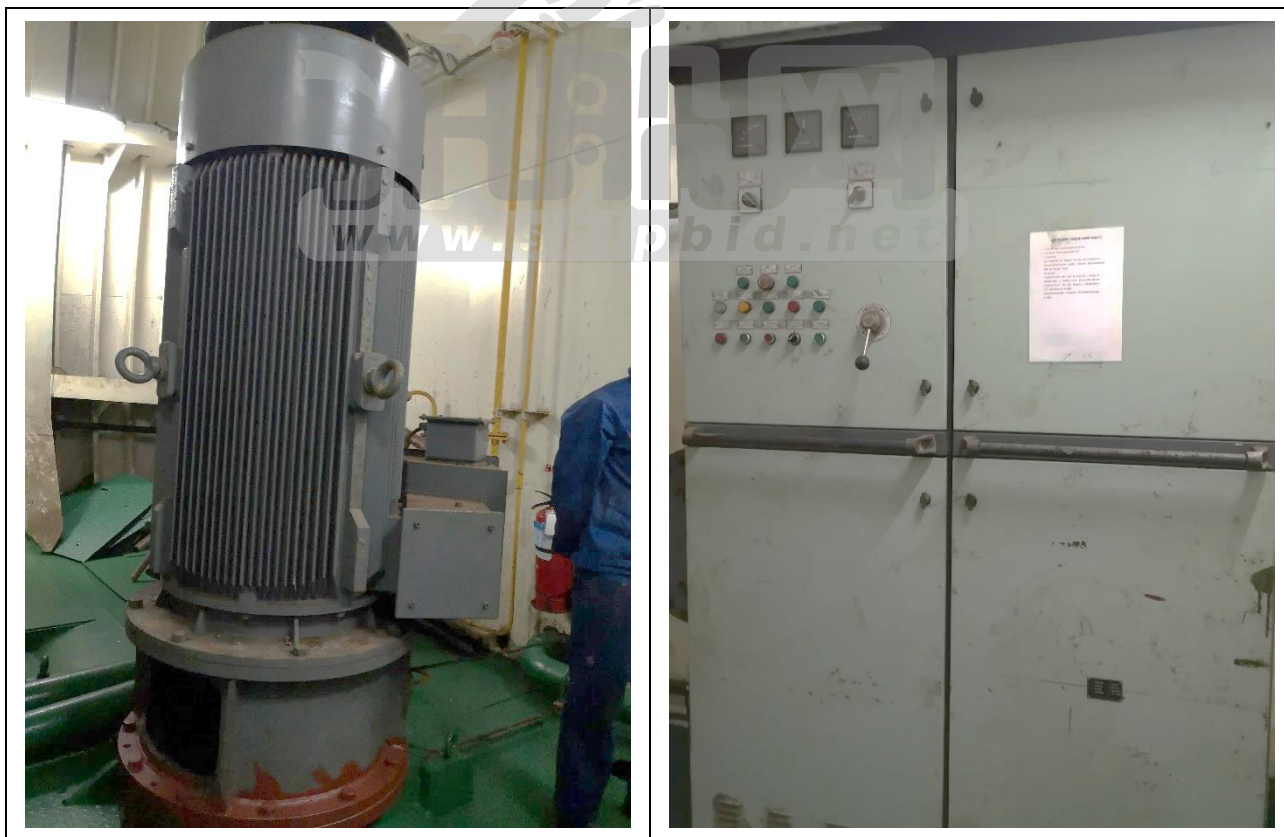
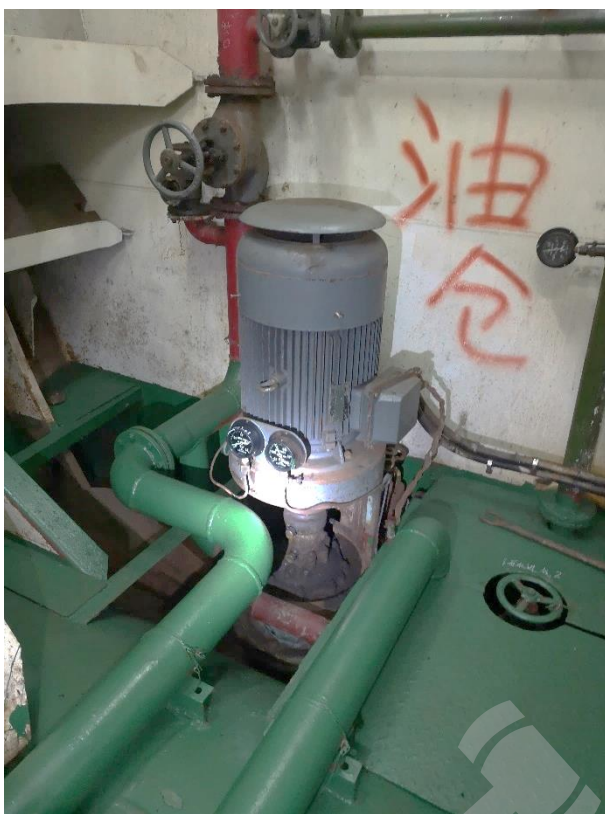
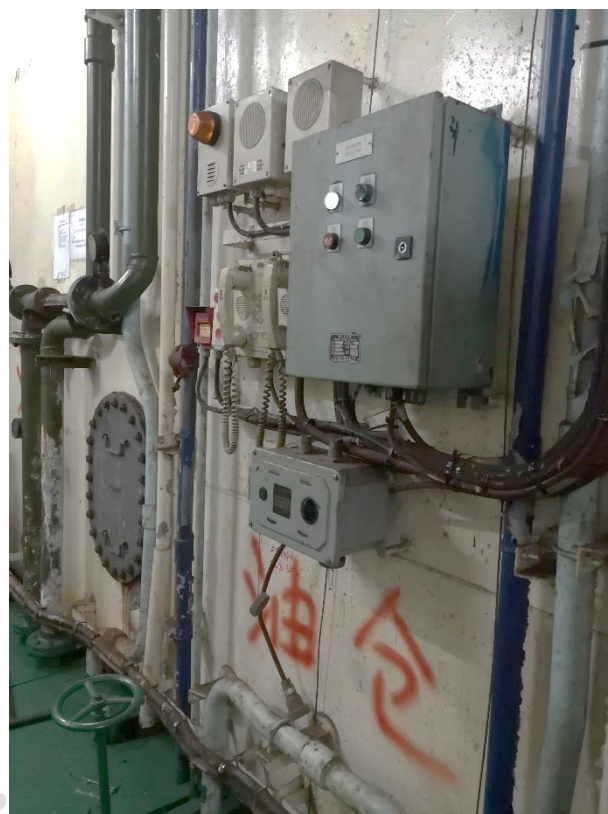
6.2 Bow thruster room and equipment

This ship is equipped with a bow thruster and an emergency fire pump device in the bow thruster room. The bow thruster room is equipped with a lifeline, and the ladder structure was found complete and free of rust. The bow thruster room is equipped with main and emergency lighting, with complete lighting fixtures and normal lighting. No significant water accumulation was found to be piled up in the bow thruster room. The housing, base, and bolts of the bow thruster motor were found to be free of rust, and operating instruction was posted next to the power distribution panel. The power supply of the emergency fire pump is supplied by the main and emergency power sources, and the distribution box was found in a constantly lit state. The housing of the emergency fire pump motor was found to be free of rust, with intact paint on the pipeline, no leakage. The inlet and outlet valves were found in a normally opening state, with a small amount of rust on the flange of the outlet.

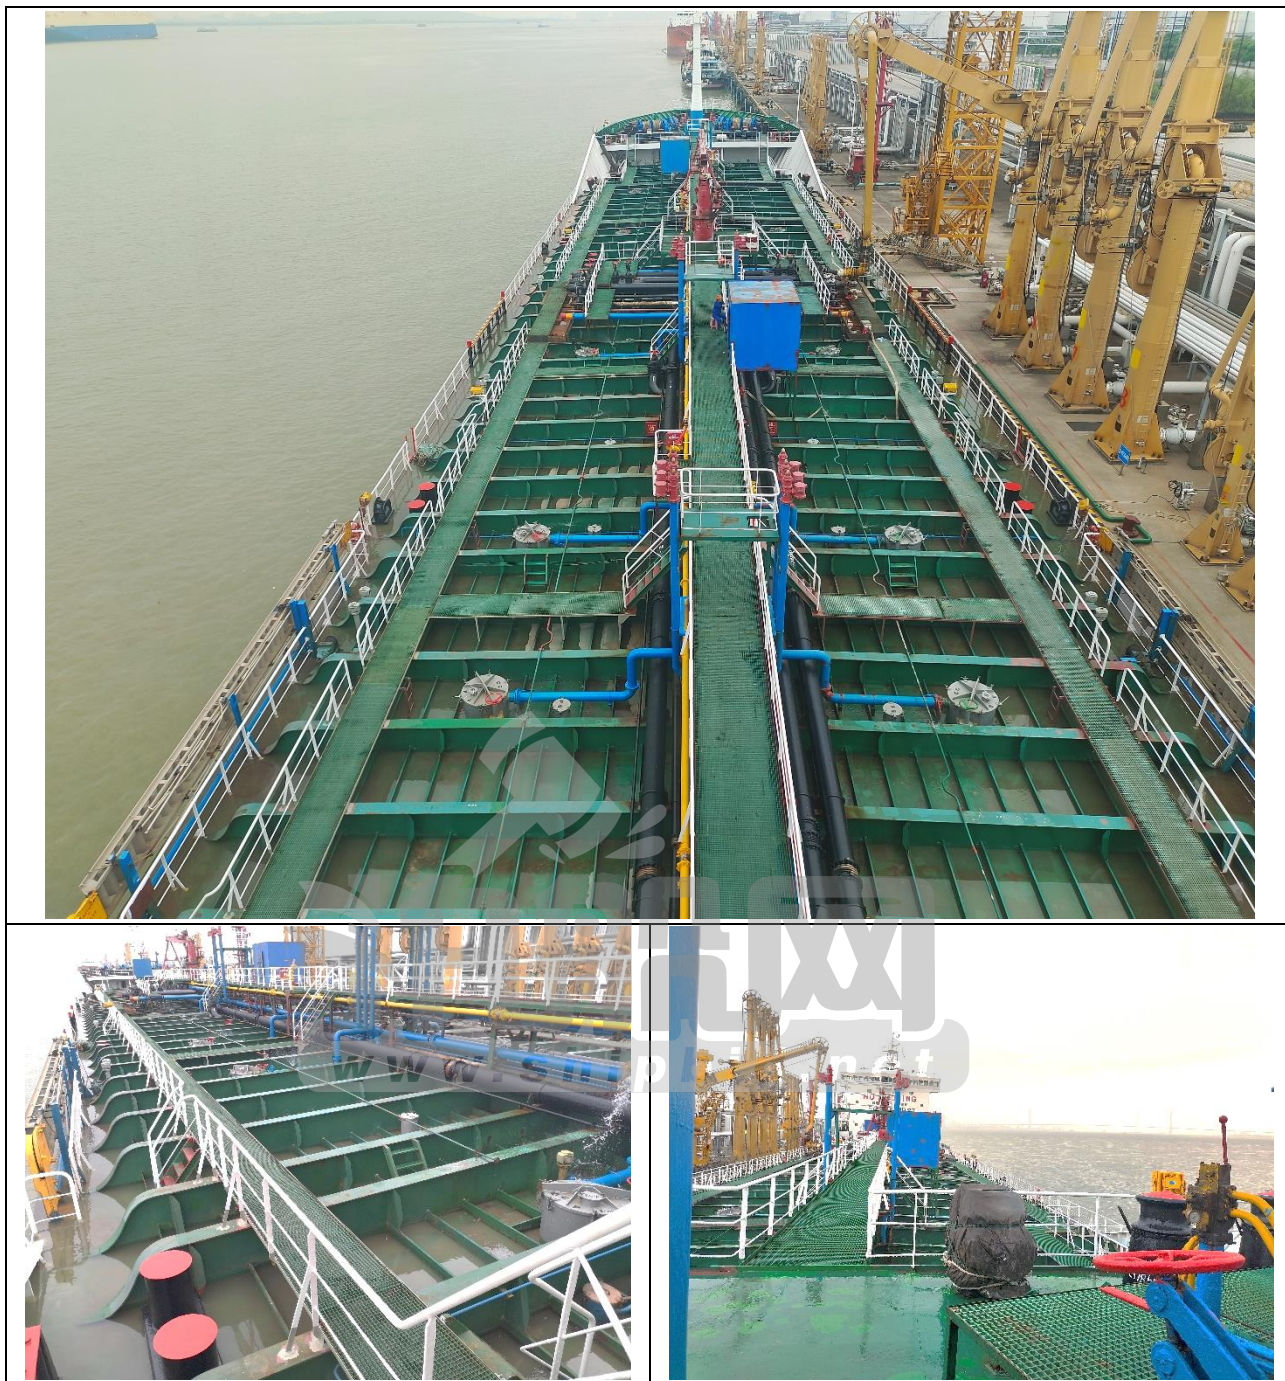
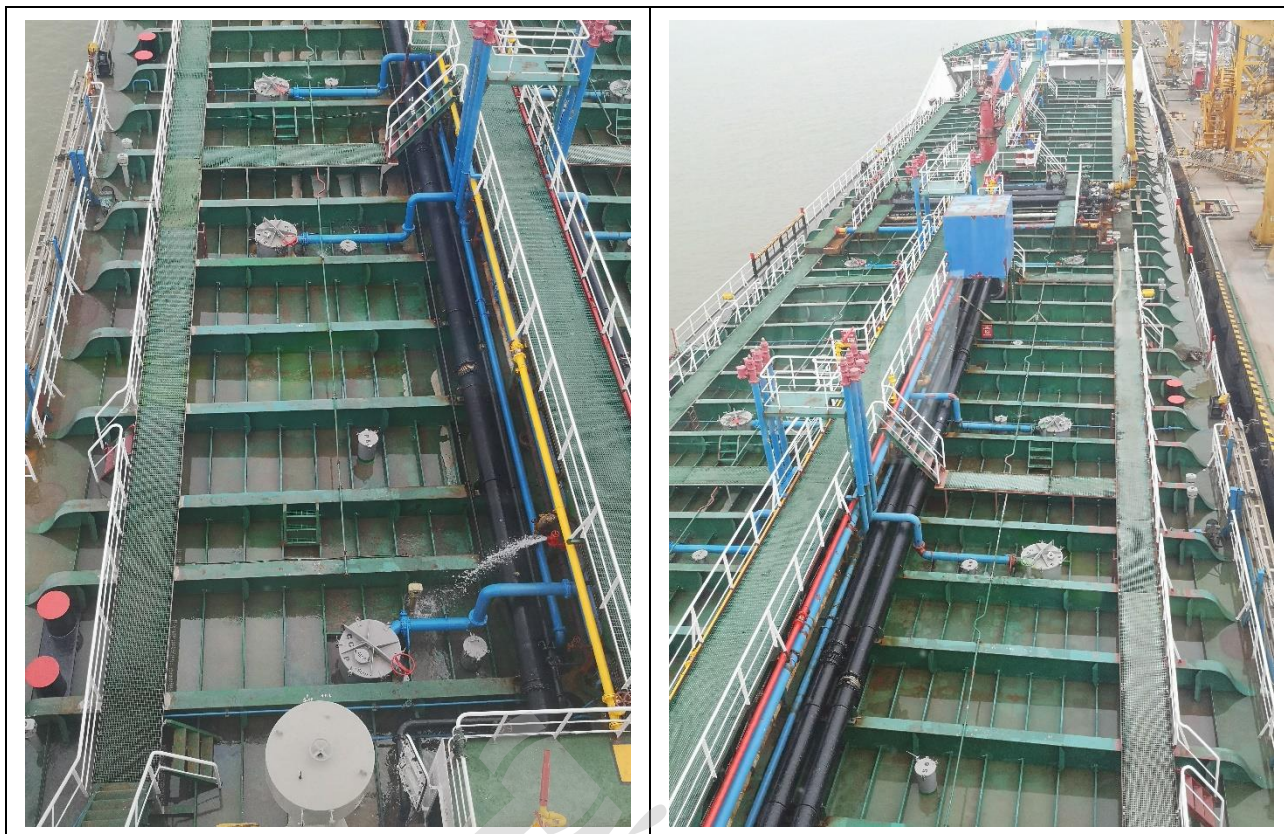
6.3.1 Cargo tank structure and pipeline

During the inspection, the ship was in an unloading state and did not meet the conditions for entry inspection, so the specific situation inside the tank was unknown. The paint condition of the deck gangway was found intact, the grille and side railing structures were found basically intact. The paint condition of the deck longitudinal was found intact and free of rust on the weld joint and the drain hole. The faceplate of the strong beam was found spot rust, without significant rust or crack at the chamfer toe end. The paint on the deck pipelines in the cargo hold area was found intact, without significant rust on the flange interface. The P/V vent pipe and vent valve were found to be free of significantly rusted. No significant rust was found on the edges of the cargo cover, the hand-wheel, and the hand-wheel screw. The sealing condition of the observation hatch cover and washing hatch cover was found general good, without significant odor of oil and gas leakage.

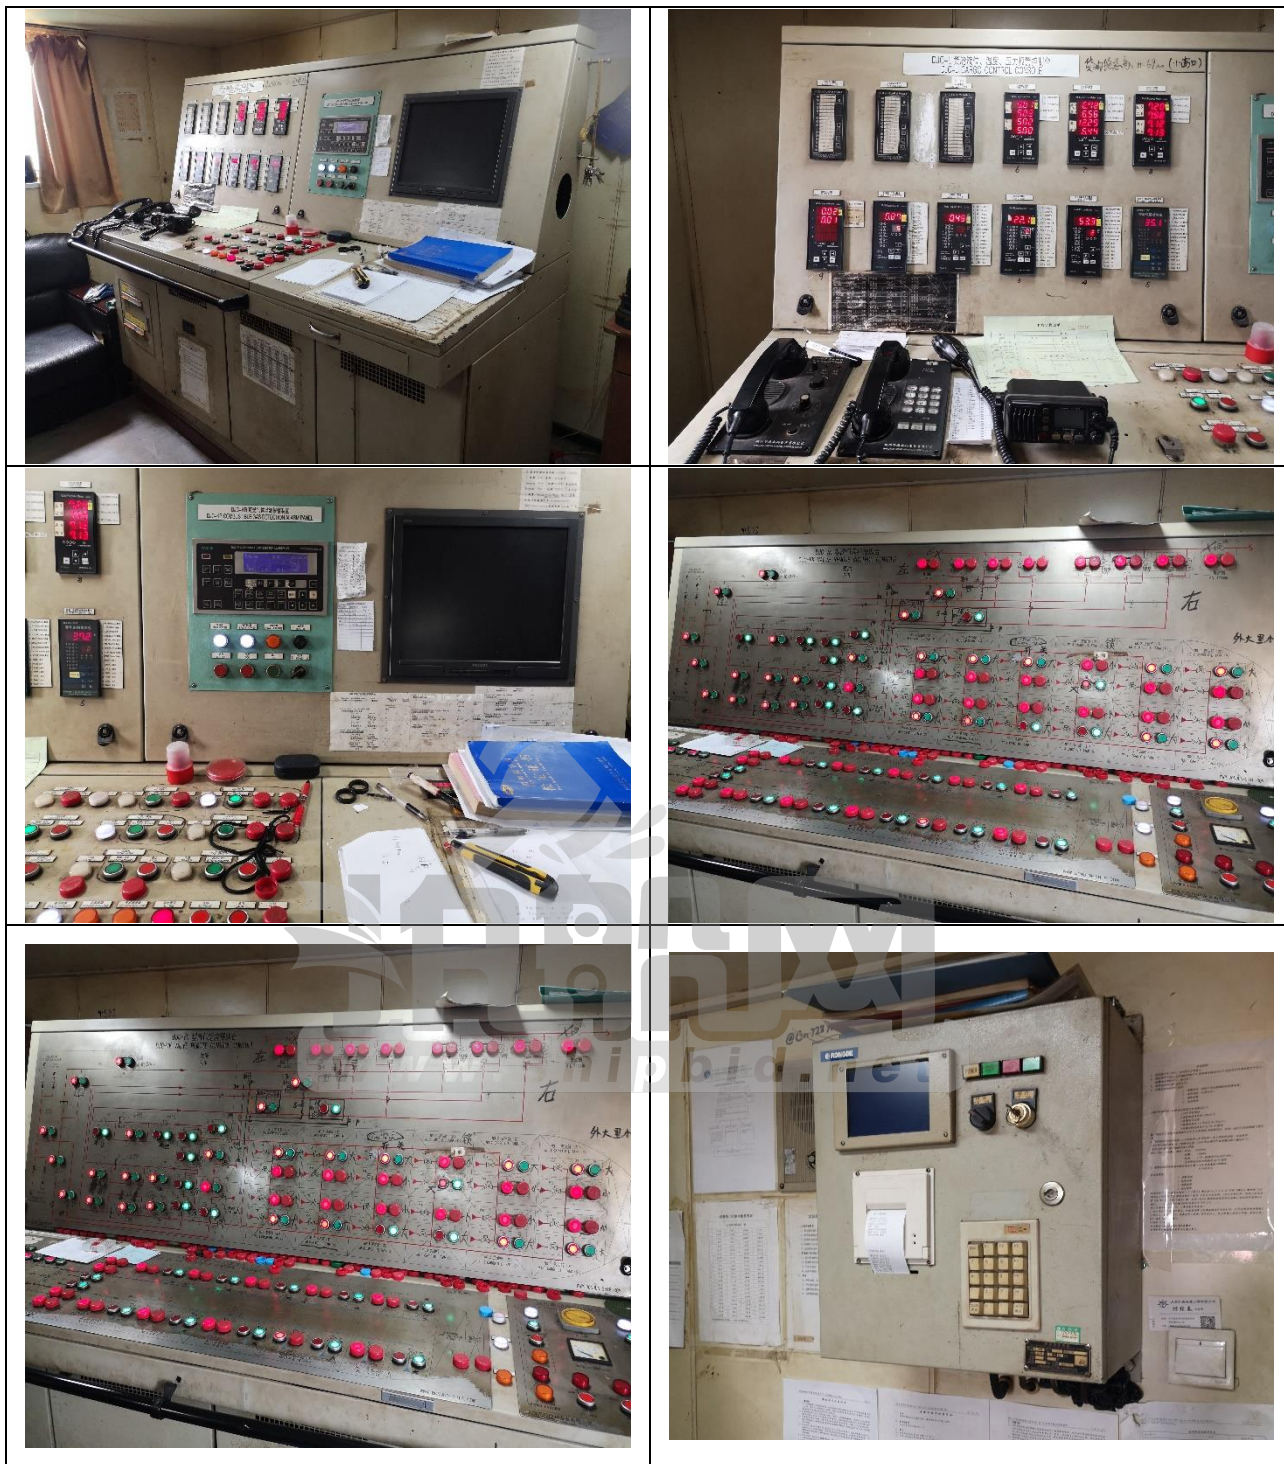
6.3.2 Cargo tank monitoring system

- The monitoring room is equipped with a monitoring console for cargo oil level, temperature and pressure in the tank and combustible gas alarm system of the pump room. The real-time monitoring indicator light was found constantly working, and the last pump room gas detection test record was on May 12th, 2023.

- The monitoring room is equipped with valve remote control console for cargo oil tank pipeline, cargo pump room pipeline, and ballast water pipe valve remote control, hydraulic pump station remote control unit operation console. The indicator light button shows that the valve of the 1 # cargo oil pump pipeline is open, the valves of the 3 # and 4 # cargo oil tanks are open, the regulating valve of the ballast water tank is open, and the ship is in the unloading state.

- The monitoring room is equipped with an ODME device, and the inspection is valid until June 3rd, 2024. The ship's oil pollution prevention certificate records that the system has been recognized in accordance with MEPC.108 (49).

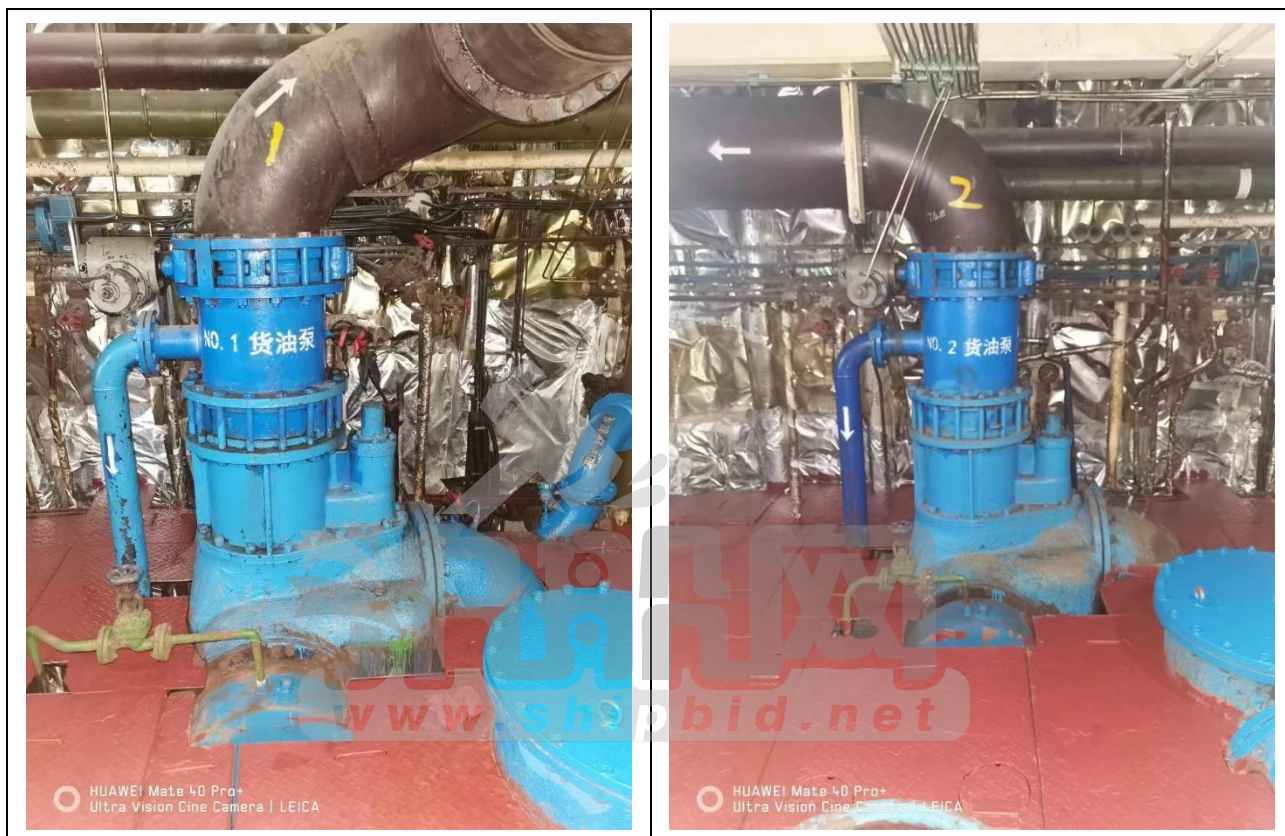
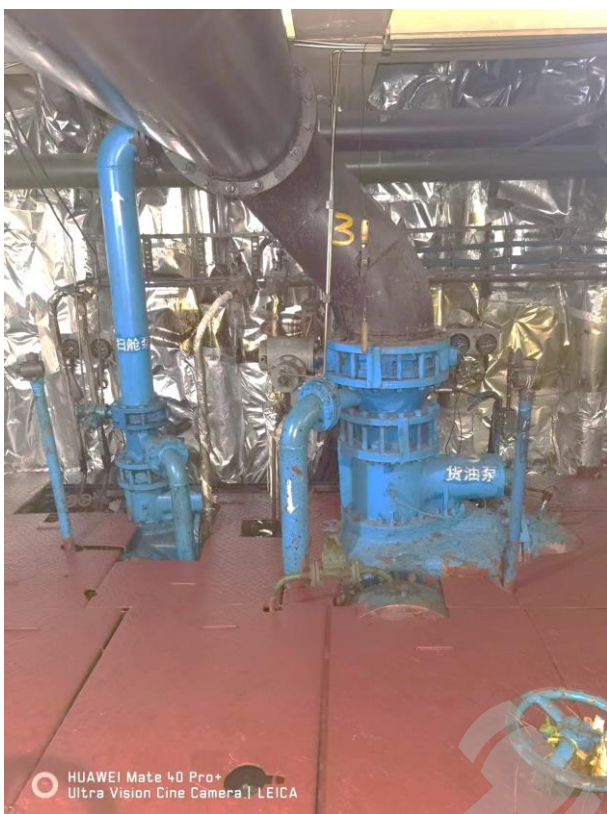
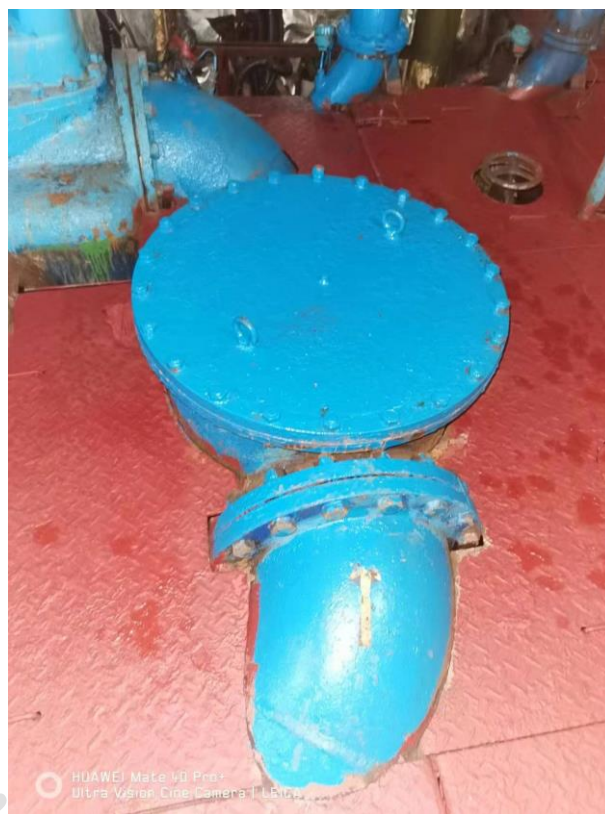
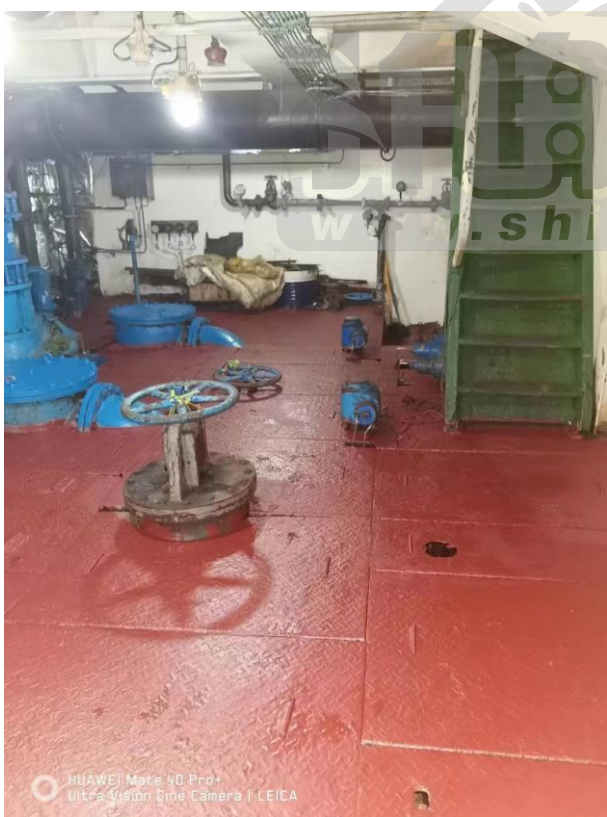
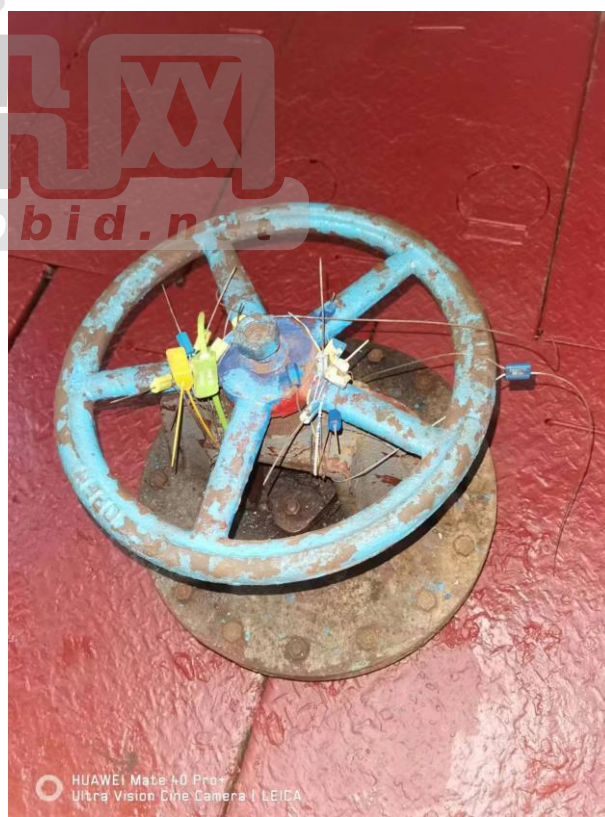
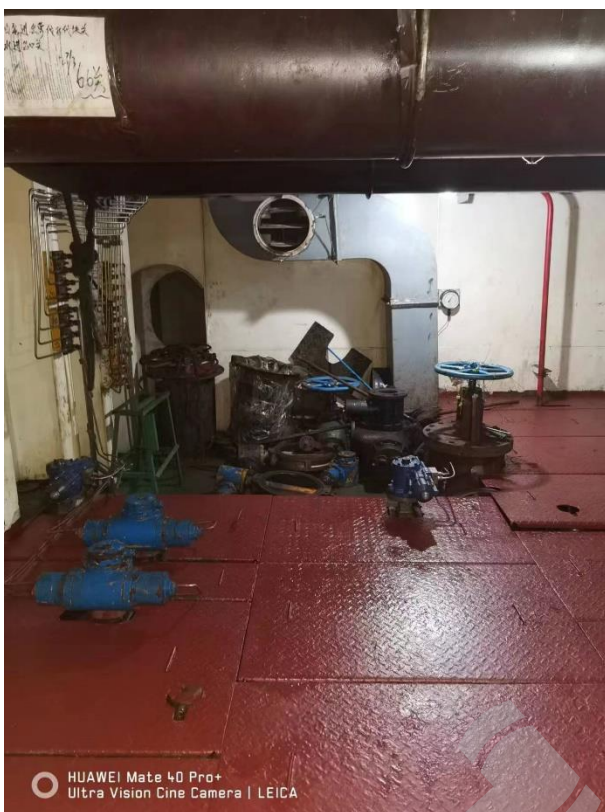
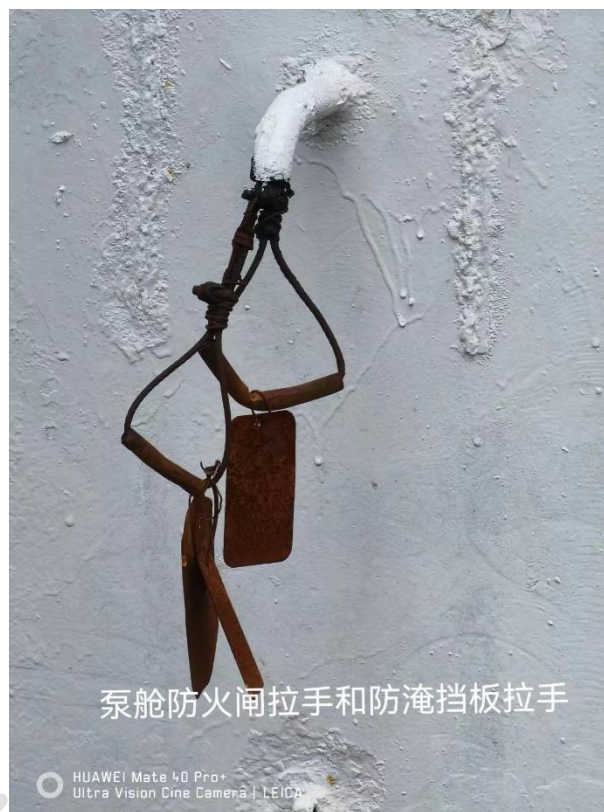
6.4 Cargo pump room and pipeline

The opening and closing of the pump room door was found interlocked with the fan and lighting inside the room. The ventilation grille blades in the pump room were found to be free of rust, and the ventilation can be closed externally. The handle of the fire gate was found intact. The watertight bulkheads separating the pump room from the engine room are equipped with fireproof insulation dressings without damaged. The paint on the pump body was found intact without significant

corrosion. The sealing of the pipeline flange was found intact without large gaps, and the bolts were found no significantly corroded. The hand-wheel screw rod of the sea chest was found general good, with a small amount of rust on the valve box. The checkered plates were found to be basically free of oil stains, no signs of leakage at the bottom of the bulkhead, and no significant oil stains at the bottom of the pump room.

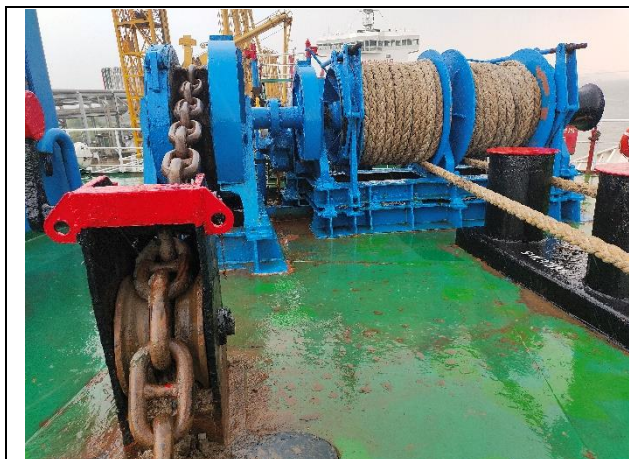
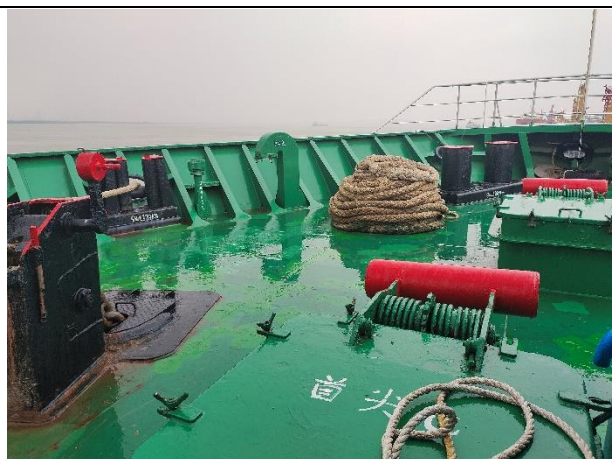
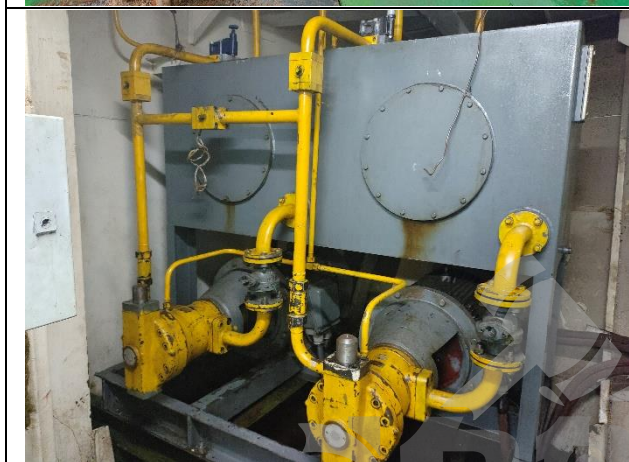
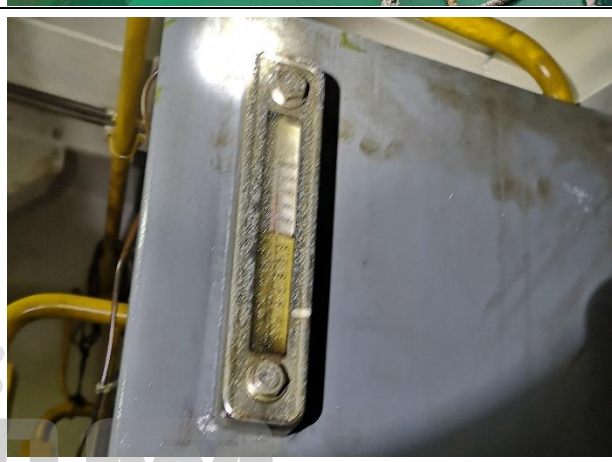
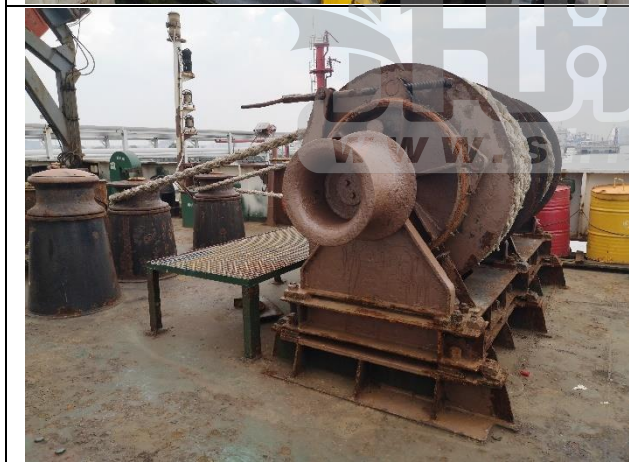
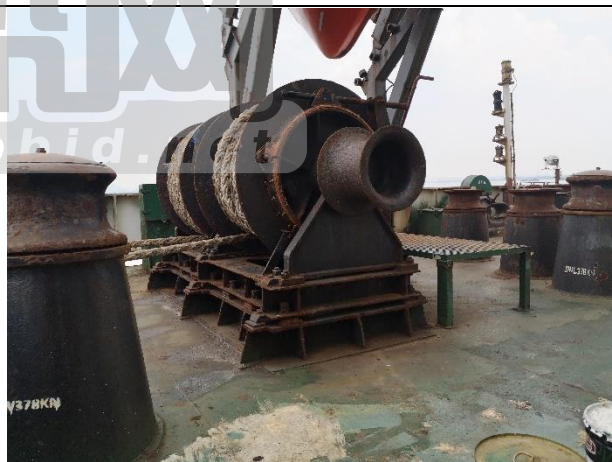
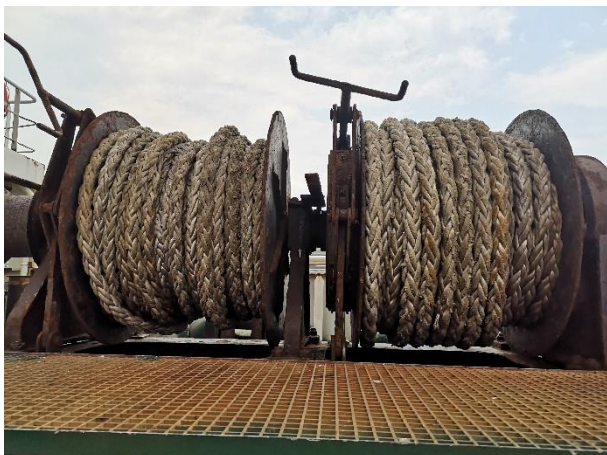
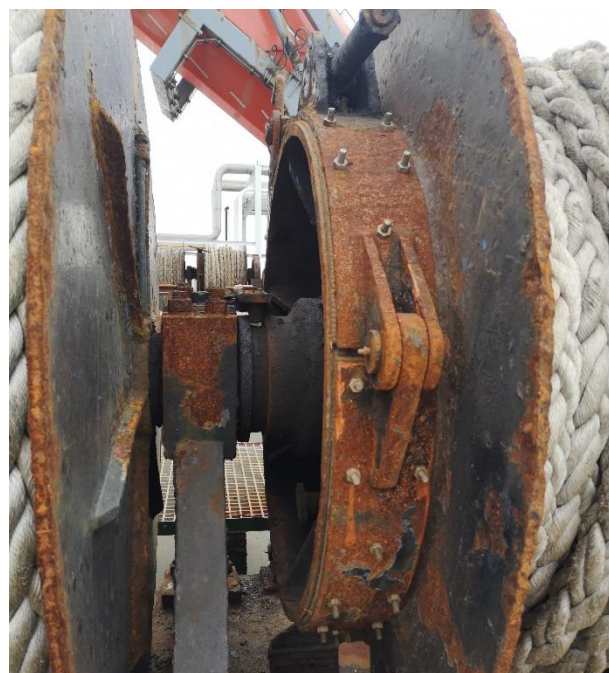
6.5 Main Deck and Deck Machinery

The ship is equipped with each set windlass on port and starboard of the forecastle deck, the body structure and base bolts were found intact. No significant corrosion was found on the brake wheel and clutch gear. The hydraulic pipeline was found to be free of damage and no significant oil leakage. The paint of the bollard on the forecastle deck was found intact and slightly worn. The guide pulley was found no notches and can rotate freely. The ship is equipped with each set winch on the port and starboard of the main deck aft, and the winch body structure and base bolts were found significant corrosion, but no thinning on structure. The brake band was found without thinning, and no deformation on the winch roller, and the mooring rope was found to be free of damage. The paint condition of the winch body was found general, with obvious rust. The guide pulley was found no notches and can rotate freely.

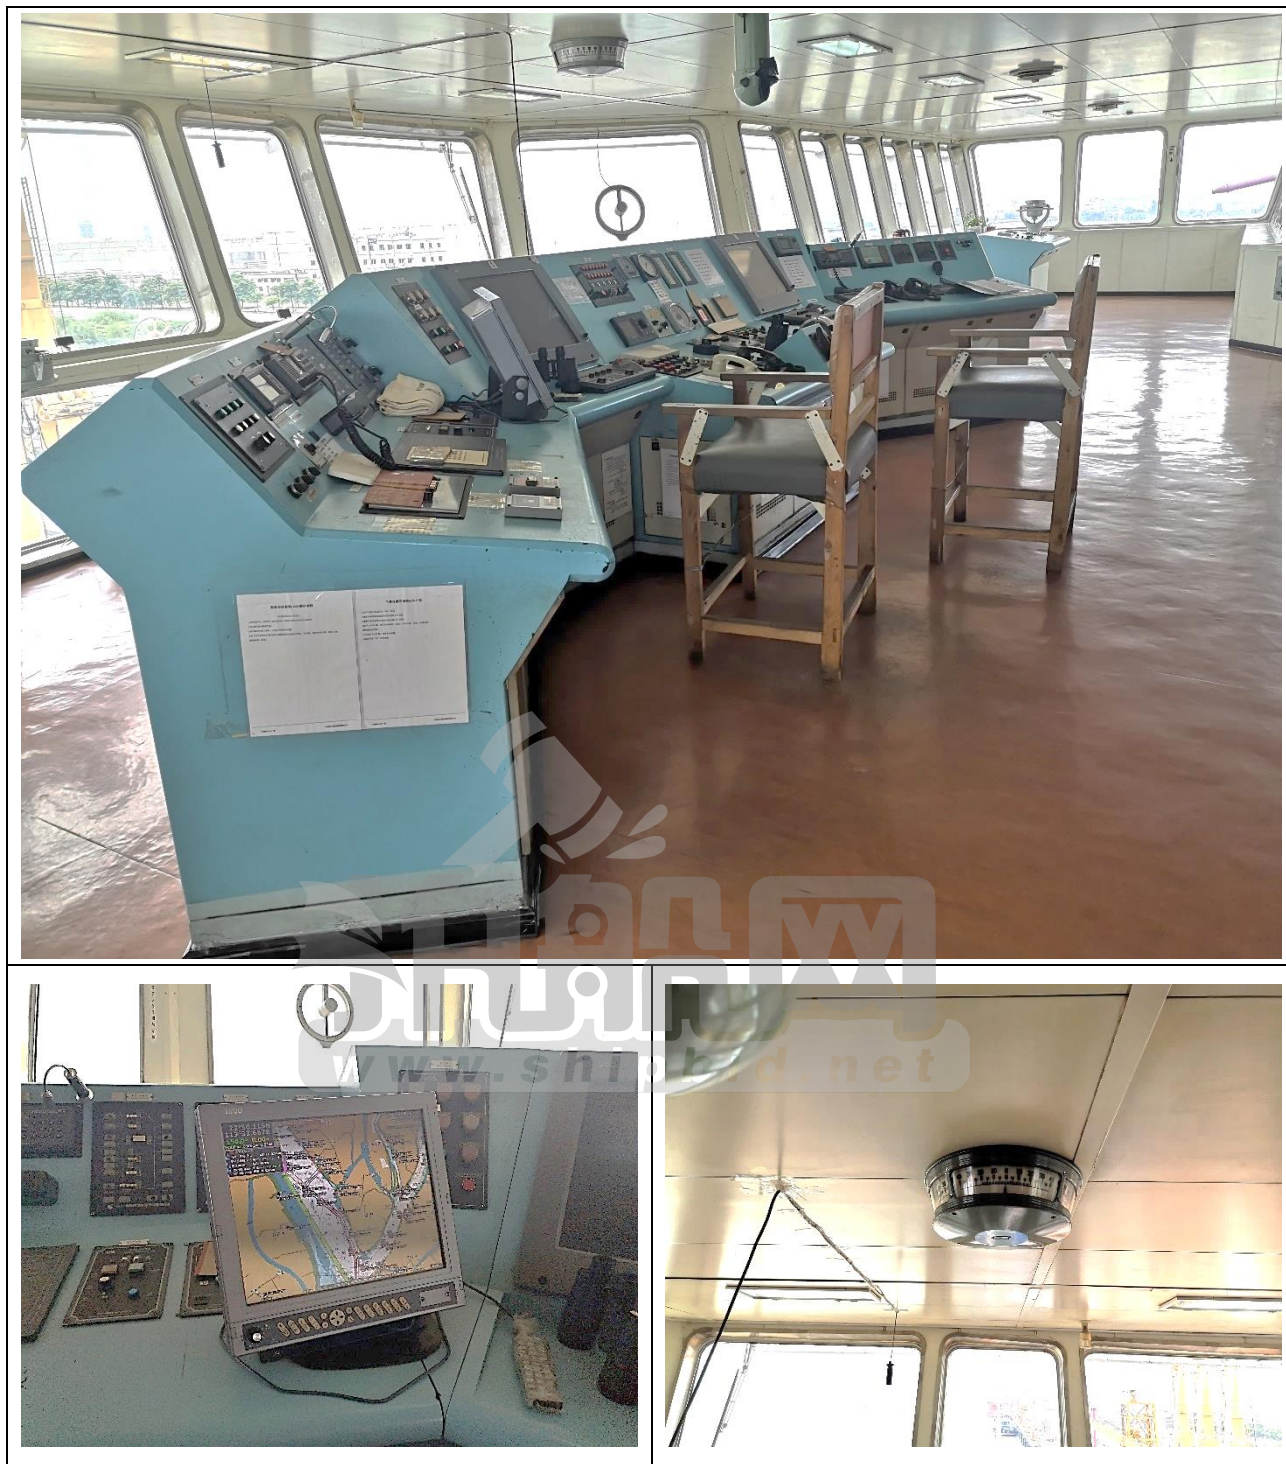
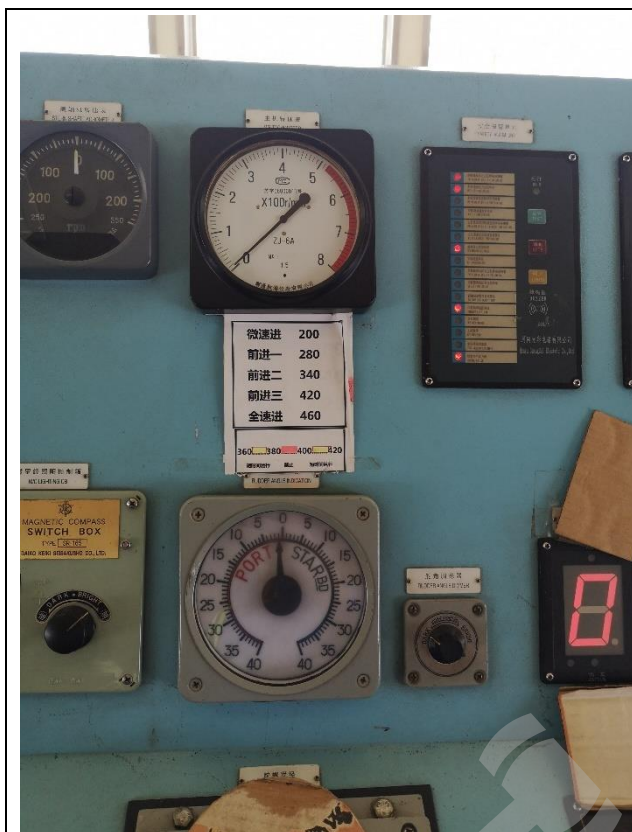
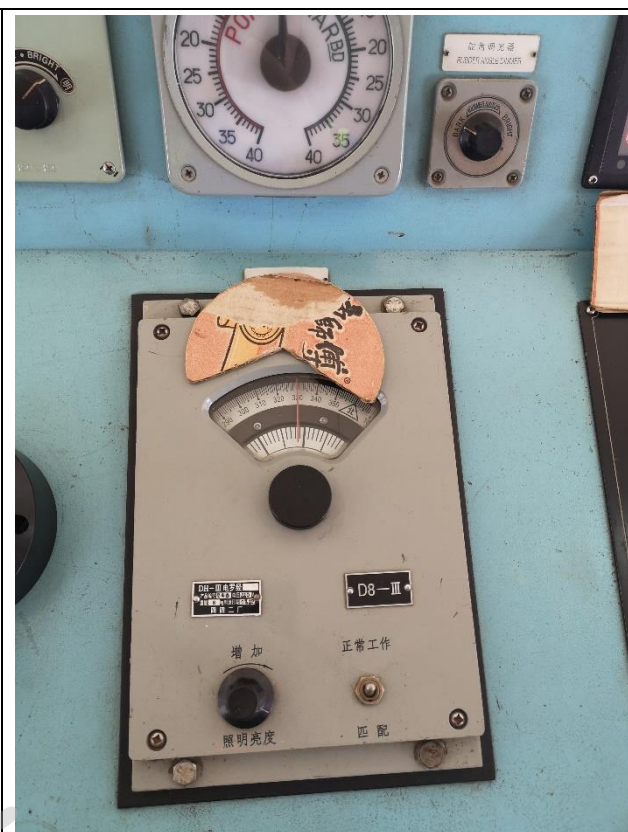
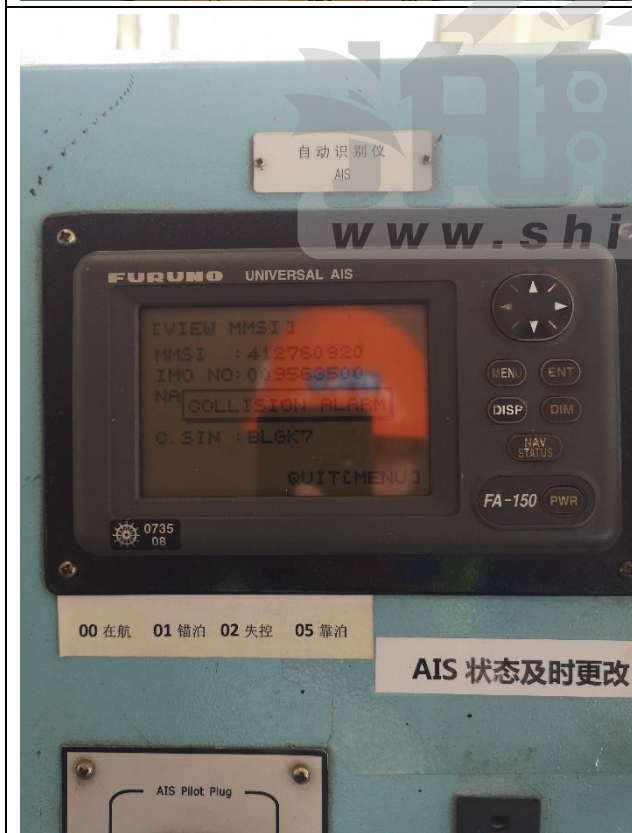
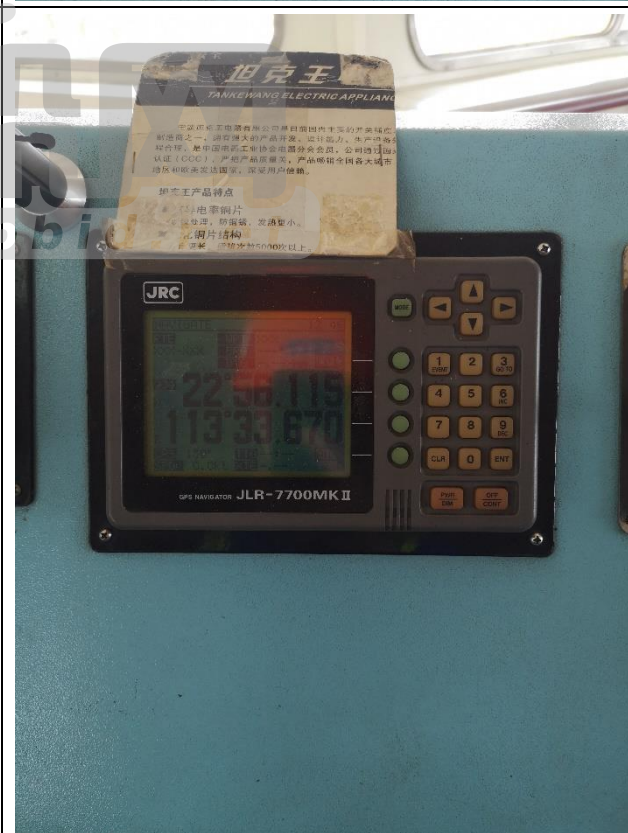
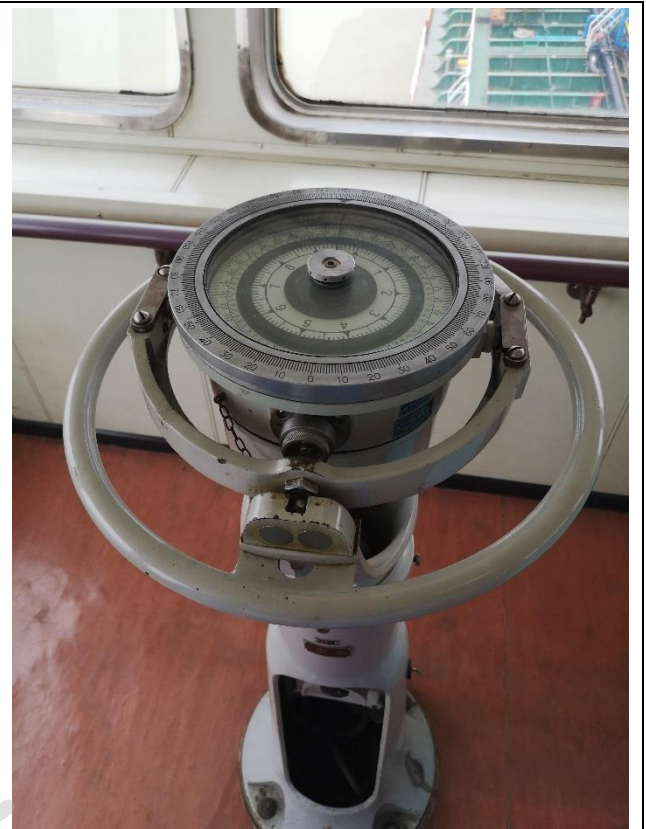
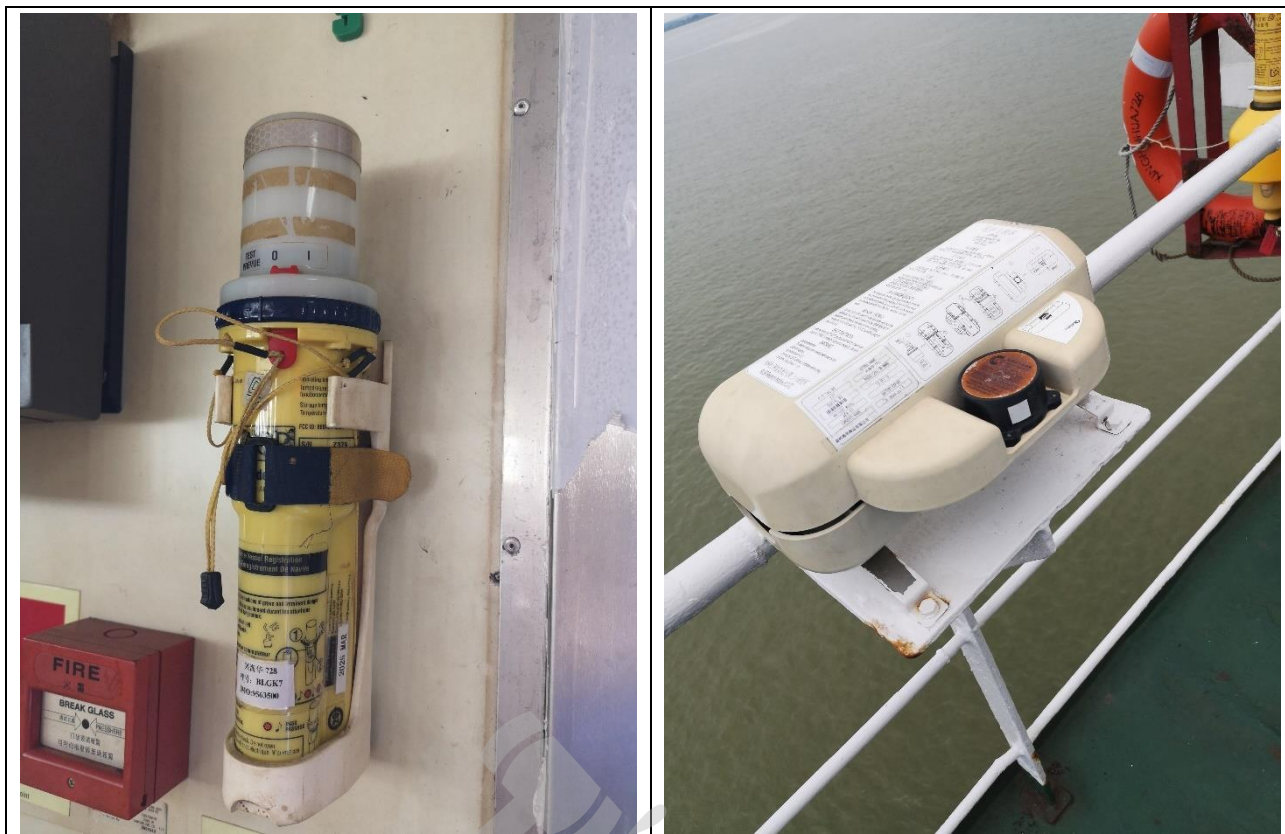
6.6 Bridge Equipment

The watertight condition of the front window in the wheelhouse was found good, with good appearance on the rotating window, and the ceiling was found intact without deformation. The navigation and communication equipment of this ship were found imported from Japan, with intact appearance. This ship is equipped with a gyro compass and a bearing compass, the reading was found consistent and no bubbles inside the compass. The readings of the autopilot, rudder angle indicator of this ship were found consistent and near zero.

The AIS static information of this ship was found consistent with the actual situation, and the MMSI, IMO number, and call sign were found consistent with the actual ship. This ship is equipped with C station (441219129), medium/high frequency and NBDP. The emergency lighting of the ship was found working normal and has one set of backup power supply. The radar transponder battery is valid until March 2025, the battery of EPIRB is valid until November 2025, and the inspection of the hydrostatic release device is valid until December 2025.
