TECHNICAL REPORT

编号: CJPG-JS-23-KY-309

XING HAI HUA 728

Technical Report of MV "XING HAI HUA 728"

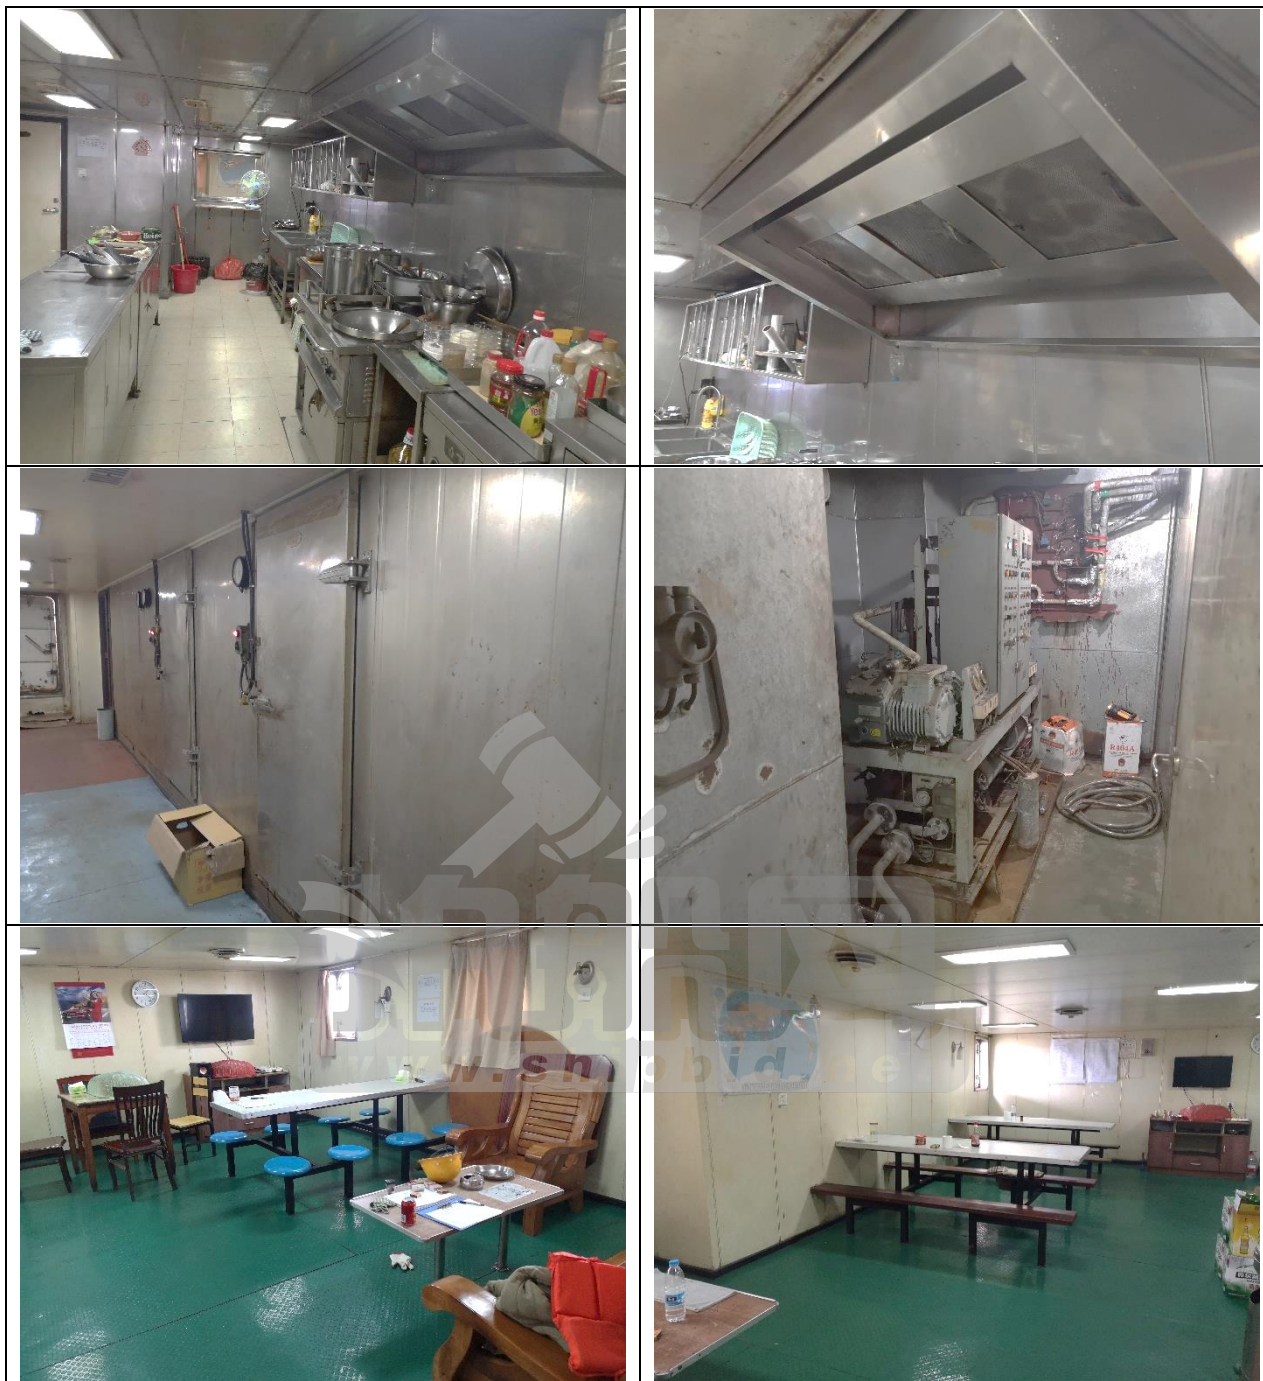
6.7 Accommodation area

This ship is equipped with a crew mess room and an officer mess room. The indoor lighting was found intact, and the decoration condition was found general good, without deformed or damaged. No crack was found on the side window glass.

The cleanliness of the kitchen was found good, and the kitchen facilities were found complete. The stove, dining table, and sink are all made of stainless steel. The range hood is a mechanical exhaust type, without a large amount of oil stains on the filter mesh.

This ship is equipped with a food cold store, with complete door locks, and temperature gauges and alarm light nearby the door. The refrigeration compressor in the cold store was found in normal working condition, without significant damage to the insulation laying and pipeline wrapping.

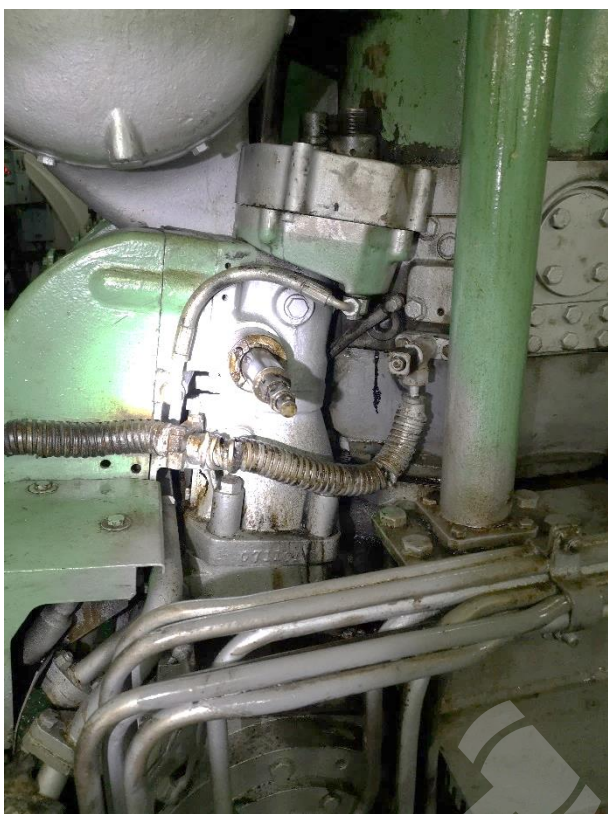
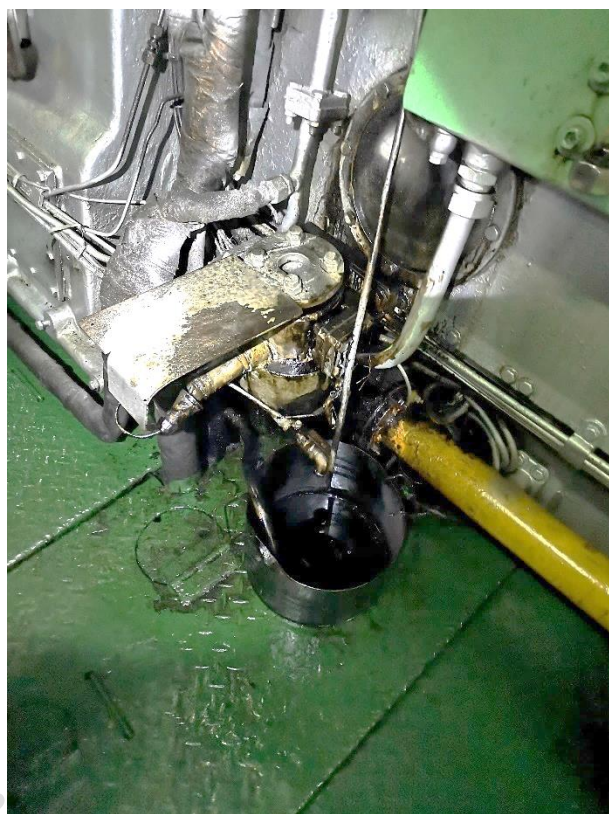
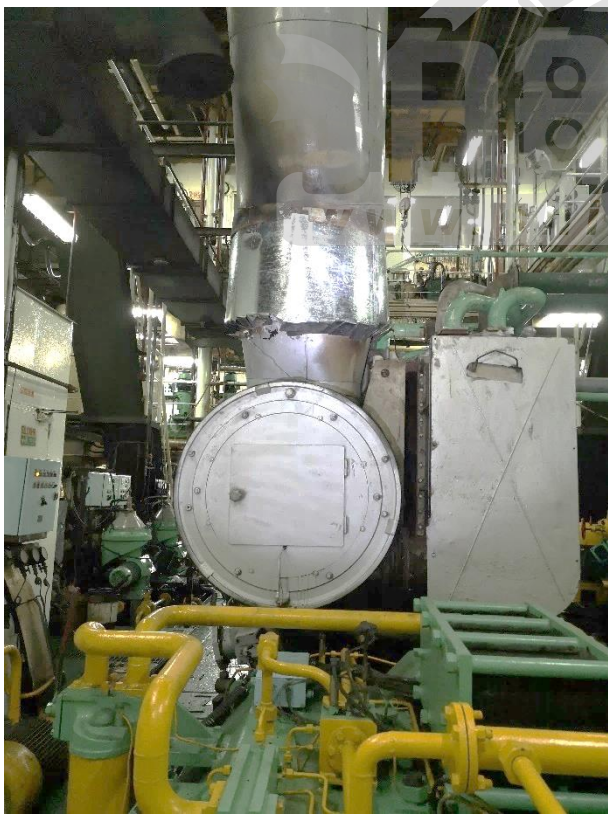
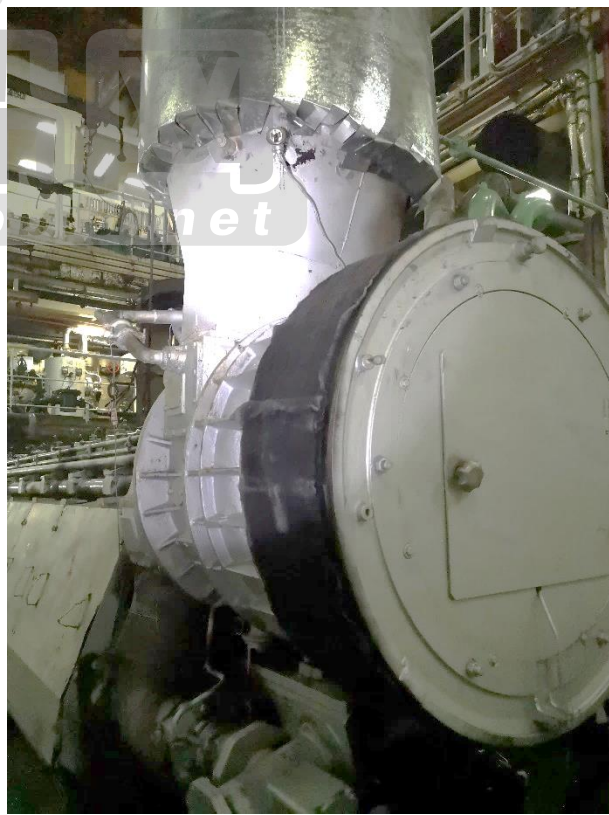
6.8.1 Main Engine

The main engine was found to be free of significant oil stain, and the explosion-proof cover of the crankcase was removed during the inspection. The nameplate of the main engine was found clear and complete, without significantly loose of the pipeline joints.

The appearance of the main engine turbocharger was found intact, and the packaging material for the exhaust pipe was found basically intact. Obvious oil contamination was found at the

high-pressure oil pipe fuel leakage alarm device, and the residual oil pipe was found not connected to the residual oil tank.

The tail shaft seal adopts oil lubrication, and the liquid level in the lubricating oil tank was found at a high level.

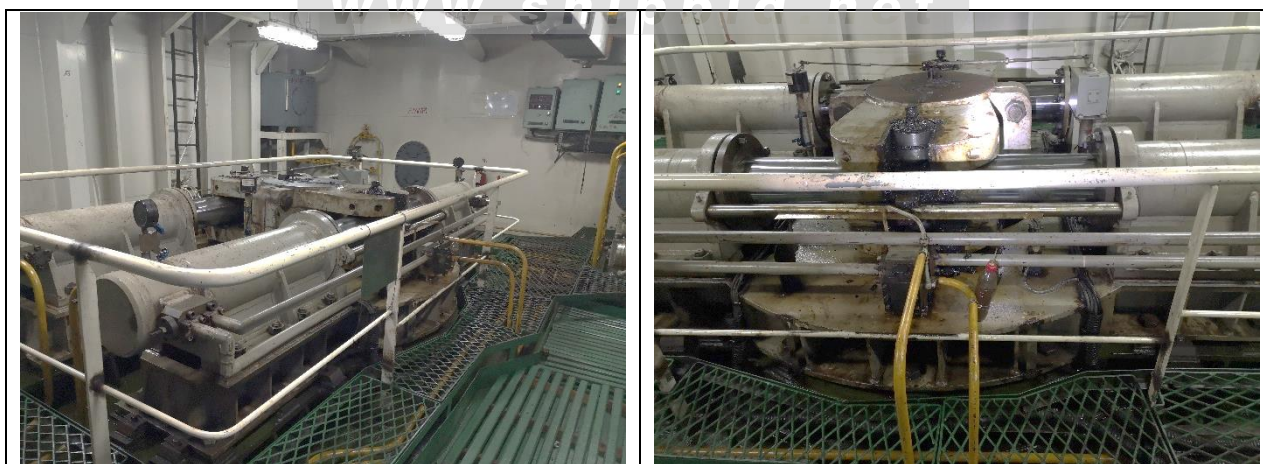
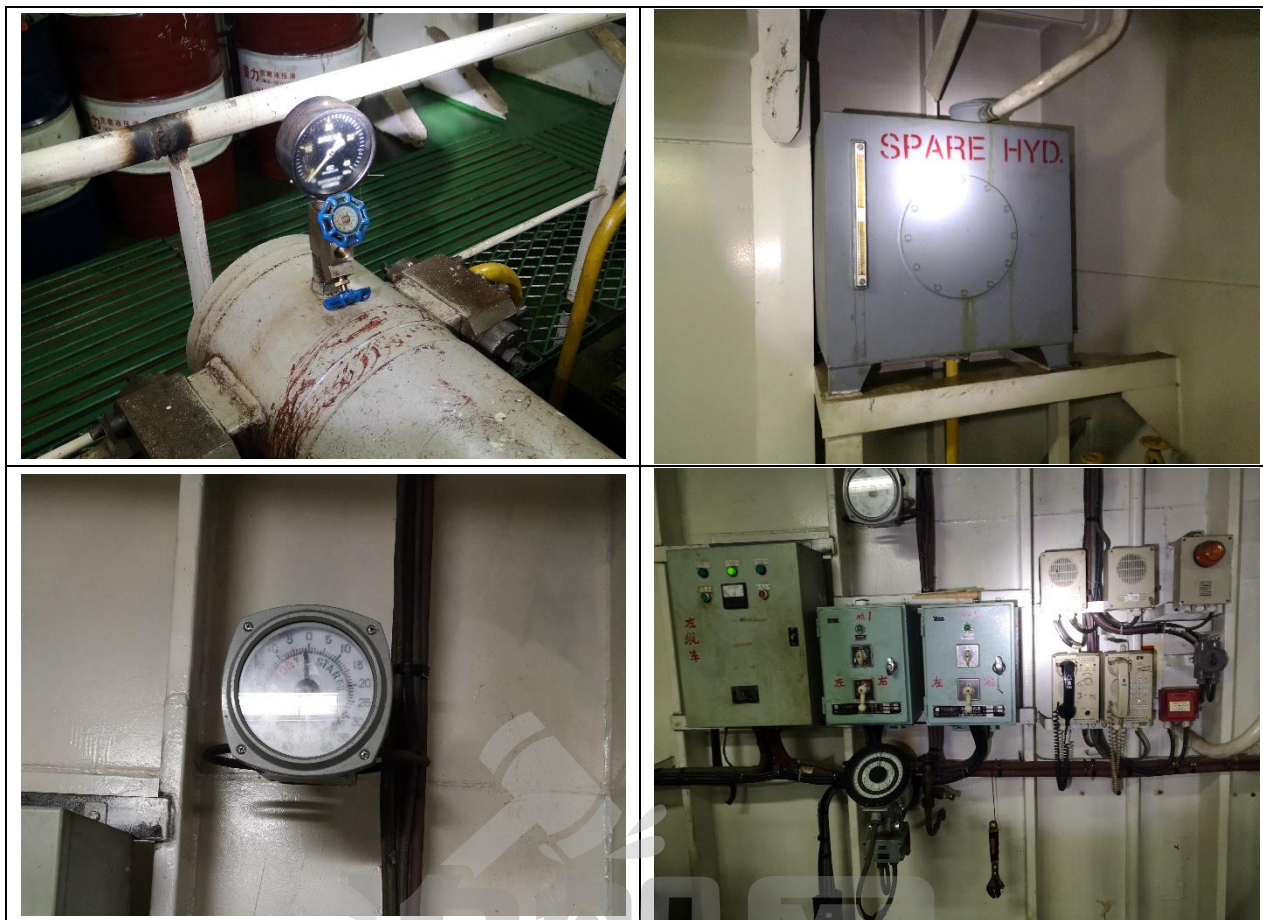
6.8.2 Steering Gear Room

The cleanliness of the steering gear was found general good, without significant leakage at the joints, valves, and cylinder fillers of the pipeline. A small amount of oil accumulation was found in the floor drip tray.

The Level sensor of the steering gear standby hydraulic oil tank was found complete, and the standby hydraulic oil was sufficient.

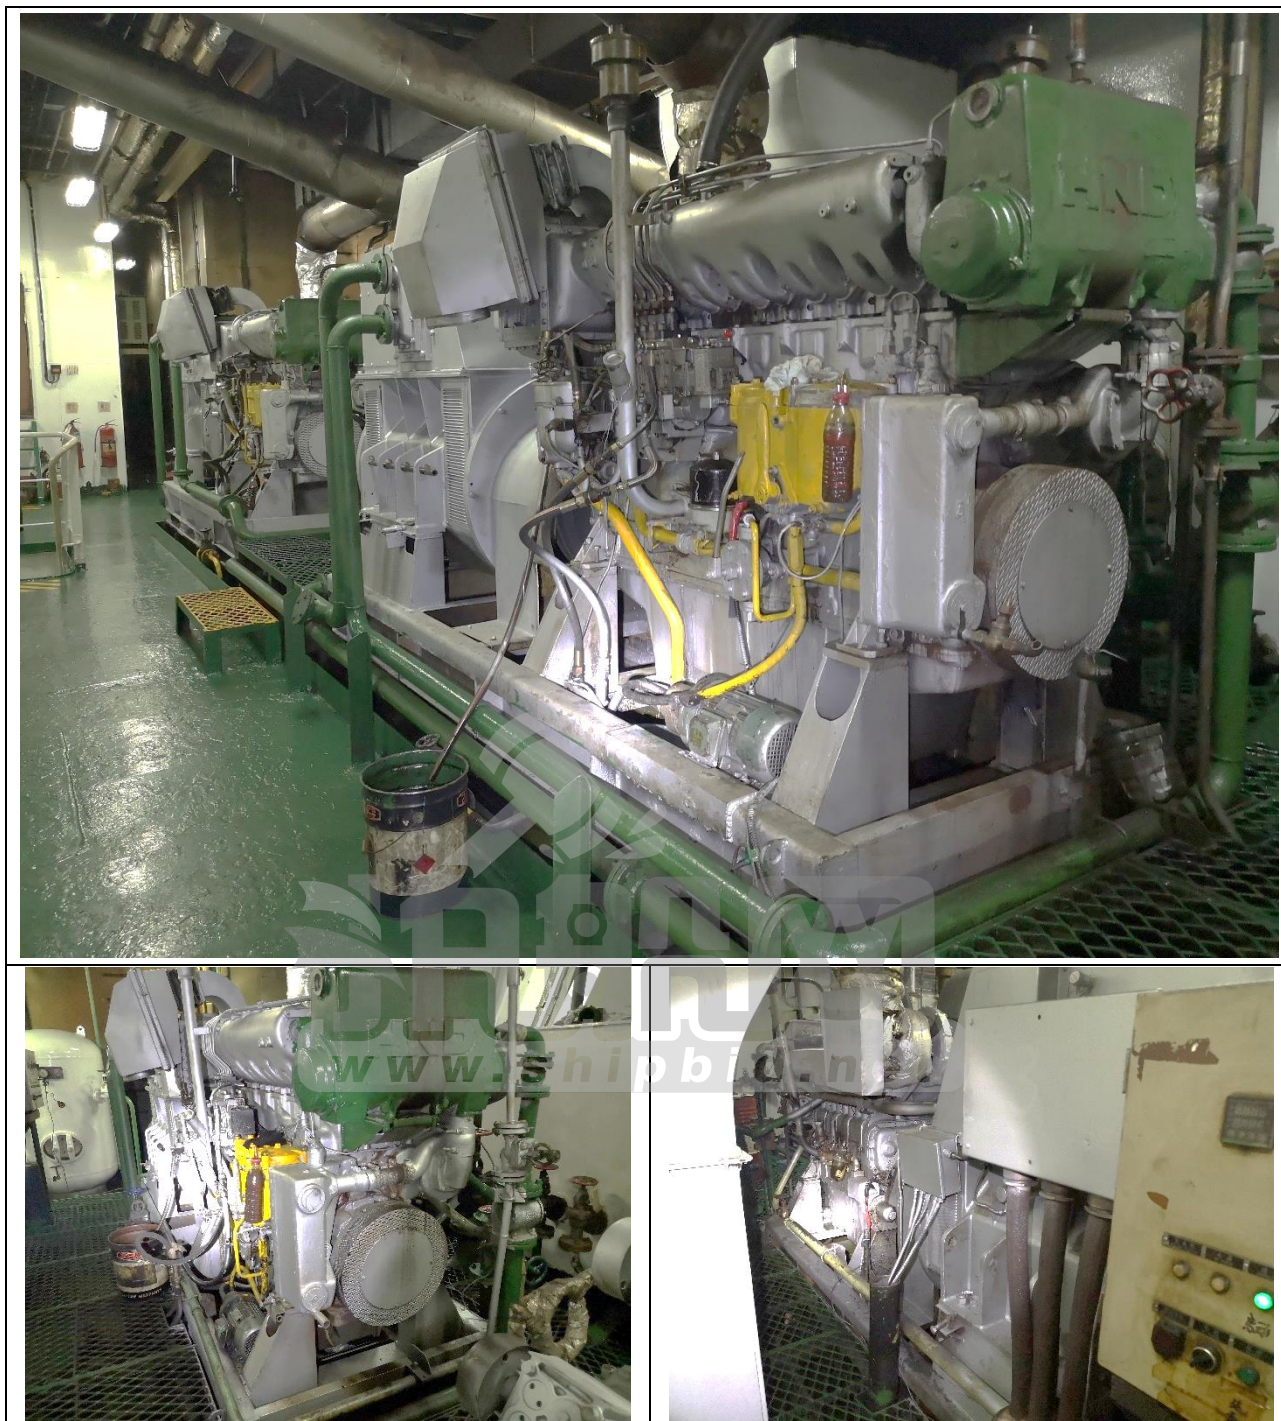
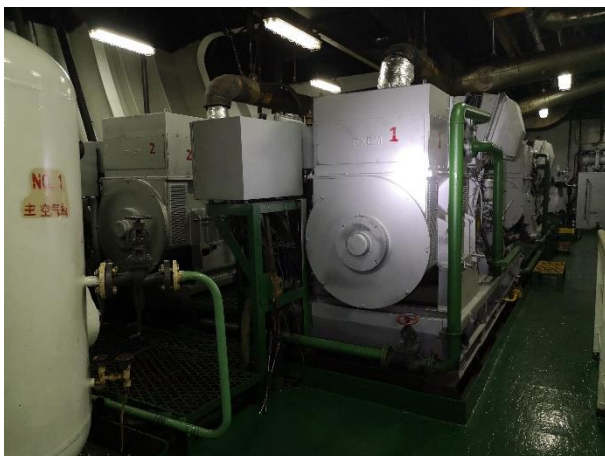
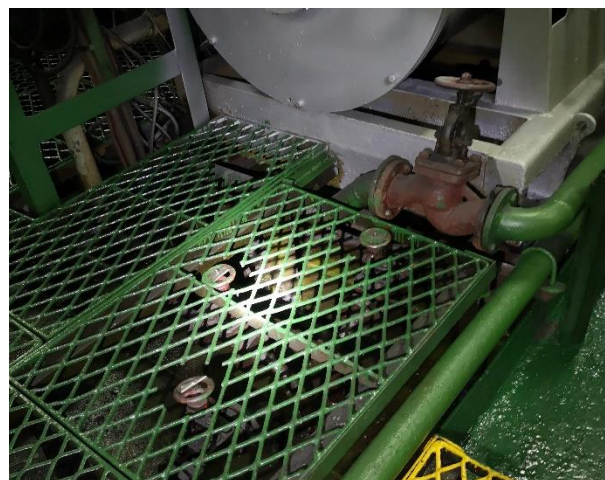
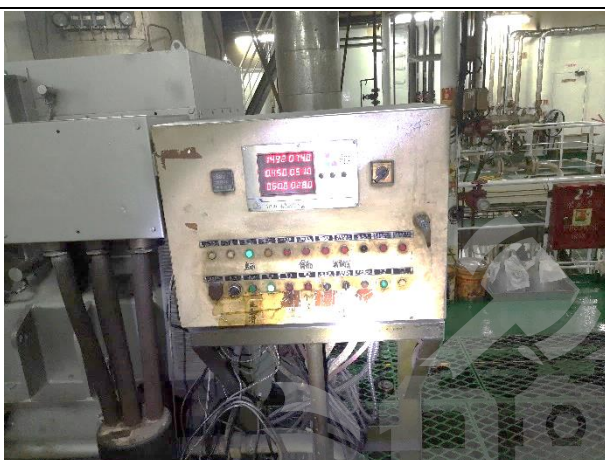
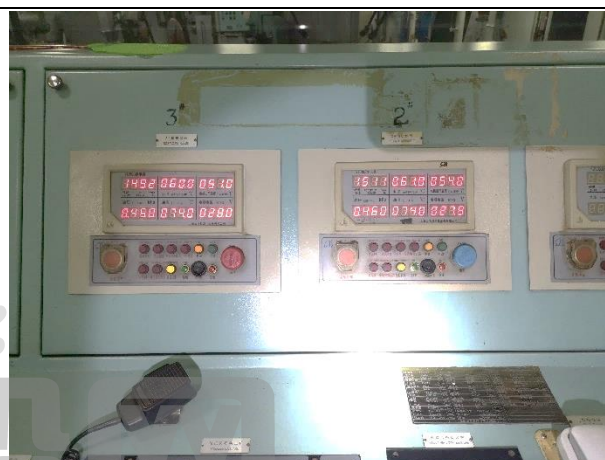
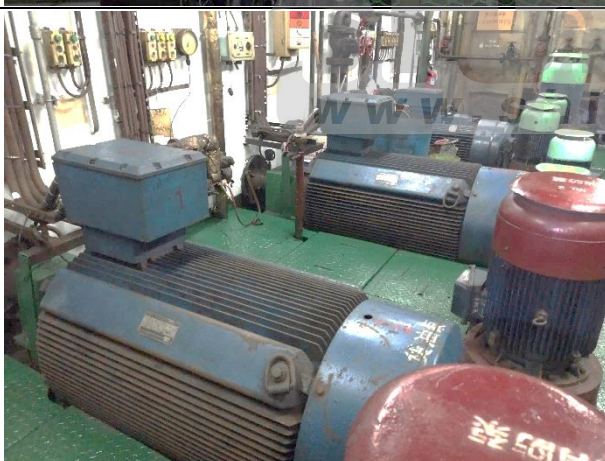
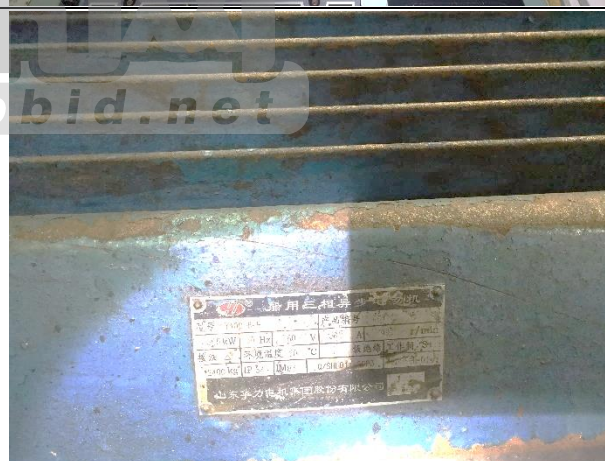
6.8.3 Main Generator

The ship is equipped with three sets main generators, and the overall appearance of the generator sets was found clean and good, with no significant oil stains on the chassis. The body paint was found to be free of damage, with no rust on the pipelines and components.

During the inspection, the # 2 and # 3 generator units were found in running, and all monitoring parameters were found within the normal range, consistent with the data from the monitoring instrument nearby the main generator.

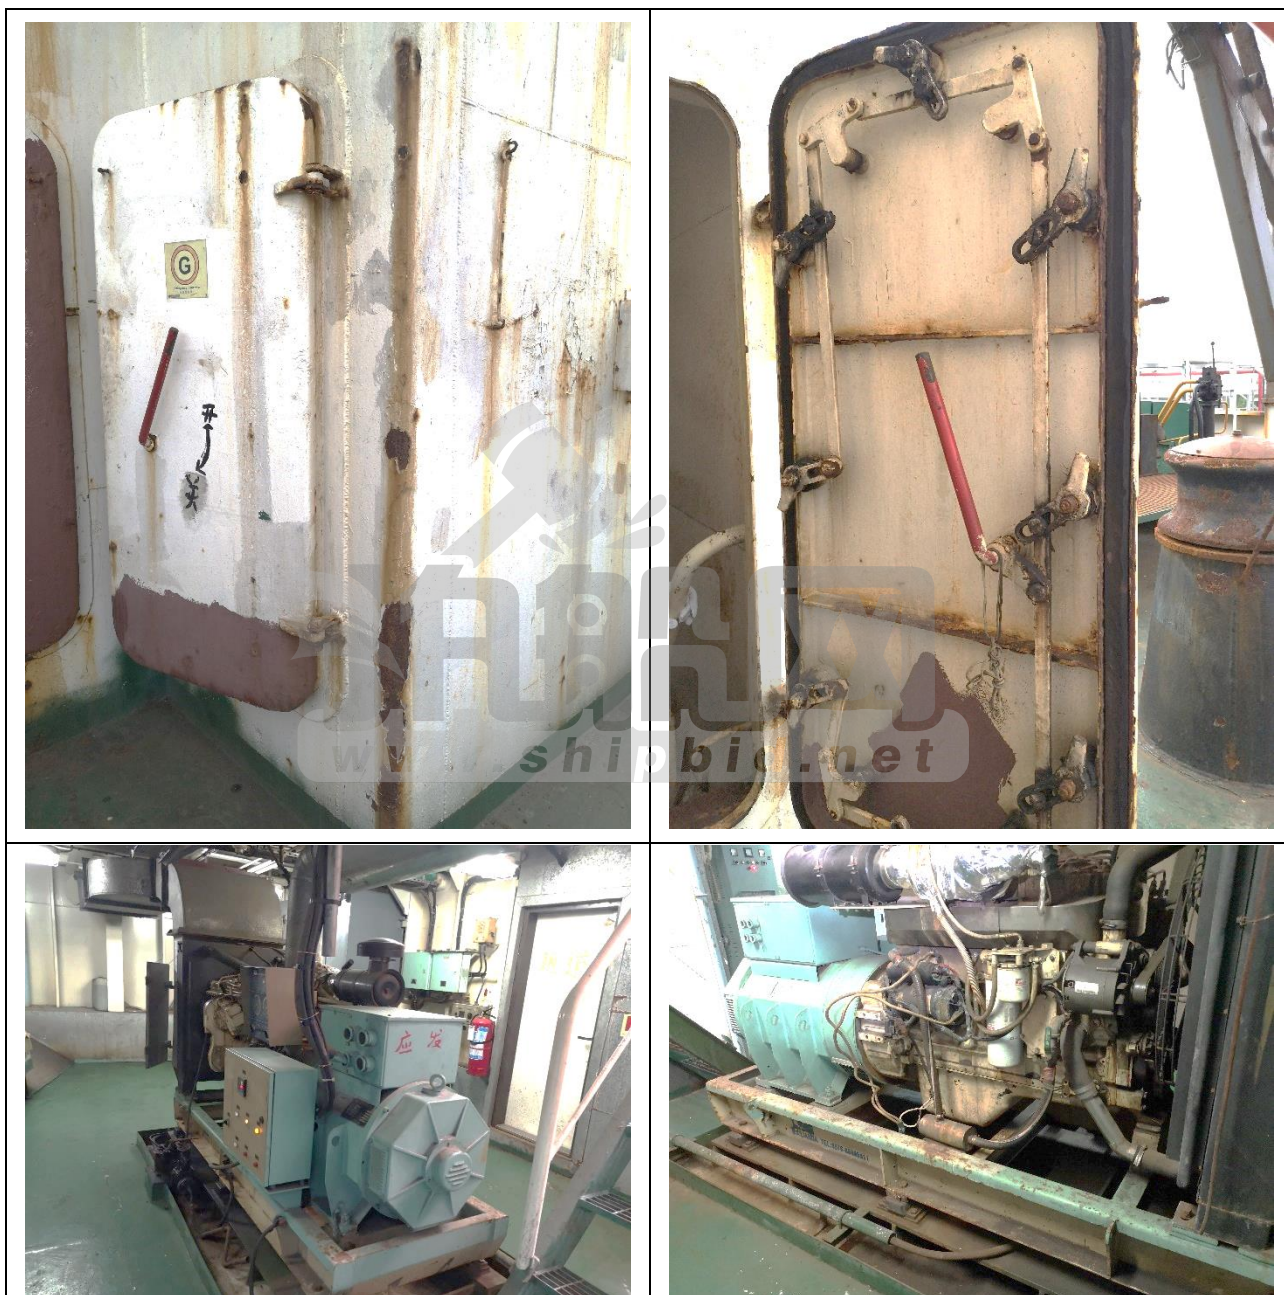
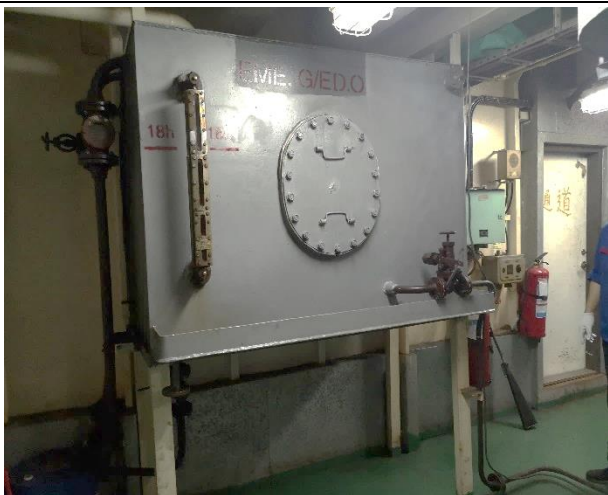
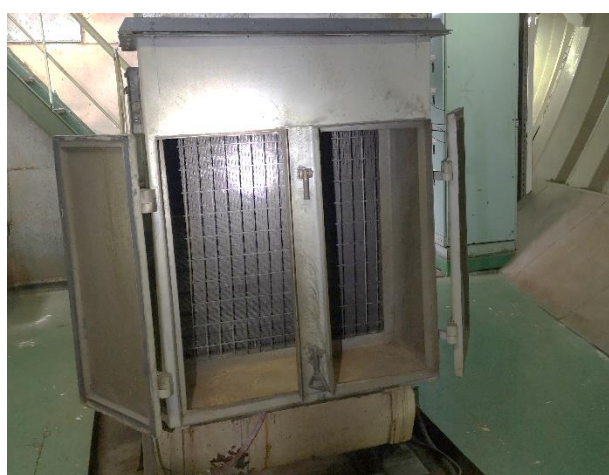
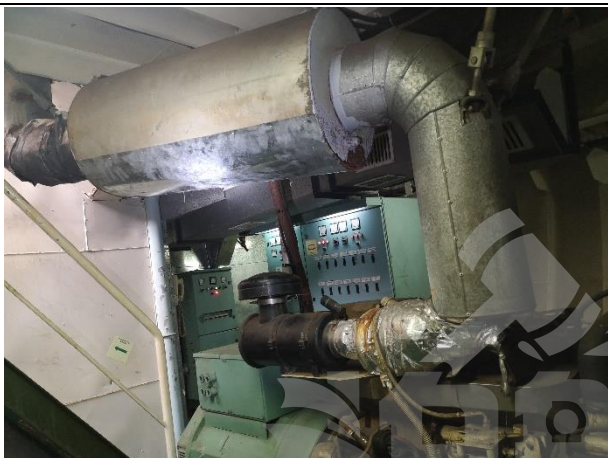
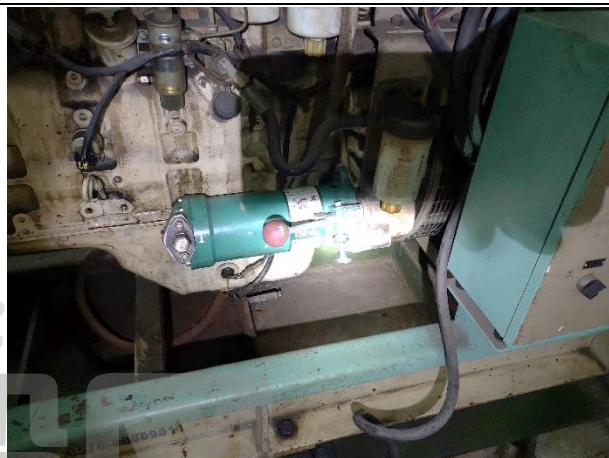
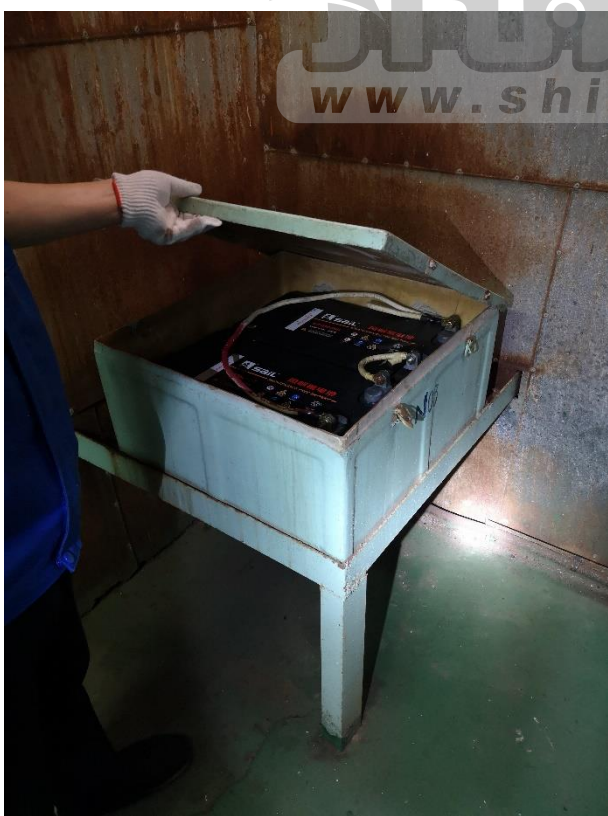
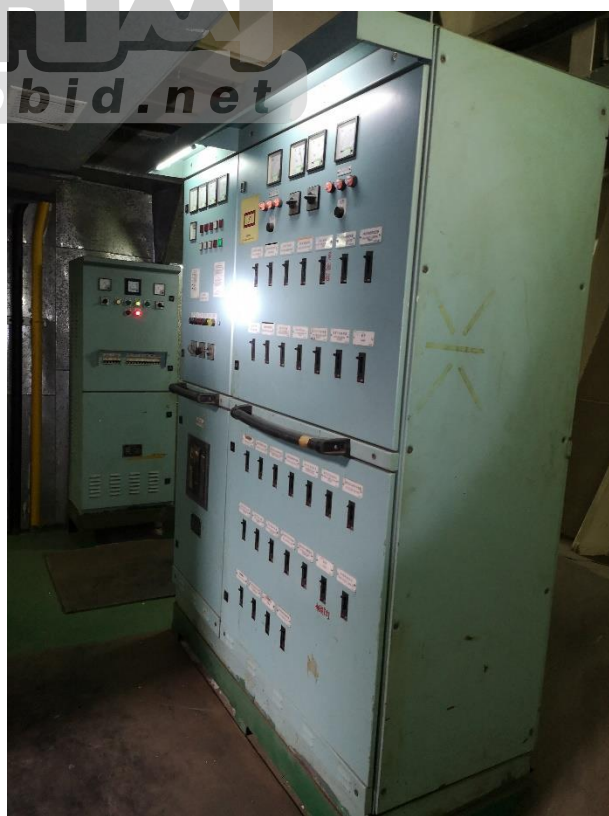
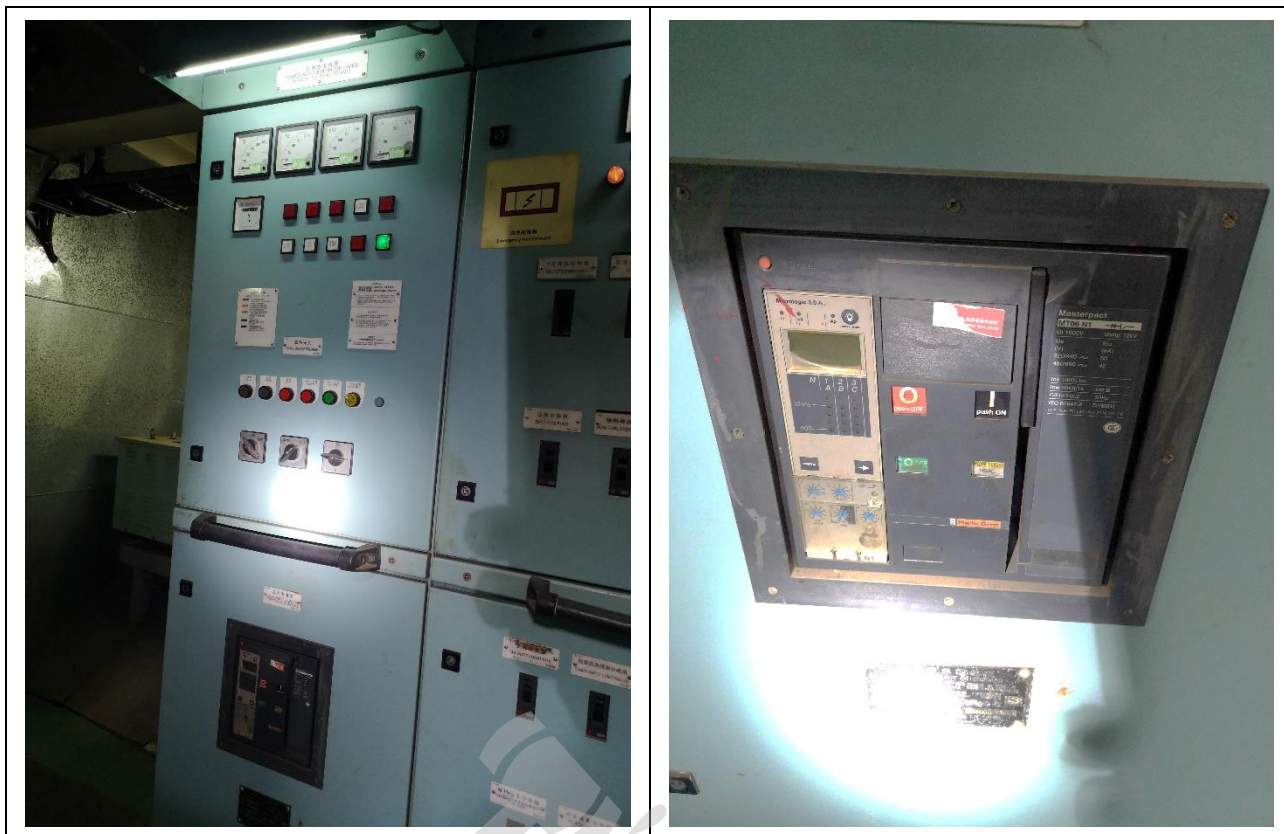
6.8.4 Emergency Generator

The emergency generator room's weathertight door and door frame were found slightly rusted, without significantly deformed on the waterproof adhesive strip. The quick opening device was found open and closed flexibly. The indoor lighting was found intact, with the fireproof laying material complete. The appearance of the emergency generator set was found clean, the insulation and wrapping of the exhaust pipe were found complete, and the ventilation grille was found complete.

The liquid level of the oil tank which supply oil to the emergency auxiliary engine was found normal, and the steel wire of the quick closing valve was found to be free of significantly rusted. The emergency auxiliary engine can be started using two modes: battery and manual start. The main switch of the emergency distribution board is Schneider, the closing switch was found always on, as well as the grounding indicator light.

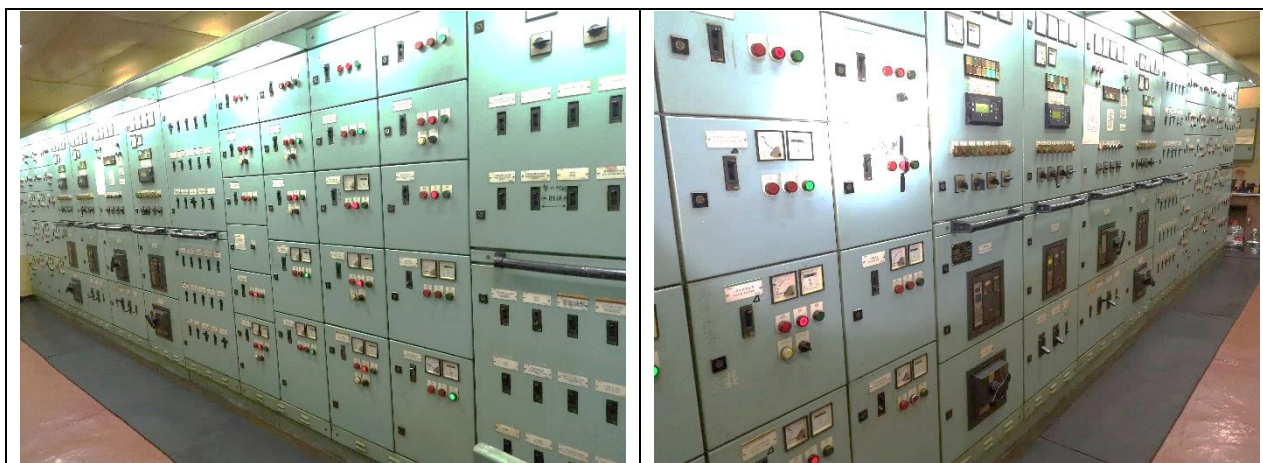
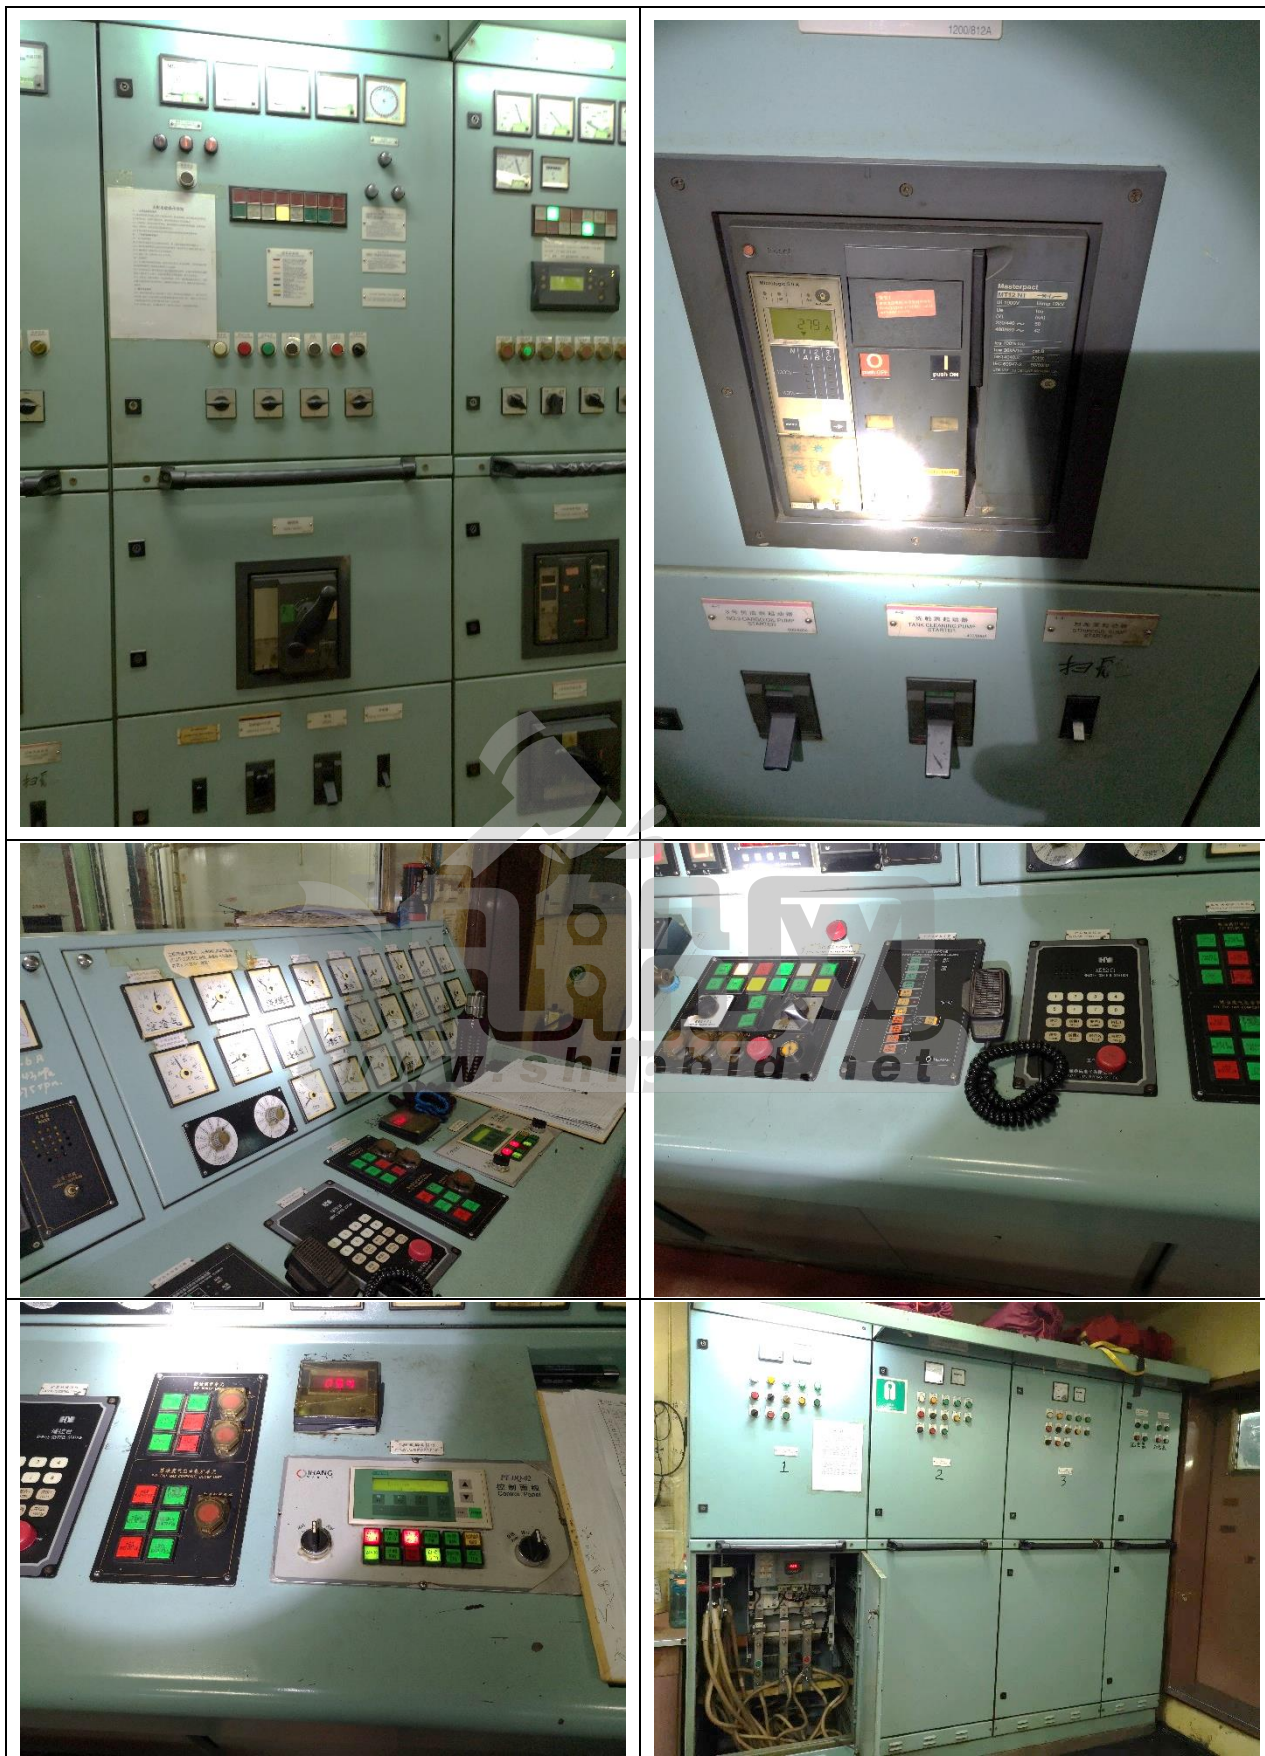
6.8.5 Engine Control Room

The self-closing door, indoor lighting fixtures, and fire insulation laying of the engine control room were found in good condition. The ship is equipped with 10 main switch boards in total, the main switch is Schneider, and the insulation pads was found set in the front and rear of the switch board. The appearance of all switches, indicator lights, and instruments was found normal.

There are three load switch boards for the cargo oil pump in the engine control room, and the # 1 pump group was found in normal operation, with the cargo oil pump operating procedures posted.

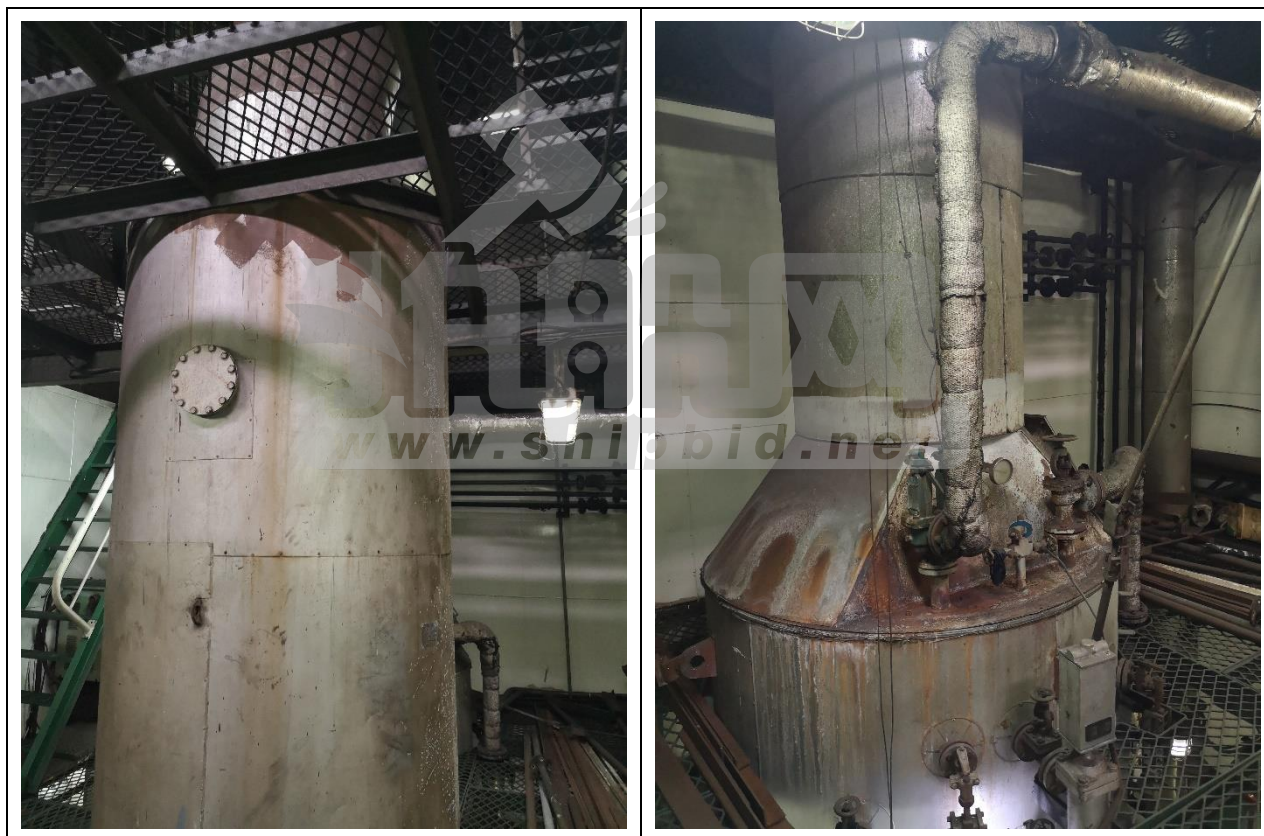
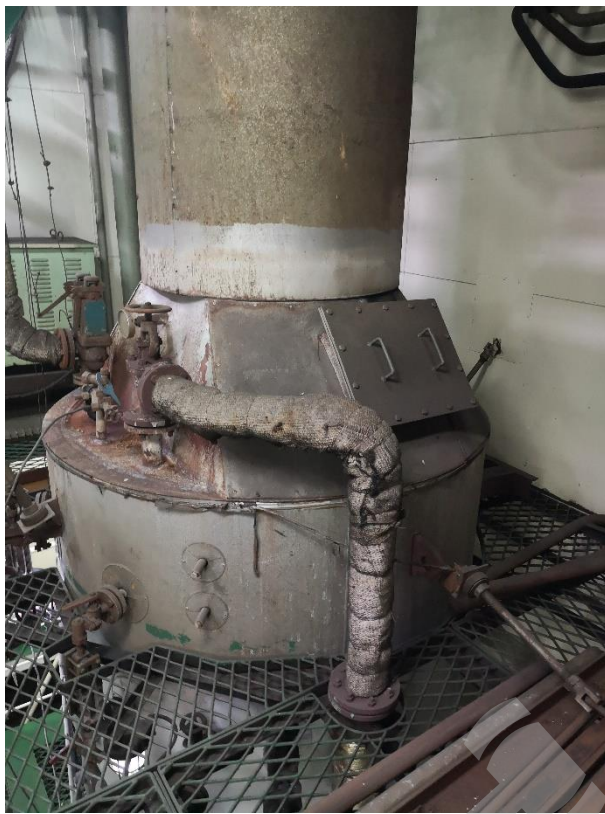
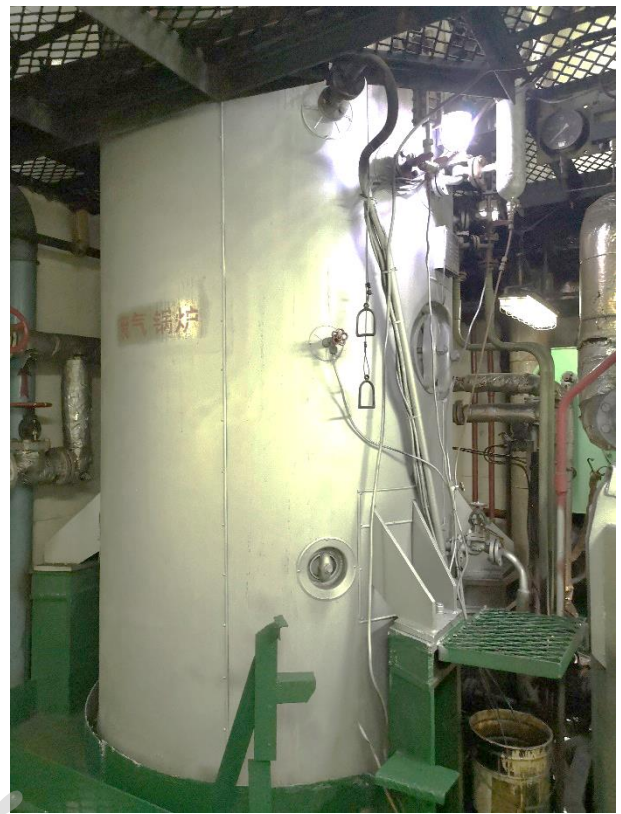
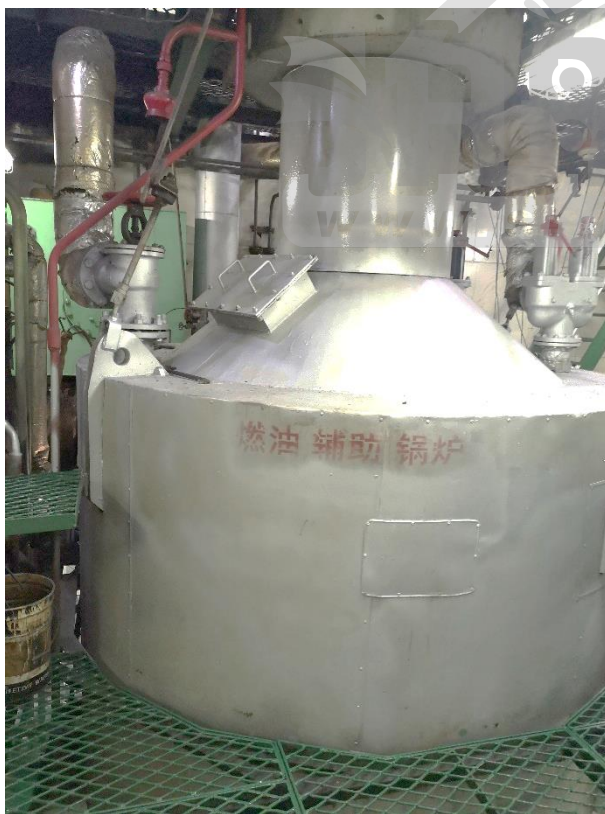
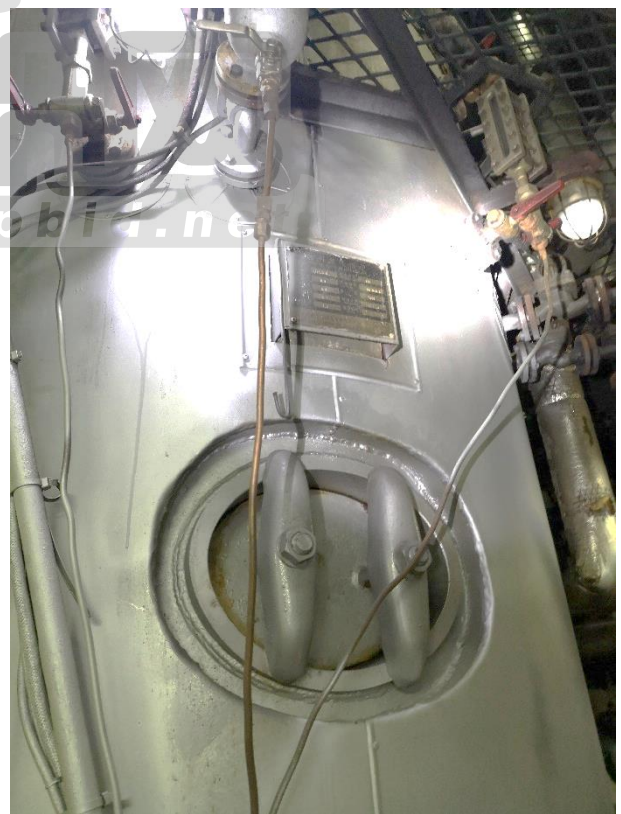
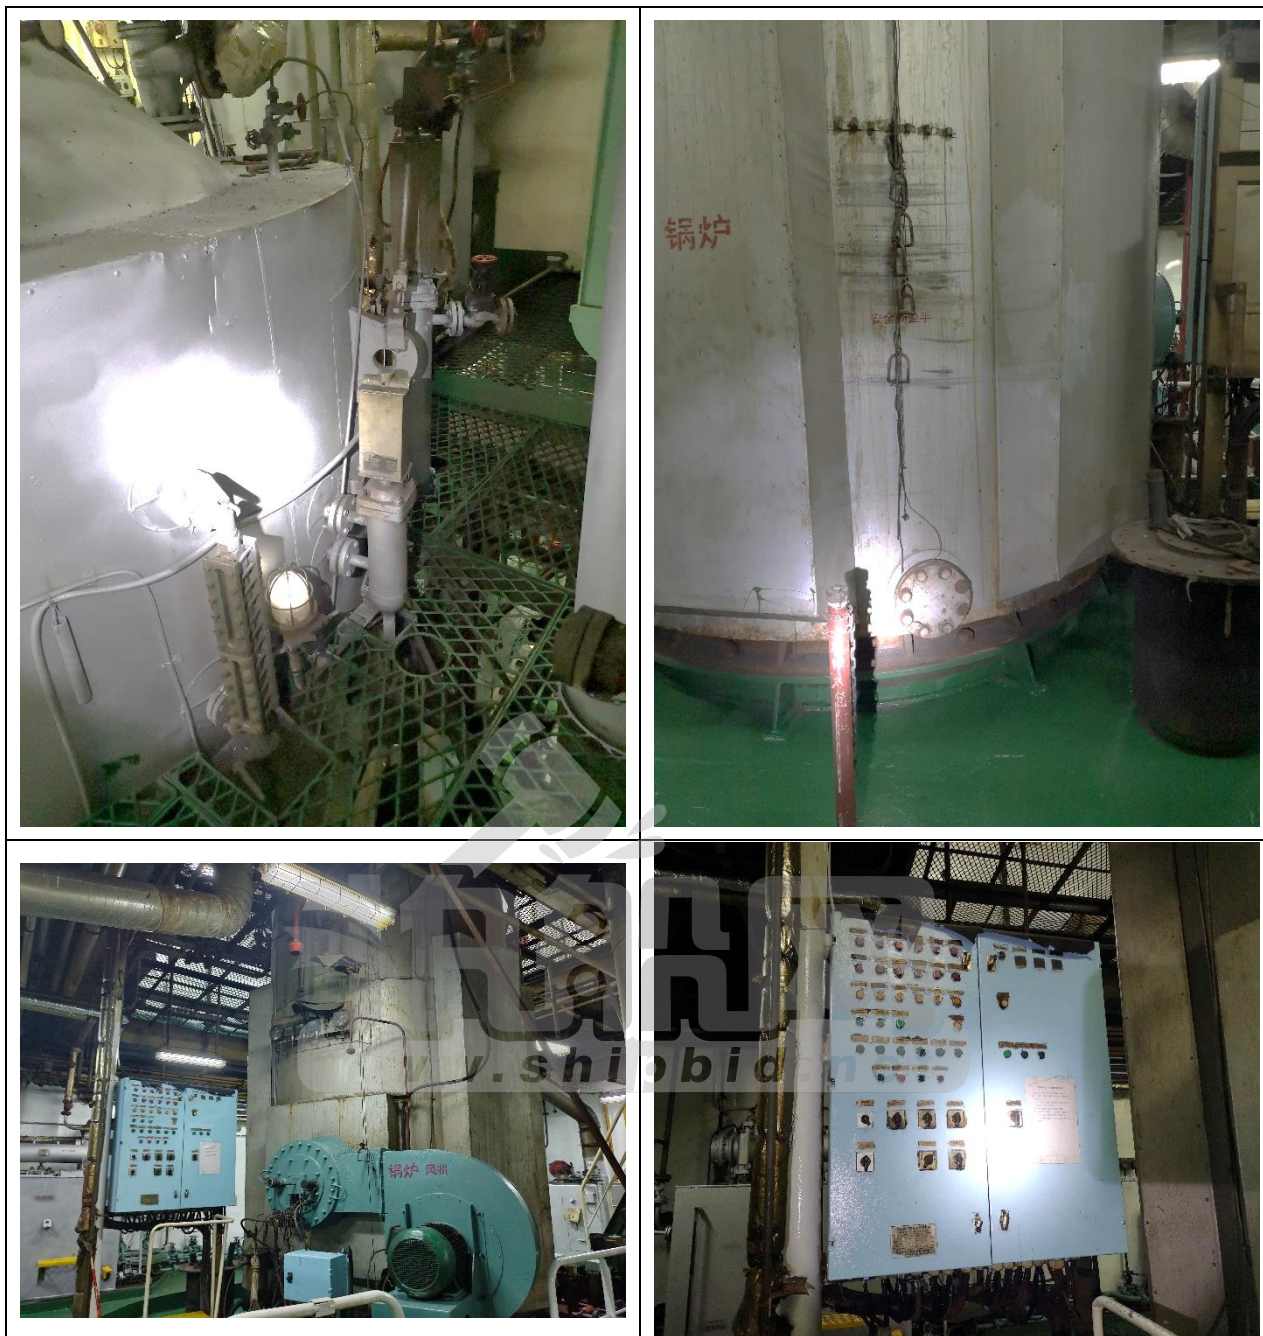
6.8.6 Boiler

The ship is equipped with exhaust boiler and oil-fired boiler in the engine room. The oil-fired boiler was found not to be used currently, but it is in a usable state.

The exterior of the boiler body, exhaust pipe, and steam pipe were found all insulated and wrapped without obvious damage.

The boiler valve components were found no significant signs of water leakage, without significant leakage on the water supply pipeline.

The appearance of the boiler safety valve was found intact, without obvious corrosion or leakage.

The drip tray was found set below the combustion device of the oil-fired boiler, and set a combustion device control box with operating instructions posted.
