TECHNICAL REPORT

编号: CJPG-JS-23-KY-309

XING HAI HUA 728

Technical Report of MV "XING HAI HUA 728"

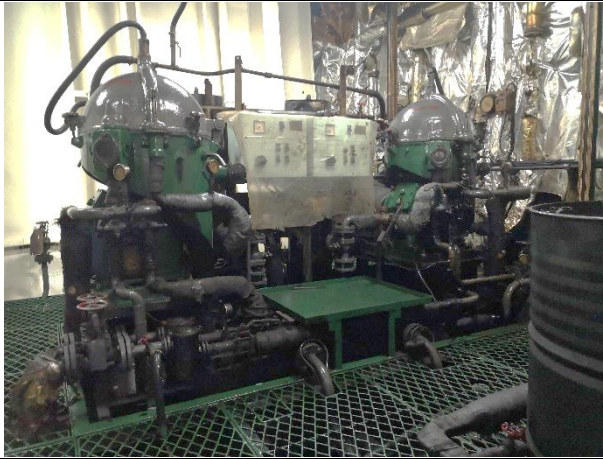
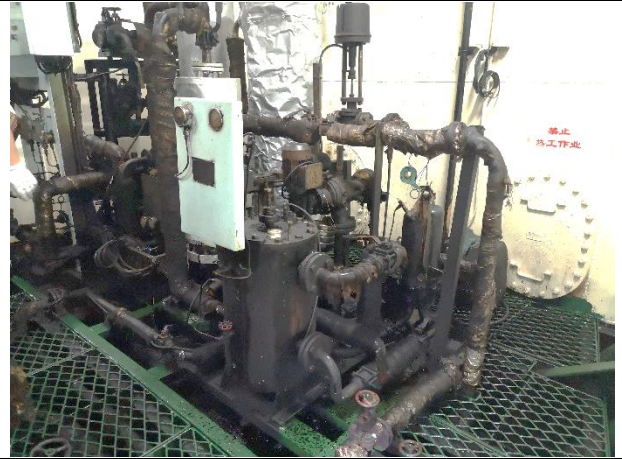
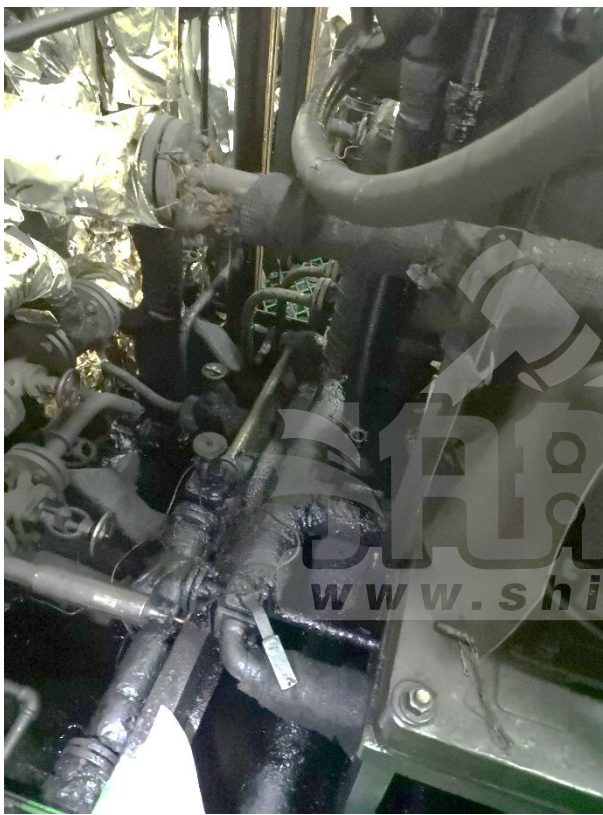
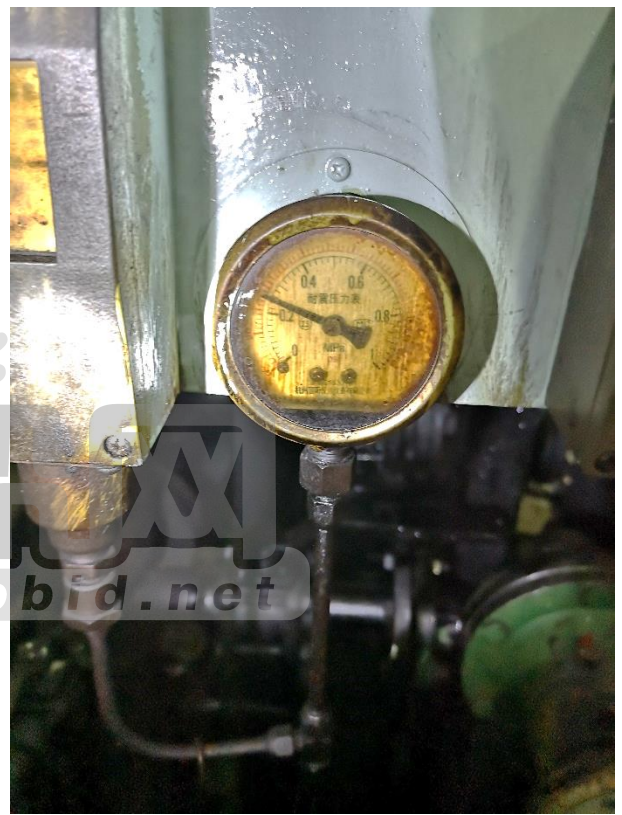
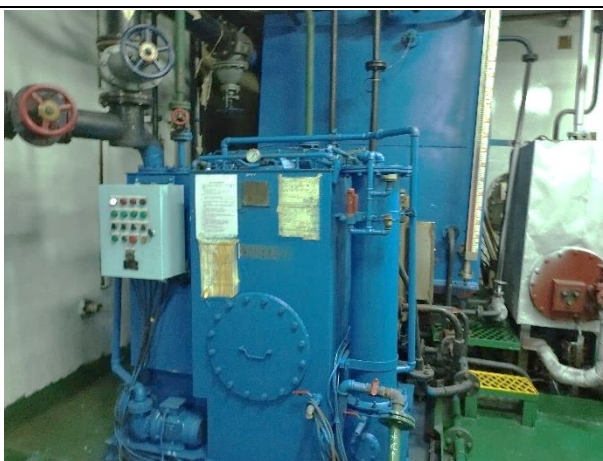
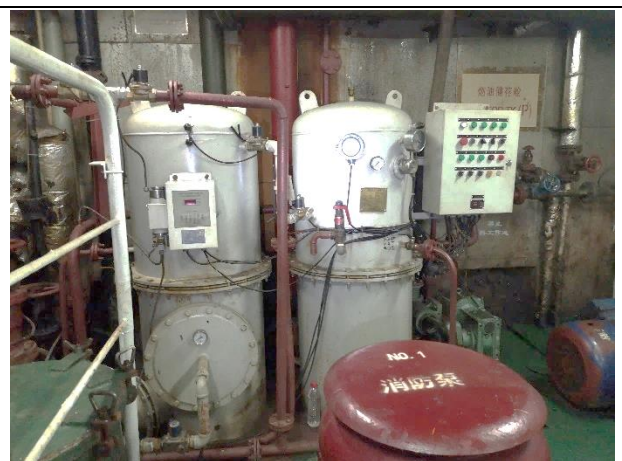
6.8.7 Anti-pollution equipment

The ship is equipped with an oil purifier and fuel supply unit in the engine room. A small amount of oil sludge was found on the chassis of the oil purifier, and the pressure gauge reading of the oil supply unit is 0.25MPa, without significant corrosion or leakage in the pipeline.

The ship is equipped with domestic sewage treatment device and bilge water separator in the engine room. The pipelines and valves were found to be free of rust, and the appearance of the control box and emission monitoring alarm was normal.

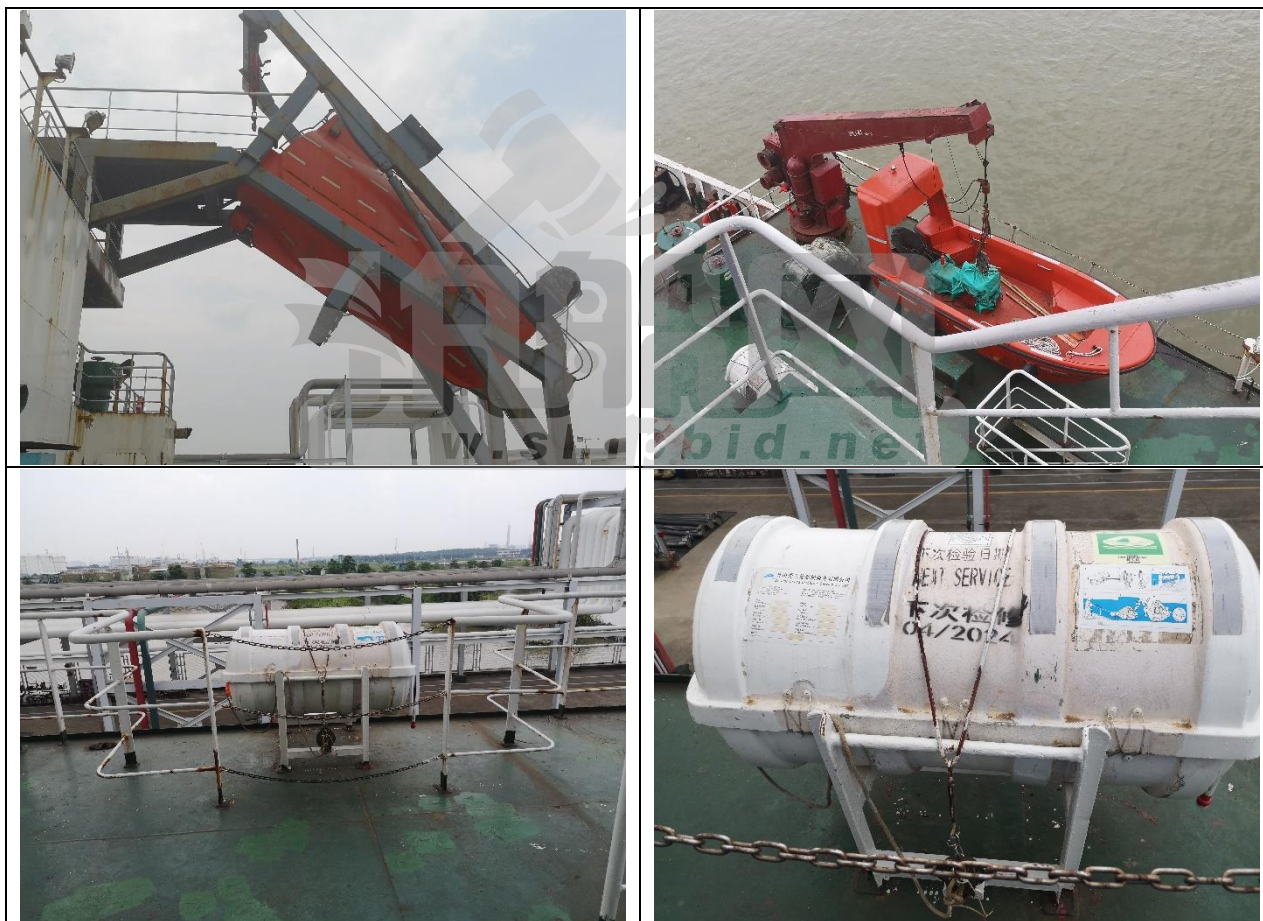
6.9.1 Lifesaving equipment

The ship is equipped with one 26-person freefall lifeboat, and one 6-person rescue boat. The hull appearance was found to be free of crack, the thruster facilities were found intact, and the keel plate has not damaged.

The roller groove of the lifeboat frame was found to be free of significant rust or thinning, without damage on the steel wire, and no rust on the lifting roller and release hook.

The ship is equipped with one inflatable life raft with 25-person and one life raft with 6-person. The release device of the life raft was found complete, the inspection marks were found clear and complete.

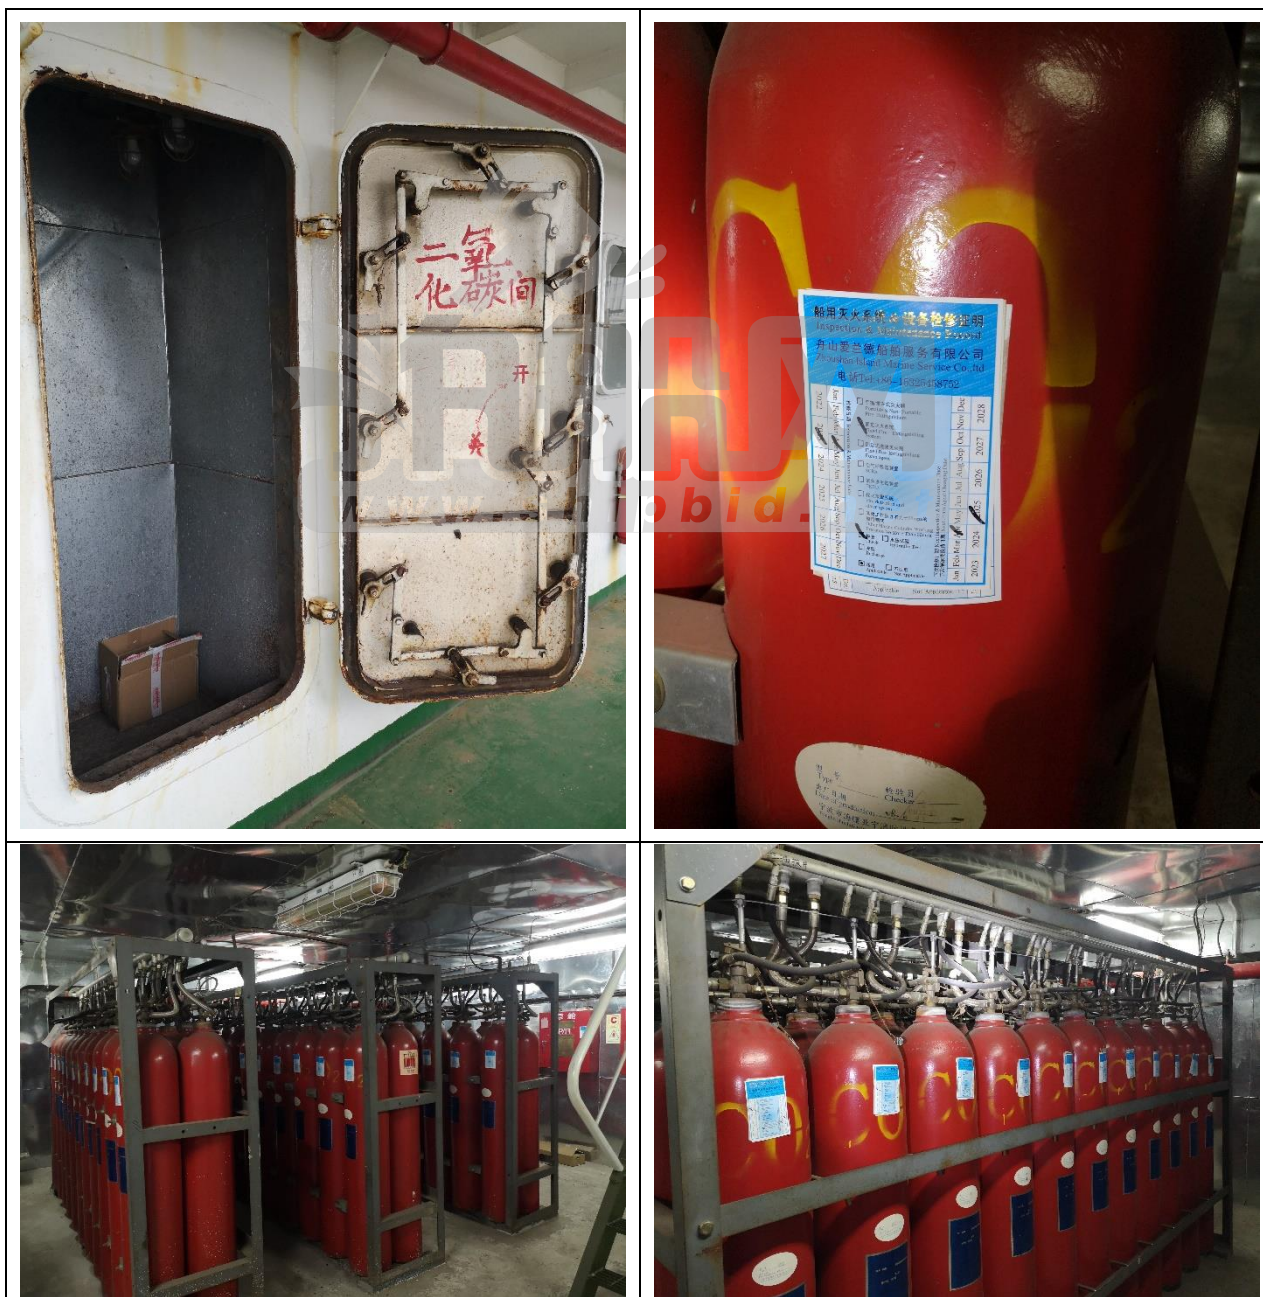
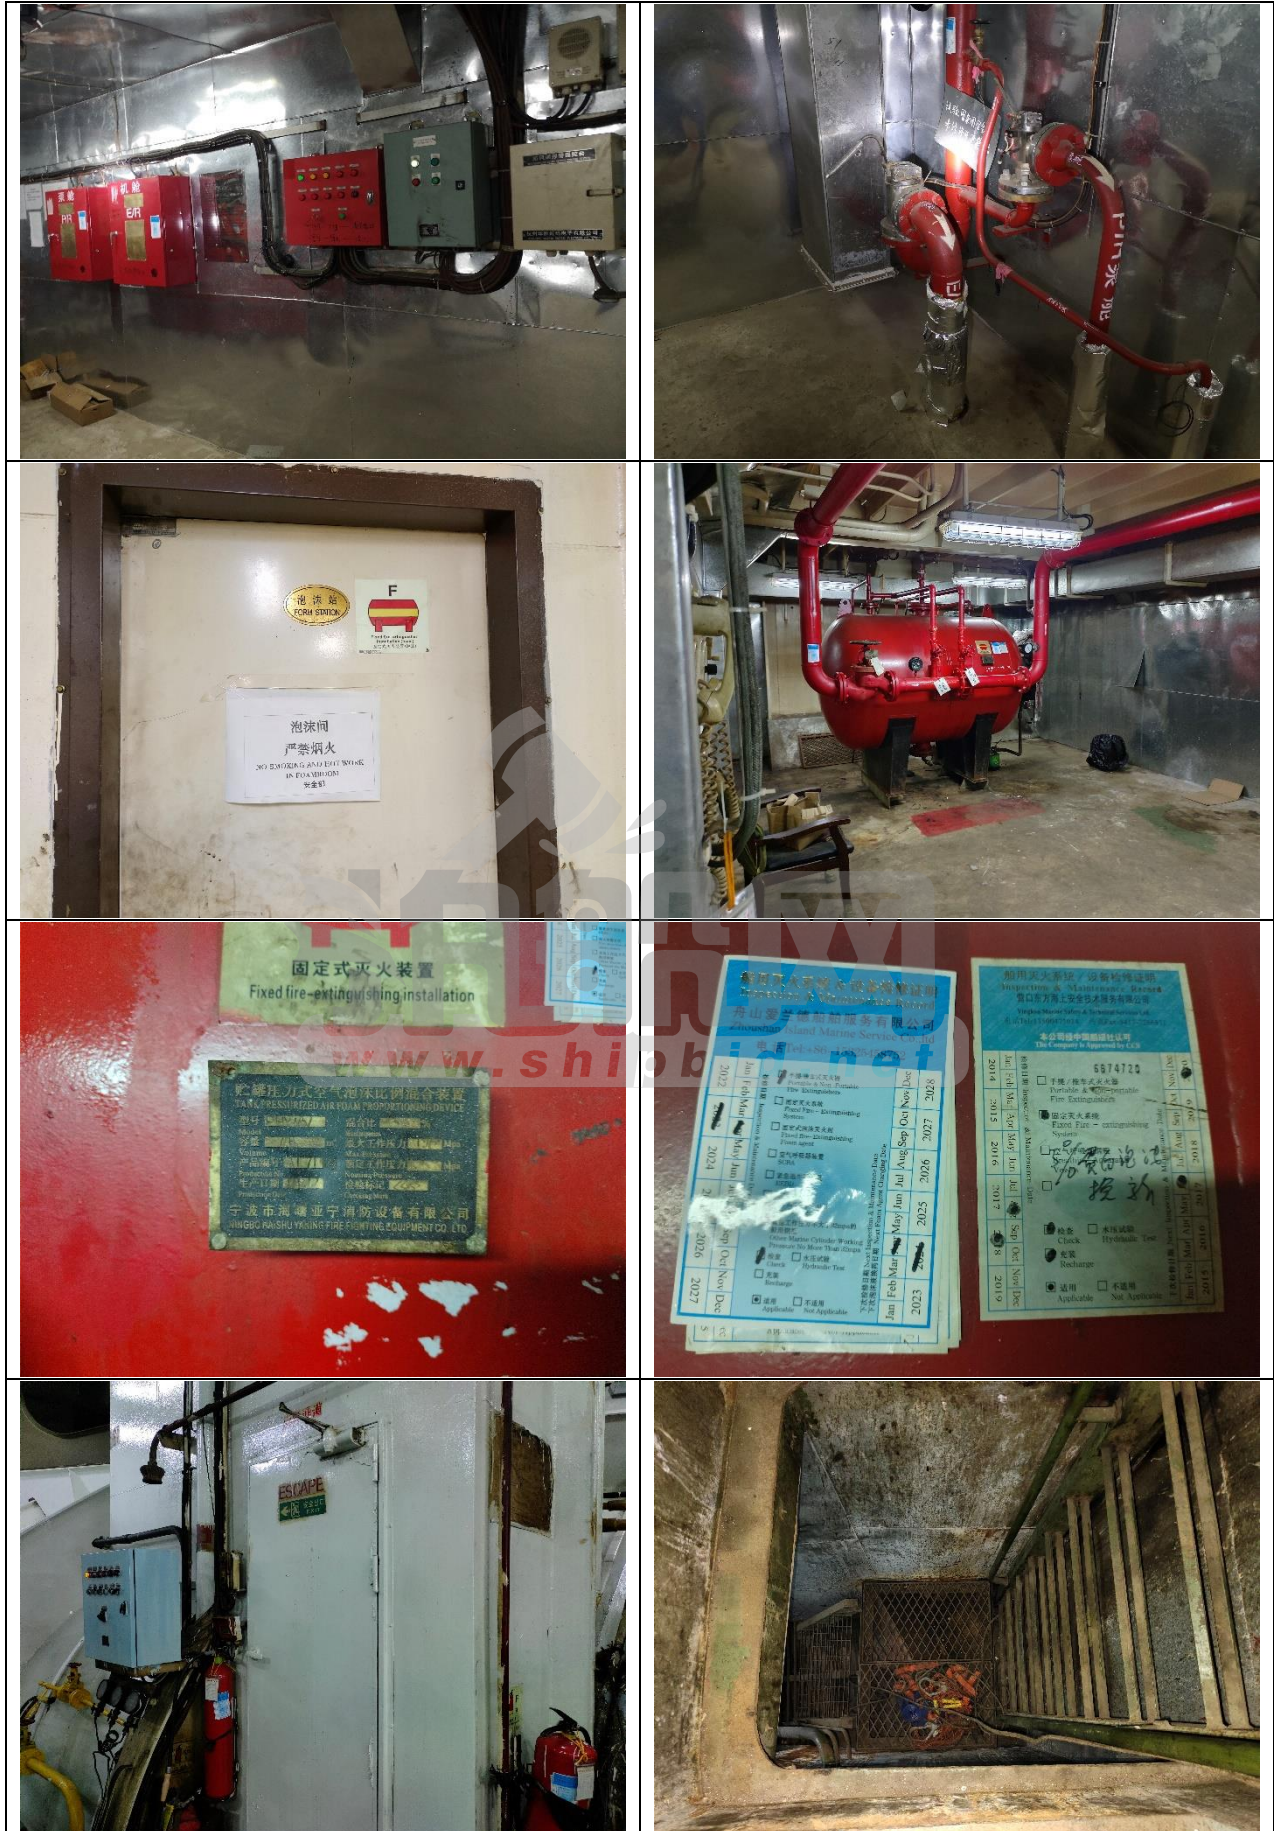
6.9.2 Firefighting equipment

A small amount of rust was found on the sealing strip groove and door frame of the CO2 room, and the indoor fire protection was found complete. The CO2 cylinder release valve and the bottom of the cylinder were found to be free of corrosion, and the safety pin has been pulled out and is in an

instant usable state. The CO2 cylinder inspection marks were found complete, and the last maintenance was in April 2023, with an expiration date of April 2025.

The fire insulation in foam room was found laid in place, the foam generator and pipeline were found basically free of rust, and the inspection marks were found complete. The last maintenance was in April 2023, with an expiration date of April 2024.

The self-closing door of the emergency passage in the engine room was found in a normally closed state, and the opening and closing of the self-closing device were normal. The fire separation structure inside the passage was found complete, the lighting was normal. The lifeline and ladder in the passage were found fully equipped.
