# TECHNICAL REPORT

编号: CJPG-JS-23-KY-358

Date of Inspection: July 5<sup>th</sup>, 2023

## Technical Report of "GLORY SEASON"

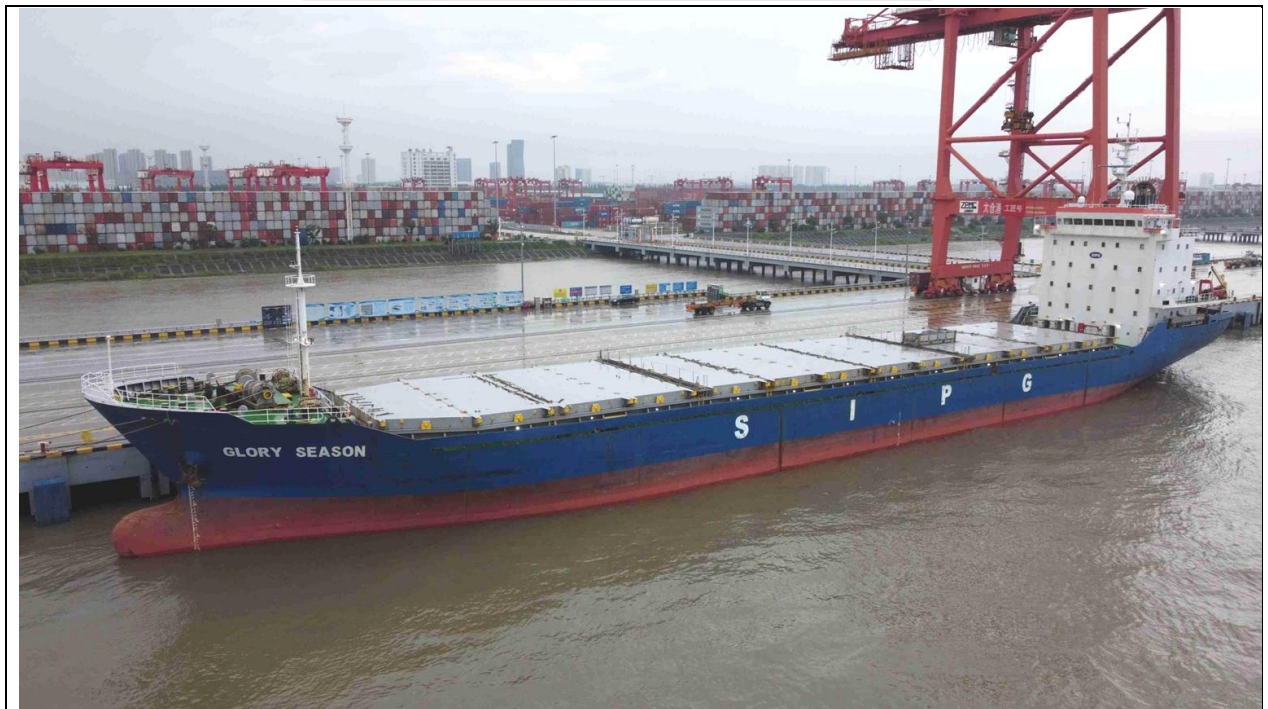
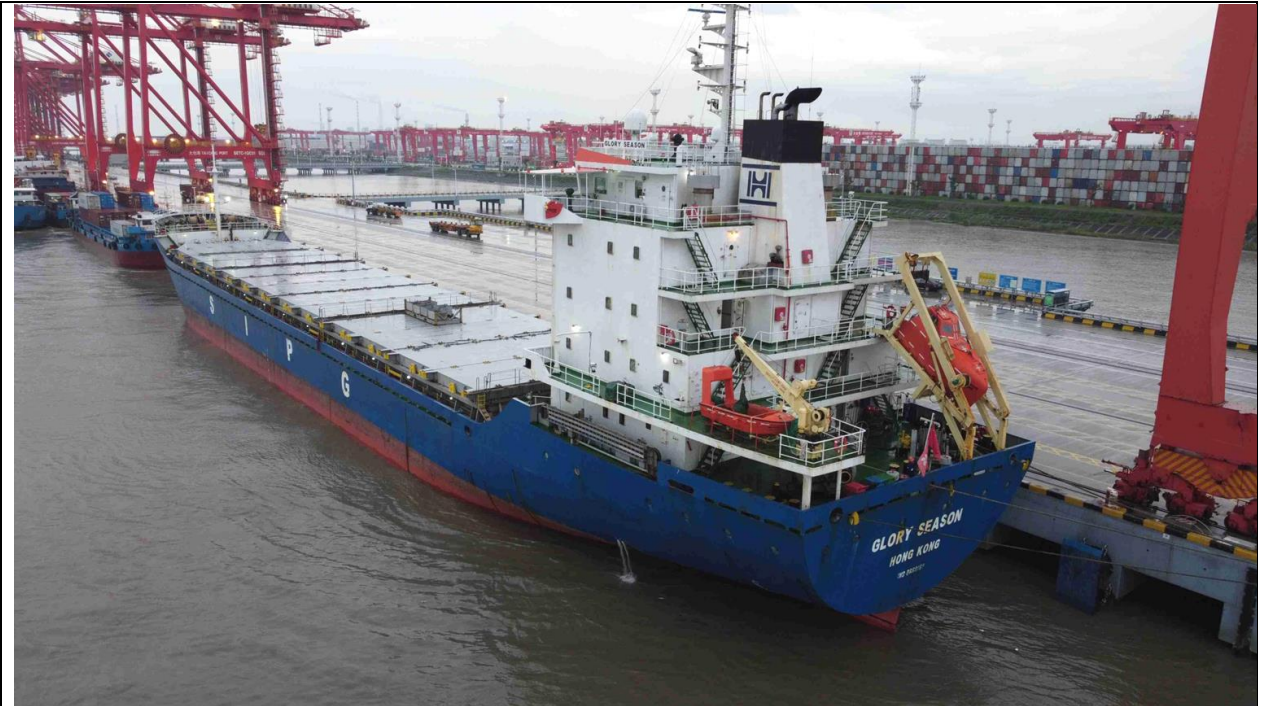
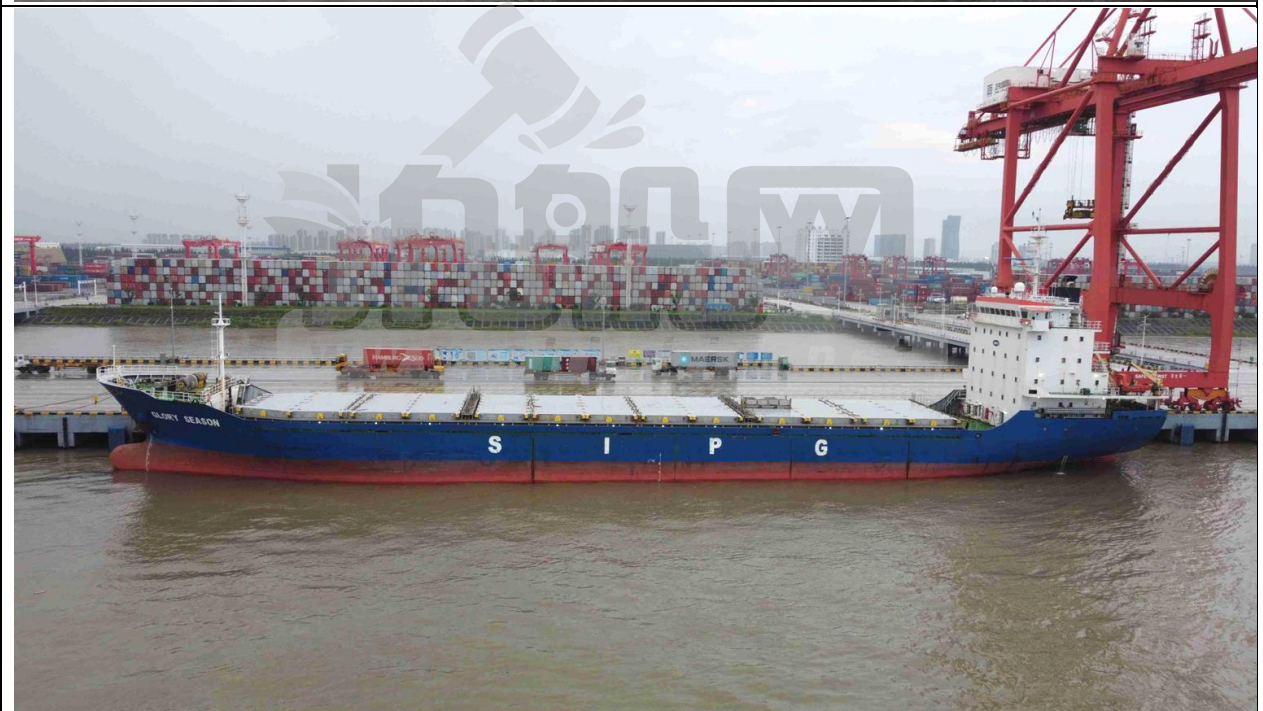
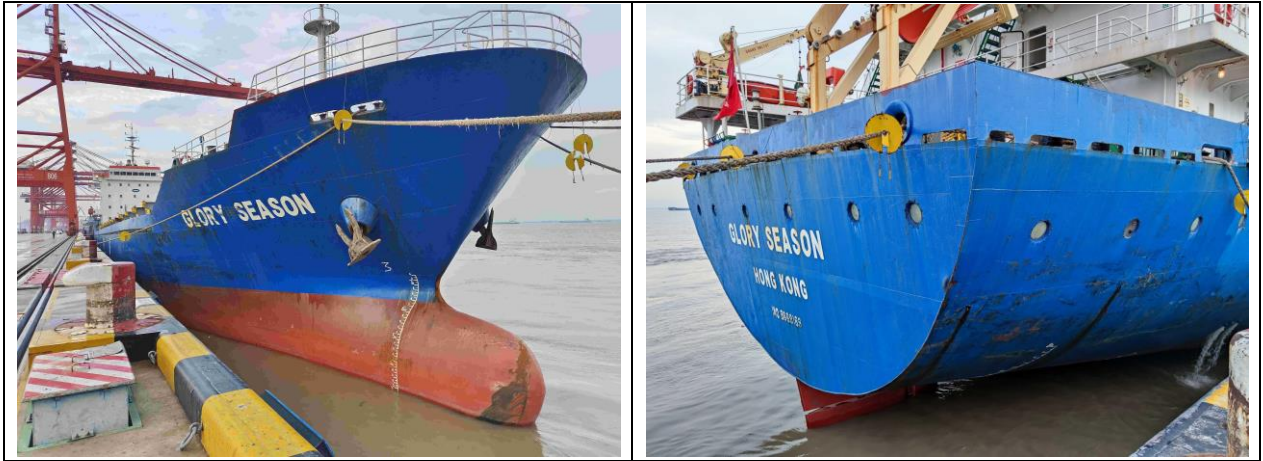
### 6.1 Hull Structure Condition

The shell plate above the load line of the ship was painted with blue paint, while the part below the waterline was painted with red antifouling paint. The paint was found basically intact, with some scratches and rust on the side shell plate. The whole condition of the shell plate was found average without obvious collision deformation. The draft marks, ship's name, port of registry and other markings on the hull was clear and full painted. The condition of the shell plate below the waterline was unknown.

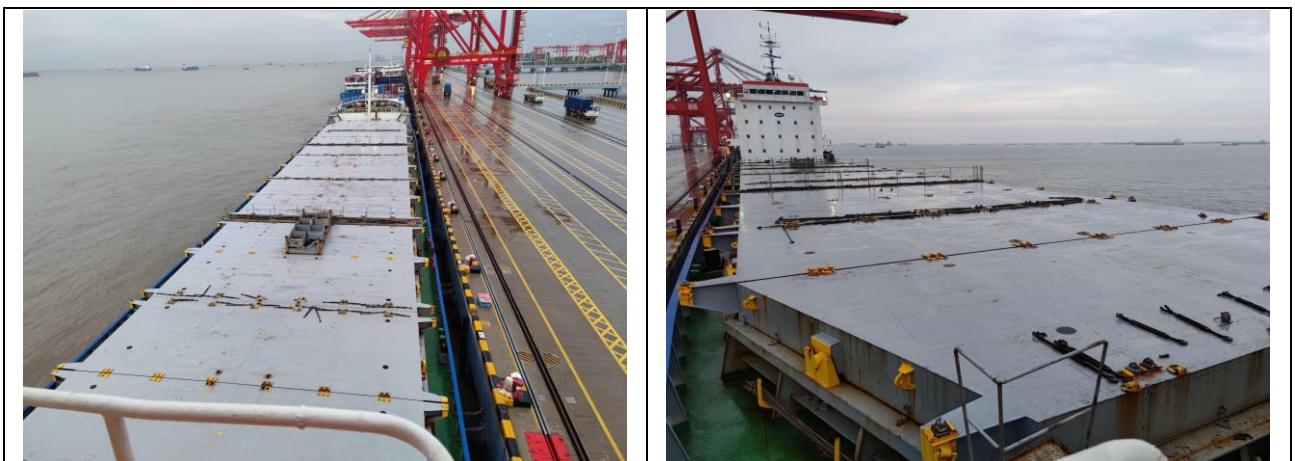
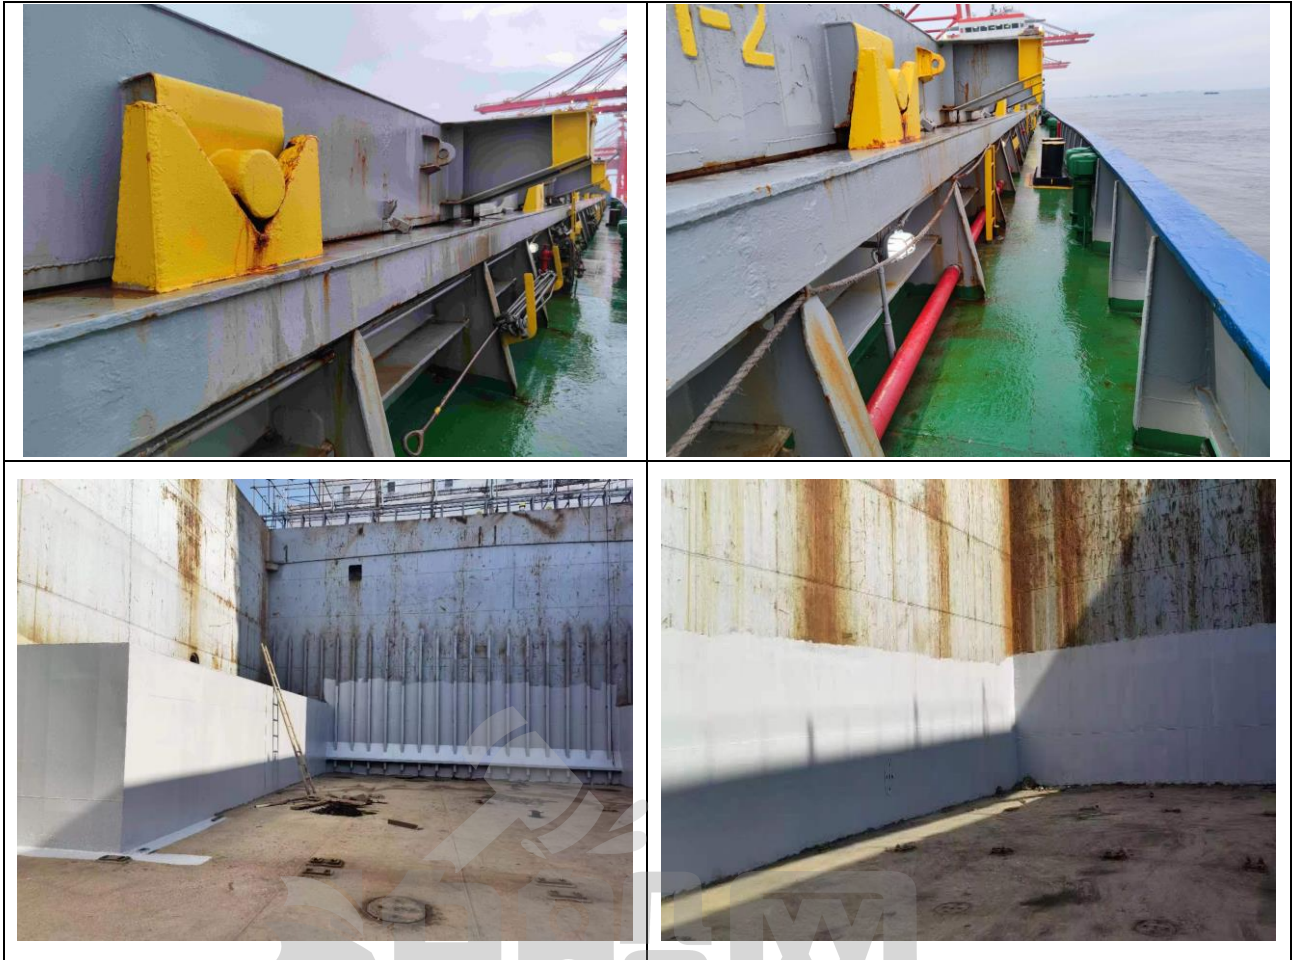
## **6.2 Cargo Holds**

The overall condition of the hatch cover was found general good, without obvious depression, deformation, or rust. The structure of the hatch coaming was found basically intact, with good surface coating condition and a small amount of rust present locally.

The overall condition of the internal structure of the cargo hold was found average, and the side shell plate and reinforced structure were found basically intact without obvious deformation. The overall condition of the inner bottom plate was found average, without serious dents or rust.

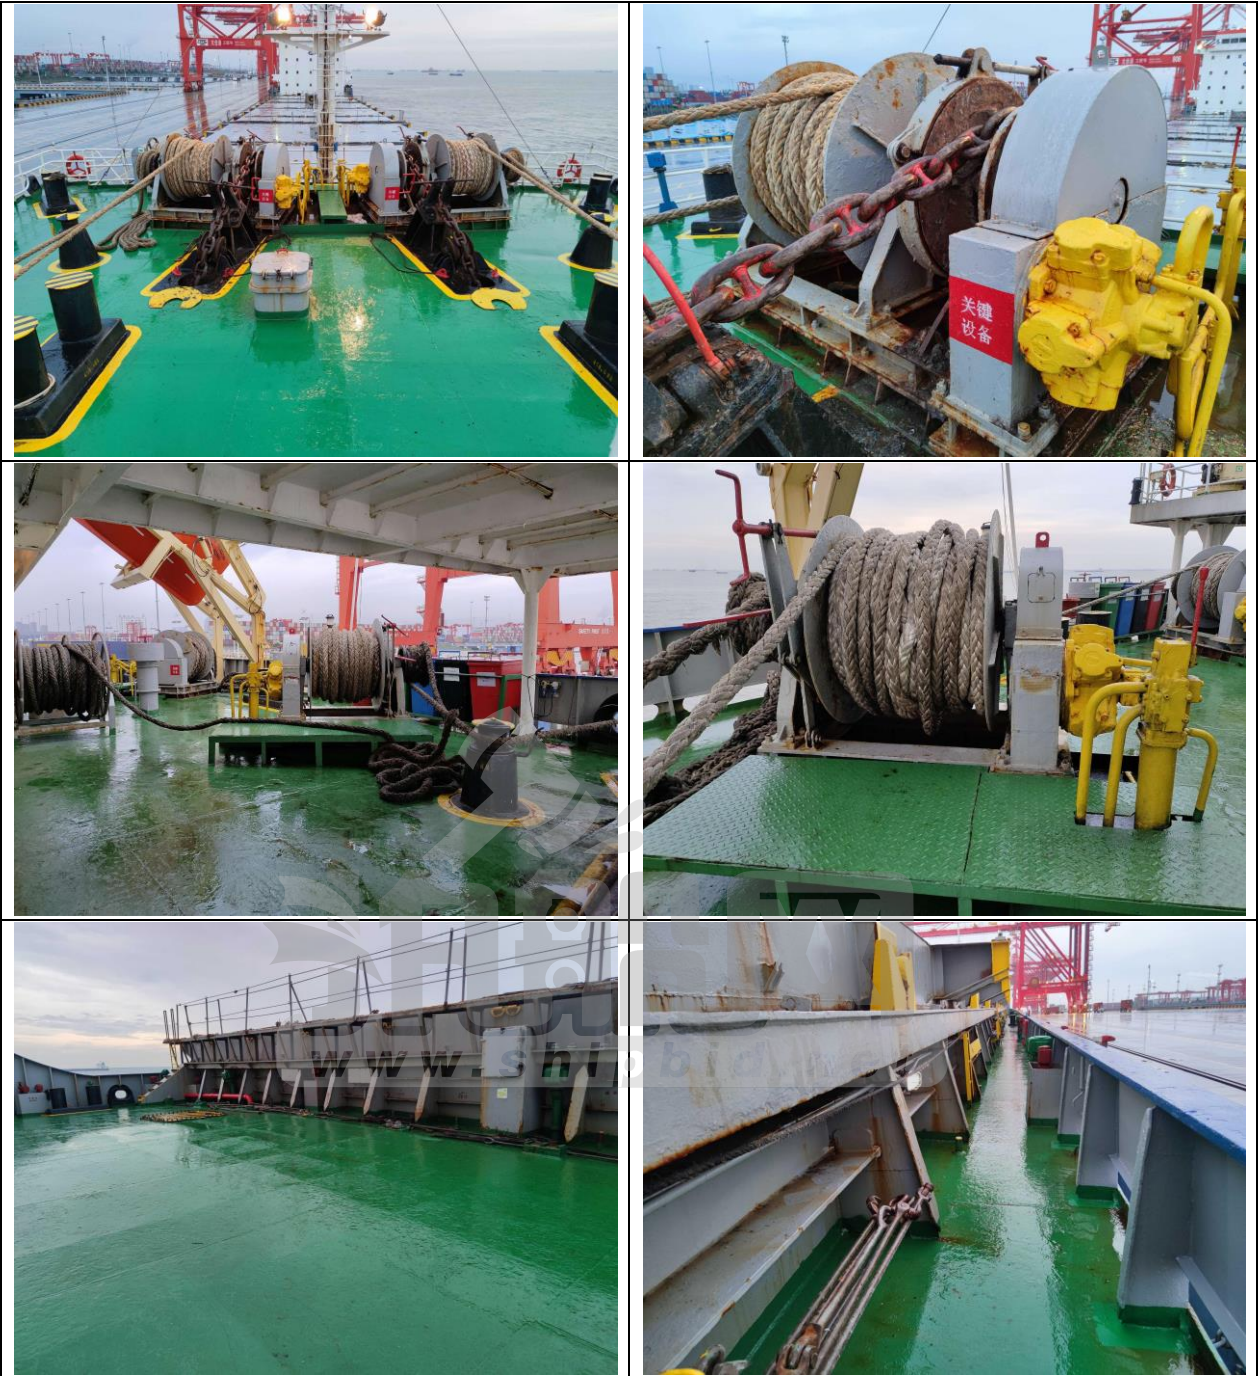
### **6.3 Main Deck and Deck Machinery**

The condition of the main deck was found good, without obvious dents, and the paint was found to be in good condition, without obvious rust. The structure of the bulwarks on both sides was found intact without significant deformation. 2 sets windlasses were installed on the port and starboard sides of the forecastle deck, and 2 sets winches were installed on the main deck aft.

The paint of the windlass was found intact, with a small amount of rust on the base. The cleanliness of the drip tray was found good, and the hydraulic oil pipes were found to be free of oil leakage.

The paint of the winch was found intact, without obvious rust on the body and base. No signs of oil leakage were found on the hydraulic oil pipes. The paint on the bollard and fairlead on the main deck aft area was found intact.

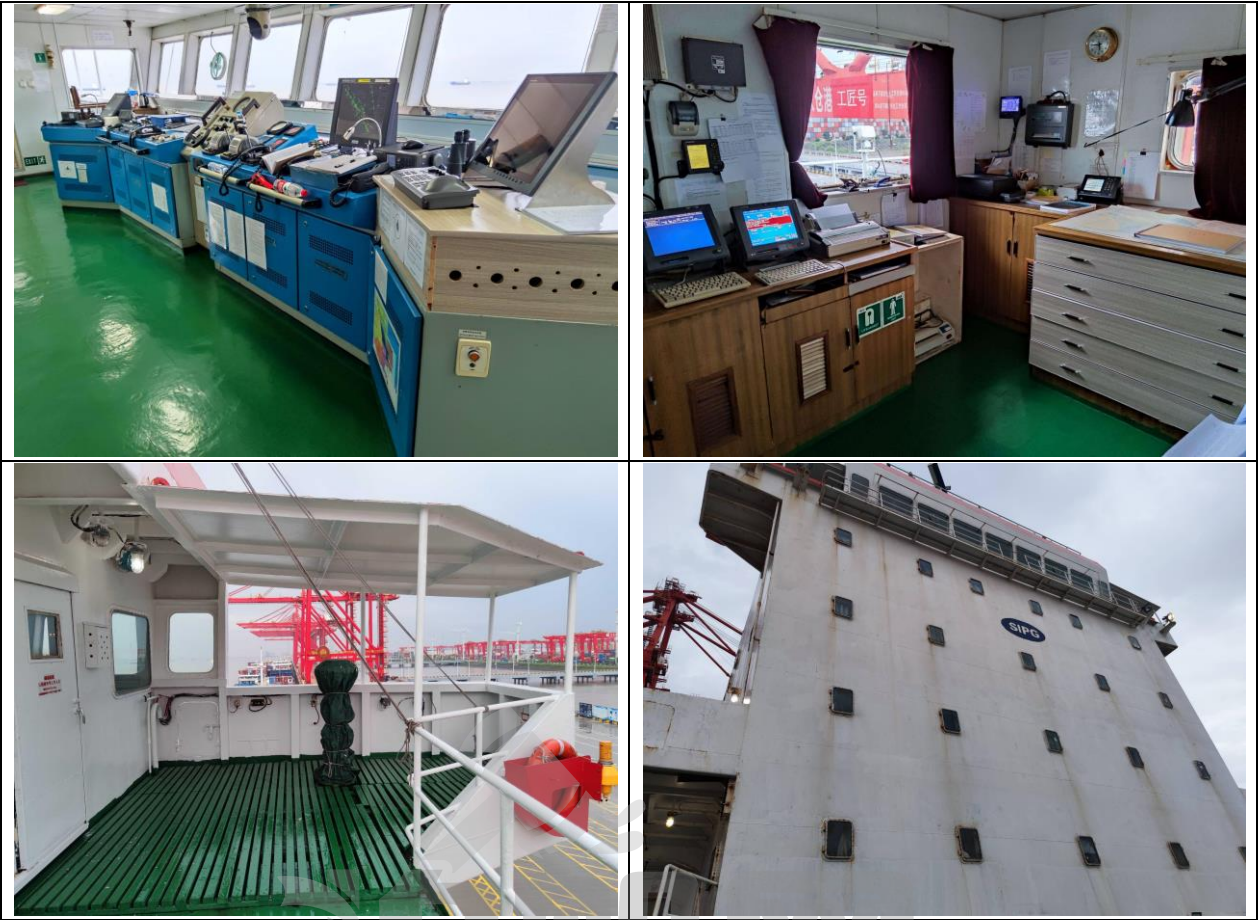
## **6.4 Bridge Equipment**

The steel doors, windows of wheelhouse were found complete, and no obvious damage on the insulation laying. The bridge console and relevant equipment were found basically clean, and some communication equipment were found in operation. The exterior condition of the bridge was found general good, with complete paint and a small amount of rust.

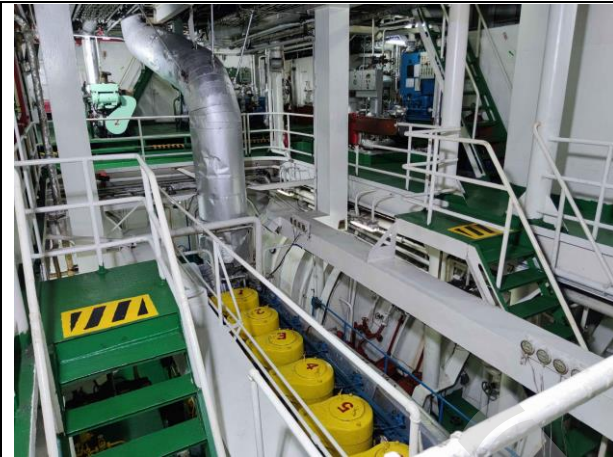
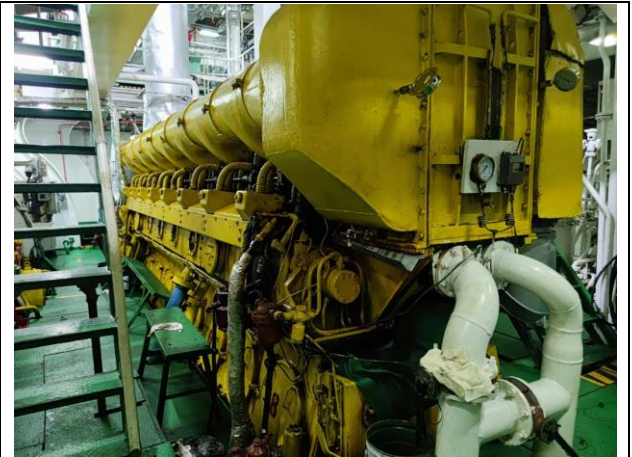
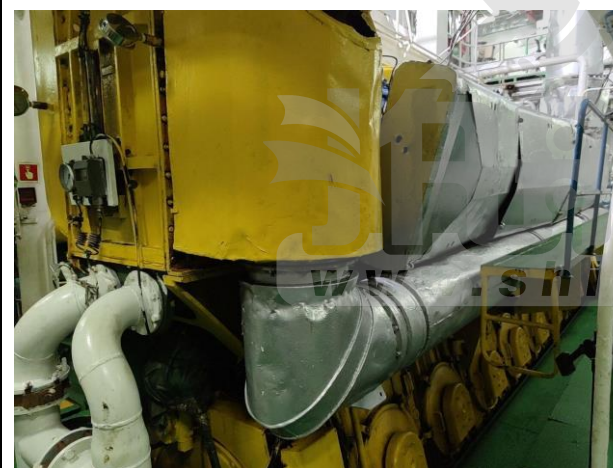
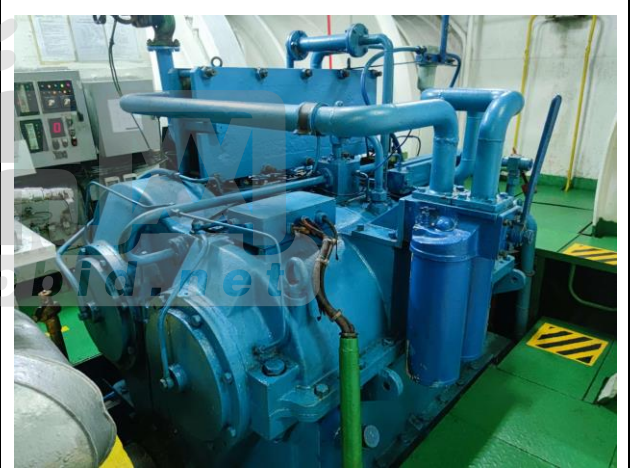
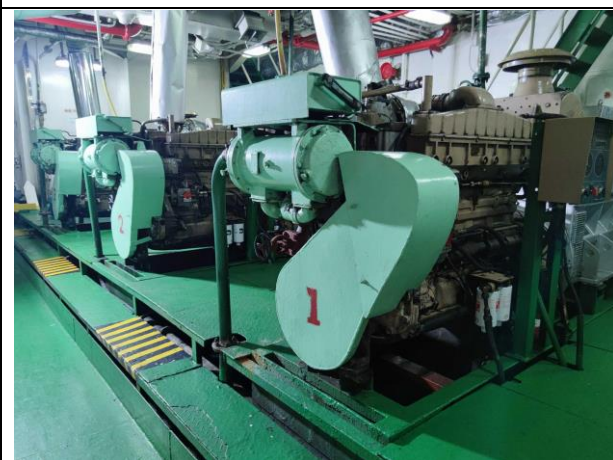
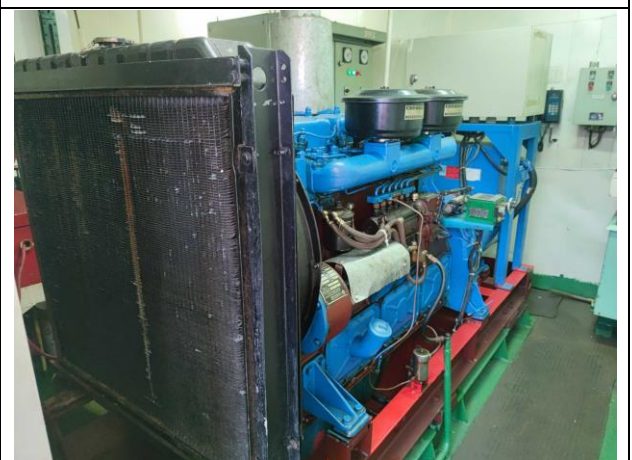
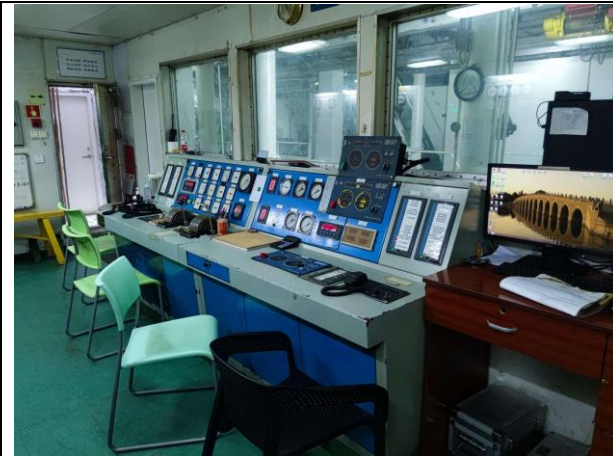
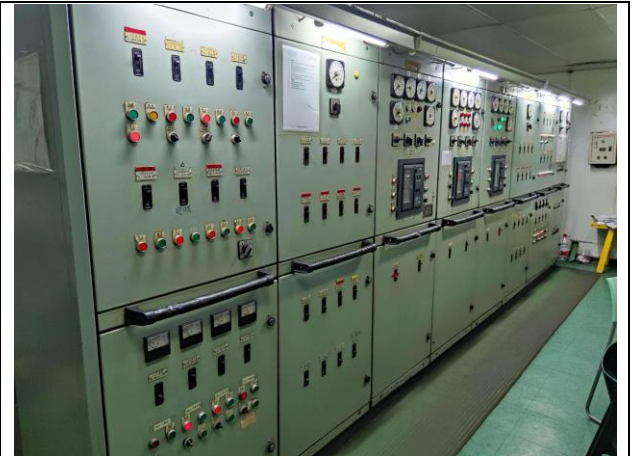
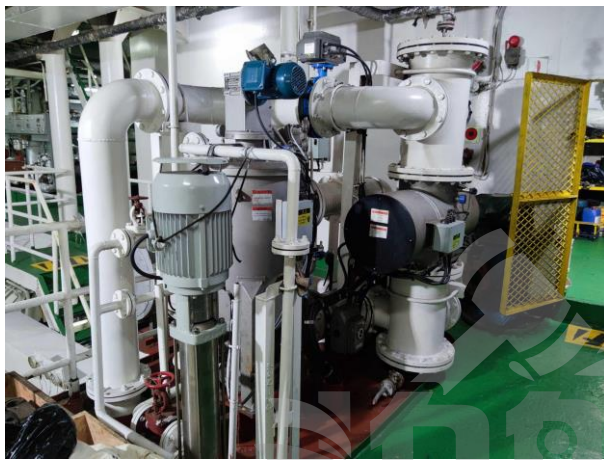
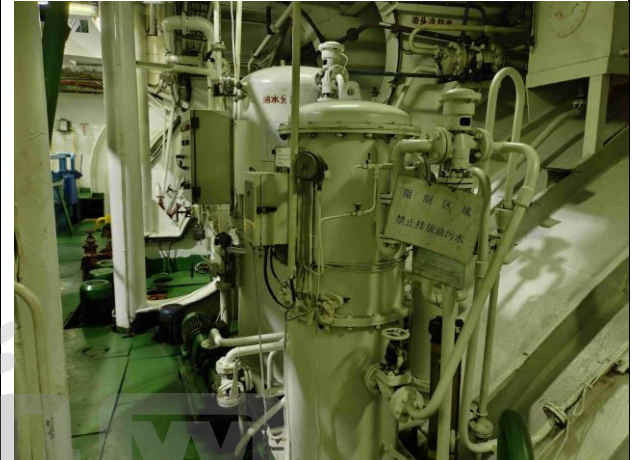
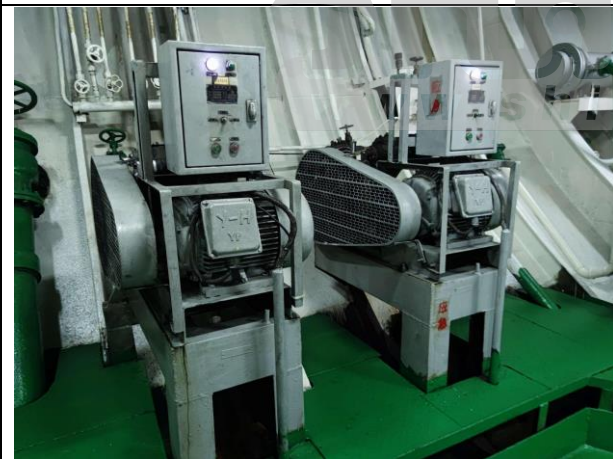
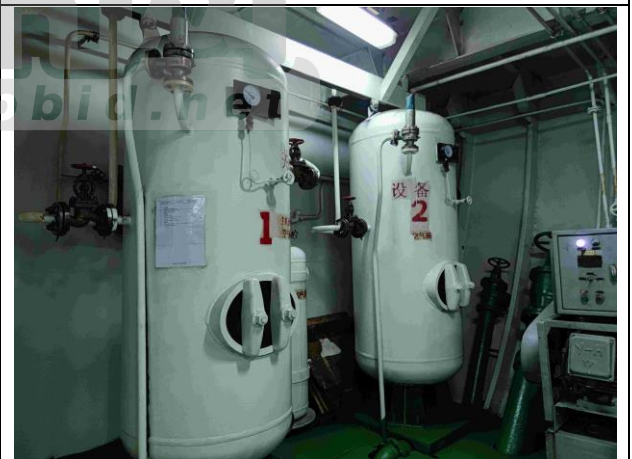
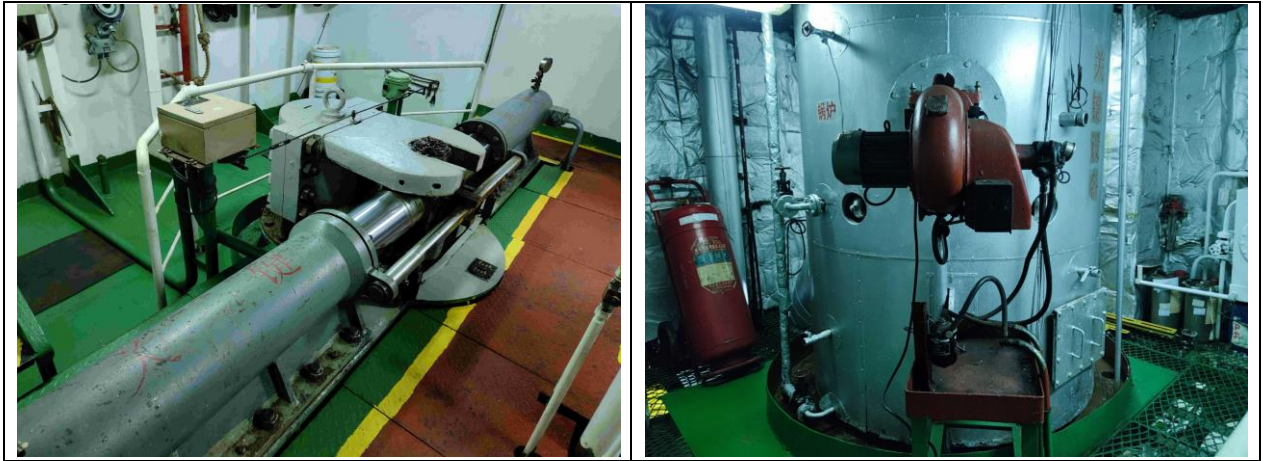
## **6.5 Engine Room and Equipment Condition**

The overall cleanliness and paint condition of the engine room was found general good. The stairways, railings, checkered plates and other facilities were found complete. The paint of the bilge pump unit and pipeline was found intact, and no obvious residue of oil or sewage in the bilge. The surface paint of the mechanical equipment was found intact, without significant rust and oil stains attached.

The distribution panel in the engine control room was found complete, without significant damage or corrosion, and the appearance of the console was found normal.

The main engine was found to be free of coating damage and significant corrosion, and no obvious oil stains attached on body. The oil pipeline connection was found intact, without obvious rust at the connection joints. The insulation laying of the exhaust pipe of the main engine was found intact, without significant damage or corrosion. According to the report of the main engine, the four cylinder liners and all main bearings have been replaced on October 31st, 2022.

The appearance of the main generator sets were found clean, without coating damage on the body, no obvious oil stain was found on the base, and no obvious rust on the pipeline. The arrangement of the checkered plates and railings in the steering gear room were found complete. The surface paint of the steering gear was found intact, without significant oil stain on the seat and bilge. No obvious rust was found on the hydraulic oil pipeline.

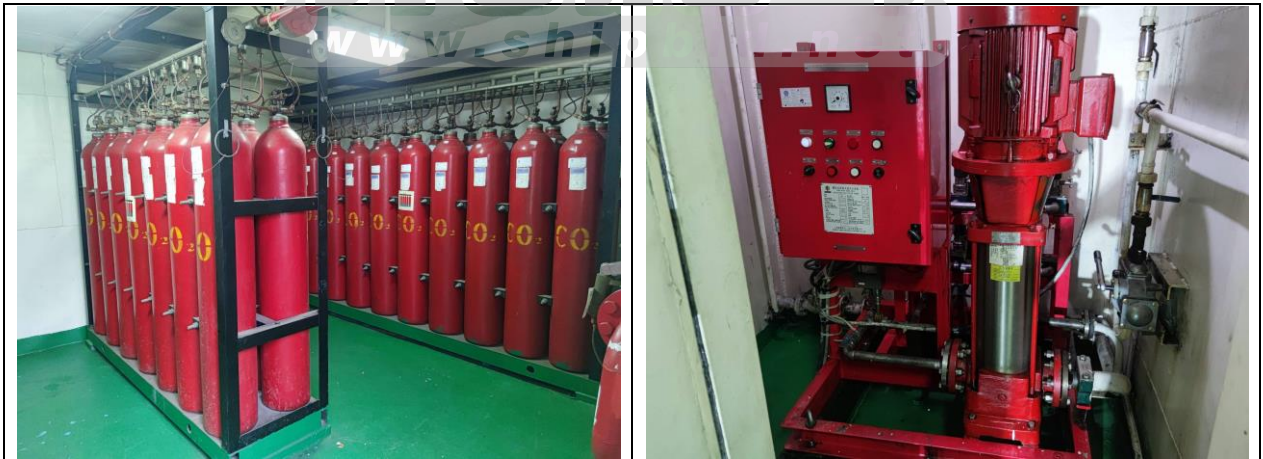
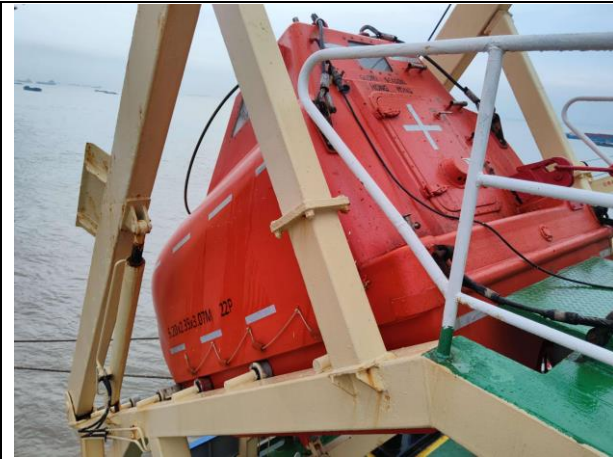
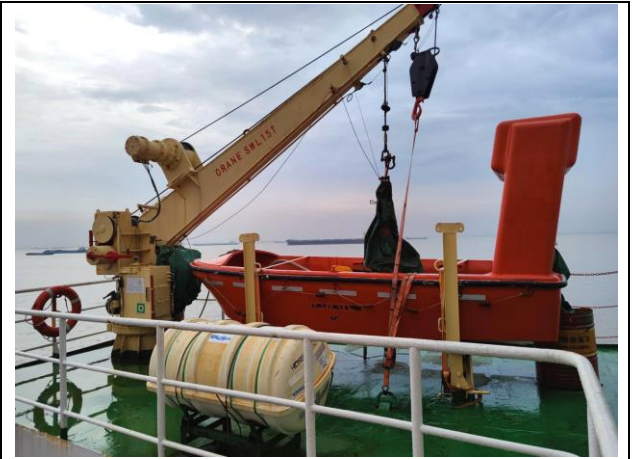
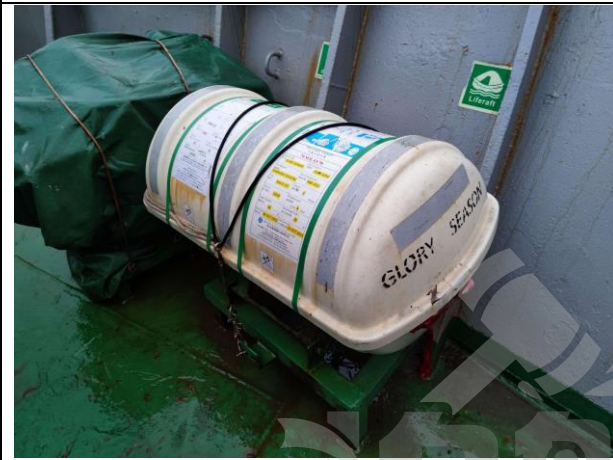
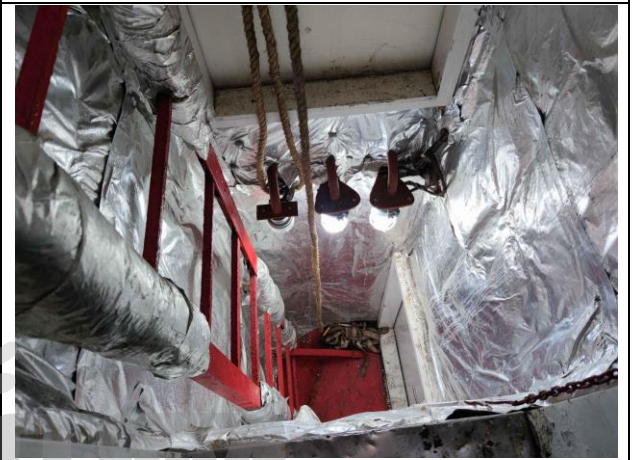
## **6.6 Firefighting and Life Saving Equipment**

The cleanliness of the CO2 room was found to be in good condition, and the inspection of the fire extinguishing system was within the validity period. The escape passage configuration in the engine room was found complete, with intact fire protection laying.

The ship is equipped with one 6-person rescue boat, and one 22-person free fall lifeboat.

The lifeboat support and hull structure were found intact, as well the paint. The ship is equipped with two life rafts with 25-person each, and the overall condition of the life raft body and release device was found good.
