M.V “NING HAI TUO 4002”

Technical Report

【 CJPG-JS-23-KY-324 】

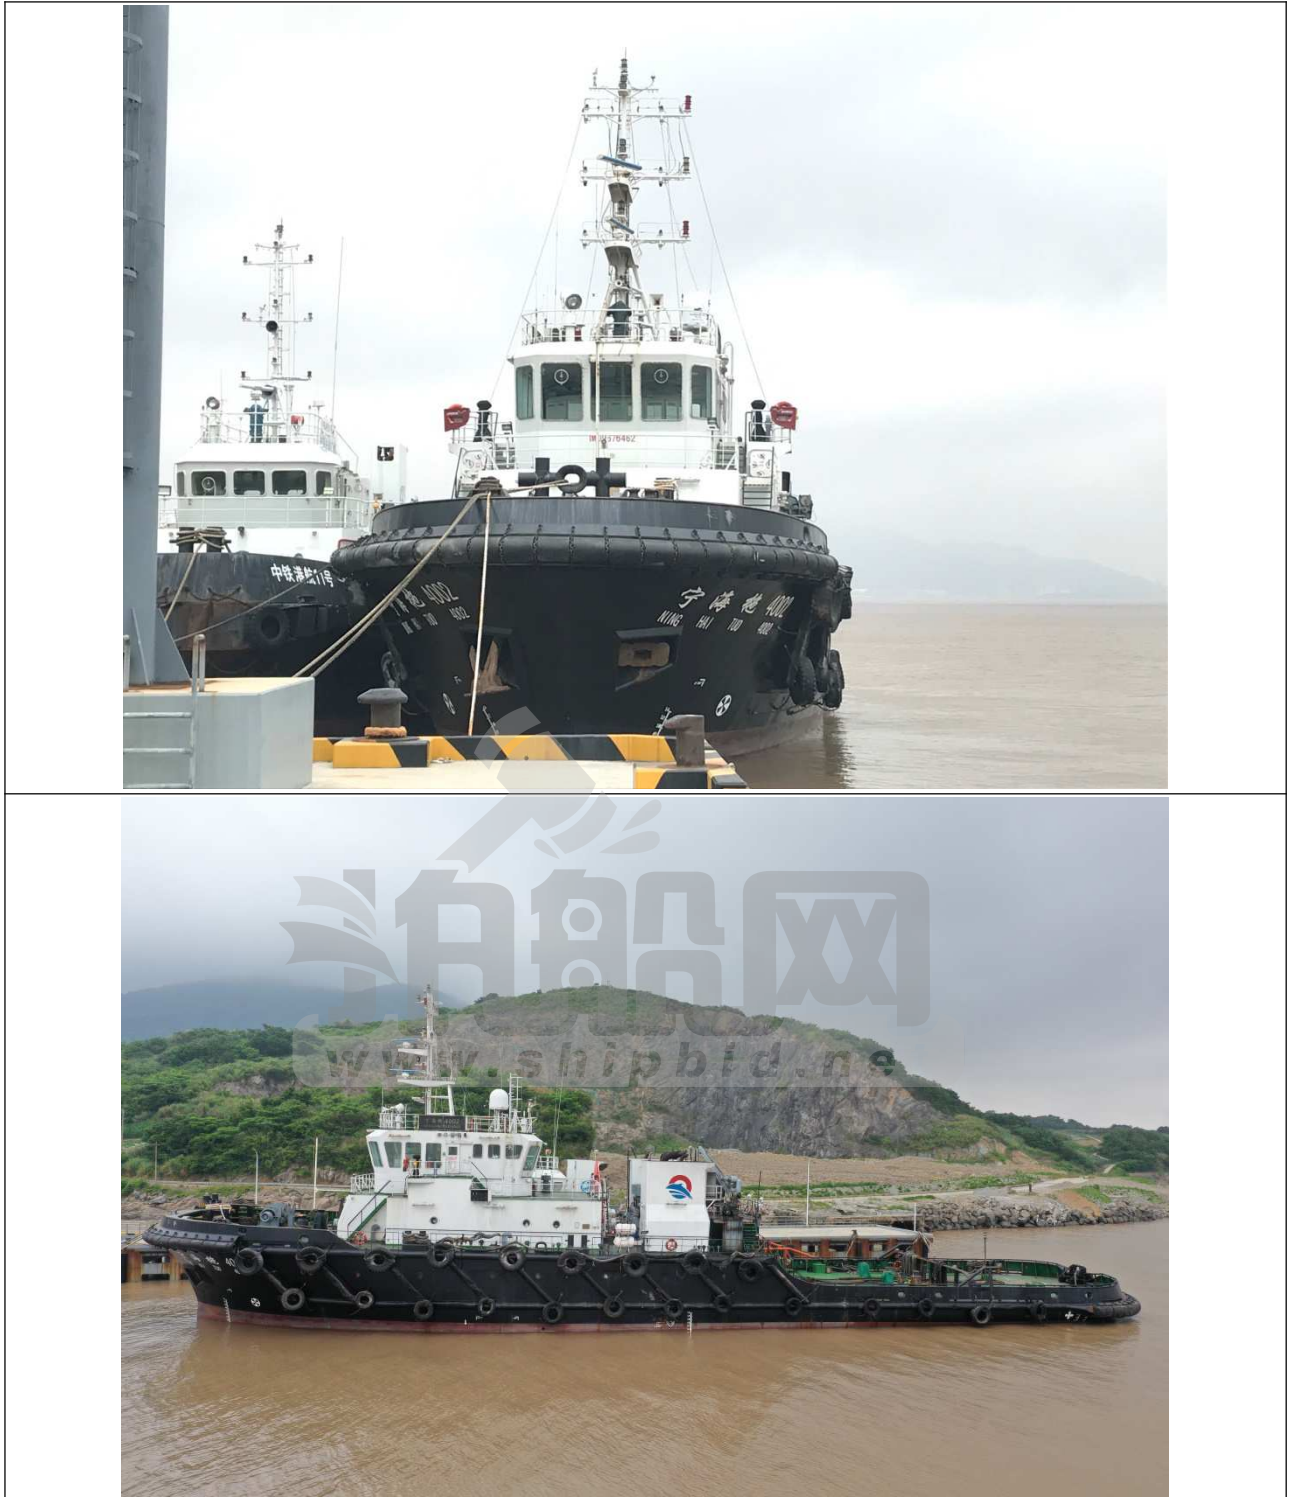
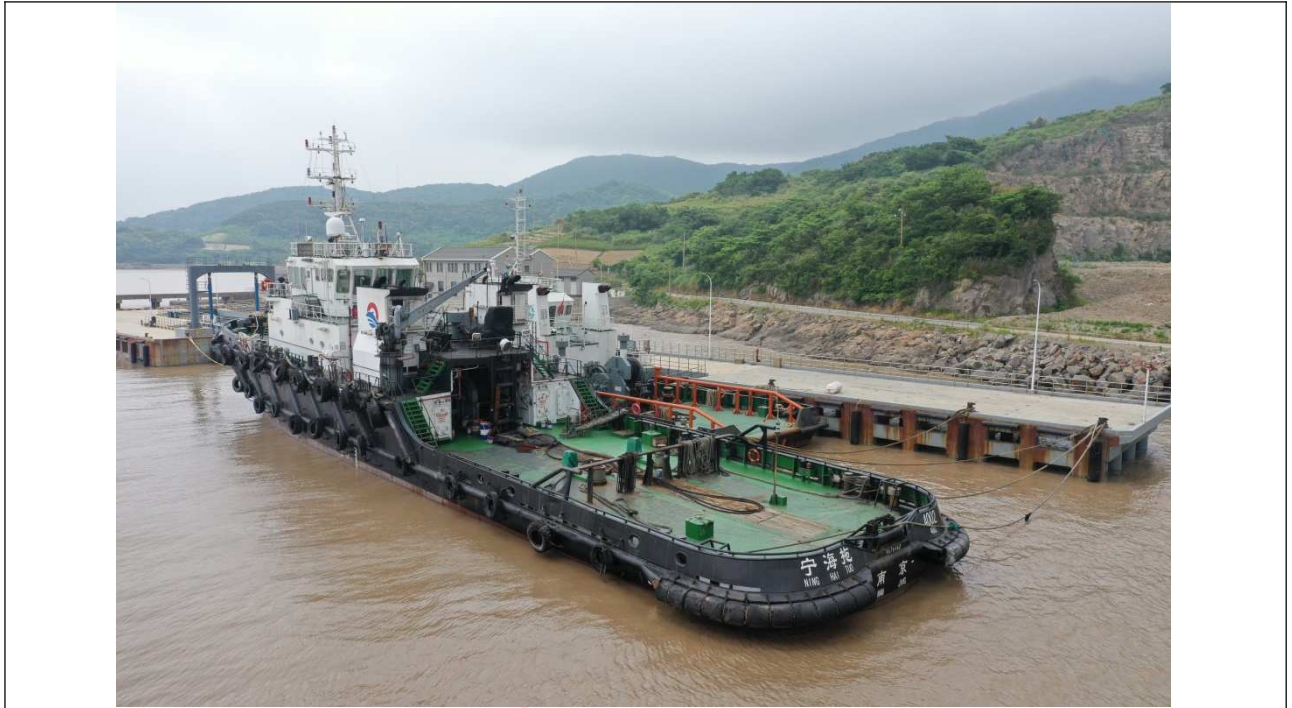
5.1 Hull Structure Condition

The condition of the shell plate above the waterline was found general good, with intact paint. The ship's name, port of registry, draft mark, bow thrust mark and other markings on the hull was found clear and full painted. The condition of the shell plate below the waterline was unknown.

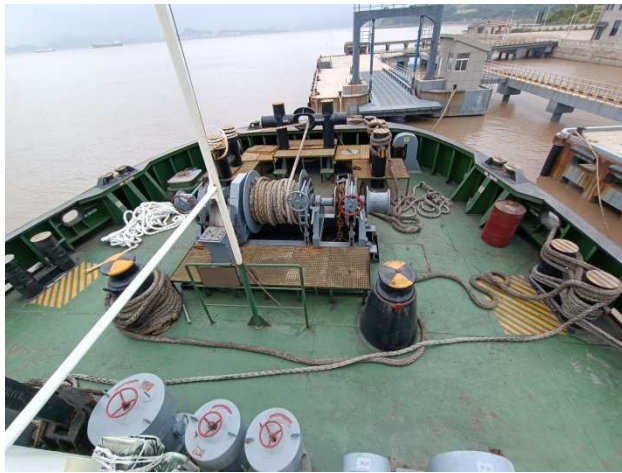
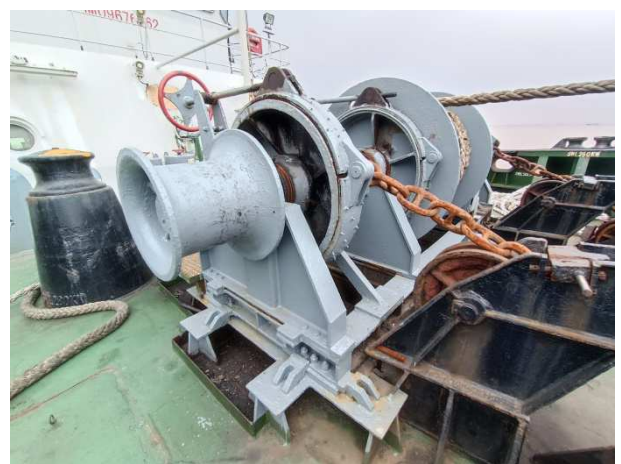
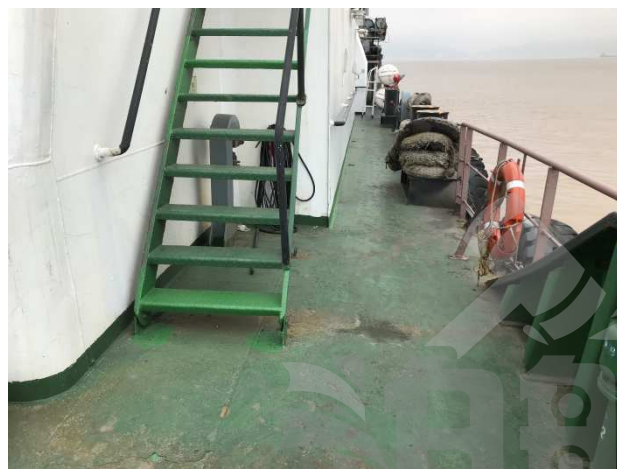
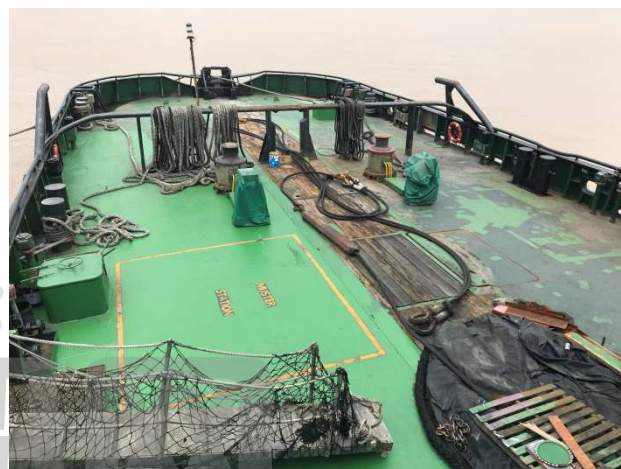
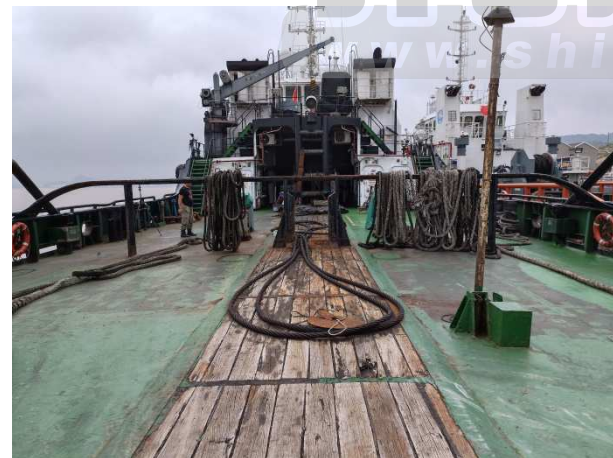
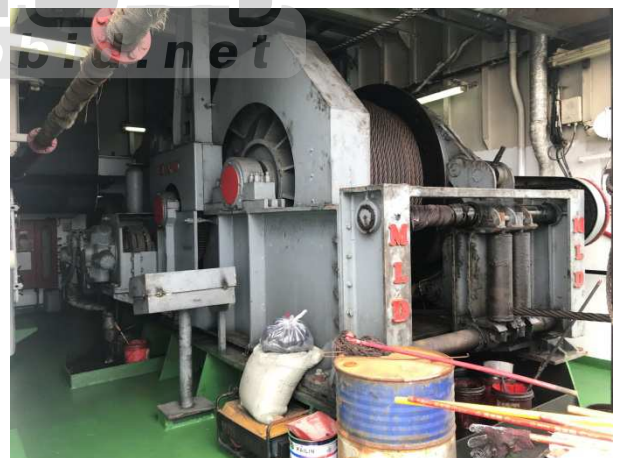
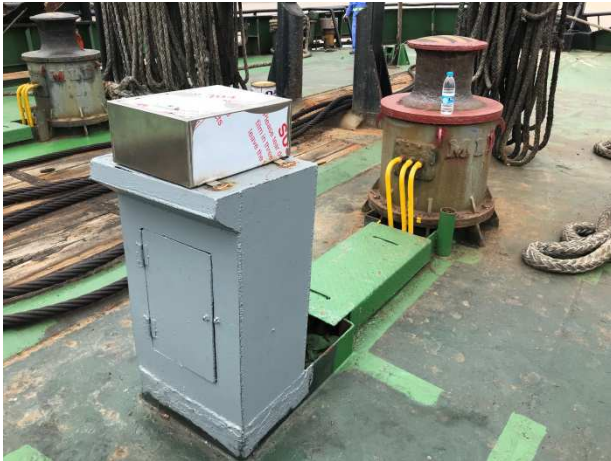
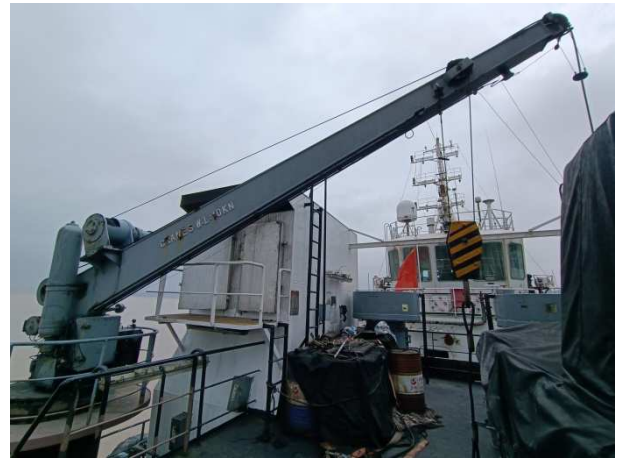
5.2 Main Deck and Deck Machinery

The overall condition of the main deck and gangway was found general. No obvious deformation was found on the bulwarks of both sides, and the pipes, ventilation ducts, and other structures on the main deck were found intact.

The ship is equipped with one set 600KN hydraulic towing winch on the main deck, with a bollard pull of 56.4T. The appearance of the winch body was found intact without damage.

One set windlass was installed on the forecastle deck, with a complete body, but the paint condition was found average and locally corroded. The structure of the outfitting components such as bollard and fairlead were found complete, and the paint condition was average.

One set crane with a lifting capacity of 10KN was installed on the forecastle deck, with a complete body structure and average paint condition.

Two sets hydraulic winches were installed on the main deck aft, with no damage to the body and poor paint condition.

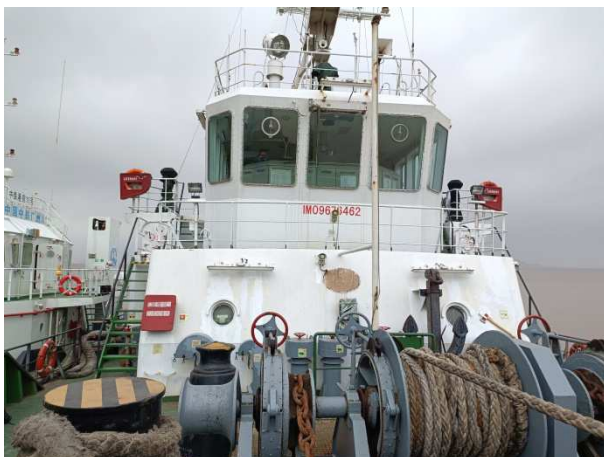
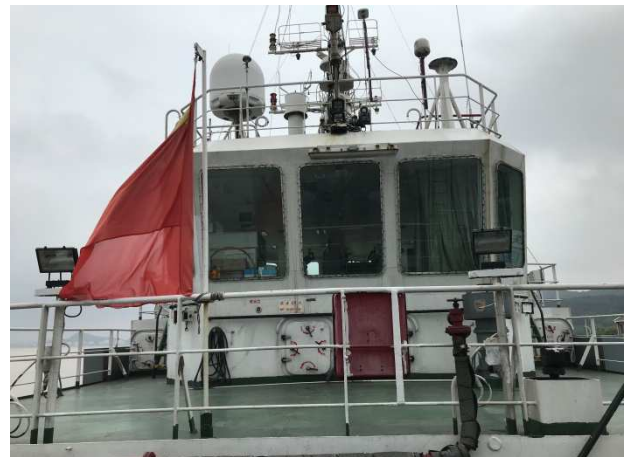
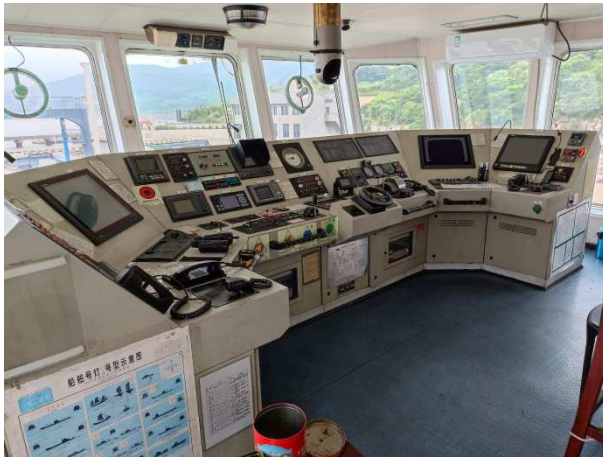
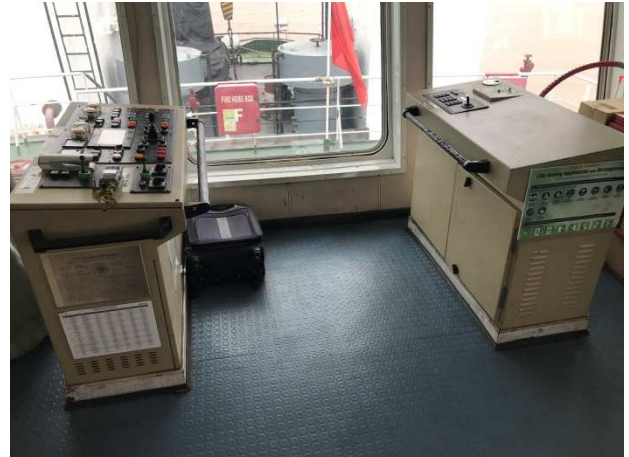
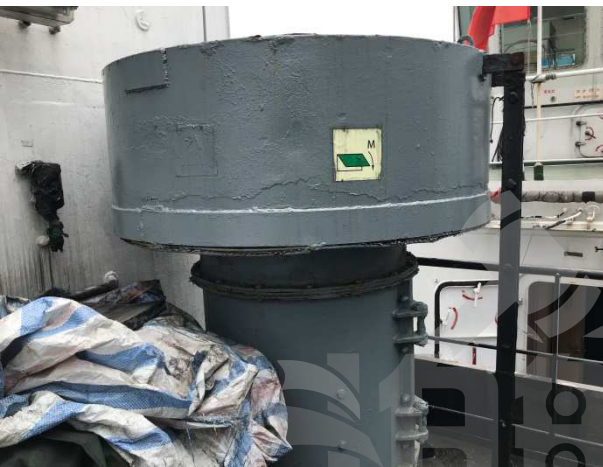
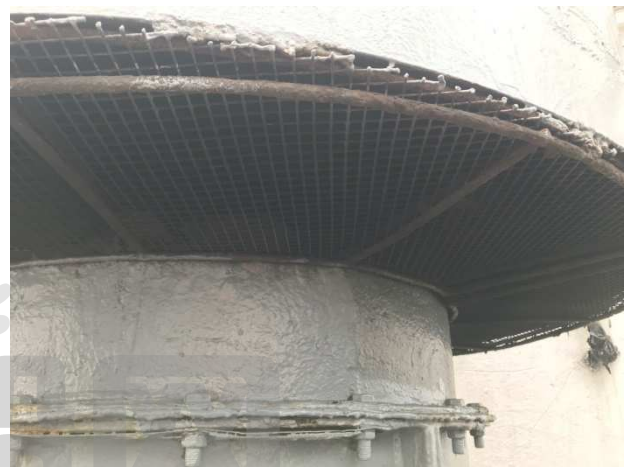
5.3 Superstructure Condition

The each deck of the superstructure was found basically flat. The structure of outdoor stairs, funnel and other facilities were found complete, with average condition paint. The condition of interior decoration was found general good, with intact insulation laying on the walkways and interior walls.

The steel doors, windows of wheelhouse were found complete, and no obvious damage on the insulation laying. The bridge console and relevant equipment were found basically complete and clean.

The ventilation duct of engine room installed on the bridge deck was found complete, with average paint, and the ventilation hood and fire screen were found basically complete.

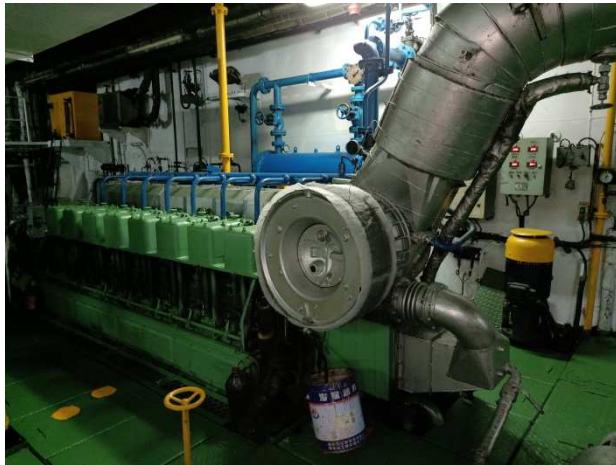
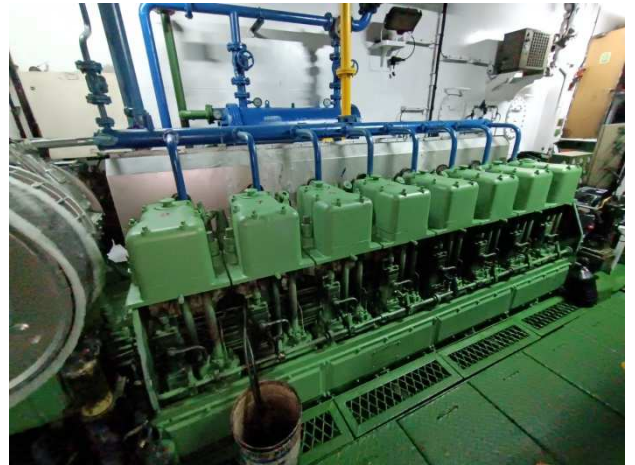
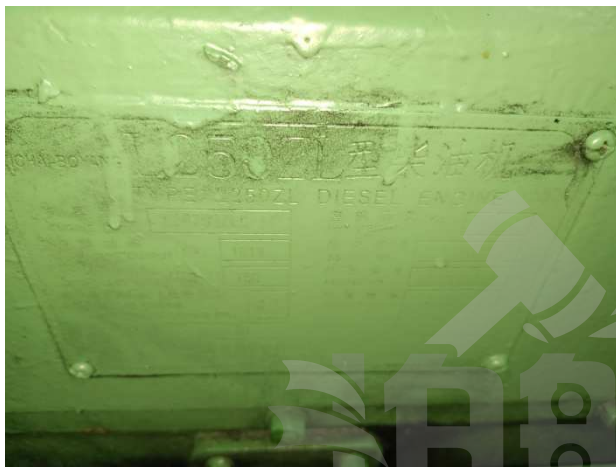
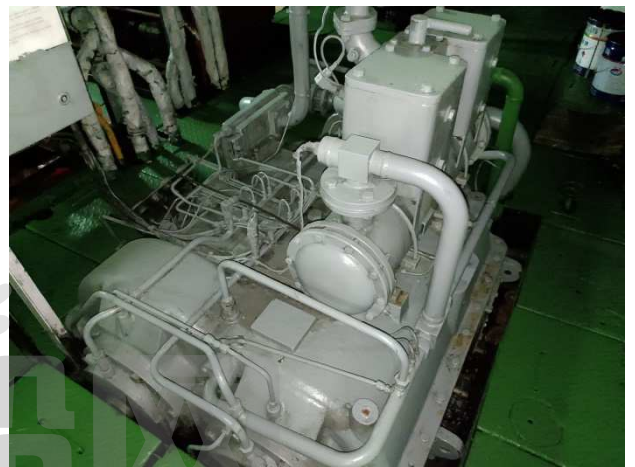
5.4.1 Main Engine

The cleanliness of the main engine was found general good, without obvious coating damage. The insulation of the pipeline was found basically intact, without significant oil stain in bilge.

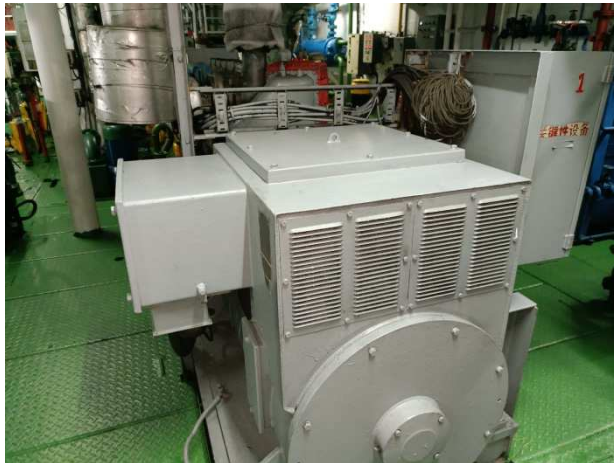
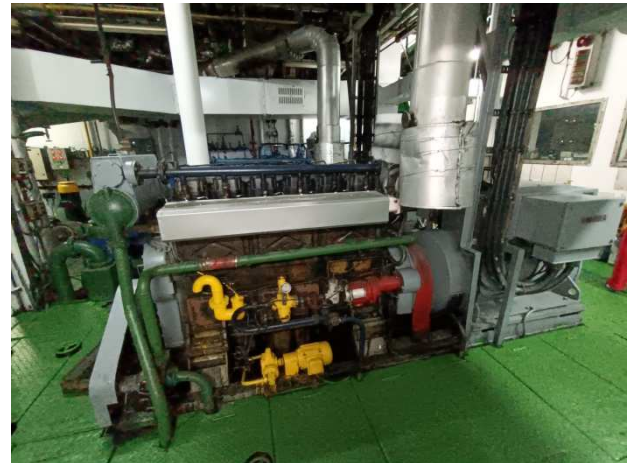
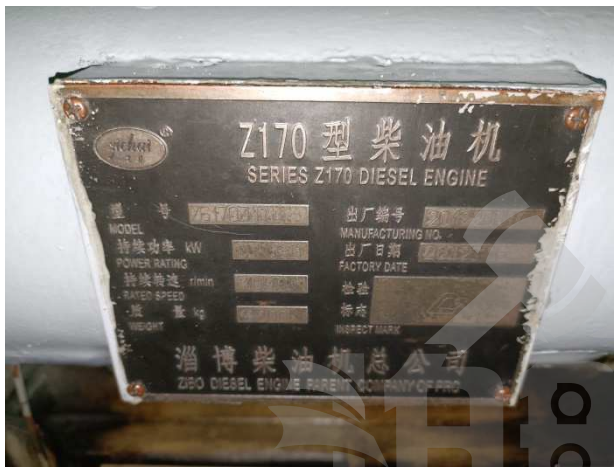
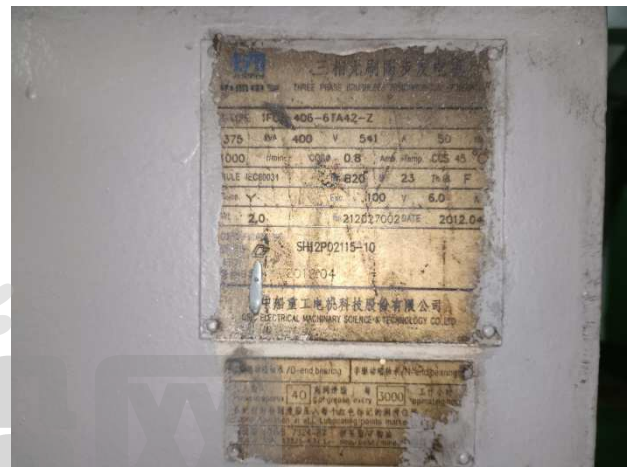
5.4.2 Main Generator

The ship is equipped with two main generator sets in the engine room, the model is 1FC5 406-6TA42-Z, 300kW. The model of the diesel engine is Z6170ZLD, 330kW * 1000r/min. The cleanliness of the main generator sets was found general good, with basically intact paint on body and local rust. No significant oil stain was found on the base, and no significant rust on the pipelines and components.

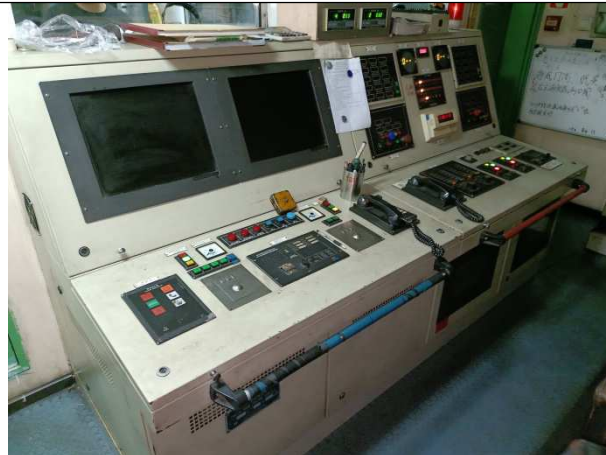
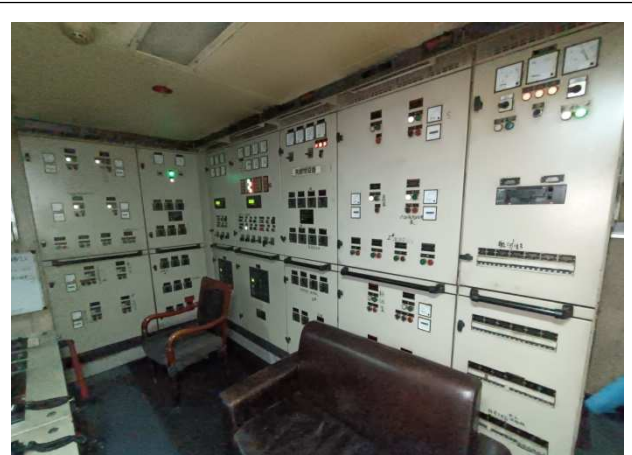
5.4.3 Engine Control Room

The ship is equipped with a console and main switch board in the engine control room. The indoor condition was found complete and clean. The appearance of the monitoring instrument was found normal, all indicator lights and button protection devices were complete.

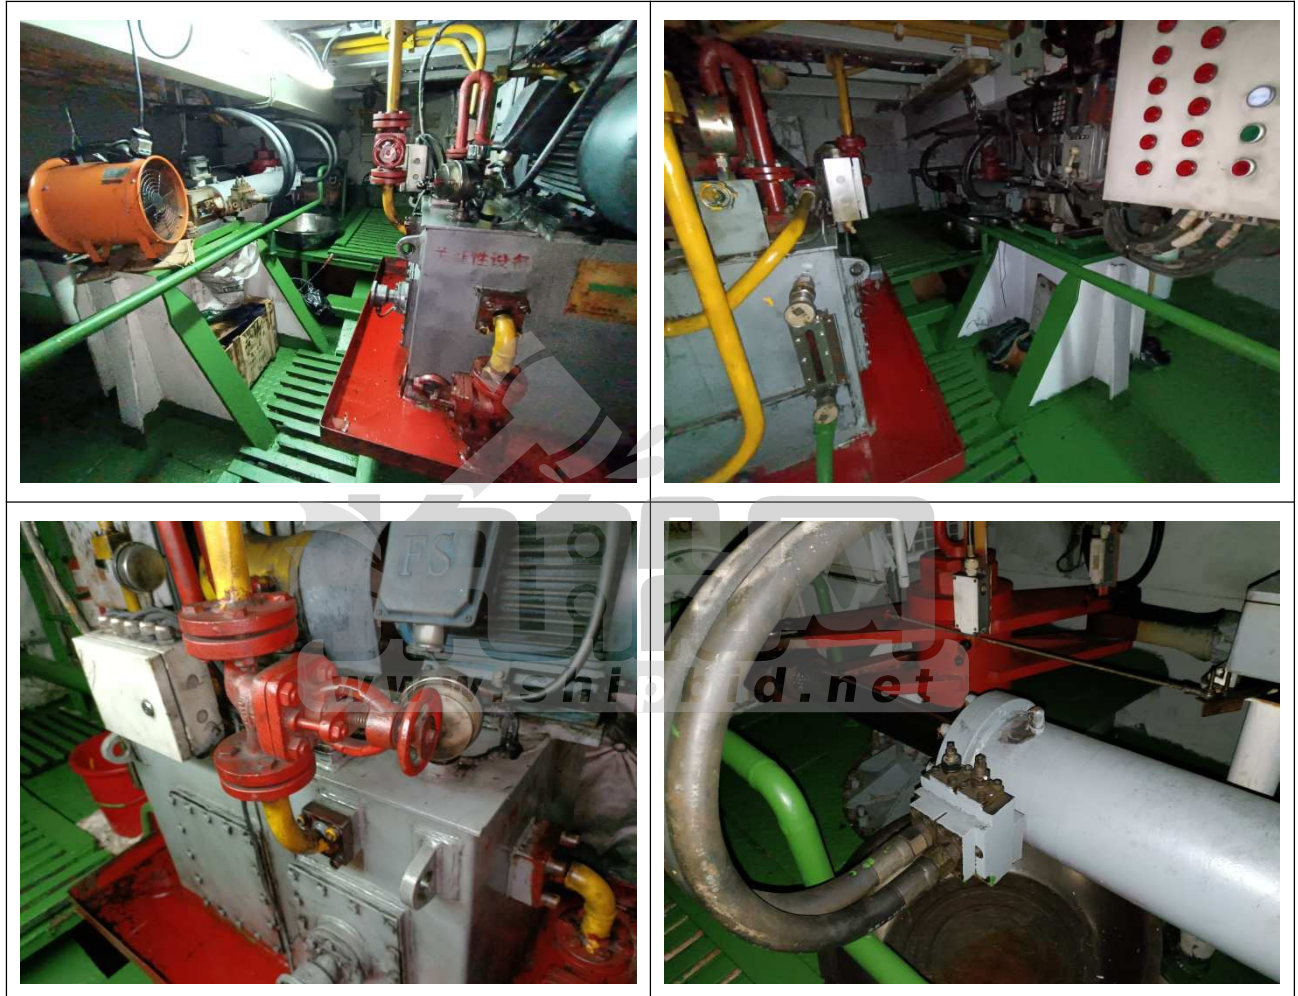
5.4.4 Steering Gear Room

The arrangement of the anti-slip wooden grille in the steering gear room was found complete, with oil leakage on the upper rudder bearing seat. The steering gear is hydraulic machinery type, with complete transmission connection structure, good paint, and a small amount of oil stain attached to the body. No rust was found on the equipment and pipelines.

6.4 The cleanliness of the main engine was found general good, with basically intact on the insulation laying of pipeline. The oil leakage was found on the upper rudder bearing seat of the steering gear.

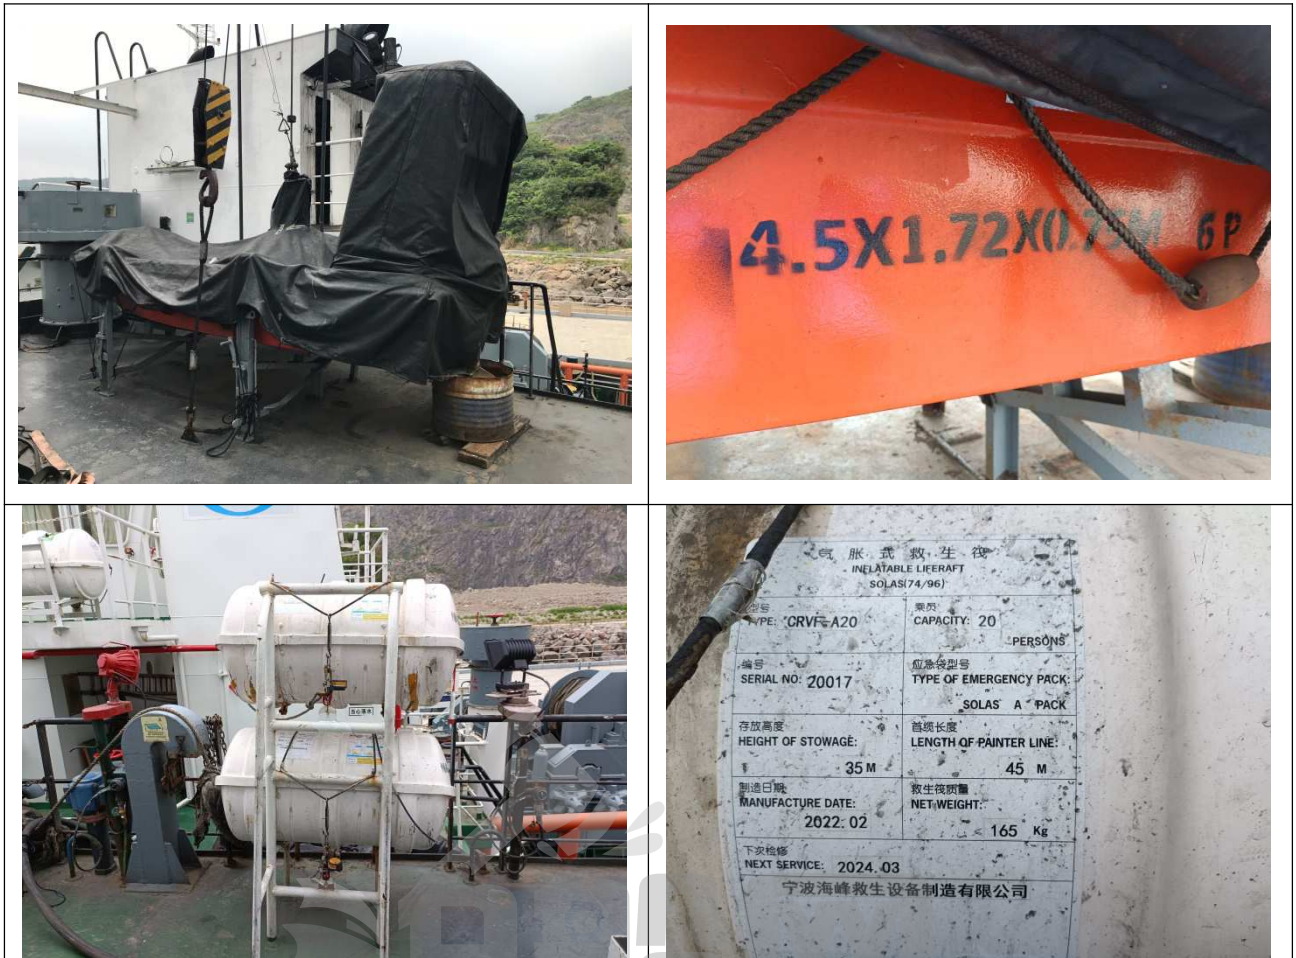
5.4.5 Life Saving Equipment

This ship is equipped with a rescue boat with a seating capacity of 6 people, without cracking or damage. The structure of the support frame was found complete without significant corrosion.

This ship is equipped with 4 life rafts with a seating capacity of 20 people each. The body appearance and the hydro-static pressure release device were found intact, without damage, and the inspection marks were clear and complete.
