M.V “MING ZHOU 58”

Technical Report

【CJPG-JS-23-KY-412】

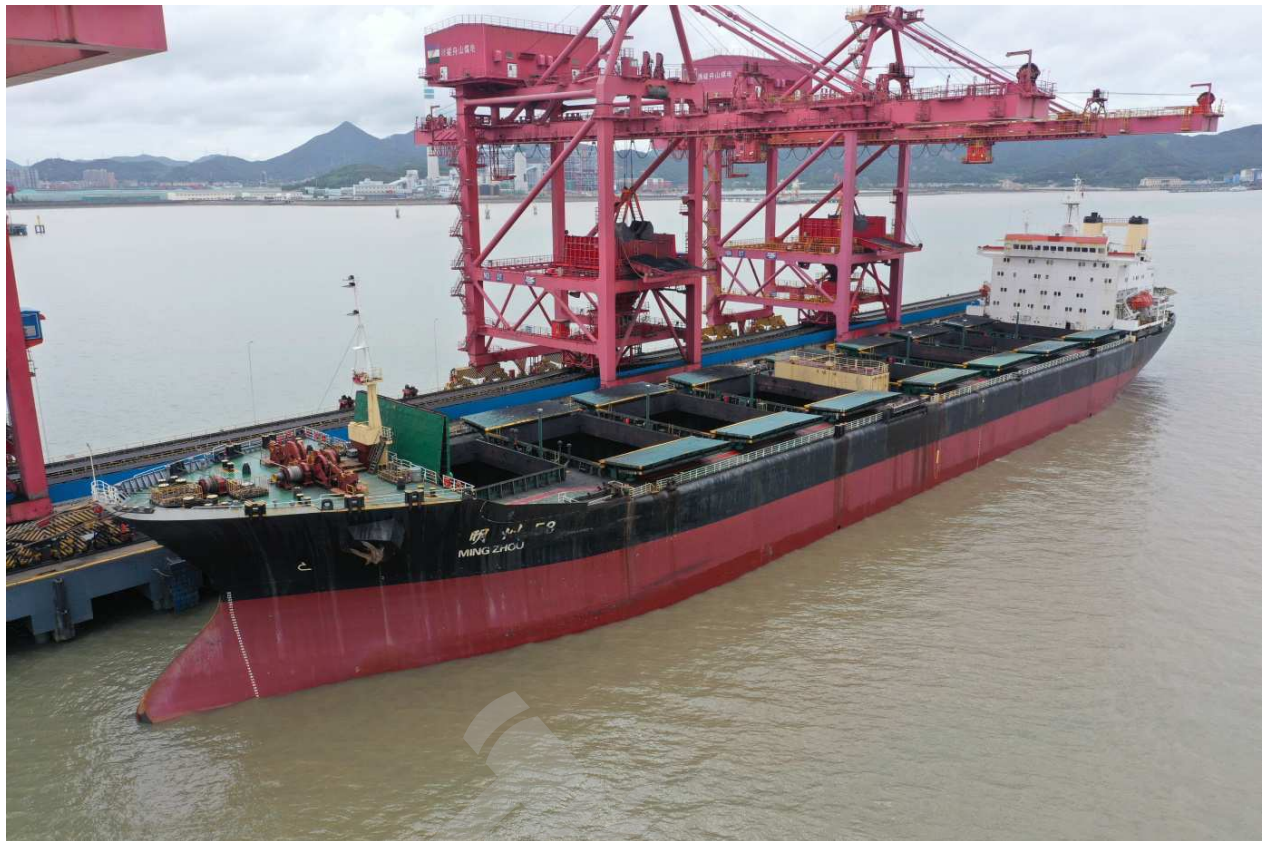
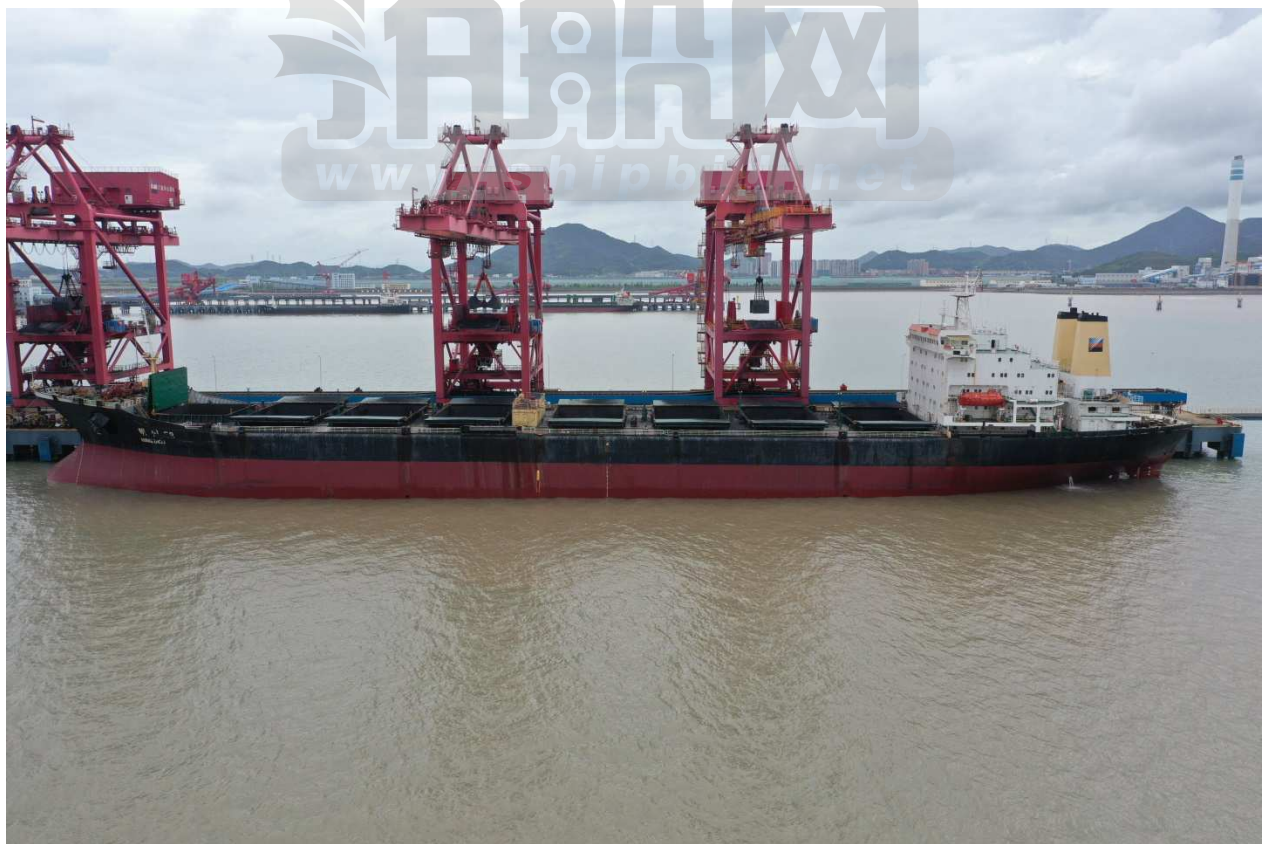
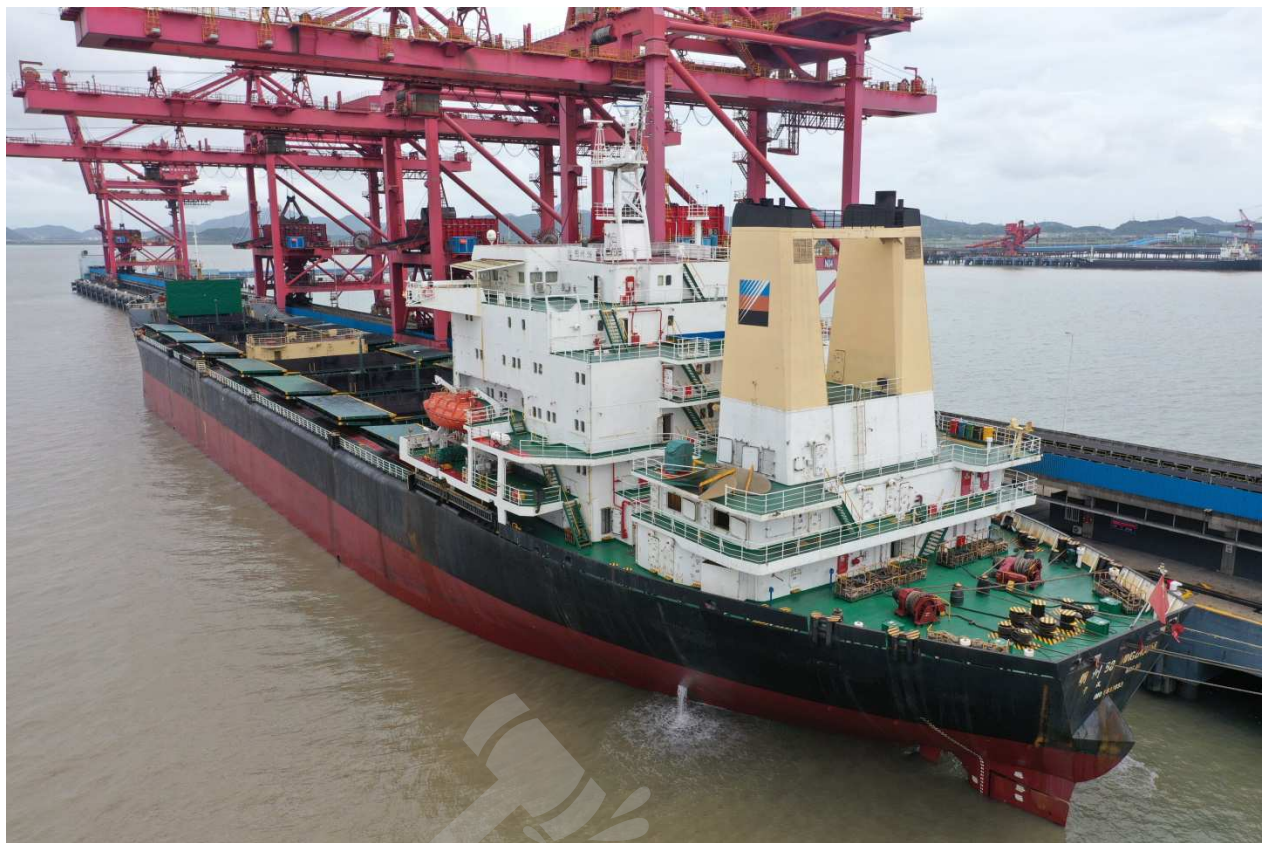
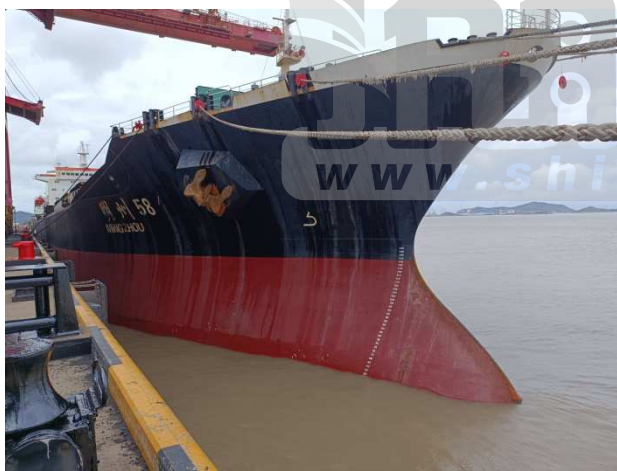
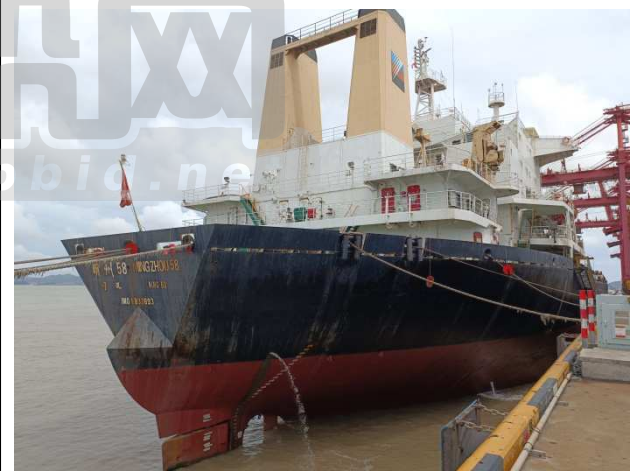
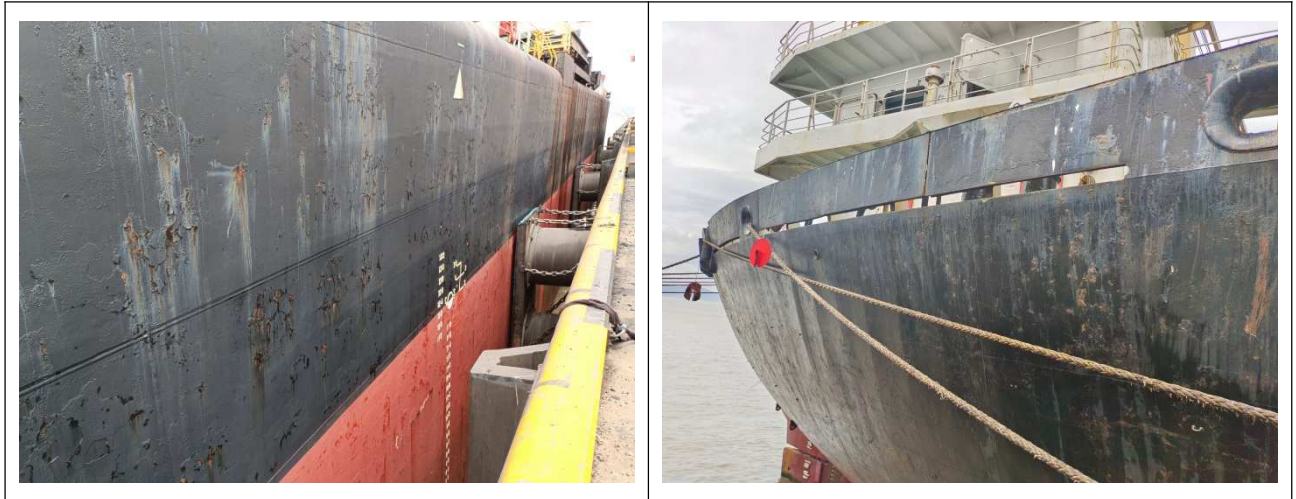
7.1 Shell Plate

The paint on the shell plate was found to be intact, and the ship name, draft marks were partially worn, while the port of registry and IMO marking were clear and full painted.

The overall condition of the shell plate was found average, with local coatings damage and corroded.

The bulwark at the bow and stern was found to be free of deformation, but local paint damage. The railings on both sides were found intact without deformation.

plate was found to be intact, and the ship name, draft marks were partially worn, while the port of registry and IMO marking were clear and full painted.

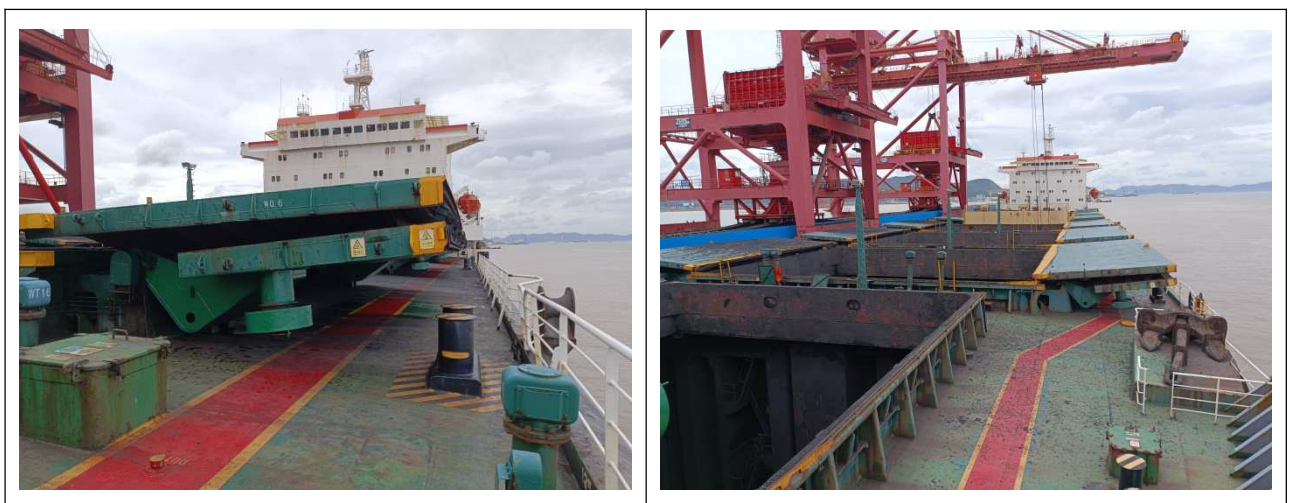
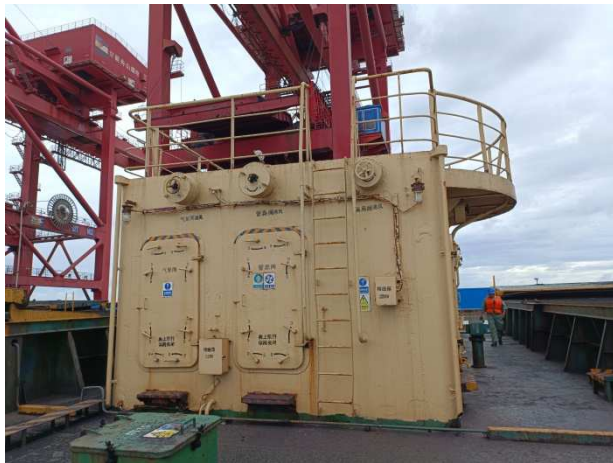
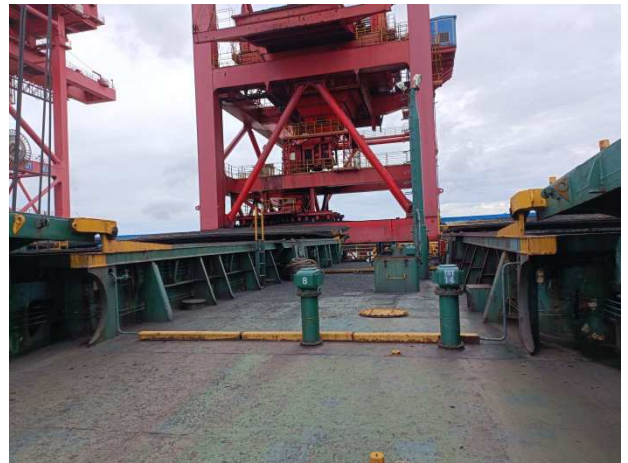
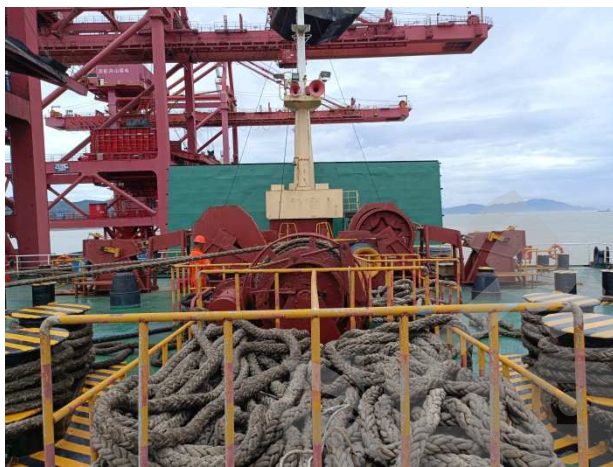
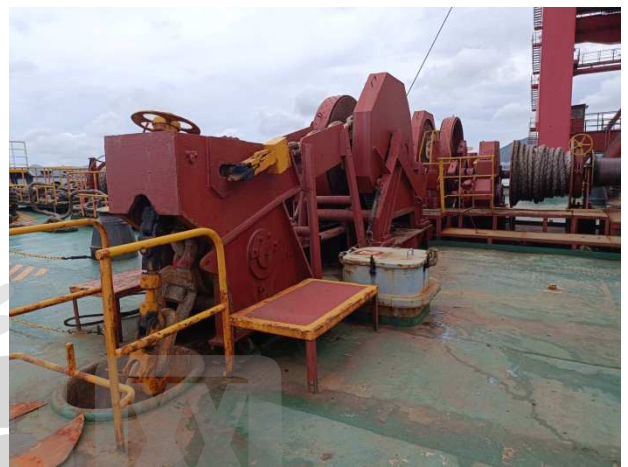
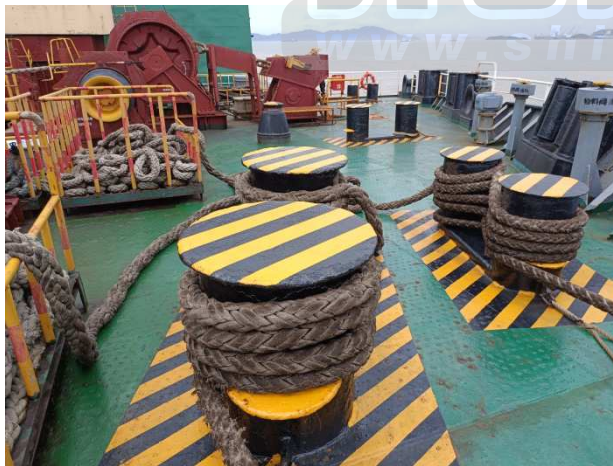
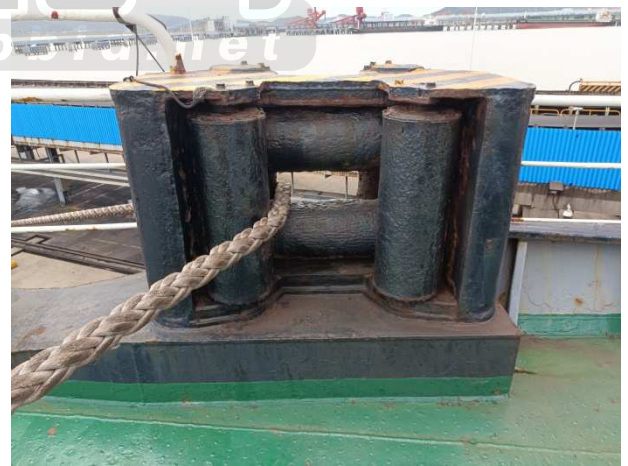
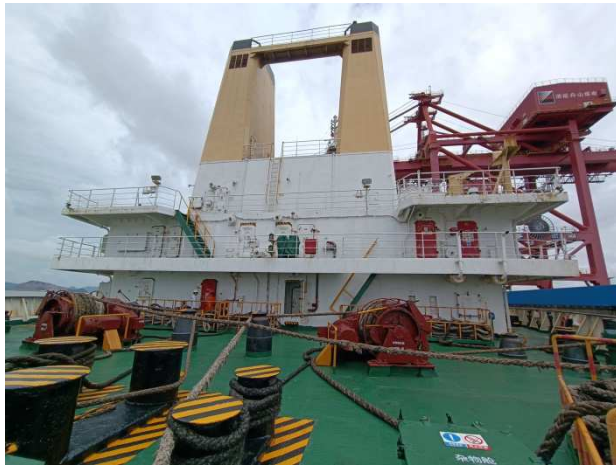
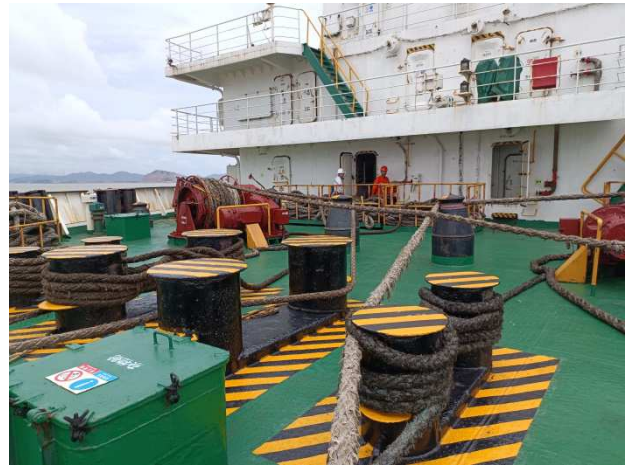
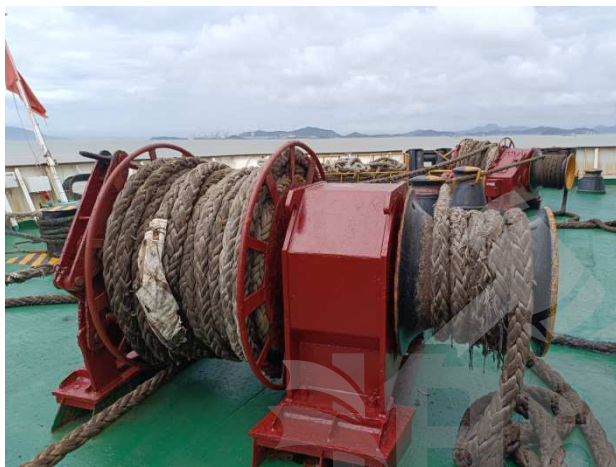
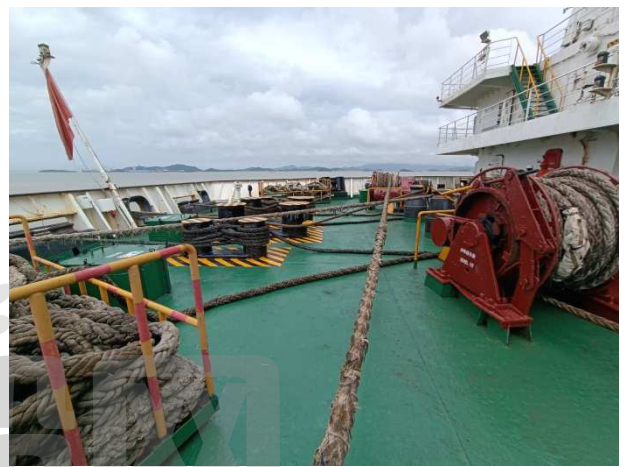
7.2 Main Deck and Deck Machinery

The overall condition of the main deck was found general good, with local painting damage and rust. The internal condition of the ballast tank was unknown, because the watertight manhole cover was rusted and could not be opened.

The condition of the forecastle deck was found general good, with pitting corrosion and no deformation of the bulwark brackets. The body structure of the windlasses was found basically intact, with obvious painting damage on the body and base. The body structure of mooring equipment such as bollard was found intact, with local wear and corrosion. The mooring rope was found to be free of significant breakage.

Two sets winches were installed on the main deck aft, with basically intact paint on the body. The surface of the guide pulley and bollard was found locally corroded.

8.2.2 The overall condition of the main deck was found general good, with local painting damage and rust. The internal condition of the ballast tank was unknown, because the watertight manhole cover was rusted and could not be opened.

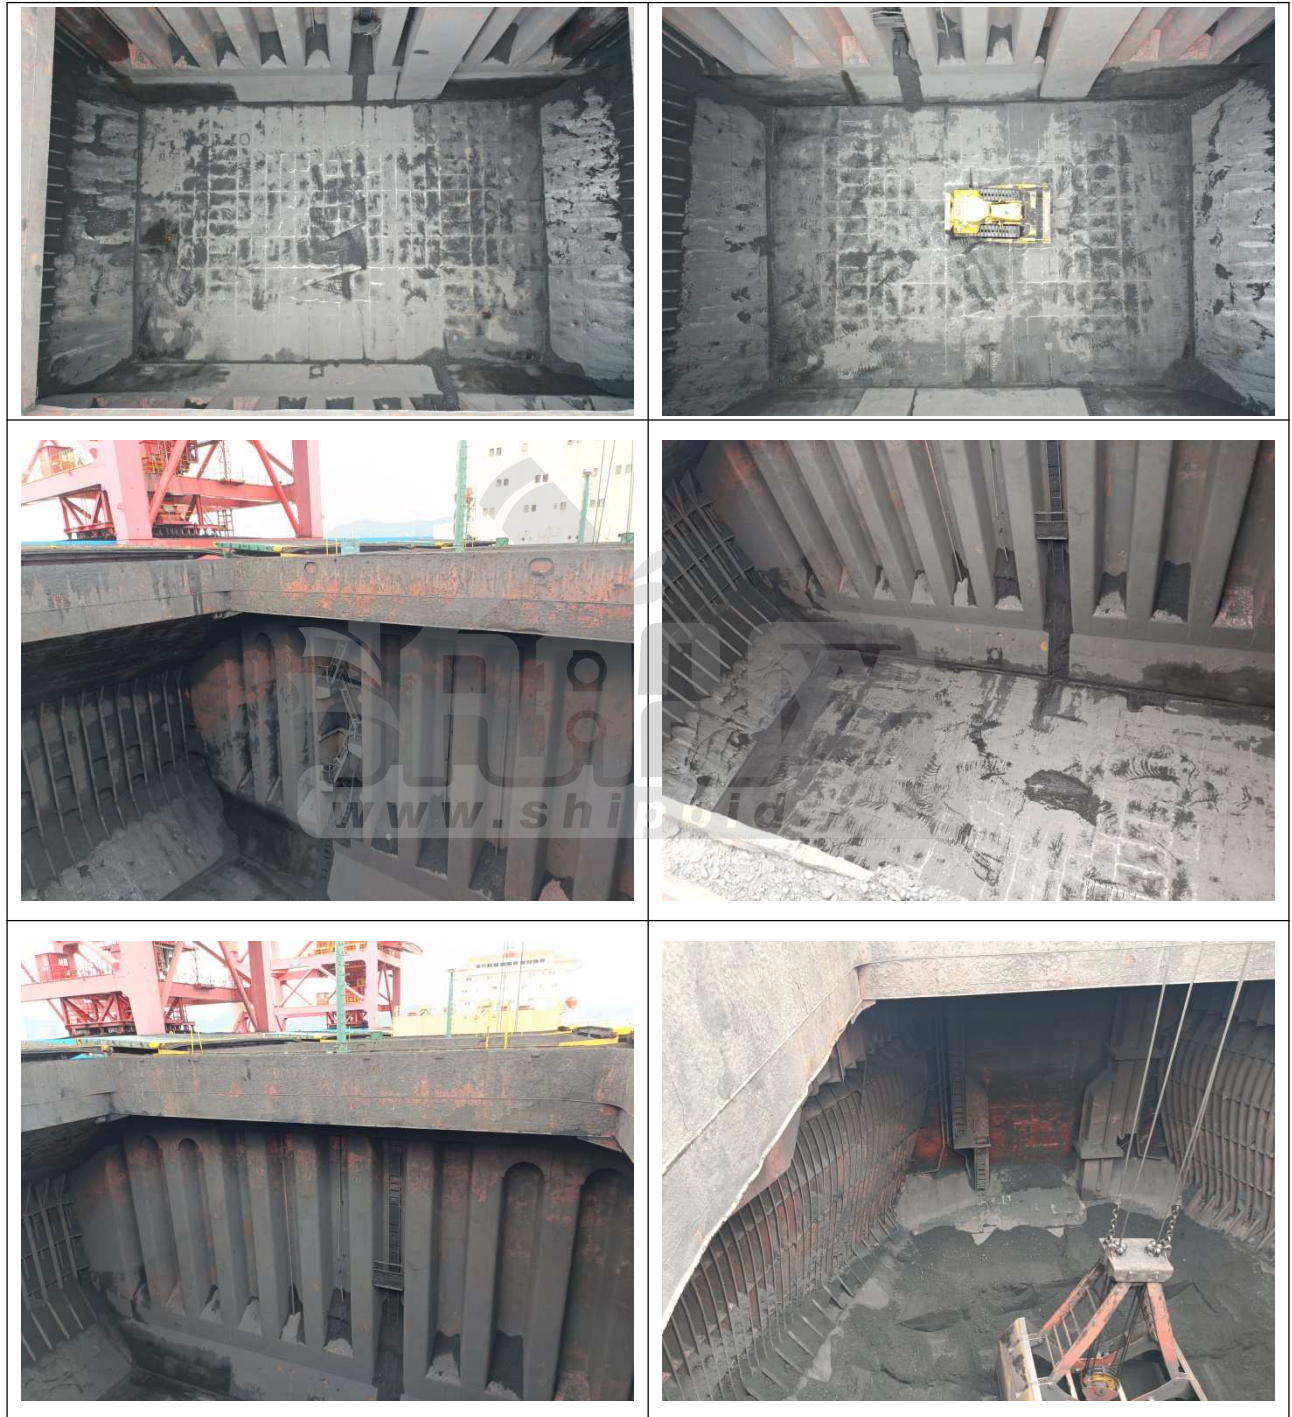
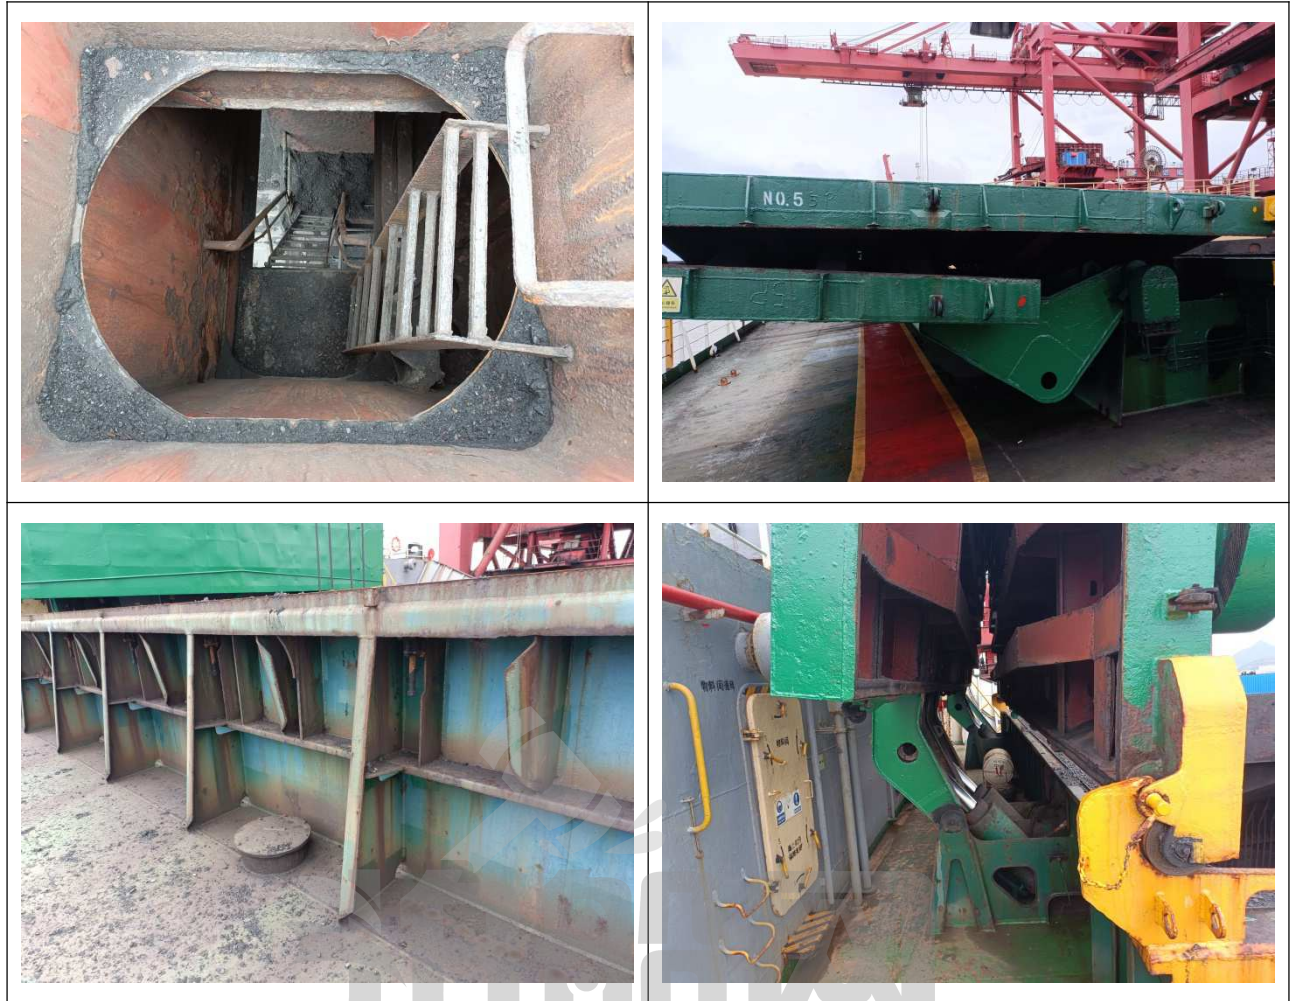
7.3 Cargo Holds

The painting of the hatch cover was found intact, without significant damage. The reverse side of the hatch cover was found corroded, as well the edges of the reinforcement. The fastening wedge was found slightly rusted, without damaged on the rubber.

The condition of the hatch corner area was found average, with local cracking mark. The rust marks were found on the batten and water guide channel on the top plate of the hatch coaming.

The reinforced bracket of the hatch coaming was found locally corroded, and the faceplate end of the bracket was welded to the main deck, with local corrosion.

During the inspection, the ship was unloading, and no significant depression was found on bulkhead of the cargo hold. The local deformation was found on the inner bottom plate. The stairway in the cargo hold was partially covered by coal, and no significant

damage was found in the visible parts.

The painting of the fire pipeline around the hatch coaming was found to be in good condition, and the fire hydrant was found completely arranged. The ventilation pipe of the cargo hold was found to be basically intact and locally corroded.

8.2.3 The condition of the hatch corner area was found average, with local cracking mark. The local obvious deformation was found on the inner bottom plate.

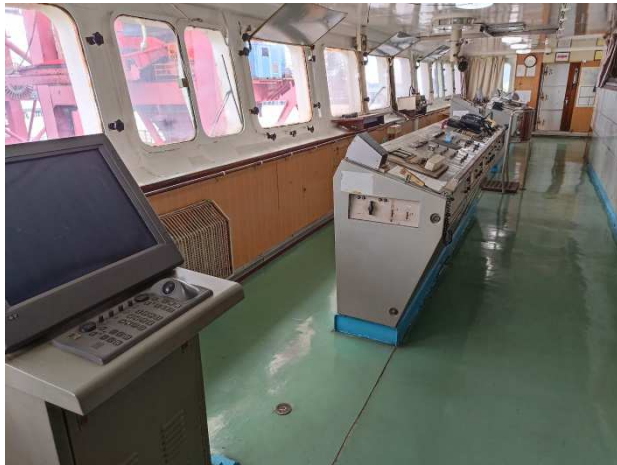
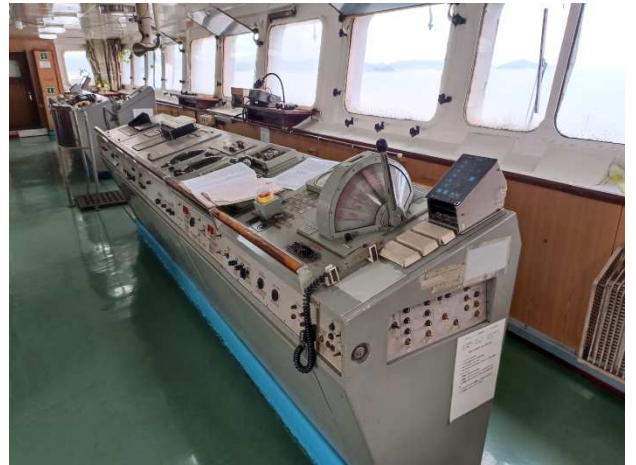
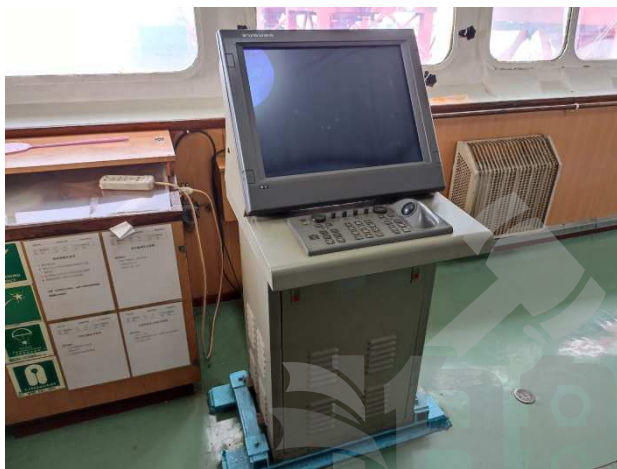
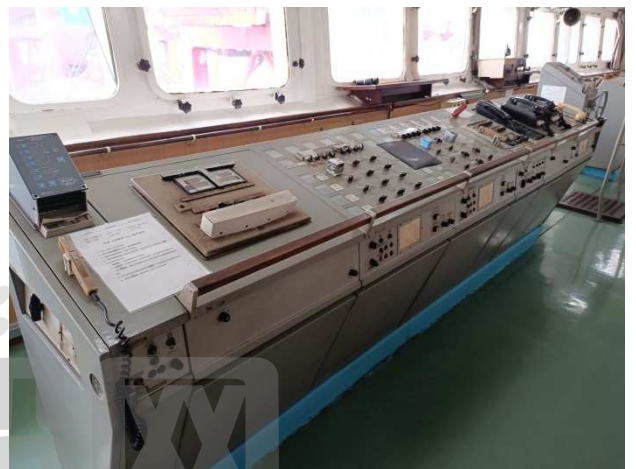
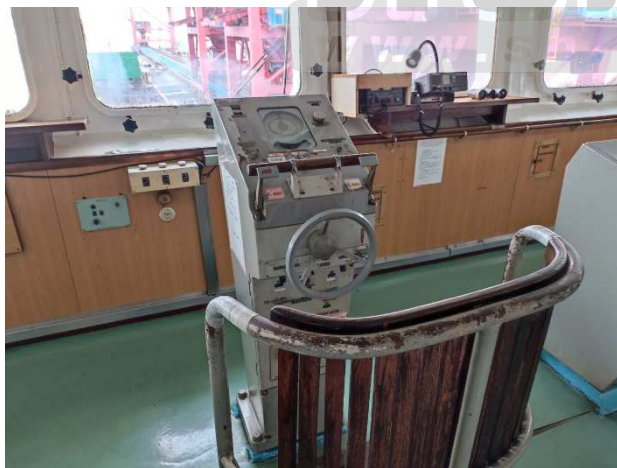
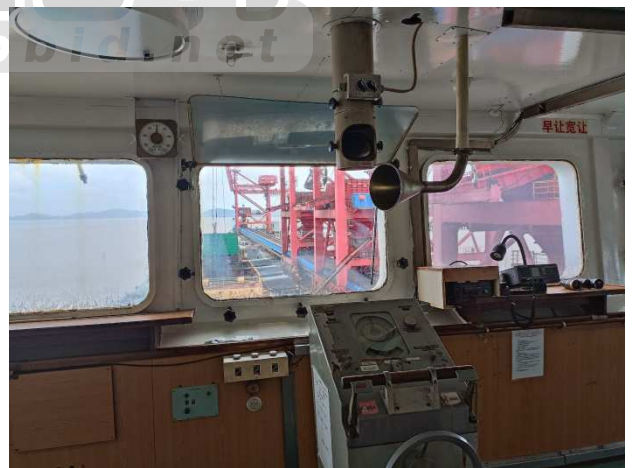
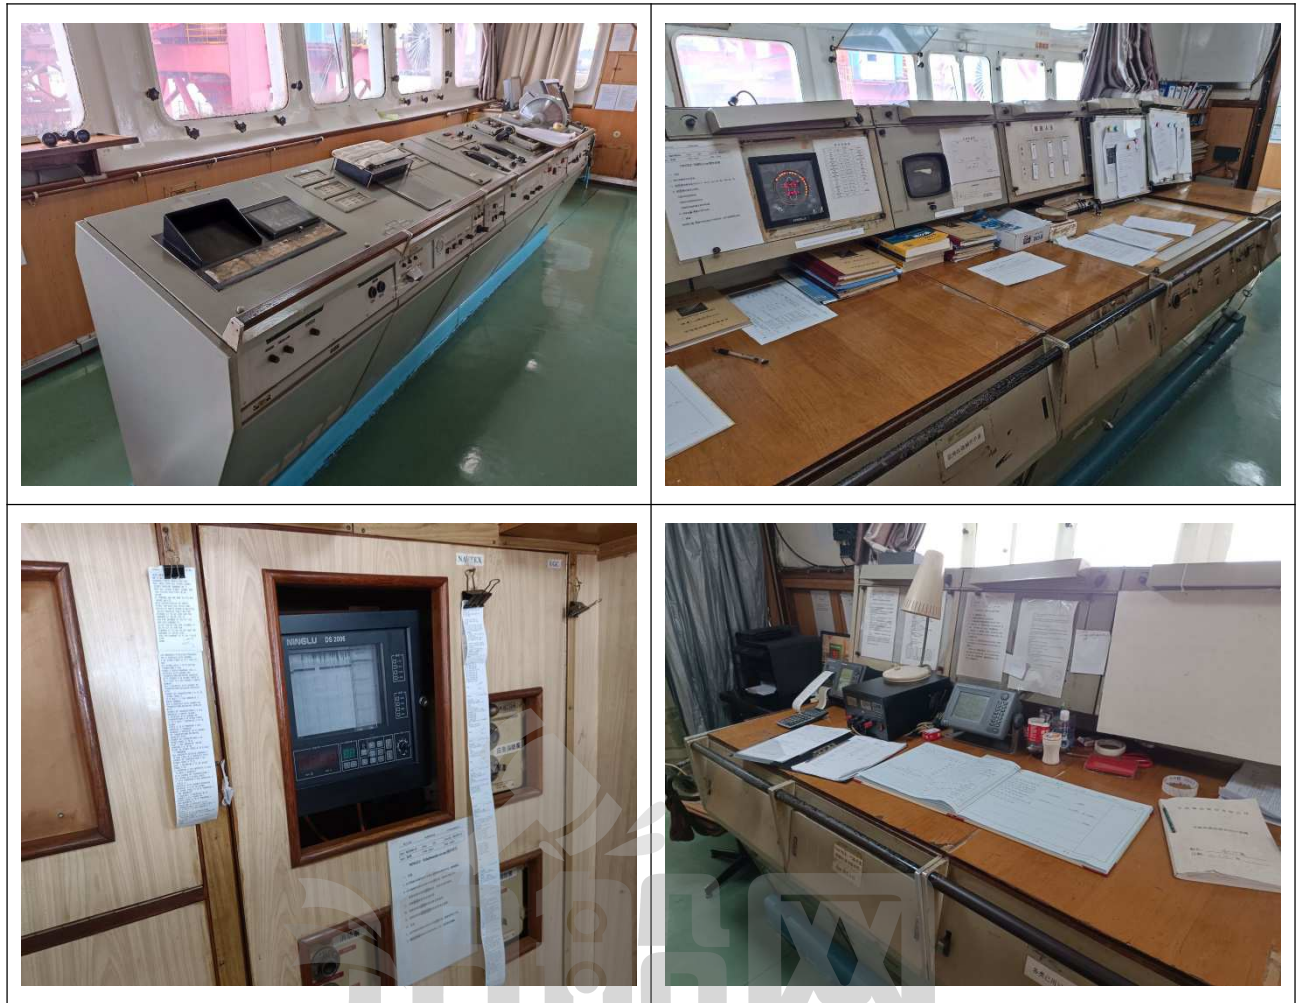
7.4 Bridge Equipment

No significant deformation or water leakage was found on the ceiling of the wheelhouse, the flame retardant floor was basically intact, and the water tightness of the front window was found good.

The structure of the door frame was found complete without deformation, with a sense of jamming when opening and closing, the bottom sliding groove was found slightly rusted, and the watertight adhesive strip was intact and undamaged.

The appearance of the console and relative equipment was found good, and the communication equipment was basically configured according to the certificate.

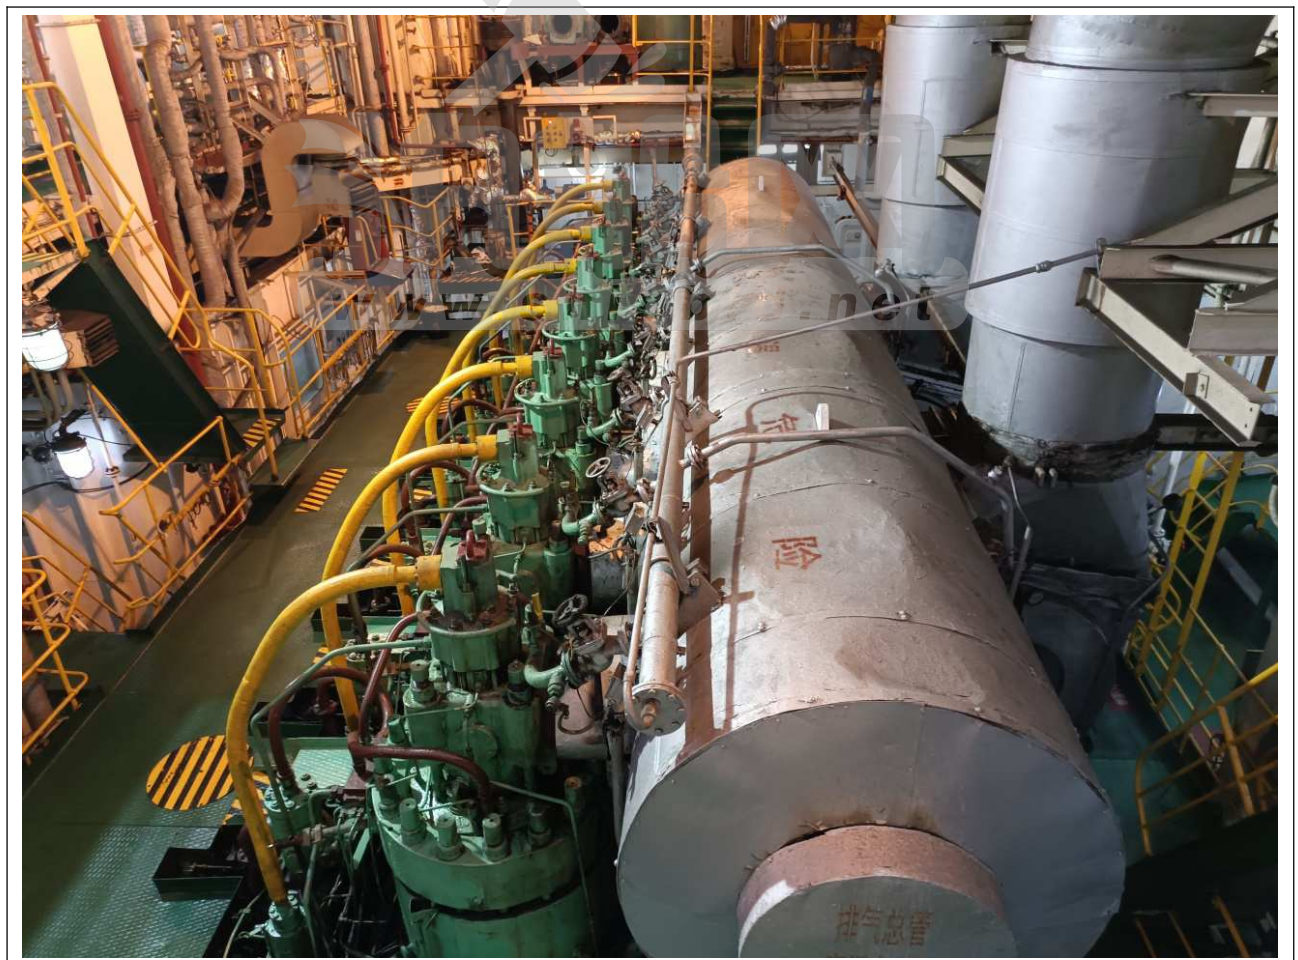
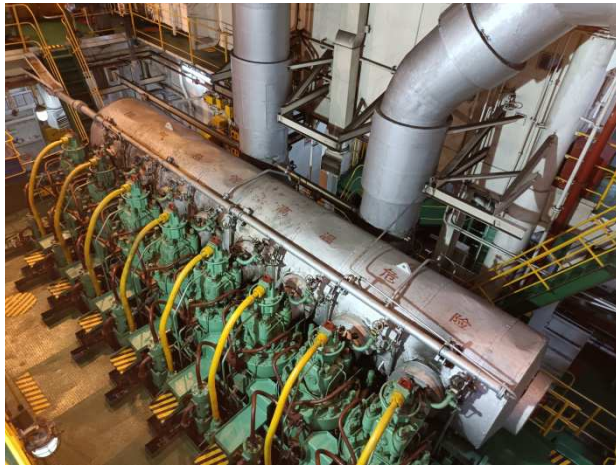
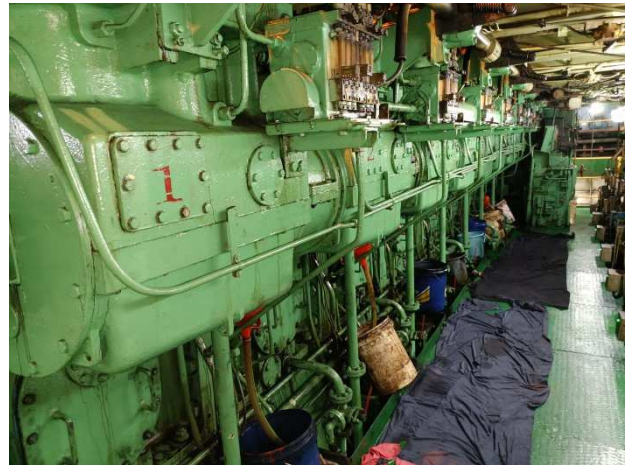
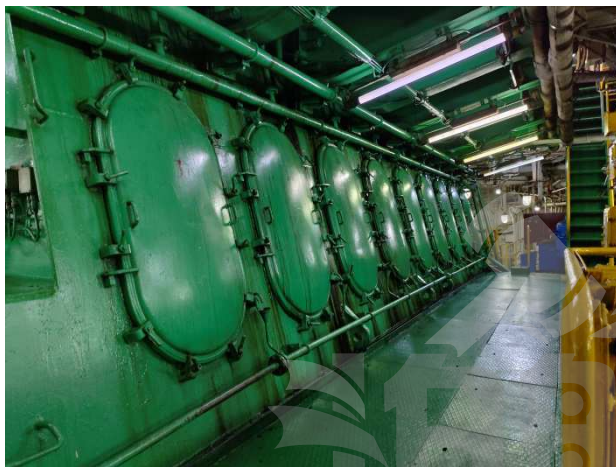
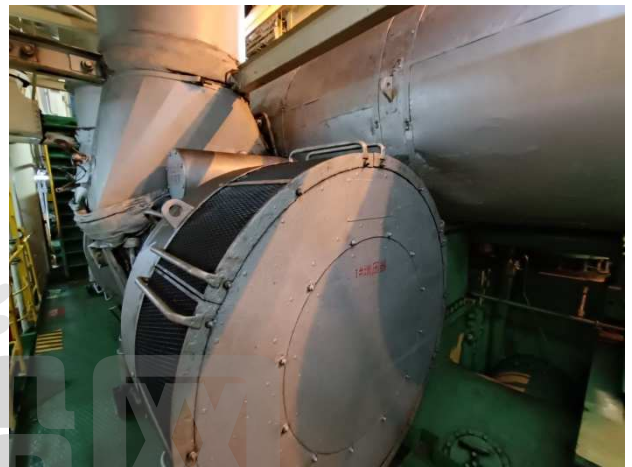
7.5.1 Main Engine

The main engine is equipped with two turbochargers, and the body coating was found complete. There was oil stains attached to the body, and the binding material for the exhaust pipe was found basically complete.

The nameplate of the main engine was found complete, the control instruments beside the M/E were basically complete, without significantly damaged on dial.

The lower part of the scavenge box was found to be connected to multiple drip tray, with signs of leakage.

According to the monthly report provided by the owner, the 2 # and 5 # cylinders of the M/E have undergone maintenance recently.

8.3.2 The oil and water pipeline joints of the main engine were found to be free of significant looseness, and The lower part of the scavenge box was found to be connected to multiple drip tray, with signs of leakage. the 2# and 5# cylinders of the M/E have undergone maintenance recently.

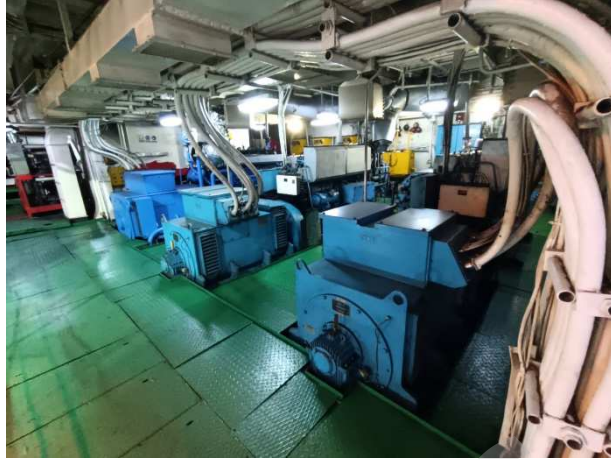
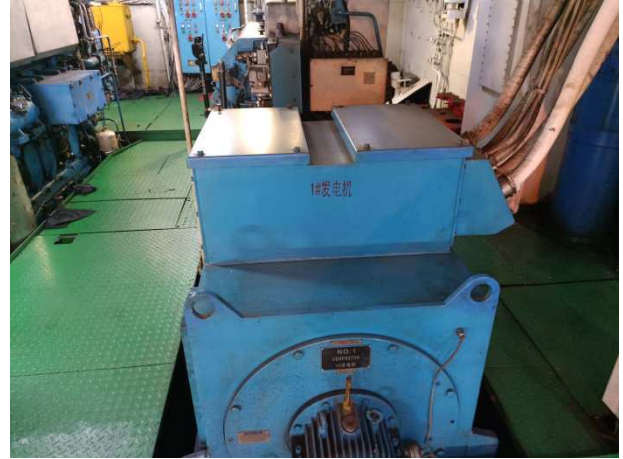
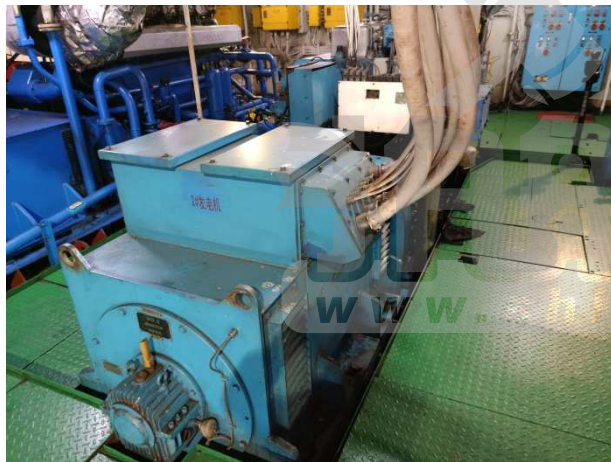
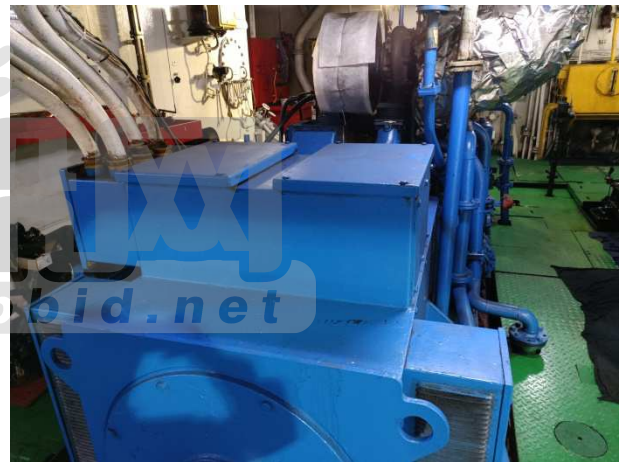
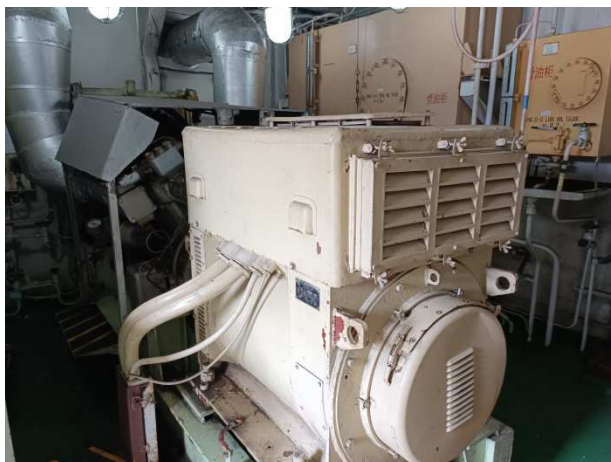
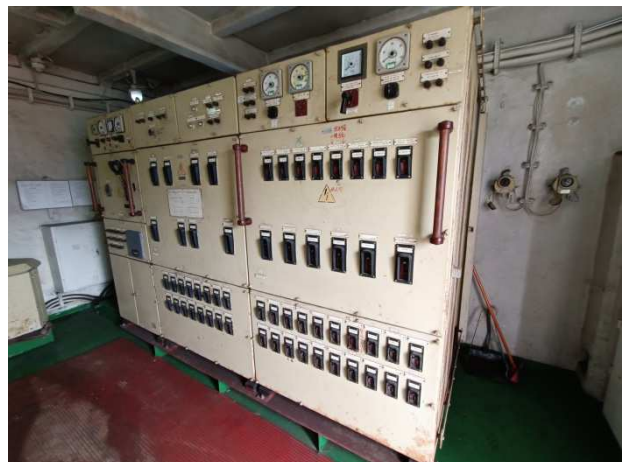
7.5.3 Main Generator

The overall appearance of the 3 sets main generators in the engine room was found clean, without significant oil stains on the base, as well coating damage on the body. The pipelines and components were found intact without damage.

The weathertight door and door frame of the emergency generator room were found to be free of significantly rusted, without aged or deformed on the waterproof adhesive strip. The structure of the ventilation grille was found complete. The appearance of the emergency generator was found clean, the liquid level in the fuel tank was normal, and the steel wire of the quick closing valve was free of significantly rusted.

During the inspection, the 3 sets main generators were found to be in working and the parameters were normal.

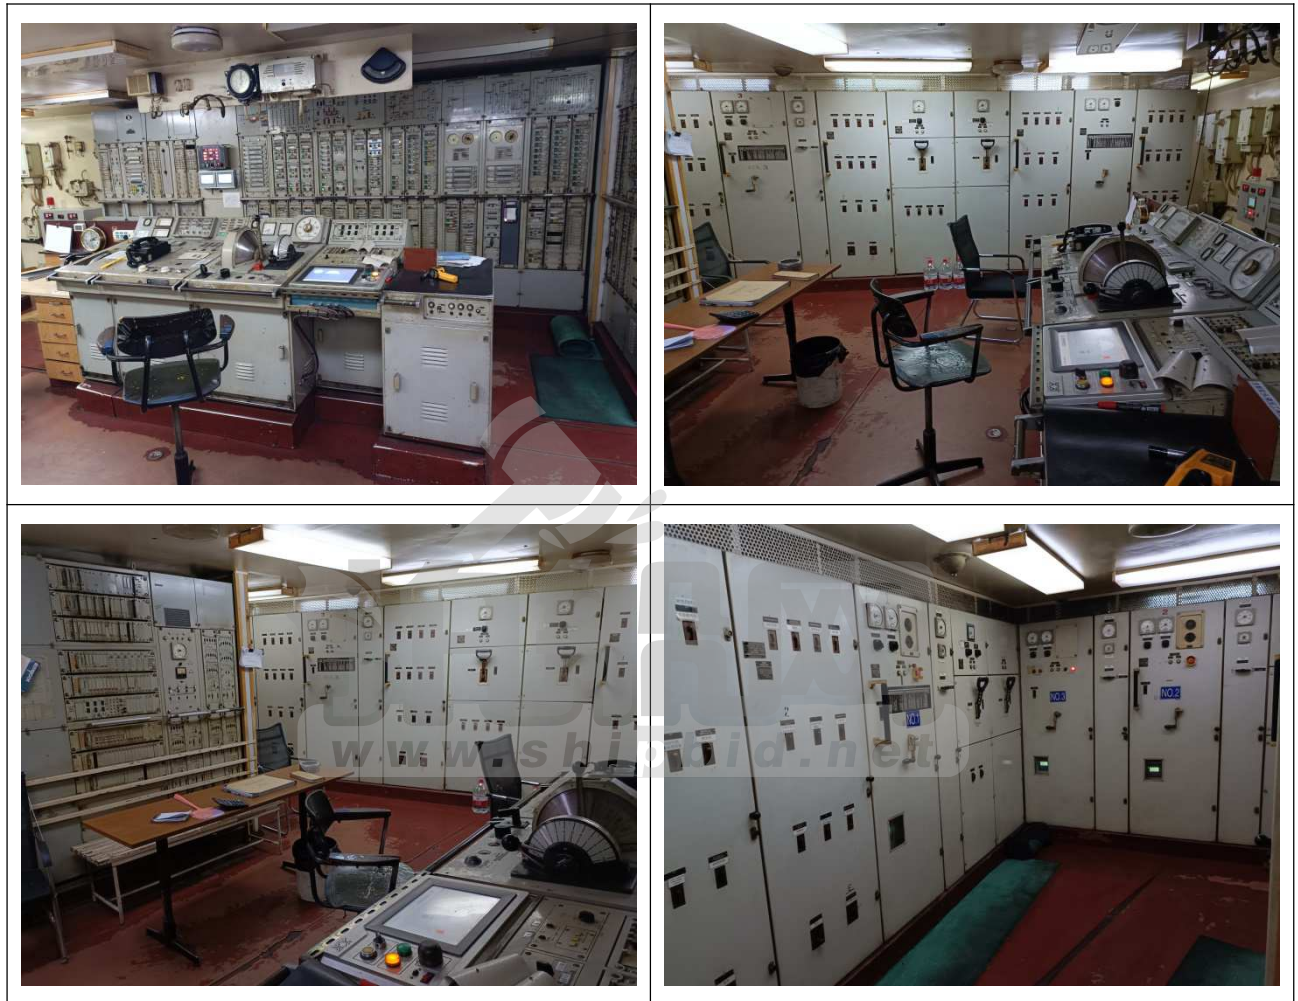
7.5.4 Engine Control Room

The self closing door, indoor lighting fixtures, and fire insulation laying in the engine

control room were found to be in good condition.

The appearance of each switch, indicator light, and instrument on the main switchboard was found normal.

The alarm lights and monitoring instrument panel on the console were found in real-time monitoring status.
