M.V “MING ZHOU 58”

Technical Report

【CJPG-JS-23-KY-412】

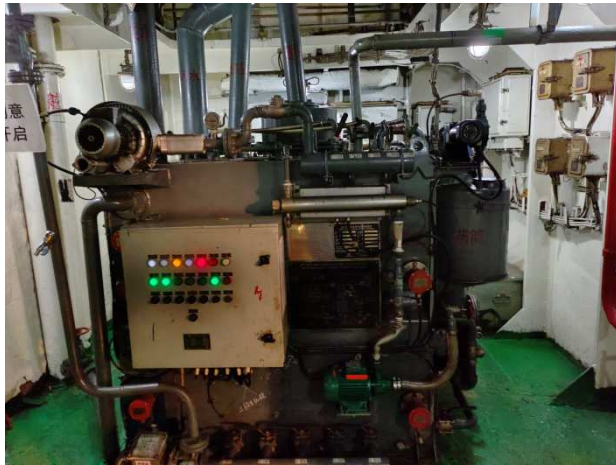
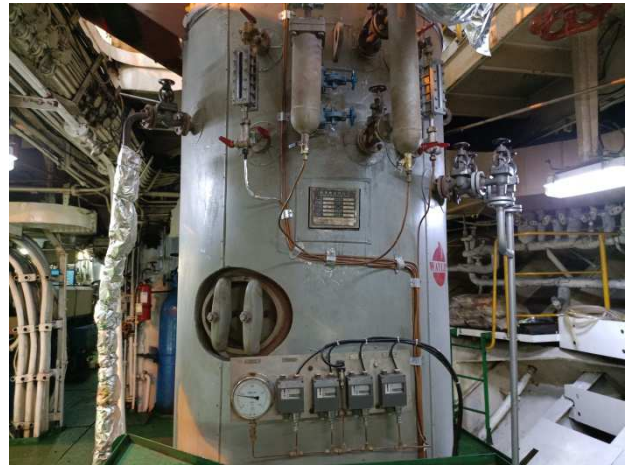
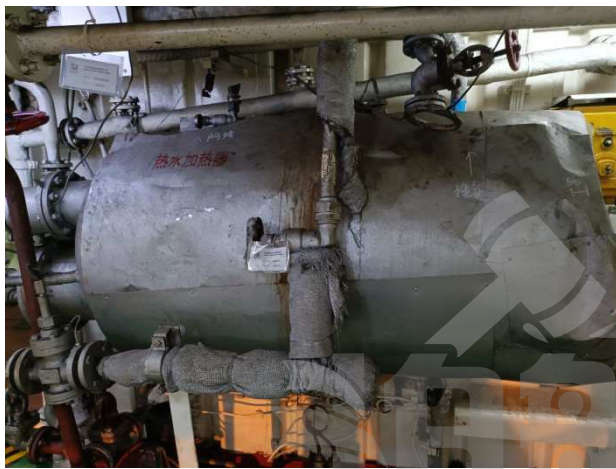
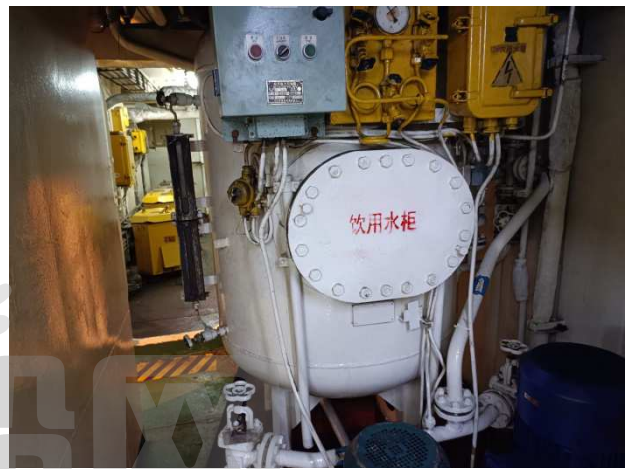
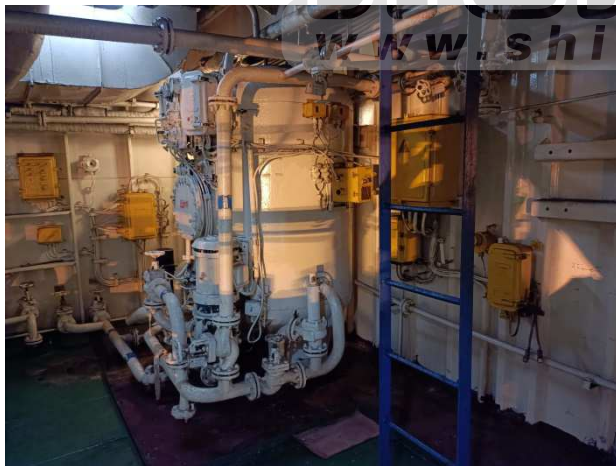
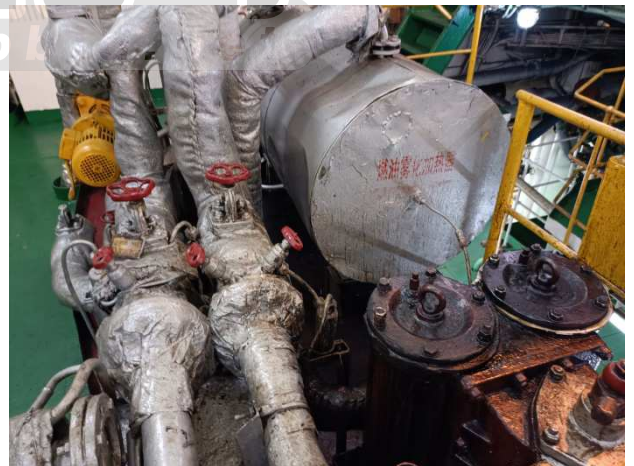
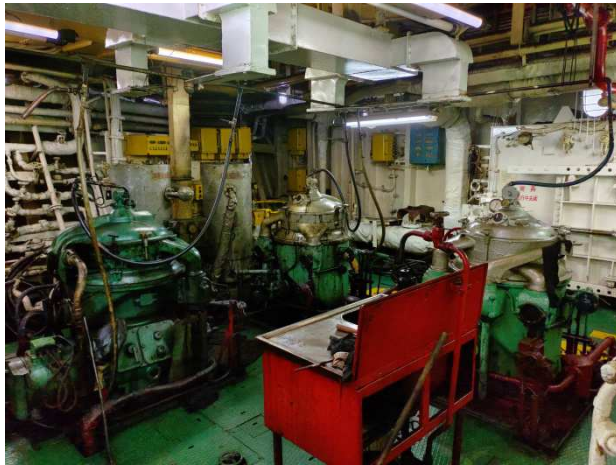
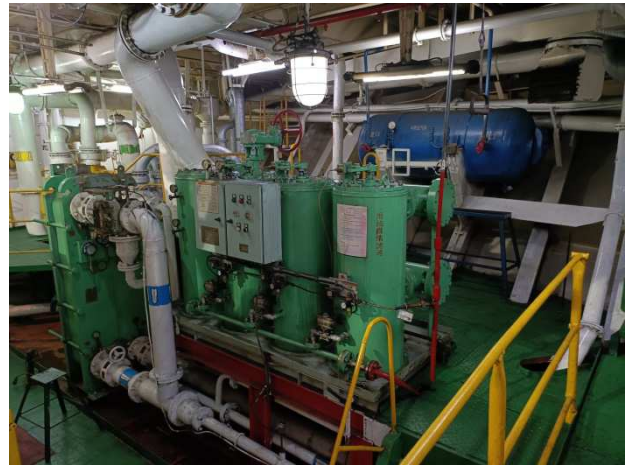
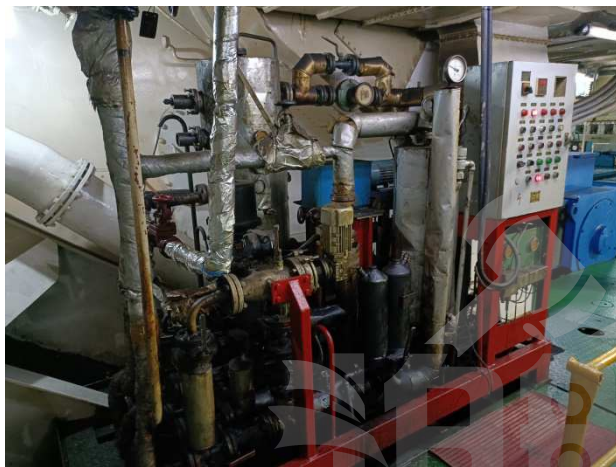
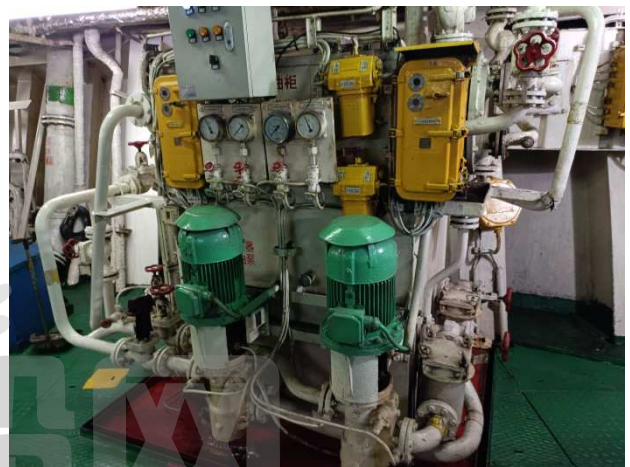
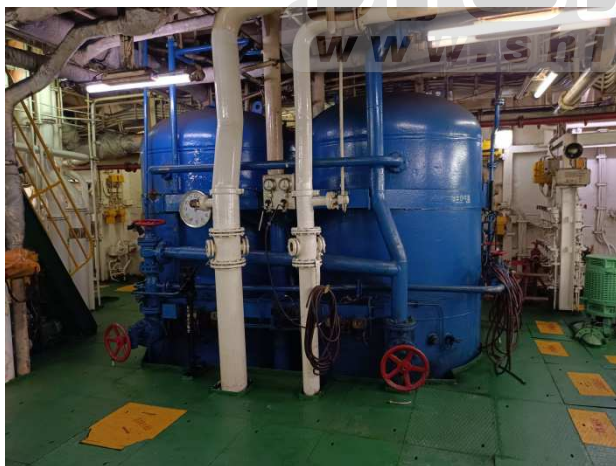
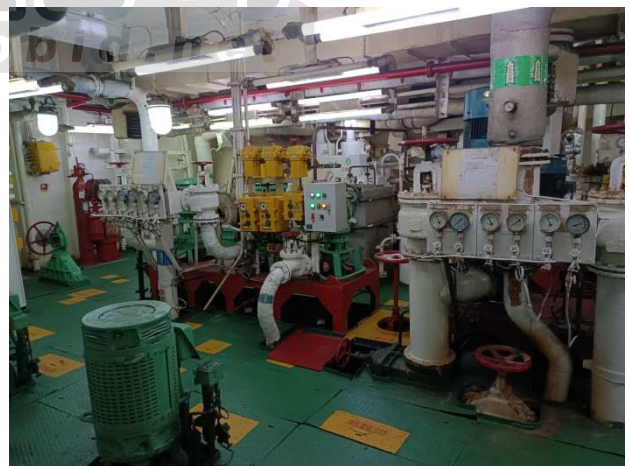
7.5.5 Other Equipment

The engine room is equipped with a fuel supply unit, with a small amount of oil stains on the equipment chassis, and no significant corrosion or leakage in the pipelines.

The engine room is equipped with a domestic sewage tank and treatment device, and the pipelines and valves were found to be free of rust. The appearance of the control box and emission monitoring alarm was found normal.

The body of the oil purifier was found oil stains attached, and no significant leakage in the pipeline.

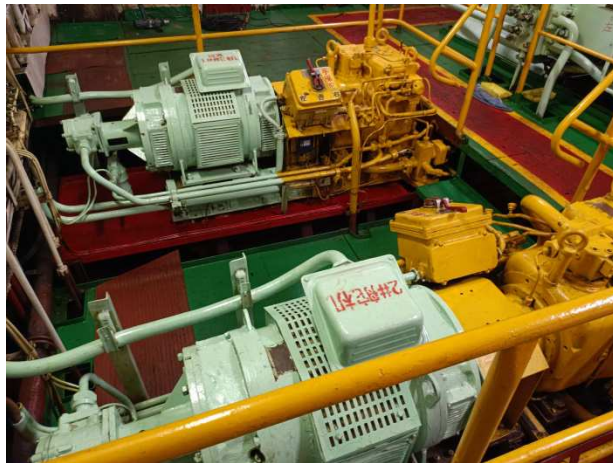
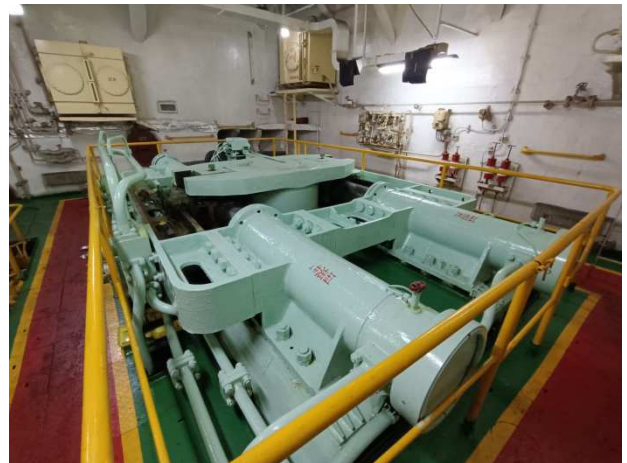
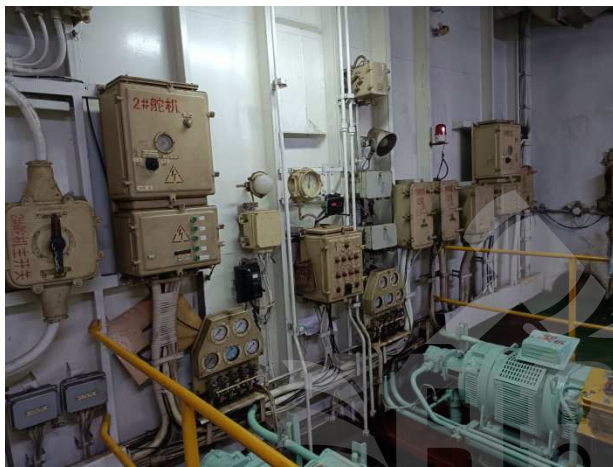
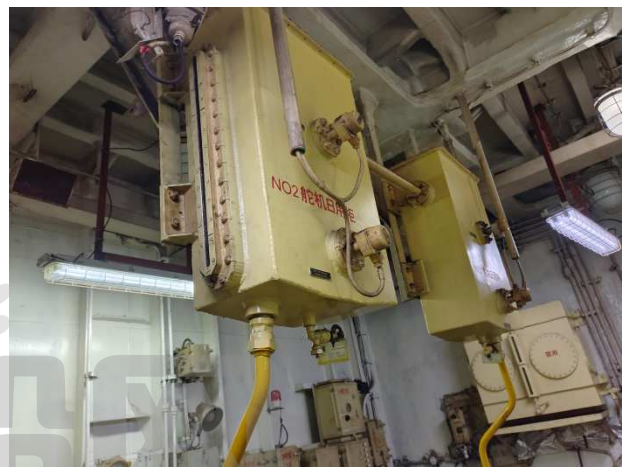
7.5.6 Steering Gear Room

The arrangement of the checkered plates in the steering gear room were found complete, and protective railings were installed next to the steering gear.

The body surface was found clean, without significant damage on coating.

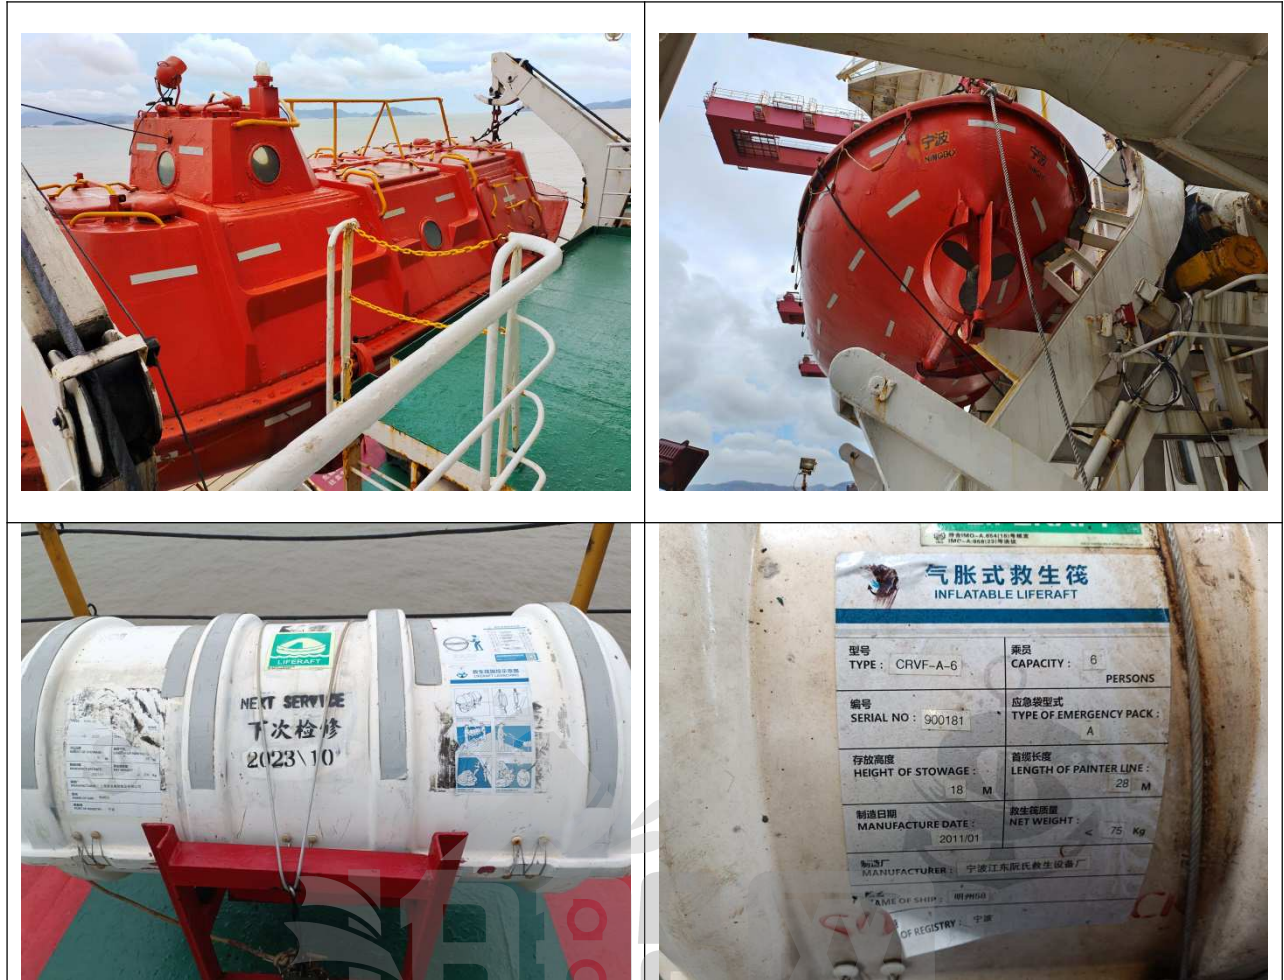
7.6.1 Lifesaving Equipment

The ship is equipped with 2 sets enclosed lifeboat on the boat deck, 1 set on each side, with a seating capacity of 30 people per boat. The appearance of the lifeboat was found no crack, and no damaged on the keel plate. The thruster facilities were found complete. The roller groove of the lifeboat frame was found to be free of significant rust or thinning, and no rust on the lifting rope and release hook.

The ship is equipped with 2 sets fall inflatable life rafts on the boat deck, 1 set on each side, with a seating capacity of 25 people per boat. The ship is equipped with 1 set fall inflatable life raft at the front area of No.1 cargo hold, with a seating capacity of 6 people. The overall condition of the life rafts were found good, with complete release device and the inspection marks.

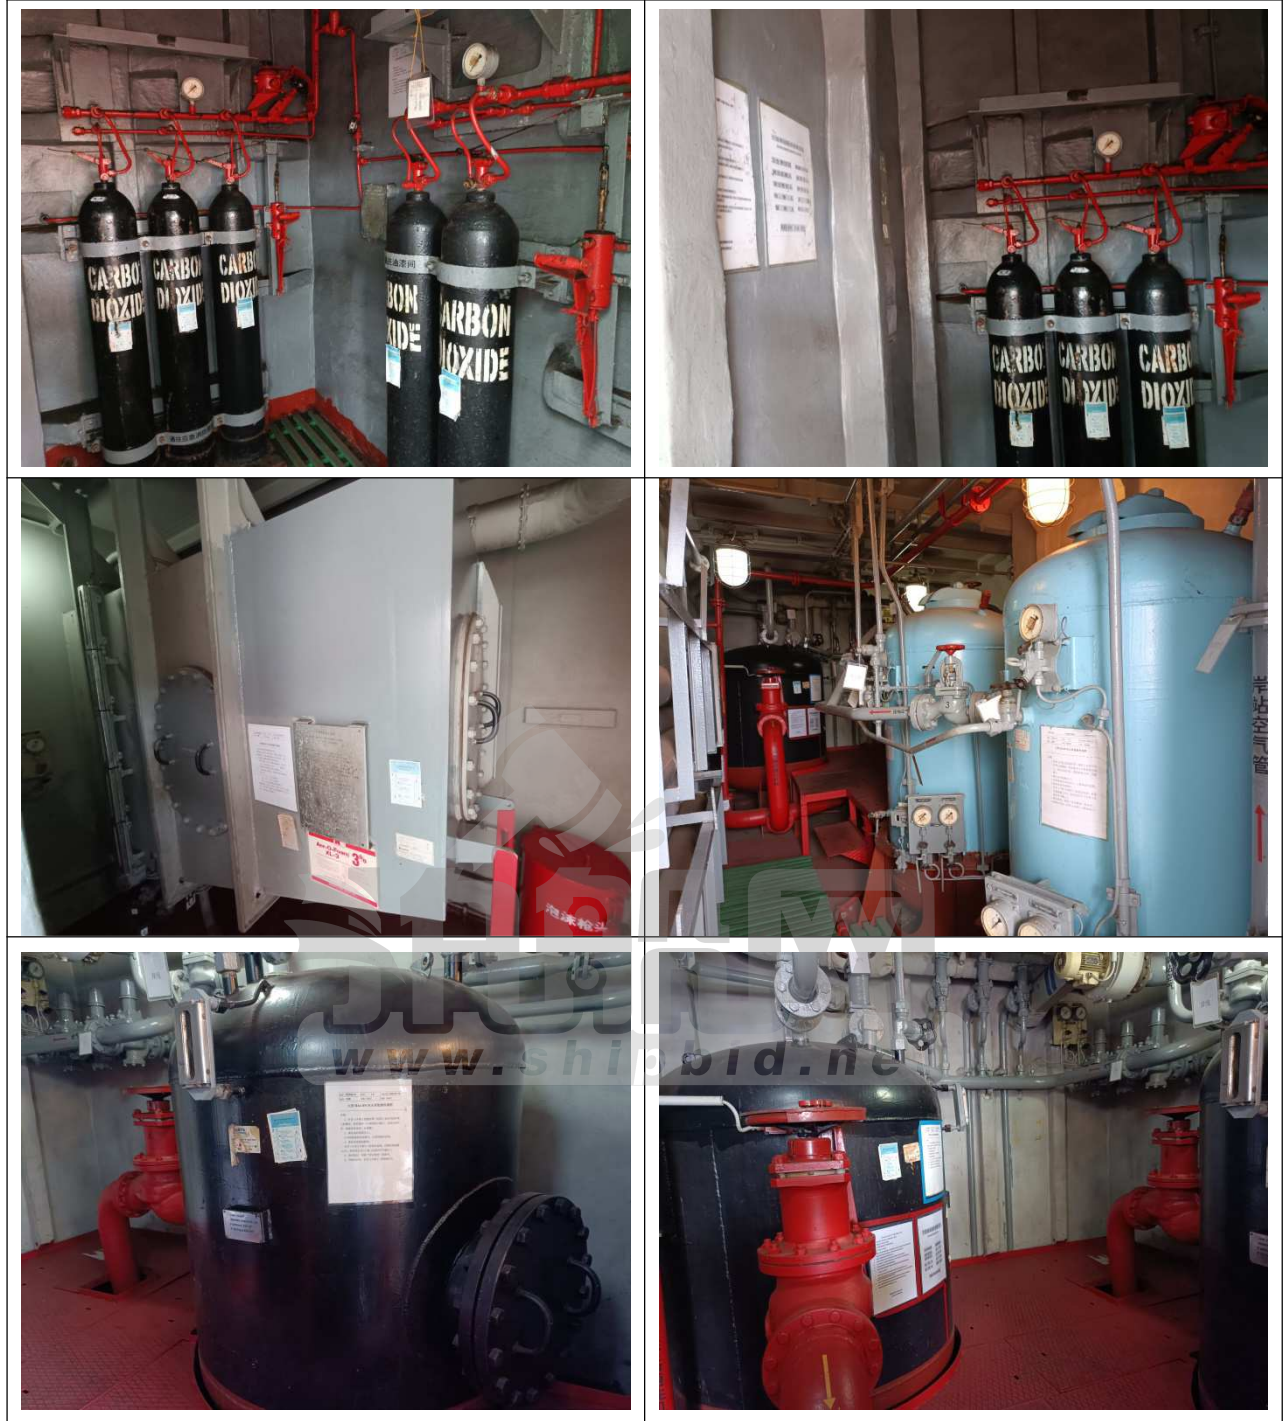
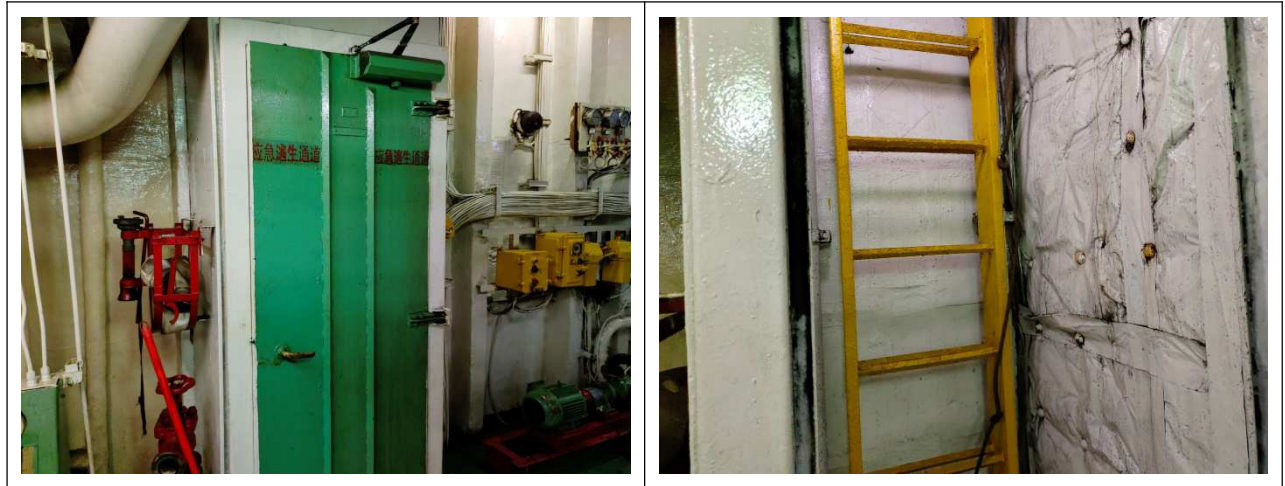
7.6.2 Firefighting Equipment

The CO2 fire extinguishing station of this ship is located in the fore peak tank. The foam fire extinguishing system and large halon fire extinguishing system are located on the poop deck, and a small amount of rust was found on the weathertight door rubber groove and the door frame. The indoor fire protection laying was found complete, and the release valve and bottom of the cylinder were free of rust. The inspection marks were found complete.

The self closing door of the emergency passage in the engine room was found to open and close normally, the fire protection material outside the passage was found basically complete, and the configuration of life ropes and life ladders inside the passage was complete.
