TECHNICAL REPORT

No.: CJPG-JS-23-KY-000

NING HAI BO 16001

Inspection date: March 6th, 2023

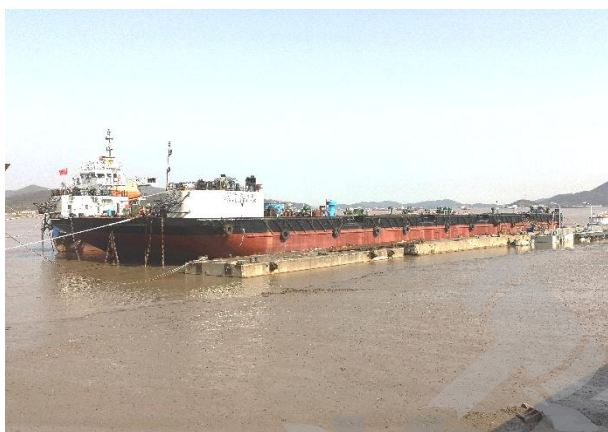
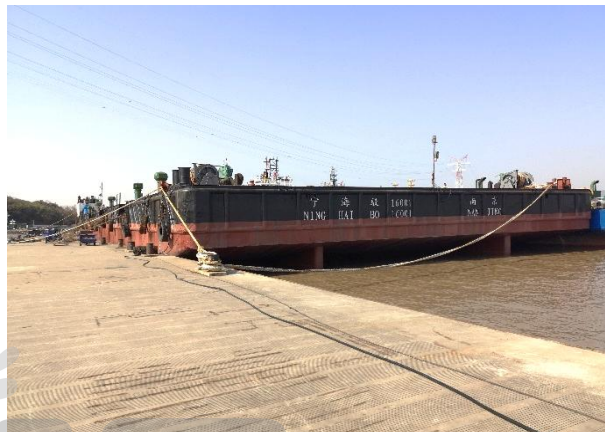
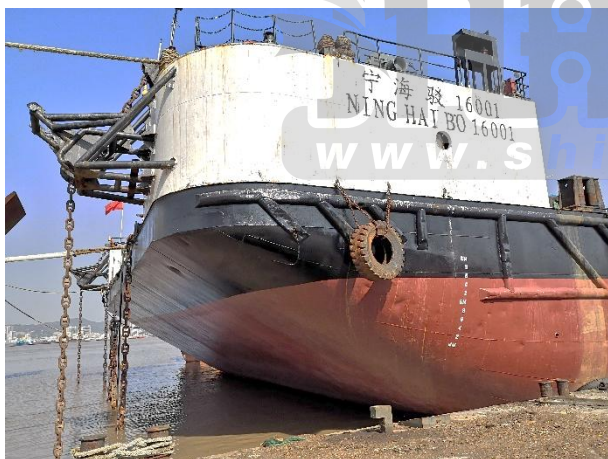
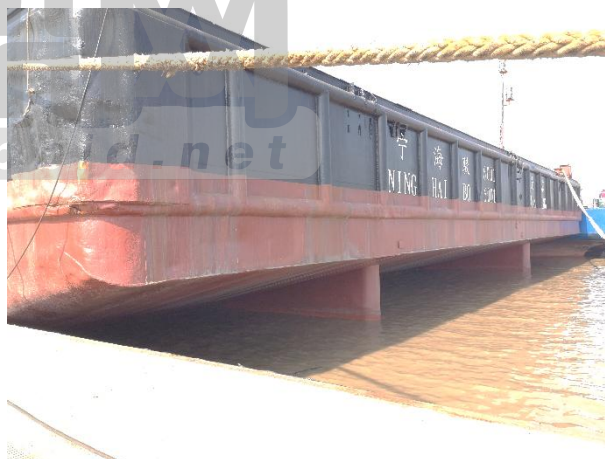
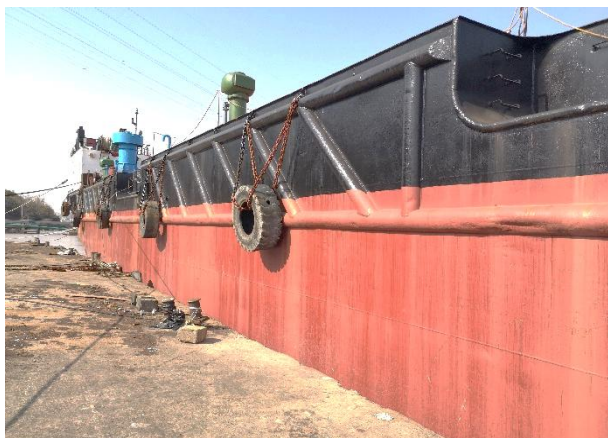
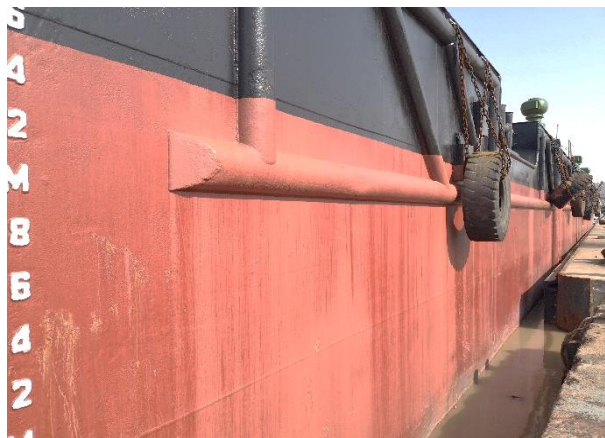
5.1 Hull Structure Condition

The paint condition of the shell plate was found basically intact, and the ship's name, port of registry, load line and other markings were found clearly and fully painted. And the local depression was found in the stern shell plate, as well on the inclined plate of the bow shell plate. The steel fenders on both sides of the ship were found with multiple local deformation and depressions, especially at the bow and stern fenders.

2. Local depression was found in the stern shell plate, as well on the inclined plate of the bow shell plate, and the blocky rusting was found on the back side of main deck in the ballast tank.

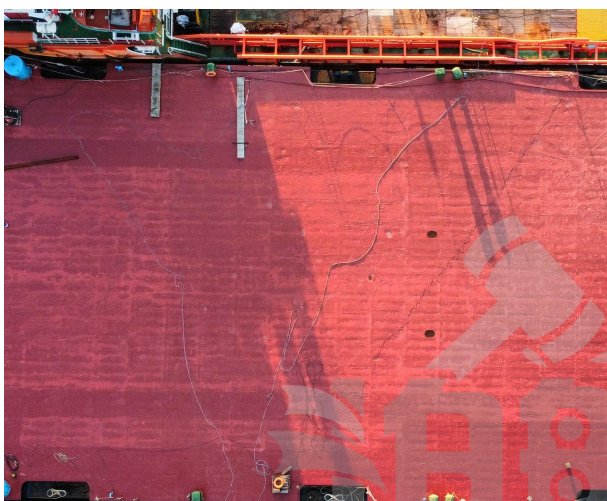
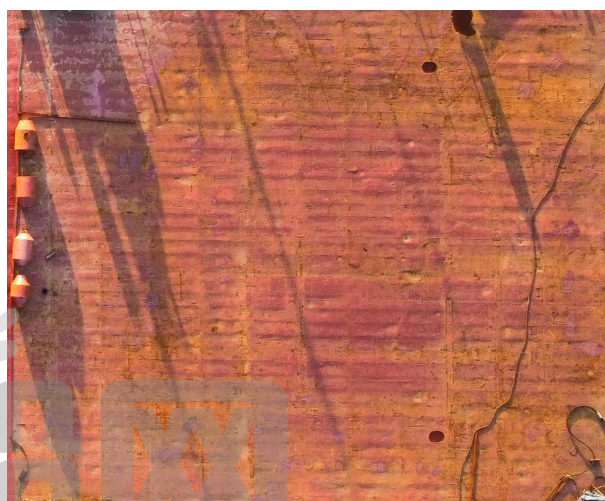
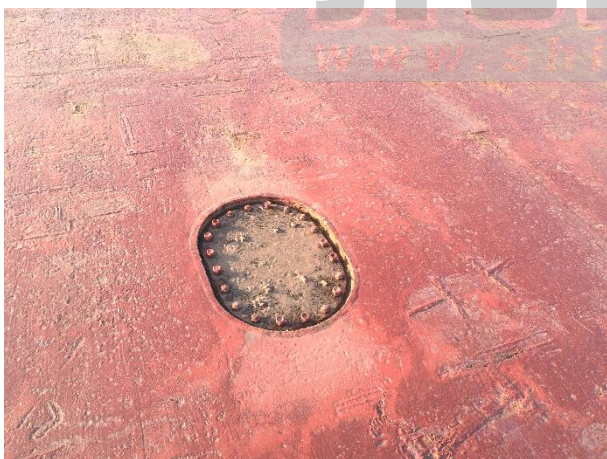
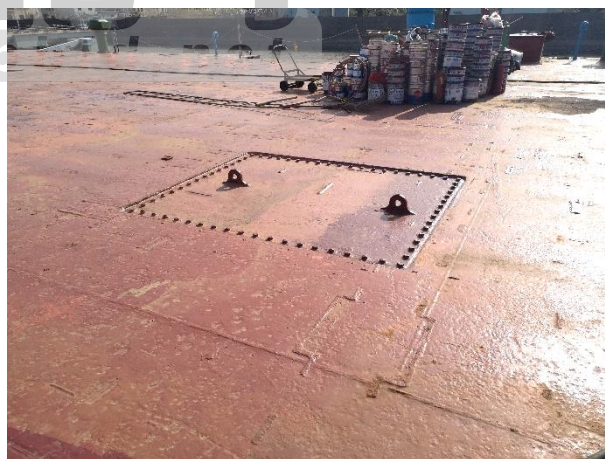
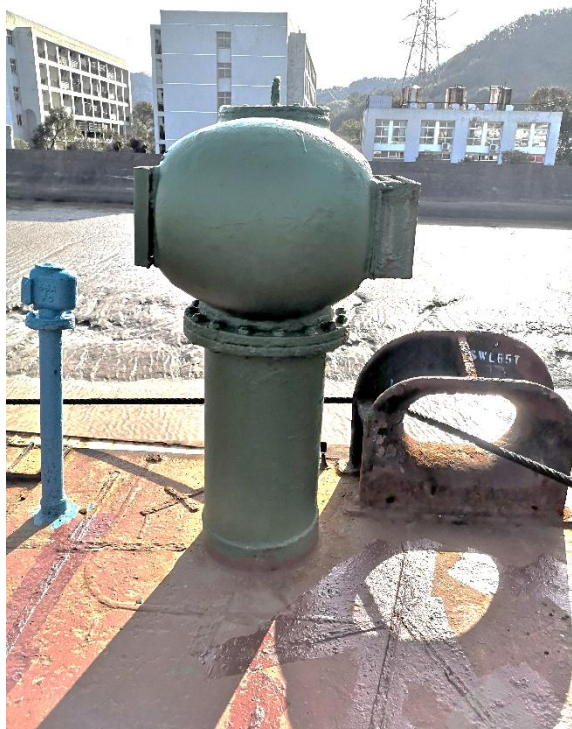
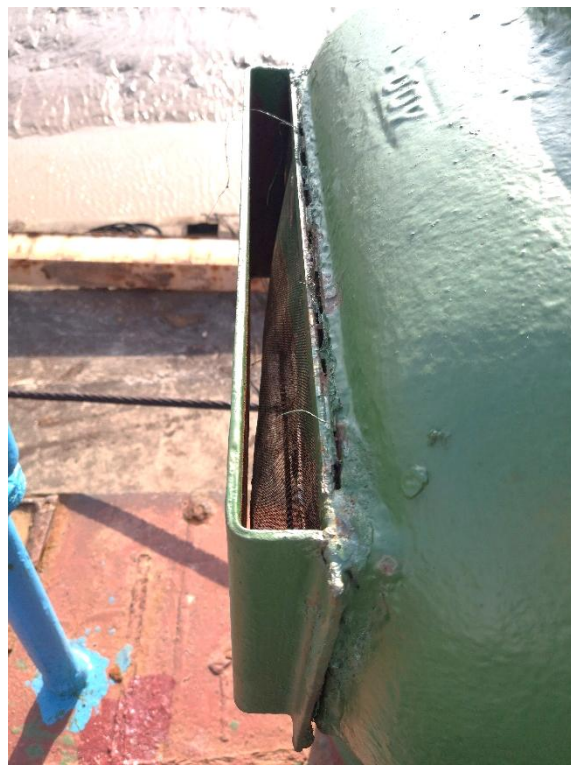
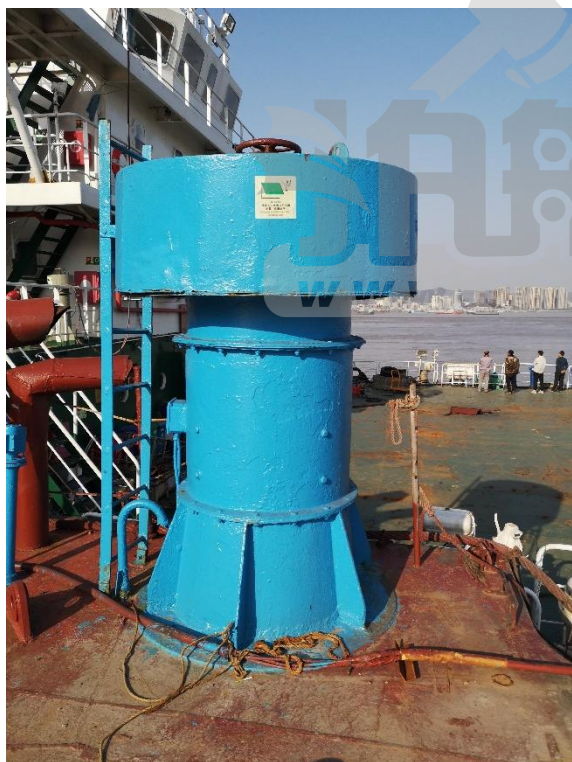
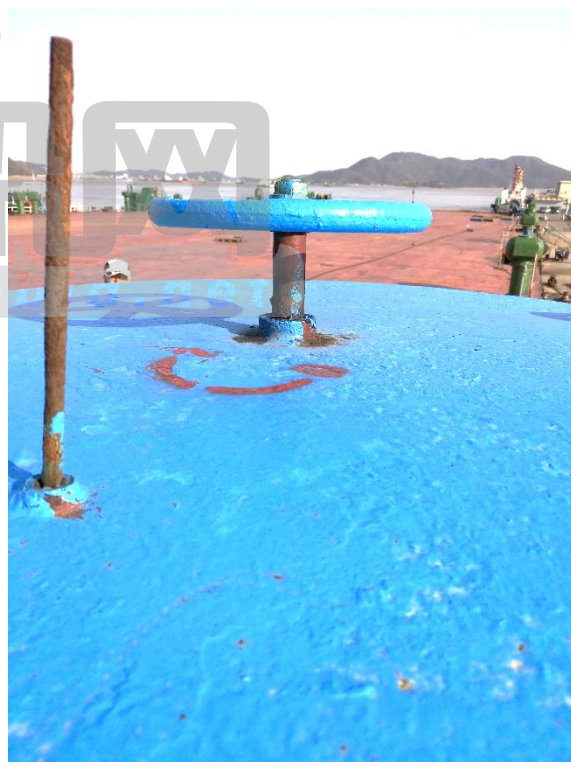
5.2 Main Deck and Outfitting

The paint condition of the main deck was found basically intact, with pitting corrosion in local area, as well multiple welding/removing marks.

The edge of some watertight manhole covers on the main deck was found corroded and deformed. The paint on the air tube was found intact, without significant rust.

The ventilation tube connected to the engine room was found blocky corrosion, with corroded on the edge of the hood, and the opening/closing hand wheel was rusted and has a sense of jamming.

3. The paint condition of the main deck was found basically intact, with pitting corrosion in local area, as well multiple welding/removing marks.
4. The deck machinery is fully configured, with intact appearance and sufficient functionality for use.

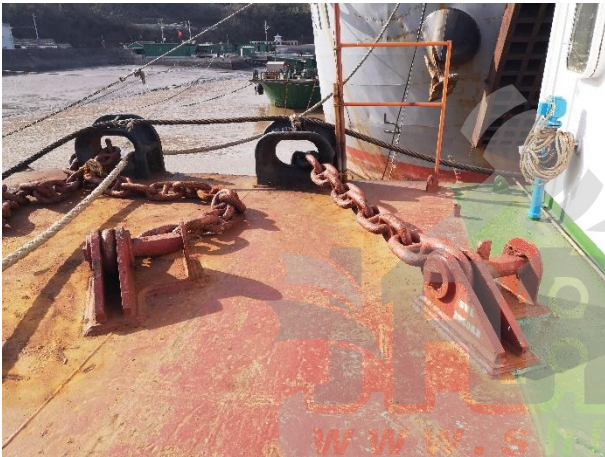
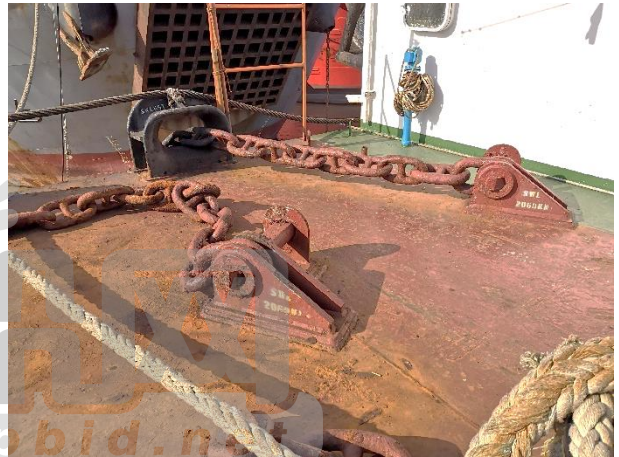
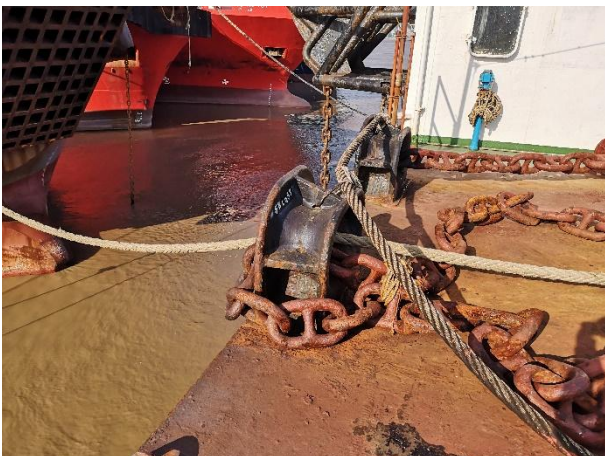
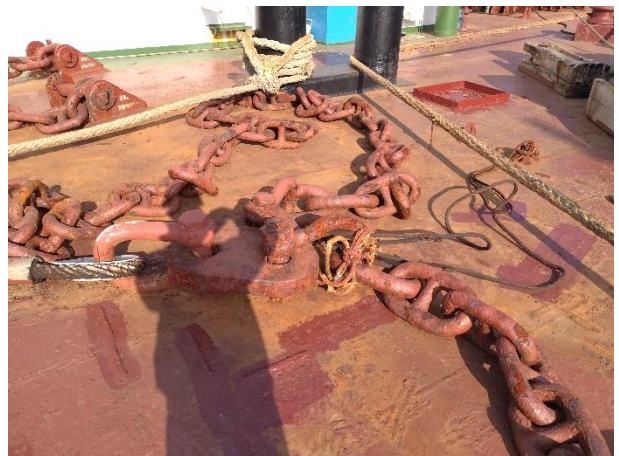
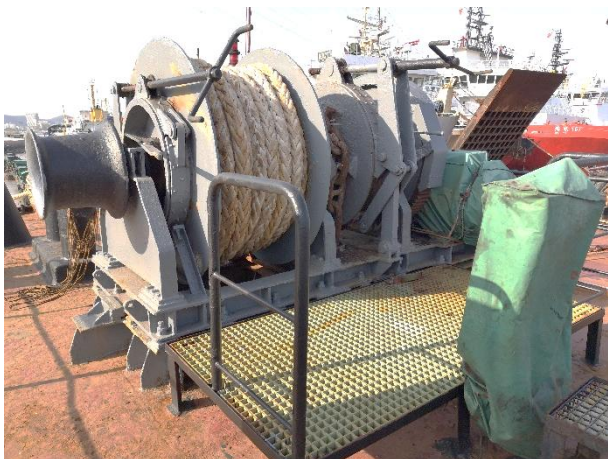
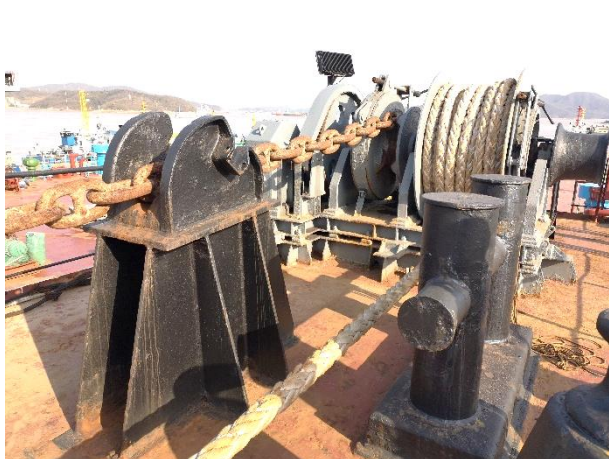
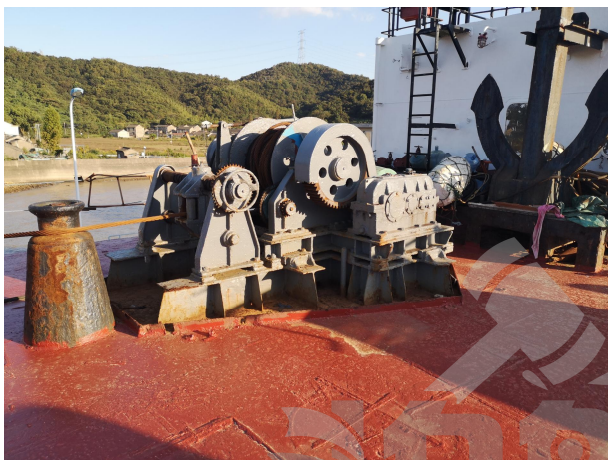
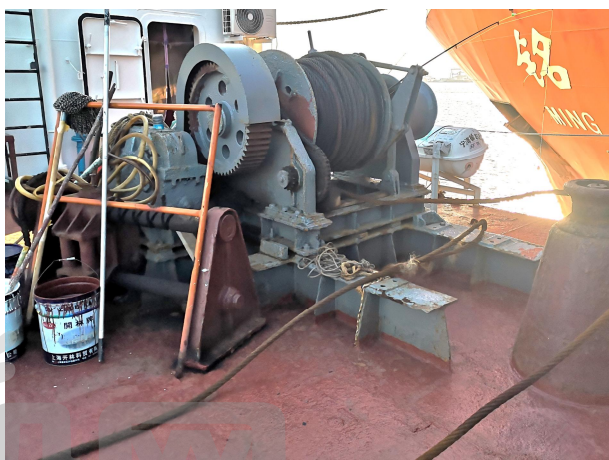
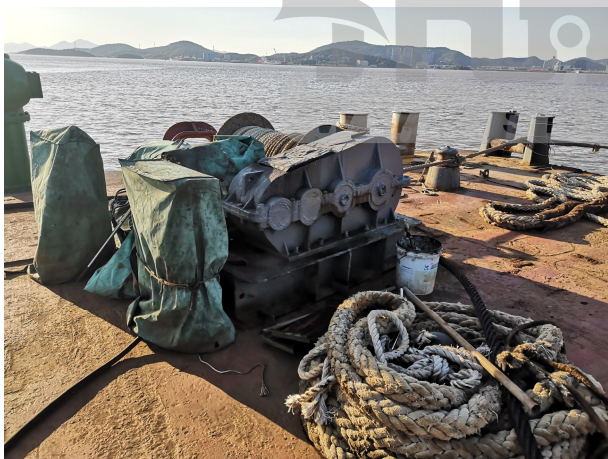
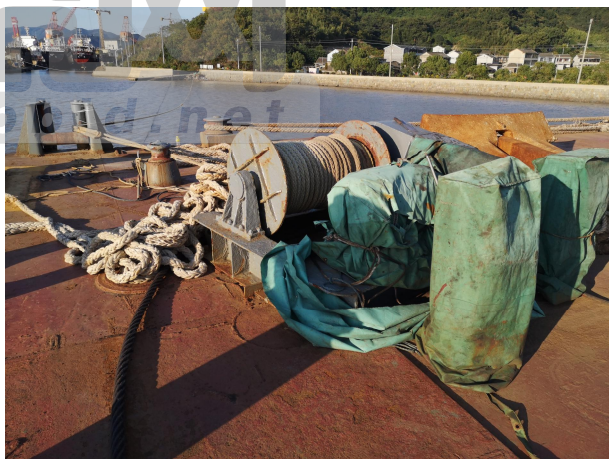
5.3 Towing and Mooring facilities

The overall paint of the towing eye plate and pedestal was found basically intact, without significant rust on the welds.

The bow fairlead was found worn and corroded, without deformed on the towing chain.

The paint of the electric windlasses on the forecastle deck was found intact, with slightly rusted on the base and reinforced structure.

The paint of the electric winches on the main deck was found intact, with slightly rusted on the reinforced structure of the base.

The paint surface of the positioning winches installed on the bow and stern of the main deck was found intact, without significantly rusted on the welds of the base.

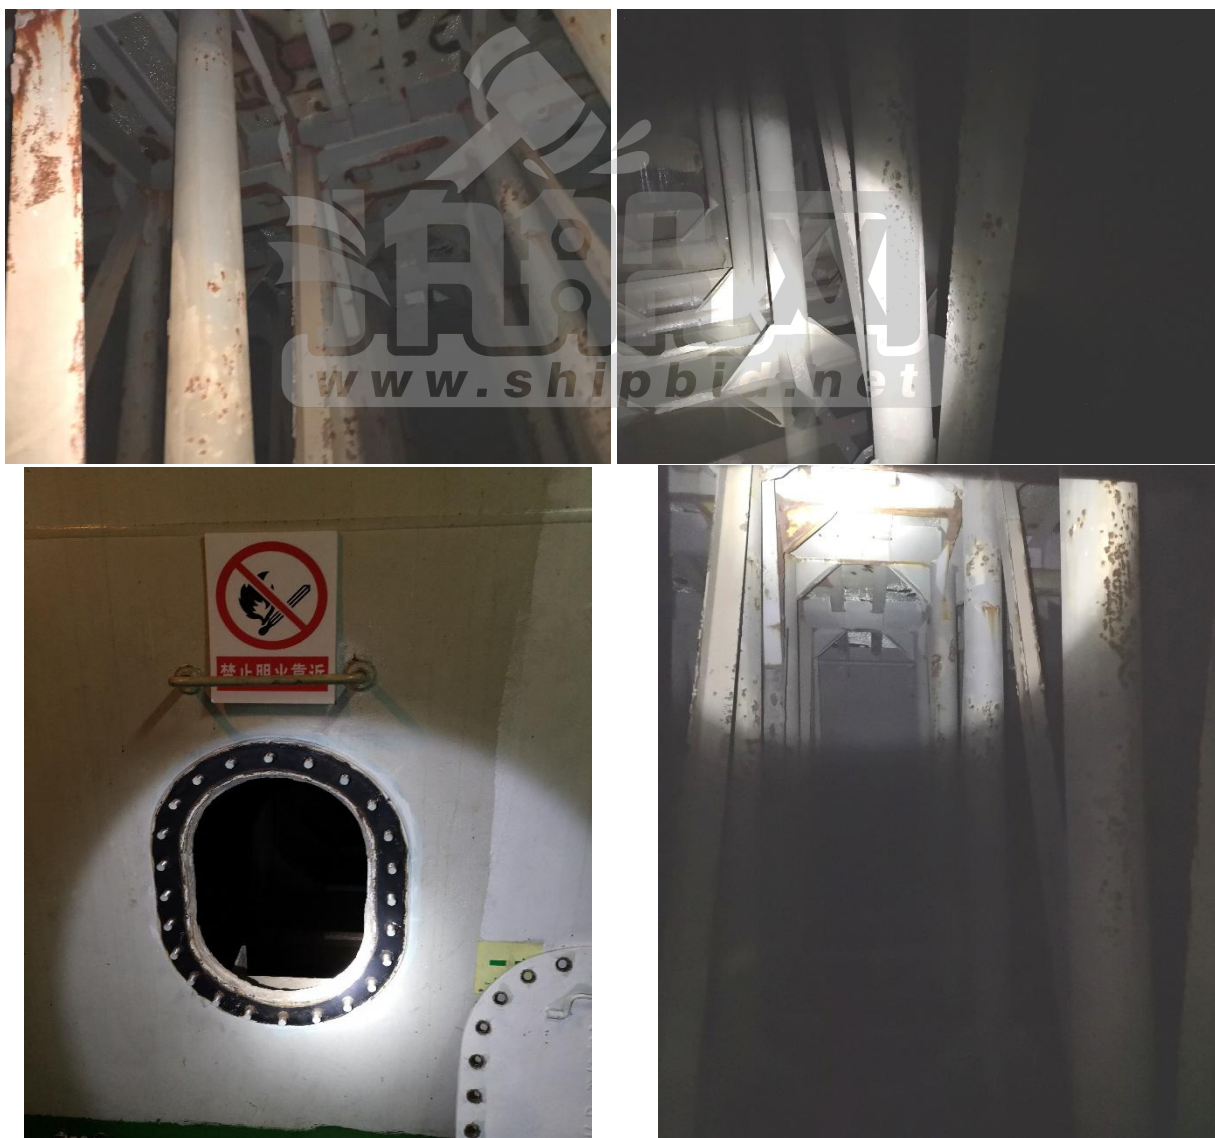
5.4 Ballast Tank

During the inspection, NO.1 ballast tank (S) was conducted an internal inspection.

The watertight manhole cover of the ballast tank was found to be free from rust, without aging and cracking on the sealing rubber.

The coating condition inside the ballast tank was found intact.

The reinforced bracket was found to be free from deformation and corrosion, but pitting corrosion on the pillars.

The blocky rusting was found on the back side of main deck, and slightly rusted on the edge of the deck longitudinal.

The anti-corrosion zinc block was found partially corroded, without obvious corrosion on the frame plate.

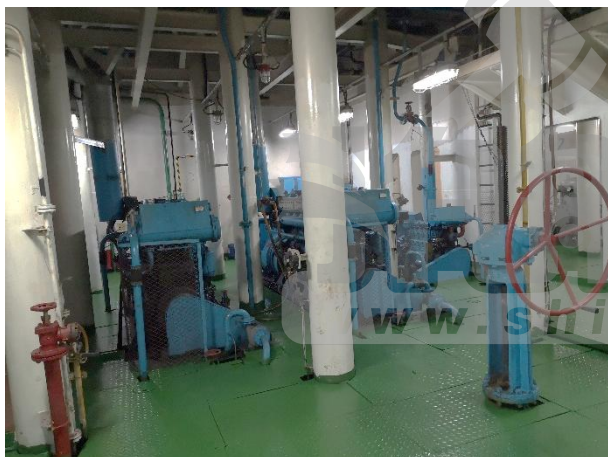
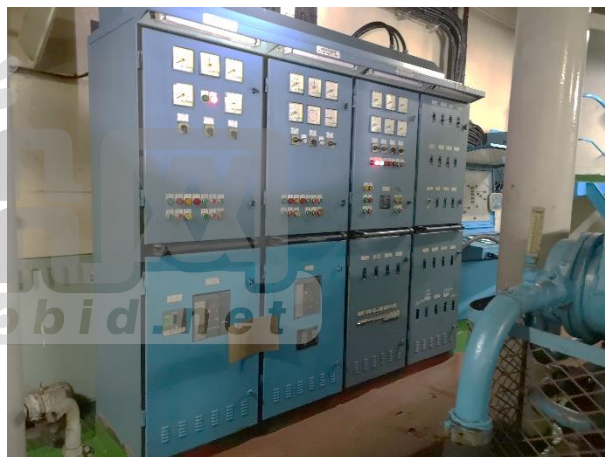
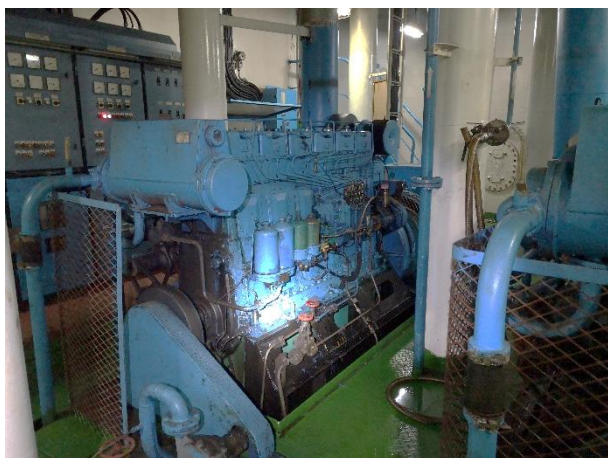
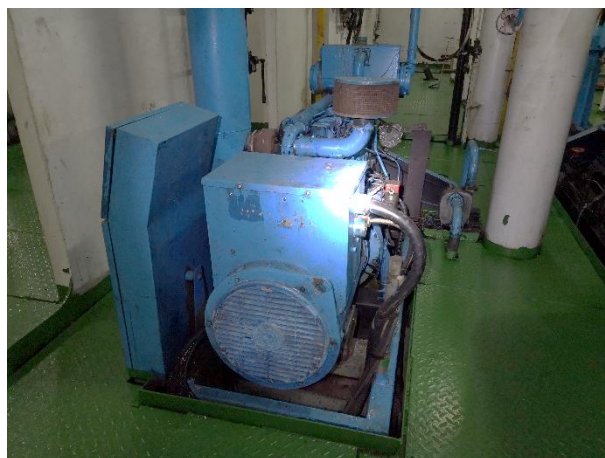
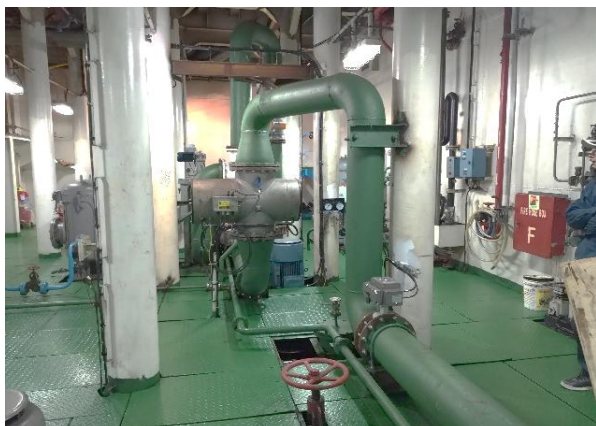
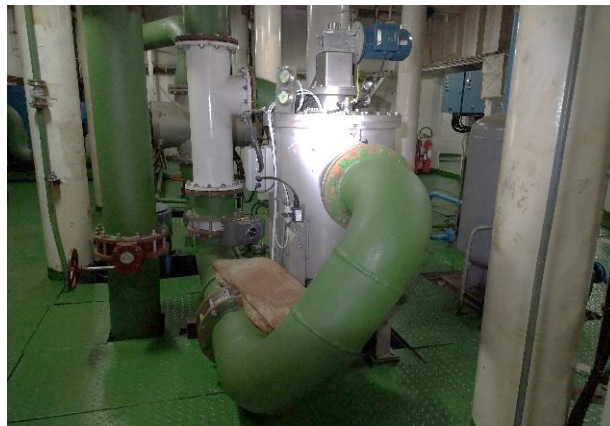
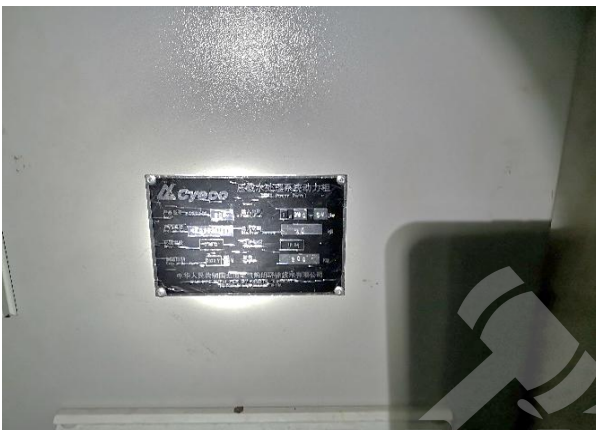
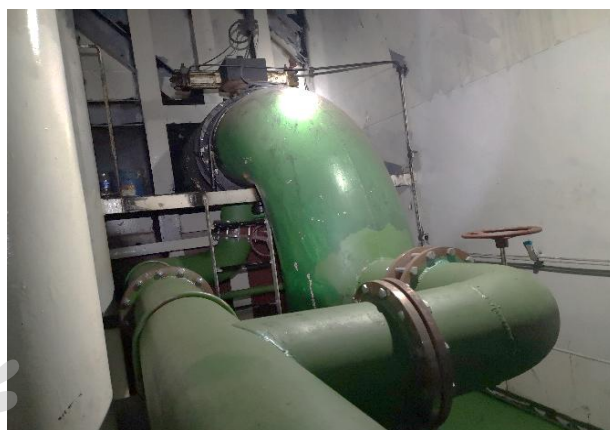
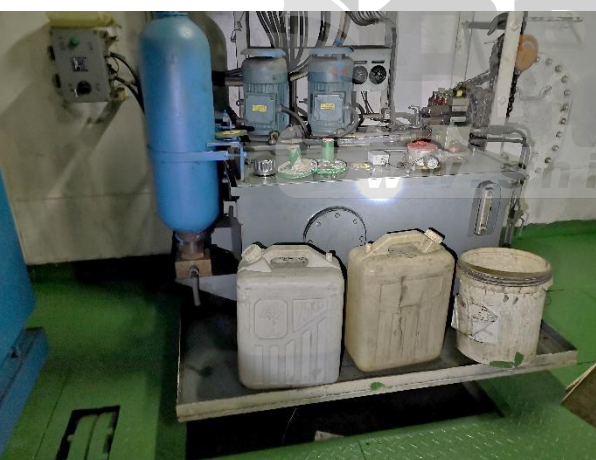
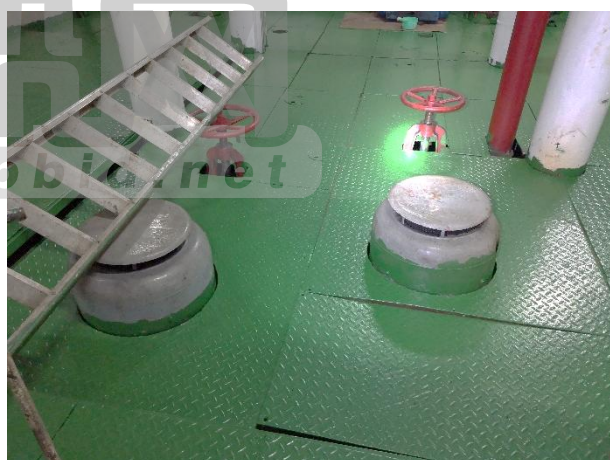
5.5 Engine Room and Machinery

The structure in the engine room was found to be complete, the paint protection was found to be general good. The cable insulation wrapping was found complete without damage.

The overall appearance of the generator sets was found clean and tidy, without significant oil stains on the chassis and rust on the pipelines and components.

The main control unit of the ballast water treatment device was found located in the generator room, and the corresponding pipeline appearance was intact and rust free.

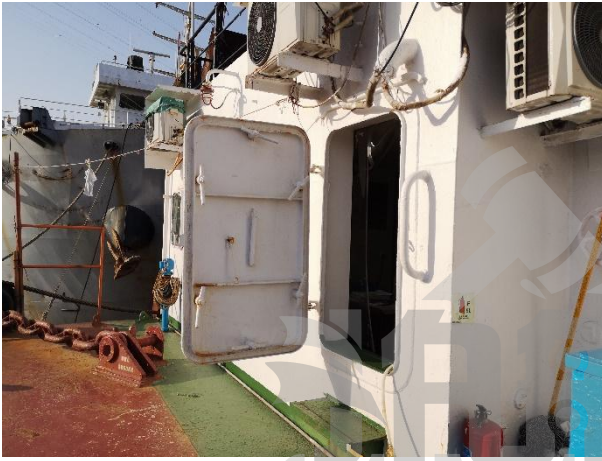
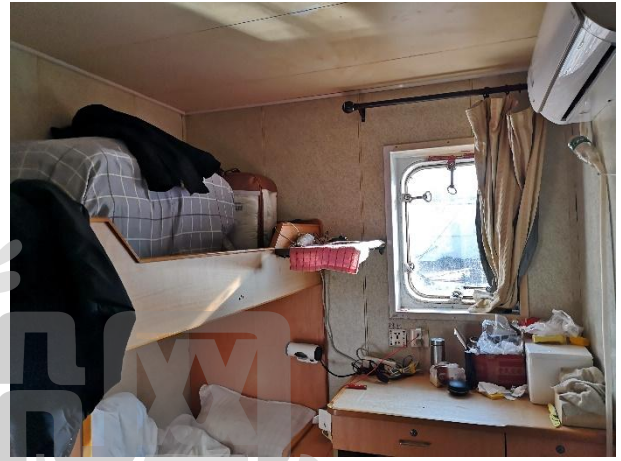
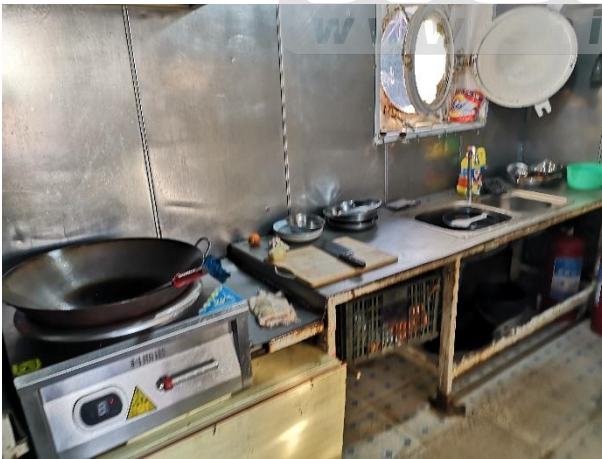
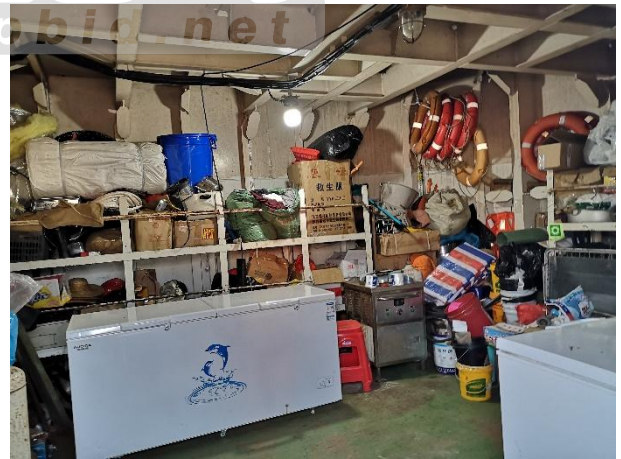
5.6 Accommodation Condition

The weathertight door and frame was found to be free from rust, with waterproof adhesive strip missing.

The decoration and furniture were found basically intact, without damage on the windows.

6. The facilities in the accommodation room were found basically complete, with waterproof adhesive strip of weathertight door missing.
