# TECHNICAL REPORT

CJPG-JS-23-KY-692

## HAO YING YUN 7

Inspection date      December 6th, 2023

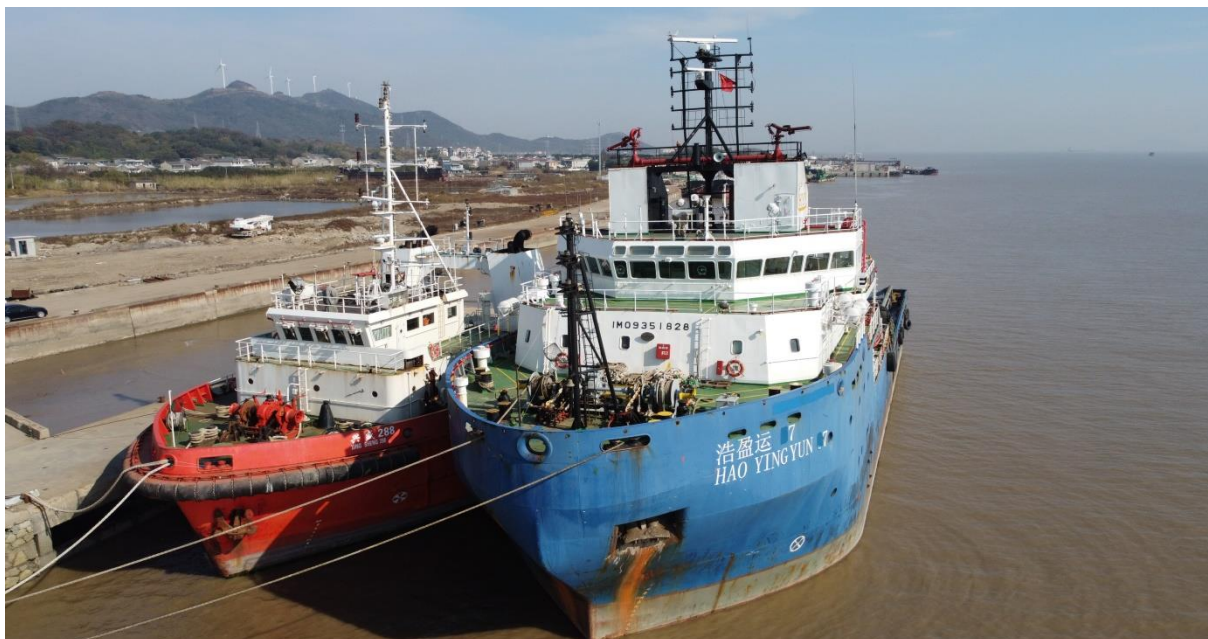
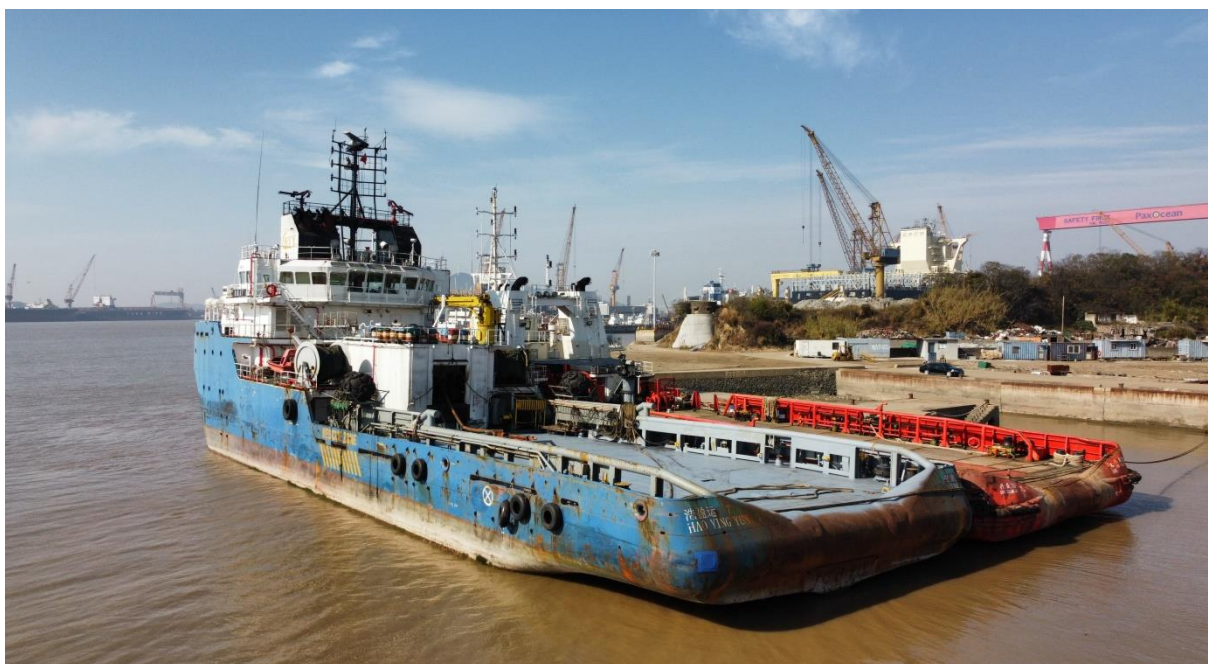
The larger corrosion rate for hull thickness measurement is 14.4% at the starboard side of the midship bottom, while the corrosion rate for other structures is basically 5% or less.
