TECHNICAL REPORT

CJPG-JS-24-KY-0438

NING FENG YOU 1

Technical Report

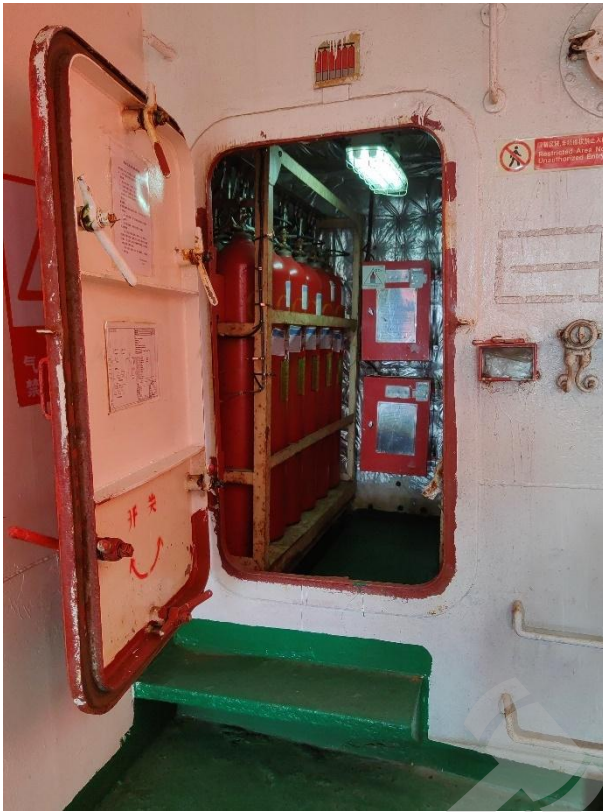
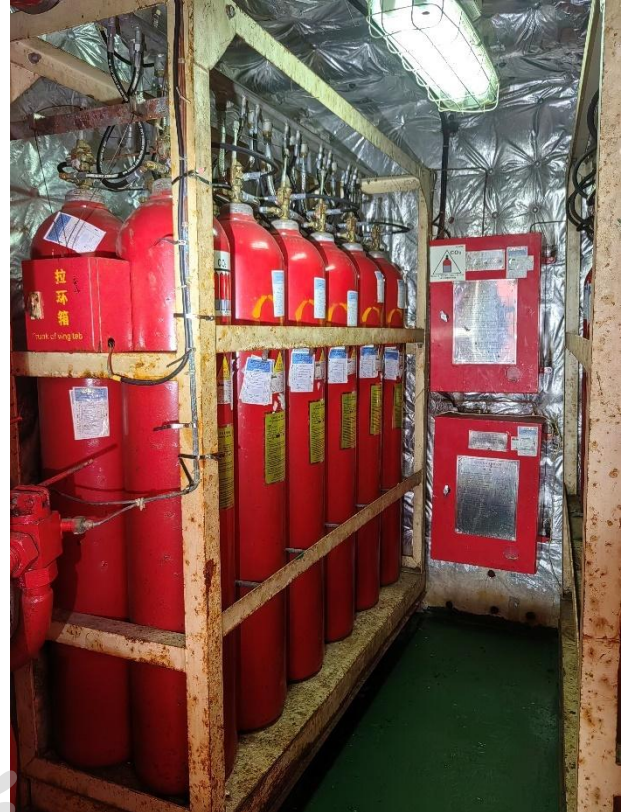
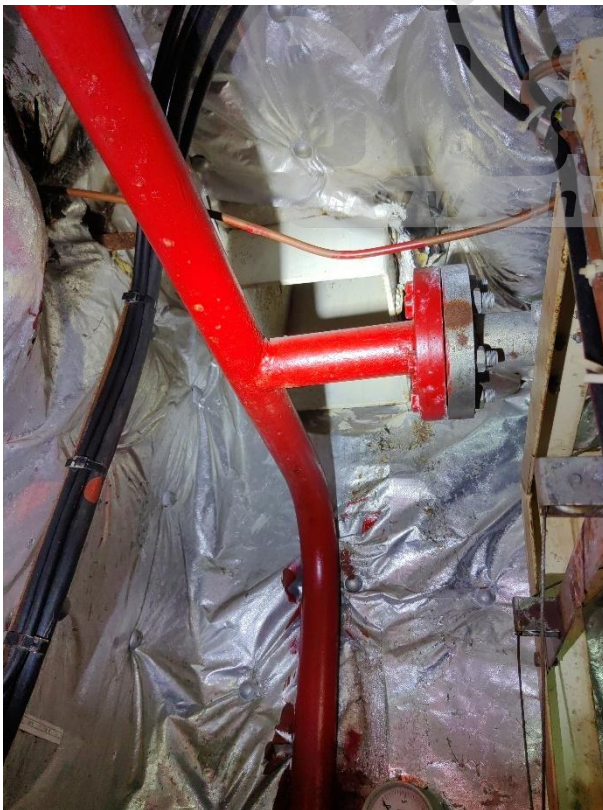
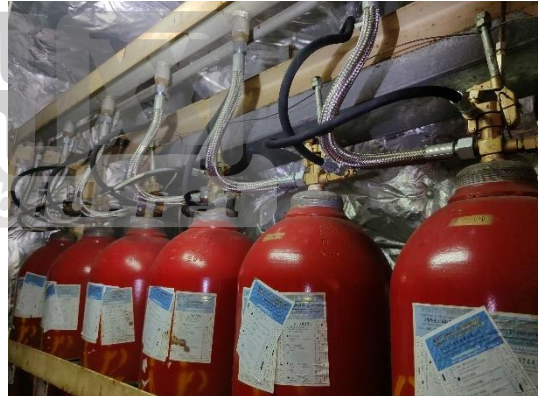
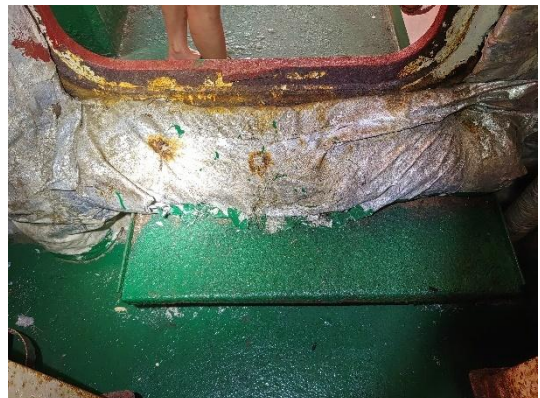
The CO2 room weatherproof door adhesive strip was found to be covered with paint.

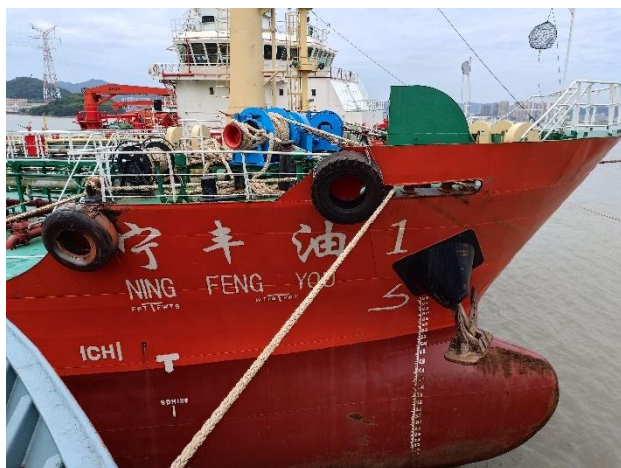
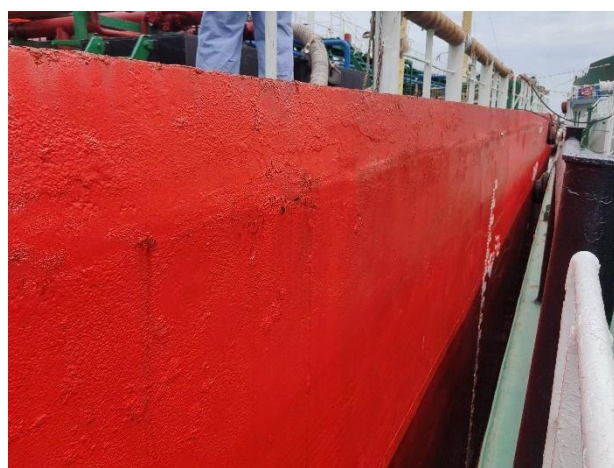
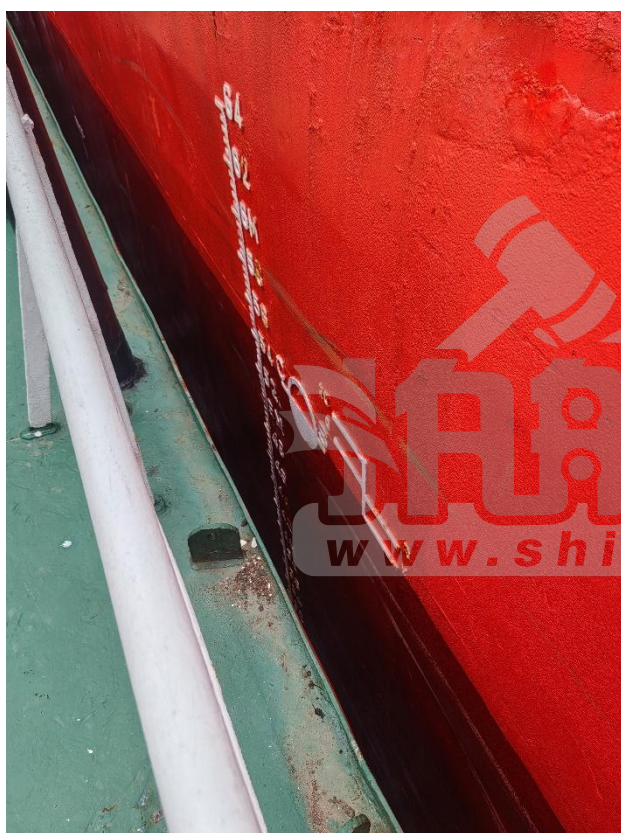
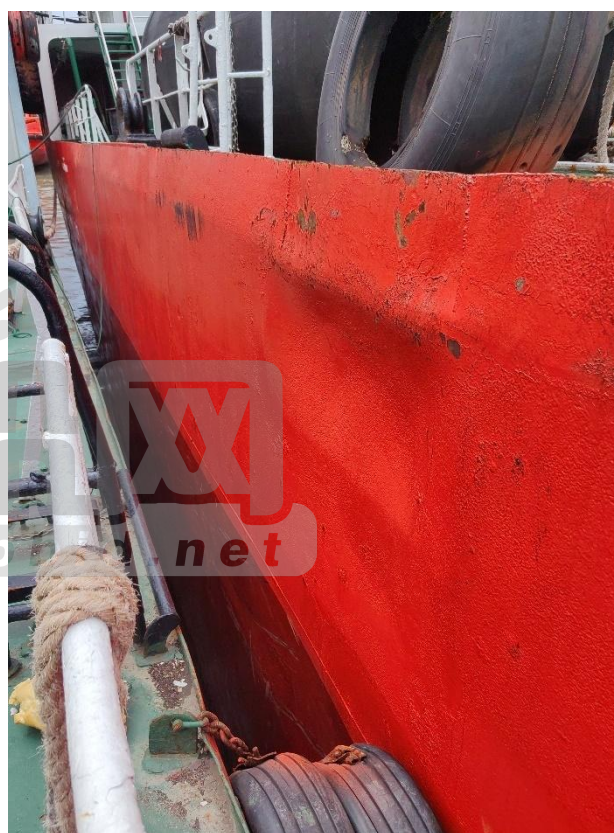
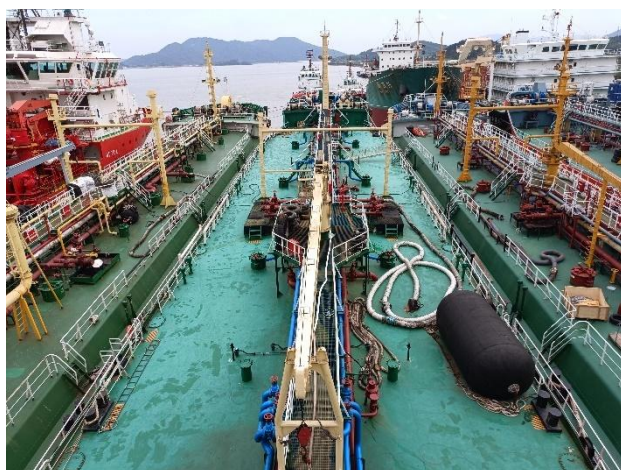
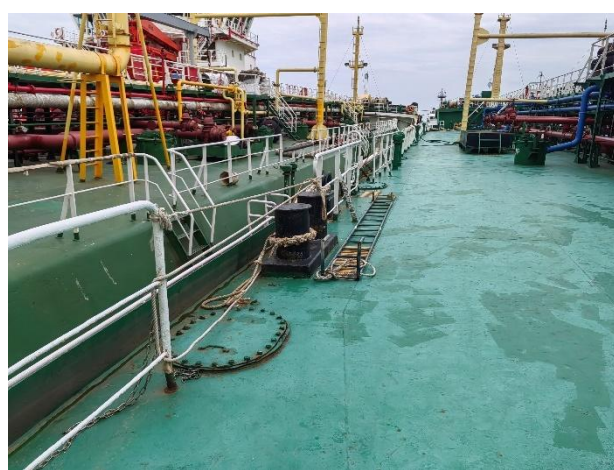
There are two obvious collision dents on the starboard shell plate.

The fastening bolt on the brake side of the right anchor machine was found to be missing.

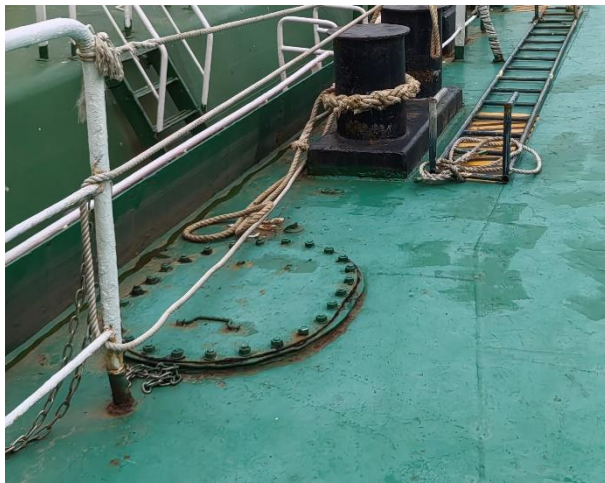
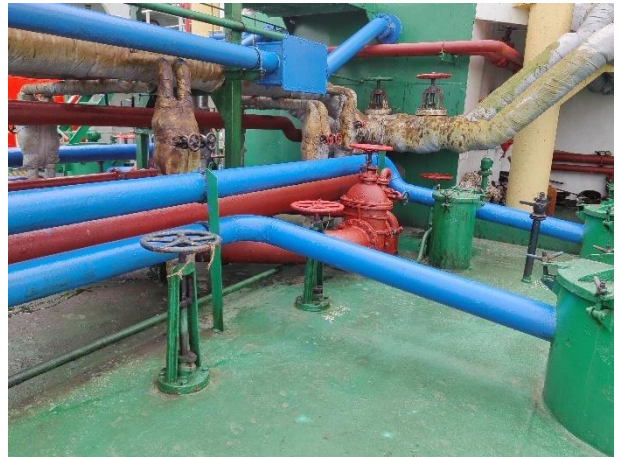
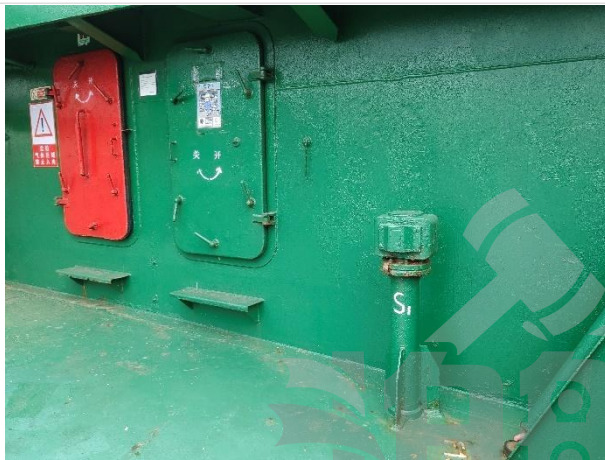
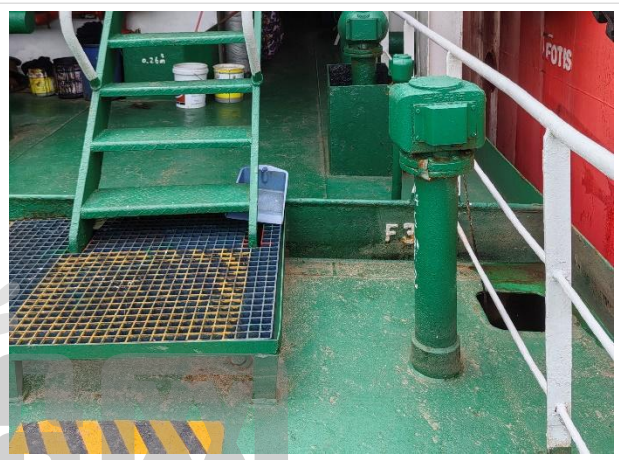
During the inspection, the effective ventilation was not carried out and the inside inspection has not been conducted. The specific situation inside the tank is unknown.

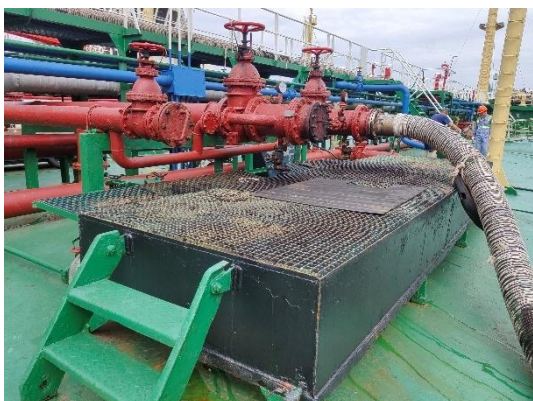
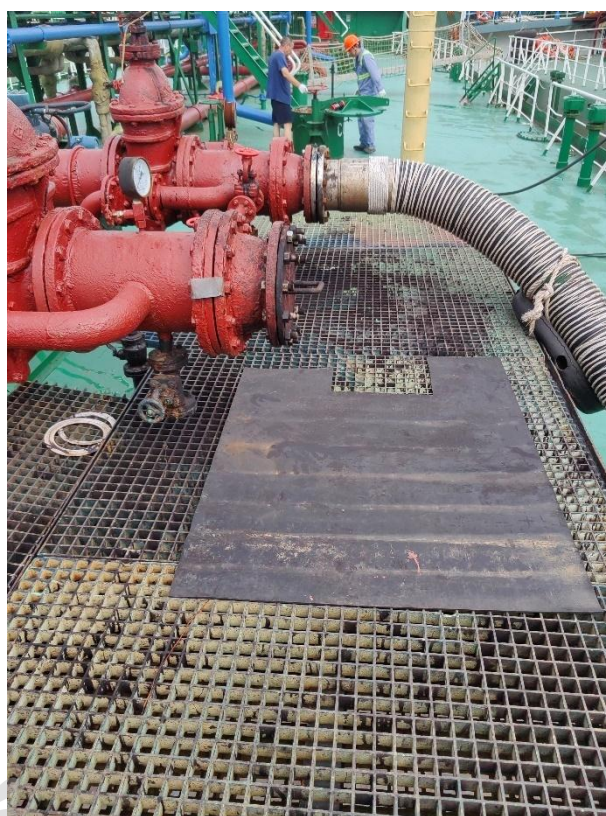
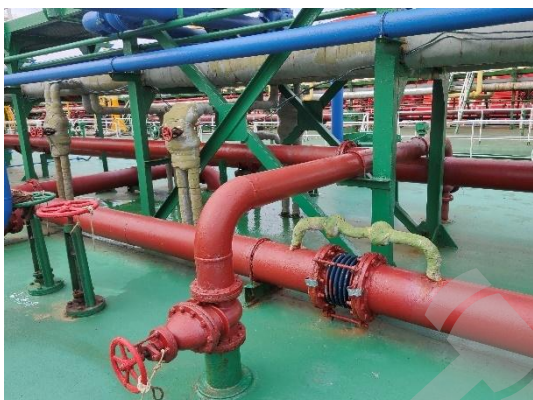
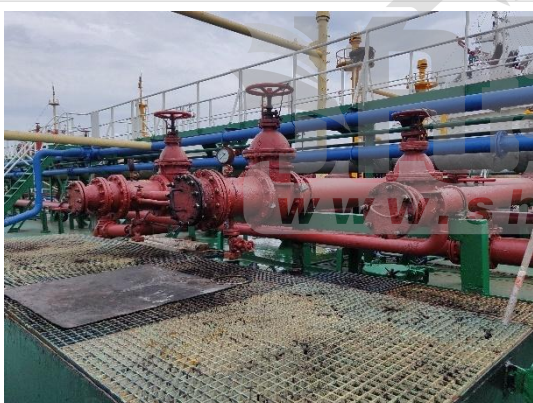
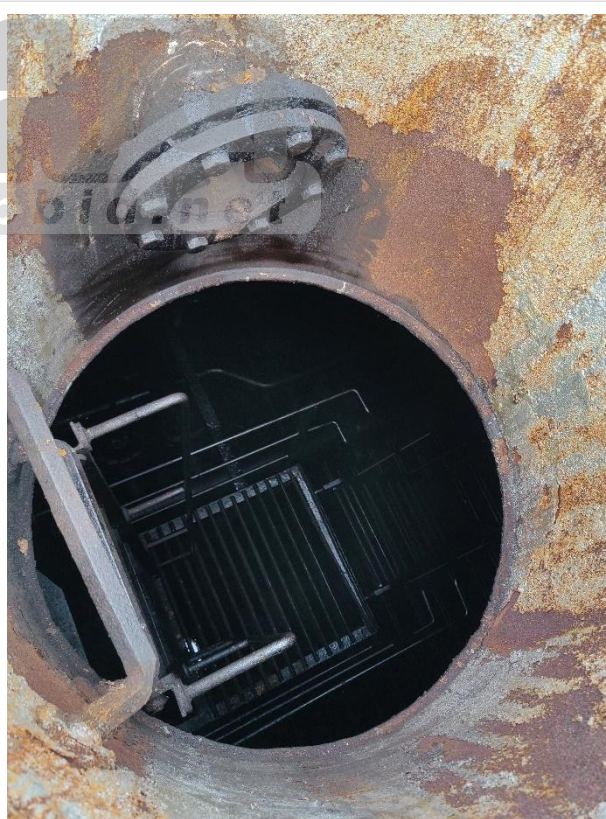
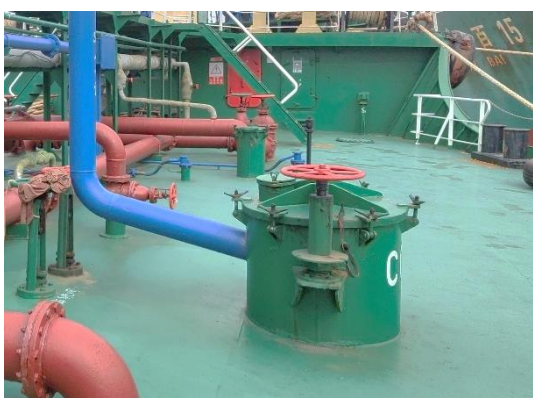
The cargo oil tank has not been cleared and no inspection has been conducted. The specific situation inside the tank is unknown.

The insulation material of the residual oil pipeline of the cargo oil screw pump in the cargo pump compartment is damaged.
