TECHNICAL REPORT

CJPG-JS-24-KY-0617

HE TAI TONG 2

Inspection date September 26th, 2024

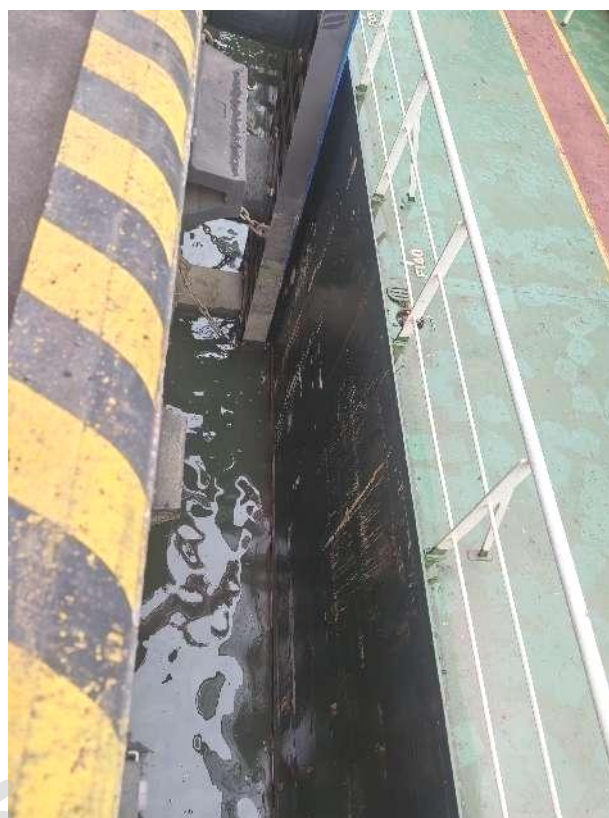
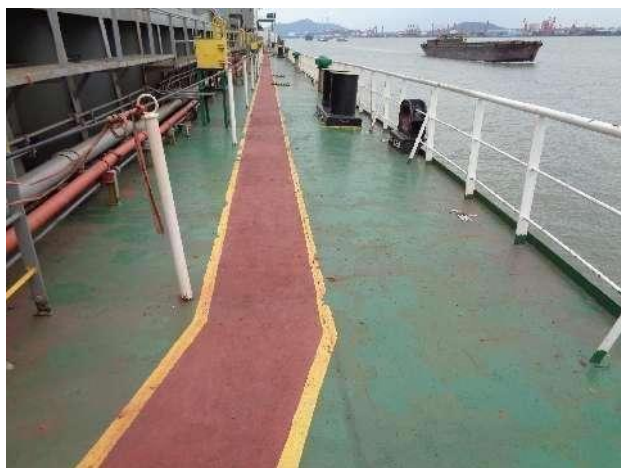
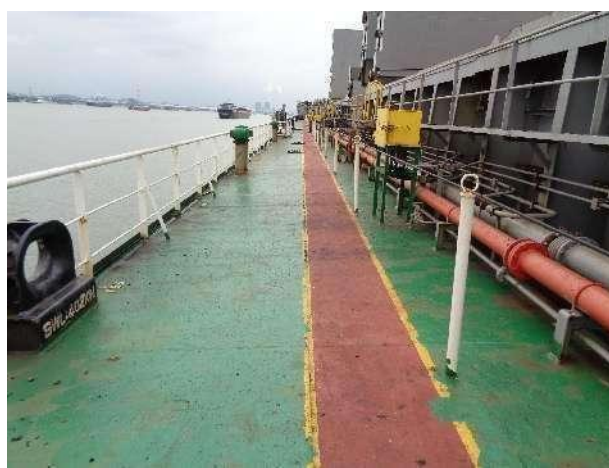
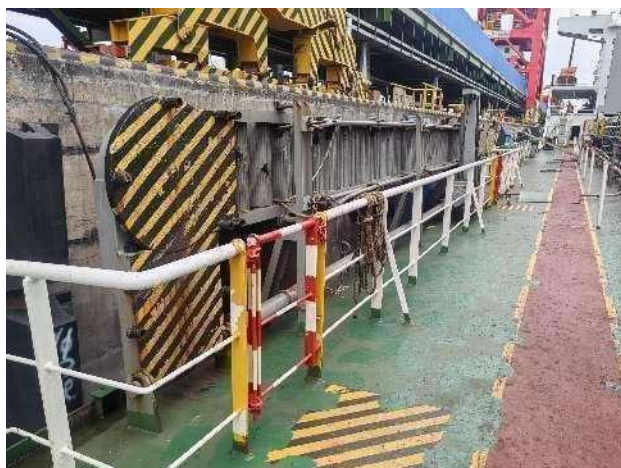
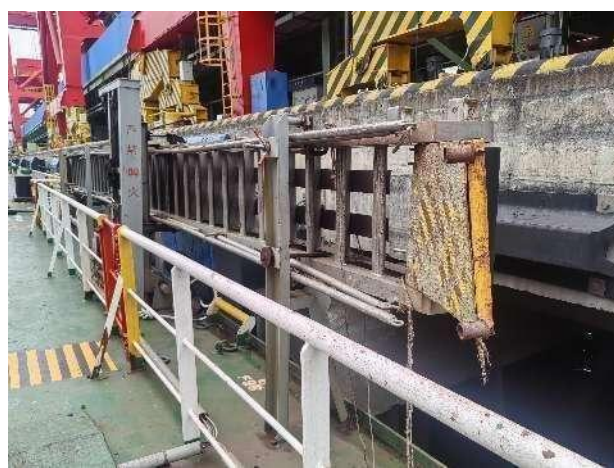
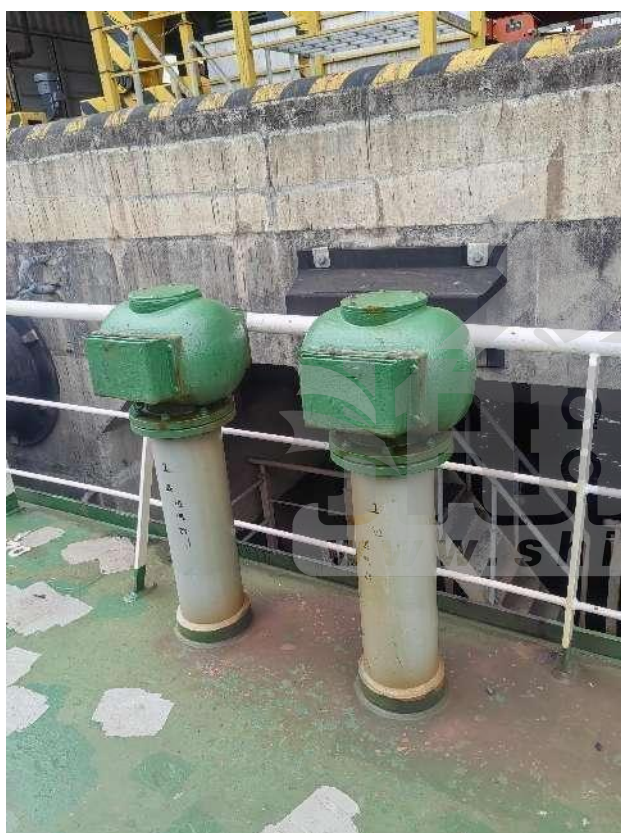
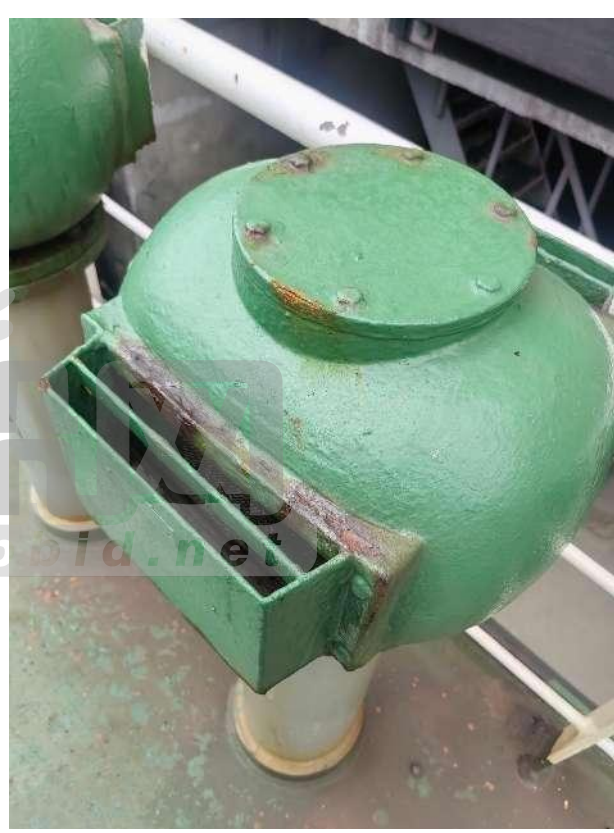
There were multiple rust spots on the weld seam of the bow shell plate, and there were obvious scratches on the paint.

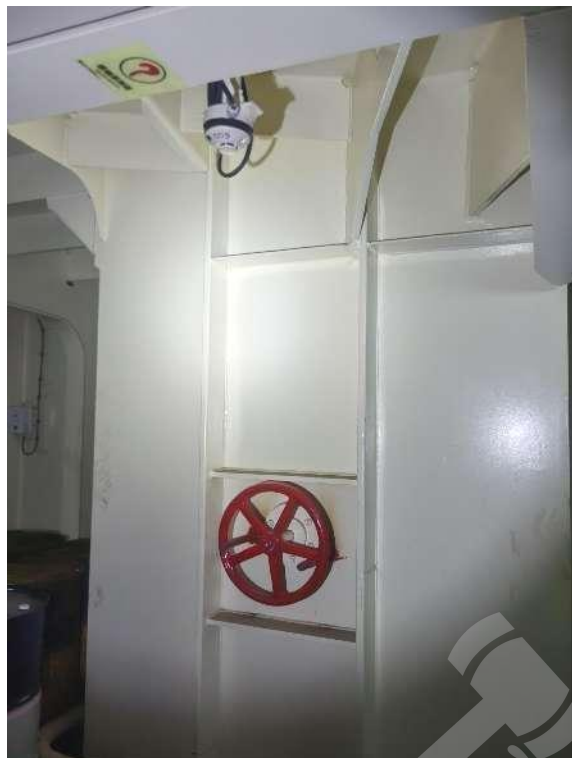
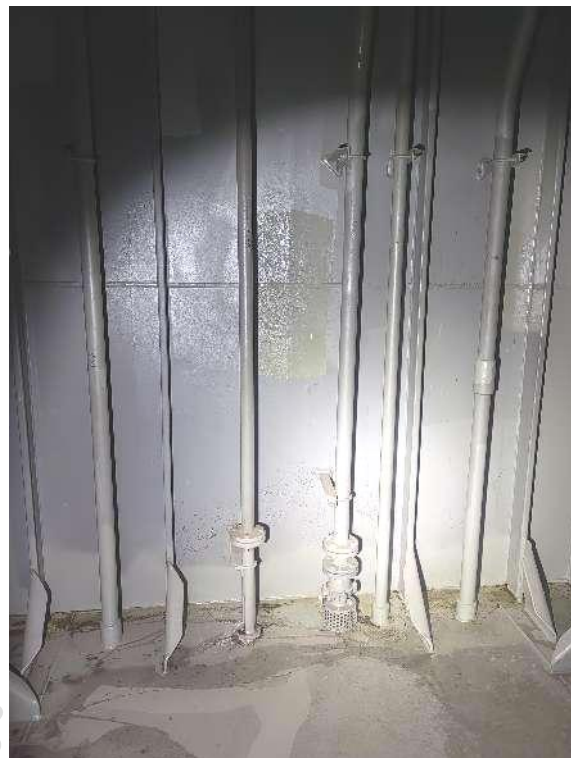
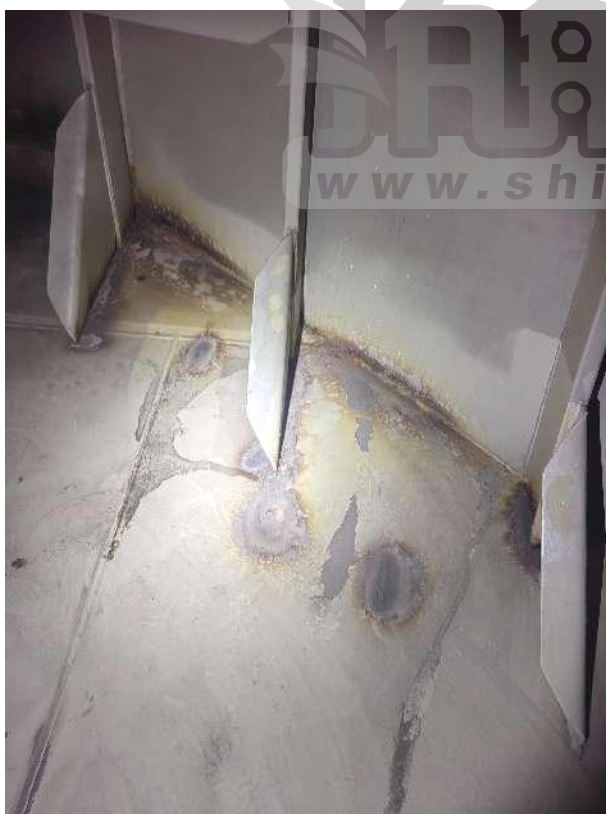
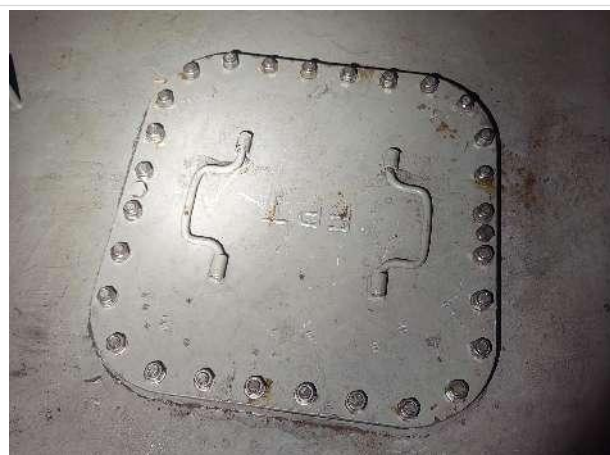
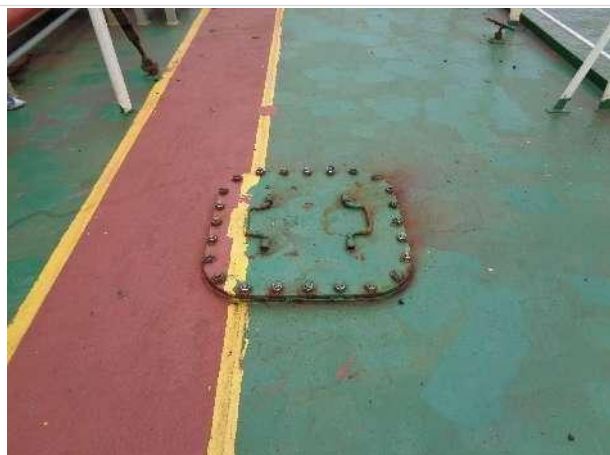
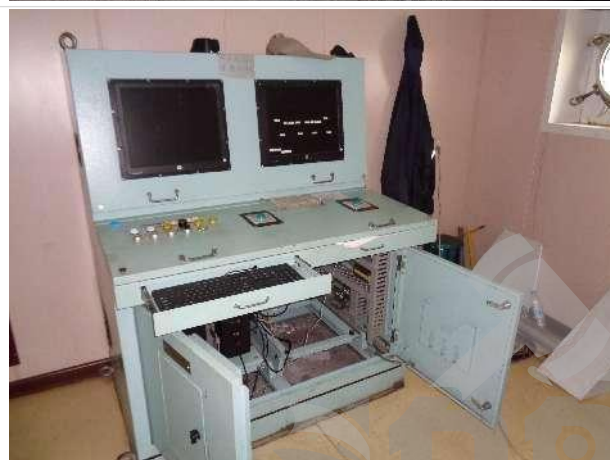
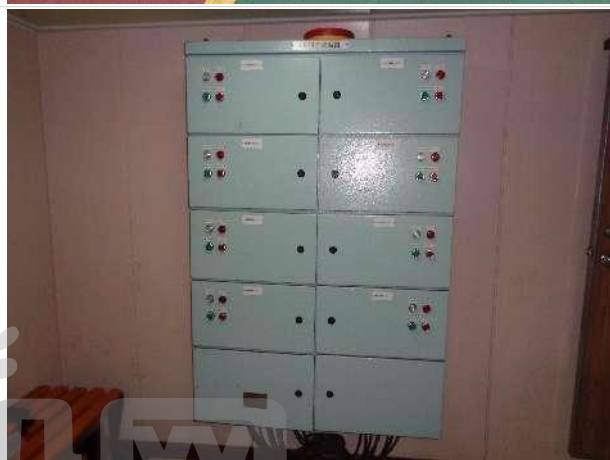
1. Due to the presence of ballast water in the ballast tank and the lack of ventilation in the void space, the surveyor is unable to enter for inspection.
2. No rotation direction mark was found on the derailleur wheel of chain gear in the chain locker.
3. The deformation bulge was found on the platform of fore void space, and there was a 1m * 30cm repair welding plate near the platform on the shell plate of the bow column in the void space.

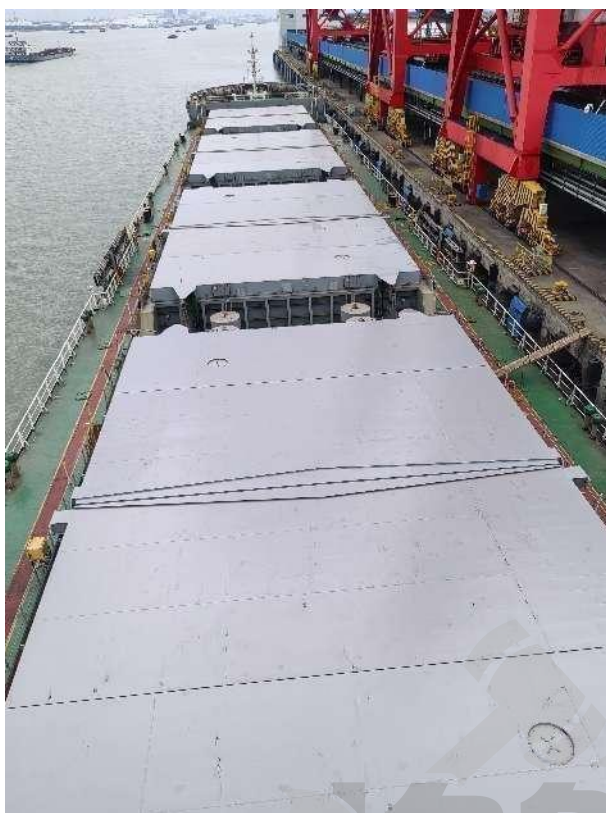
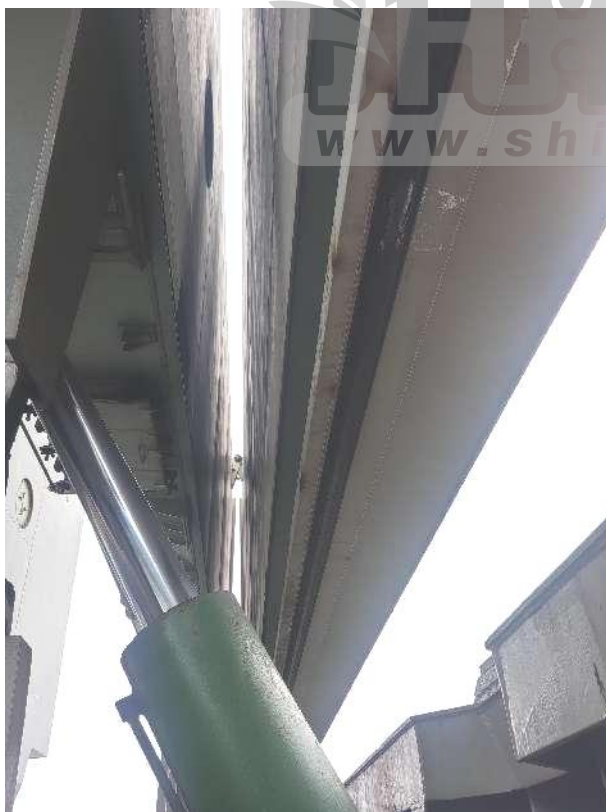
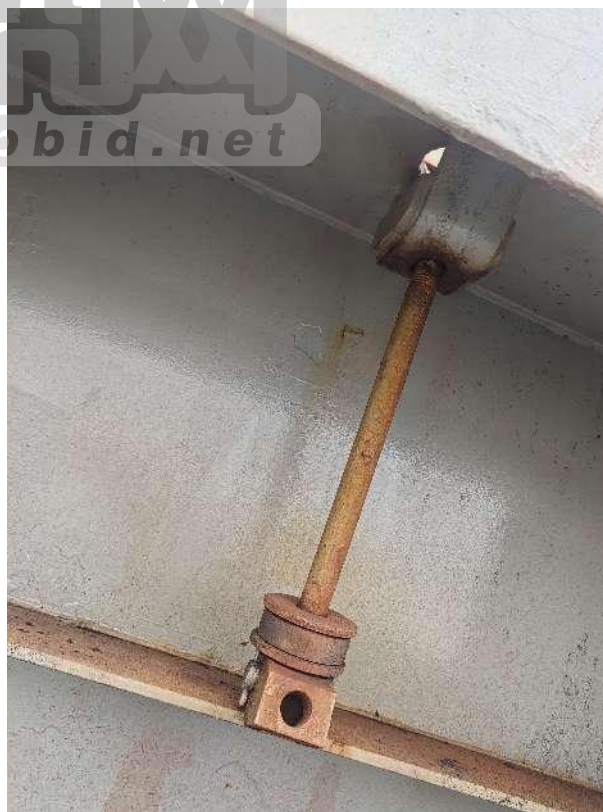
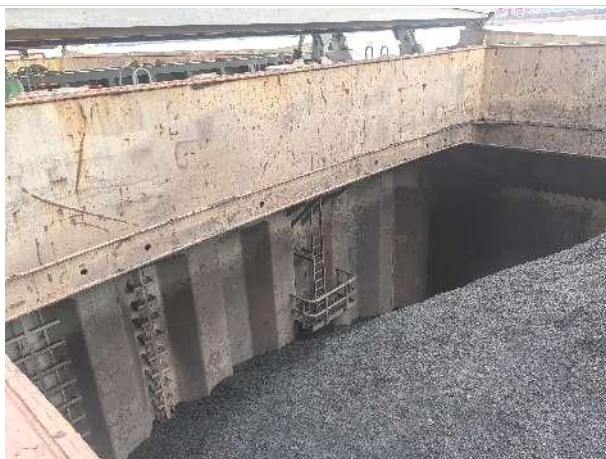
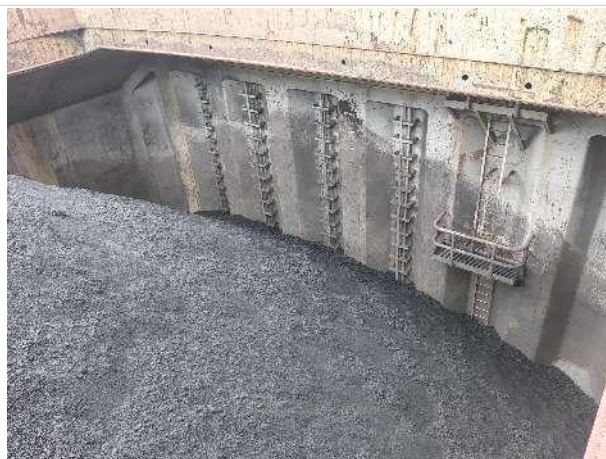
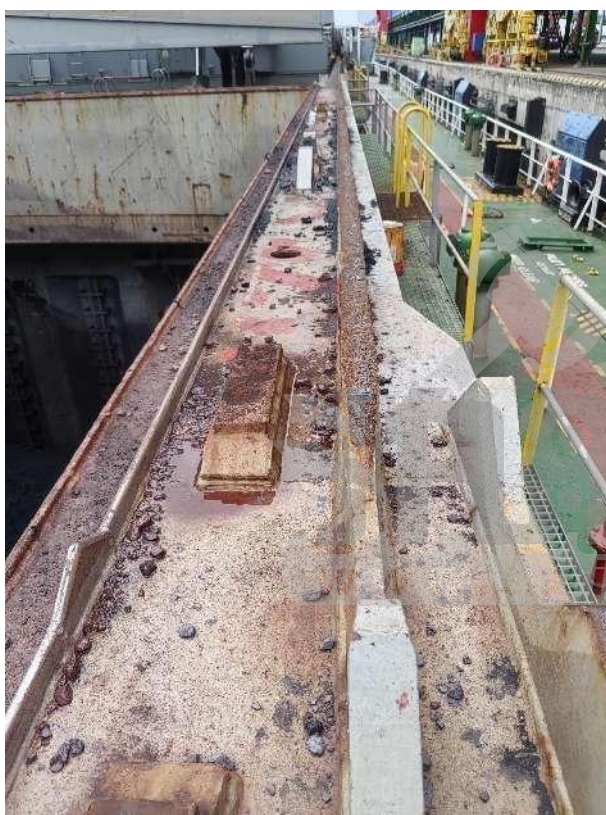
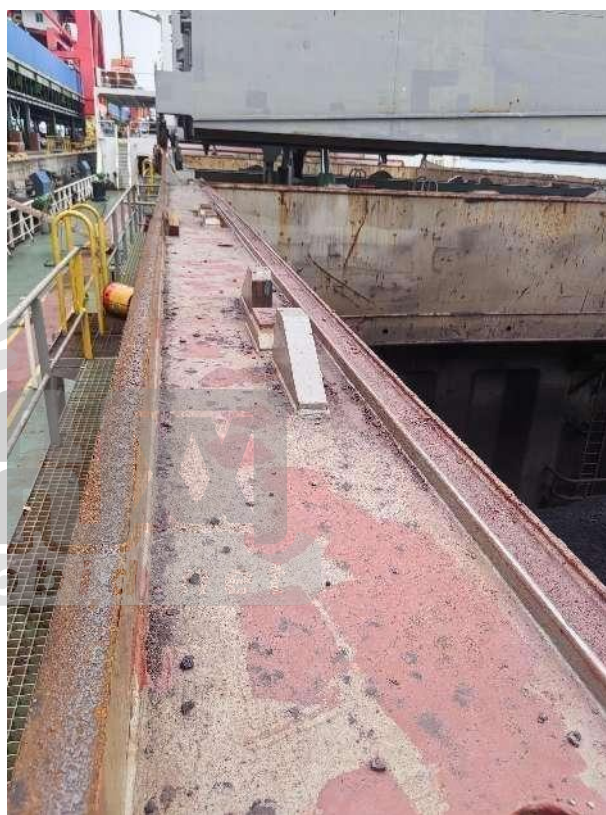
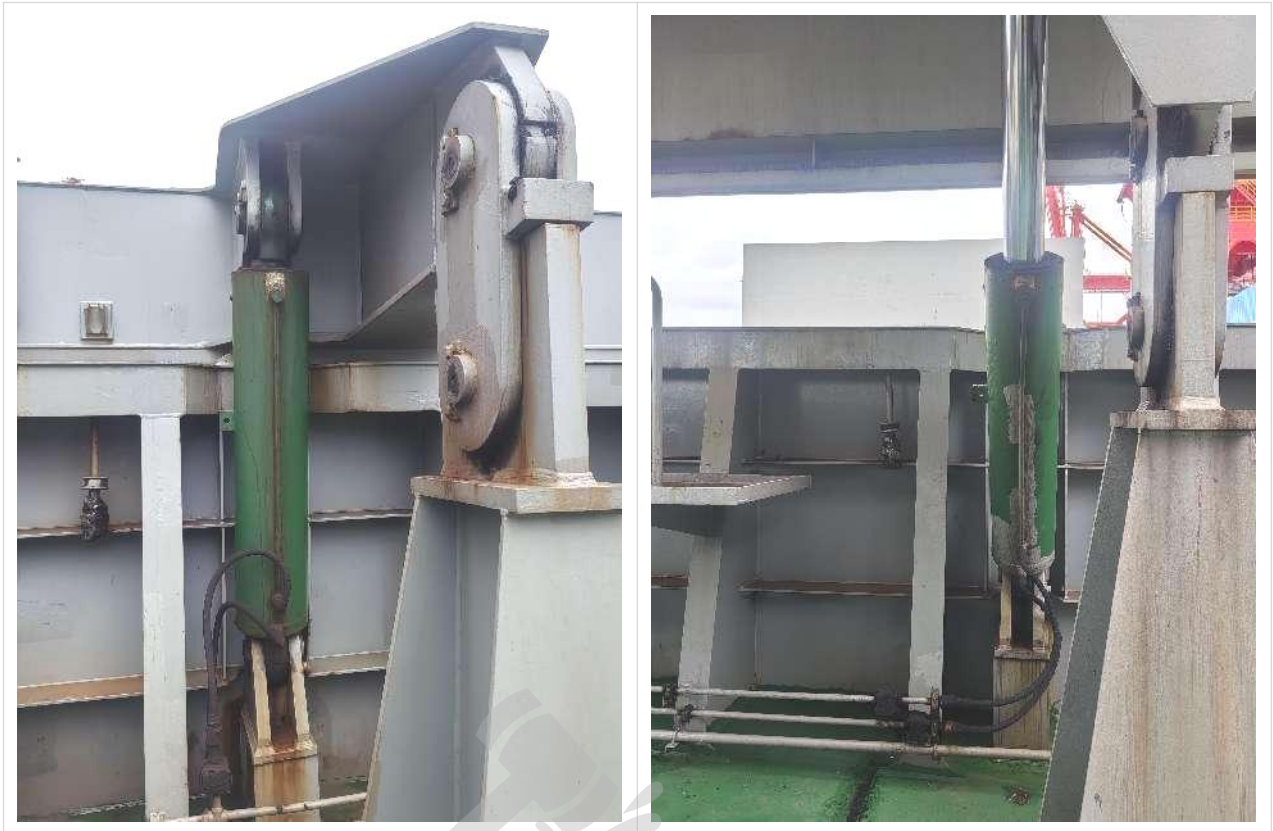
During the inspection, all of 4 cargo holds were in a state of waiting to be unloaded, and the condition of the watertight bulkheads and inner bottom plates was unknown.
