# TECHNICAL REPORT

CJPG-JS-24-KY-028

## GUO DIAN 36

Inspection date      January 4th, 2024

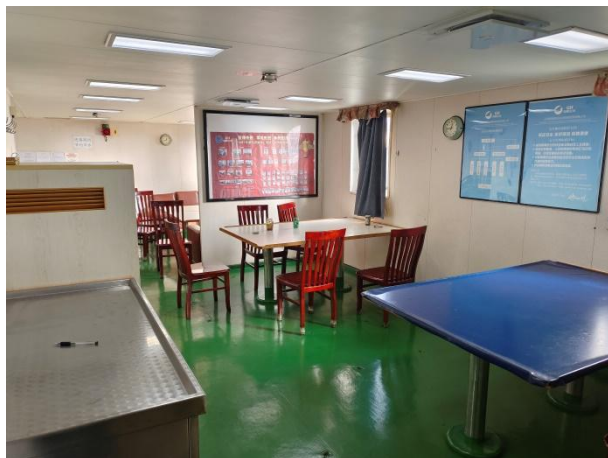
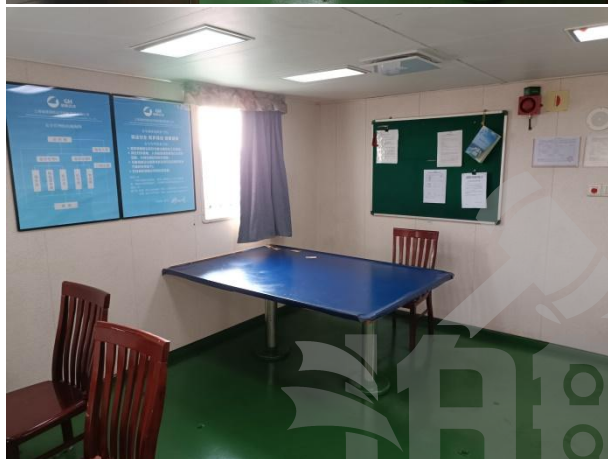
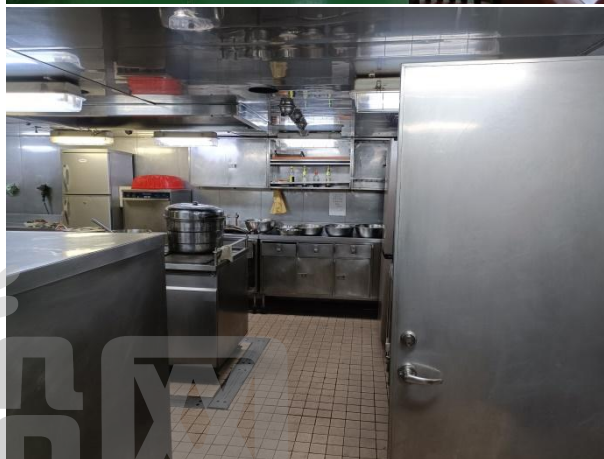
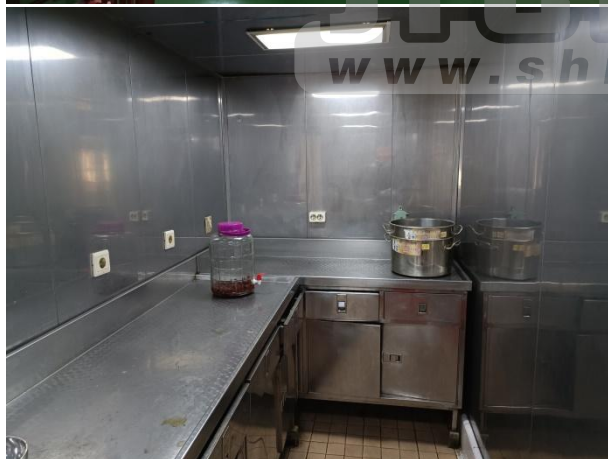
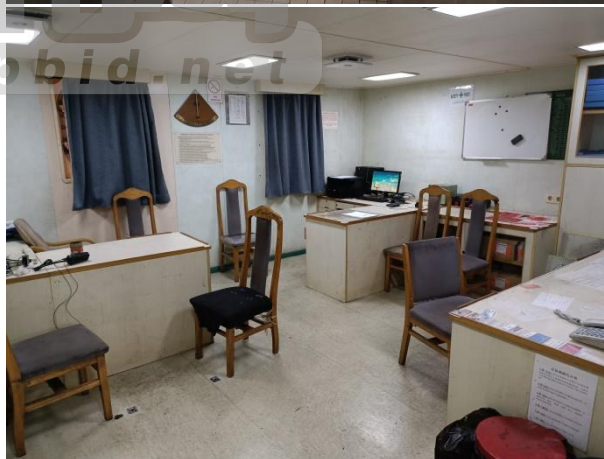
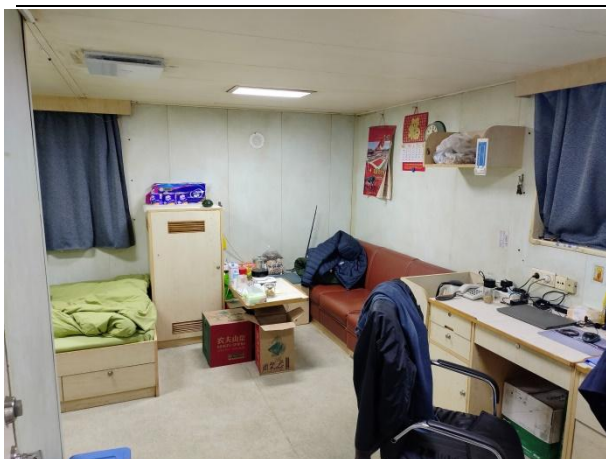
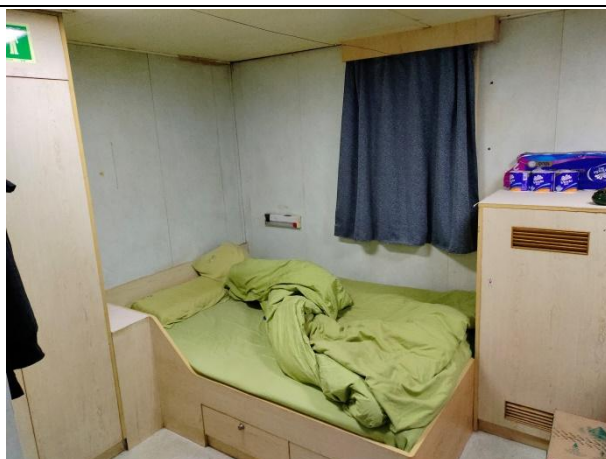
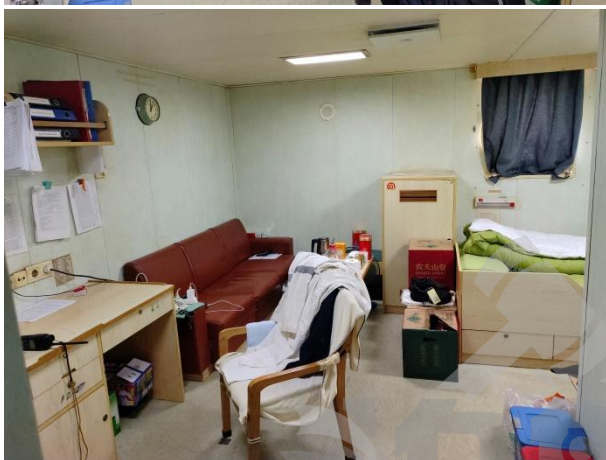
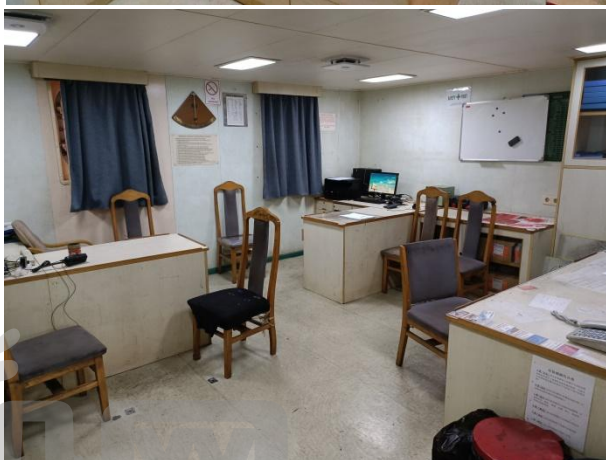
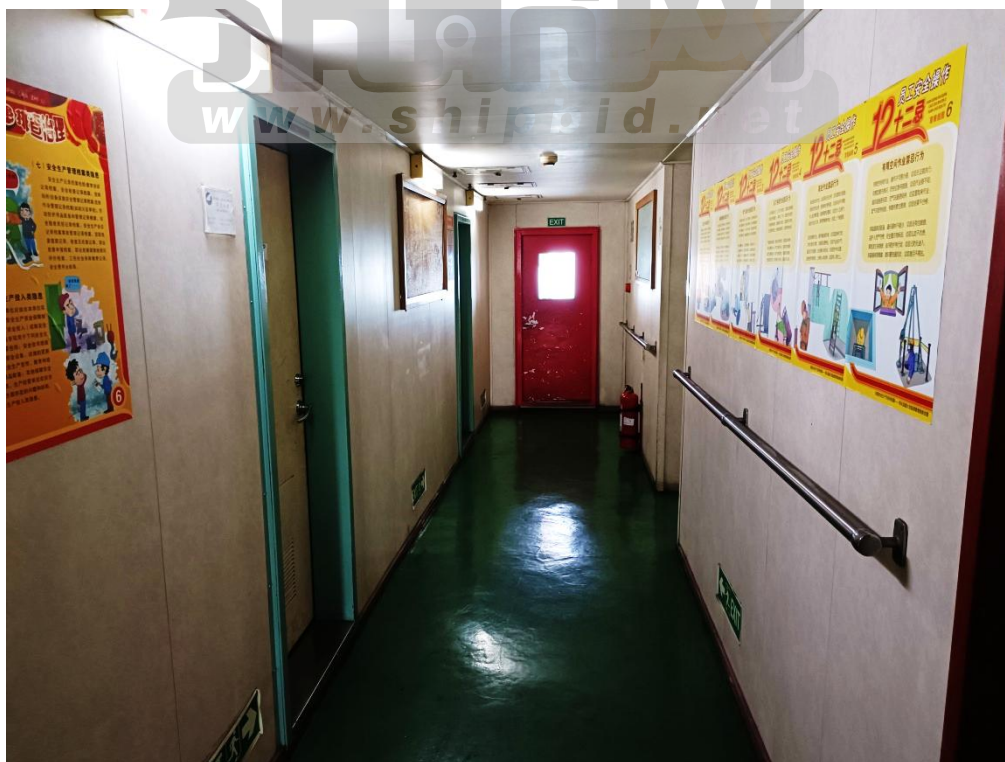
Wear and tear found on the accommodation area floor.

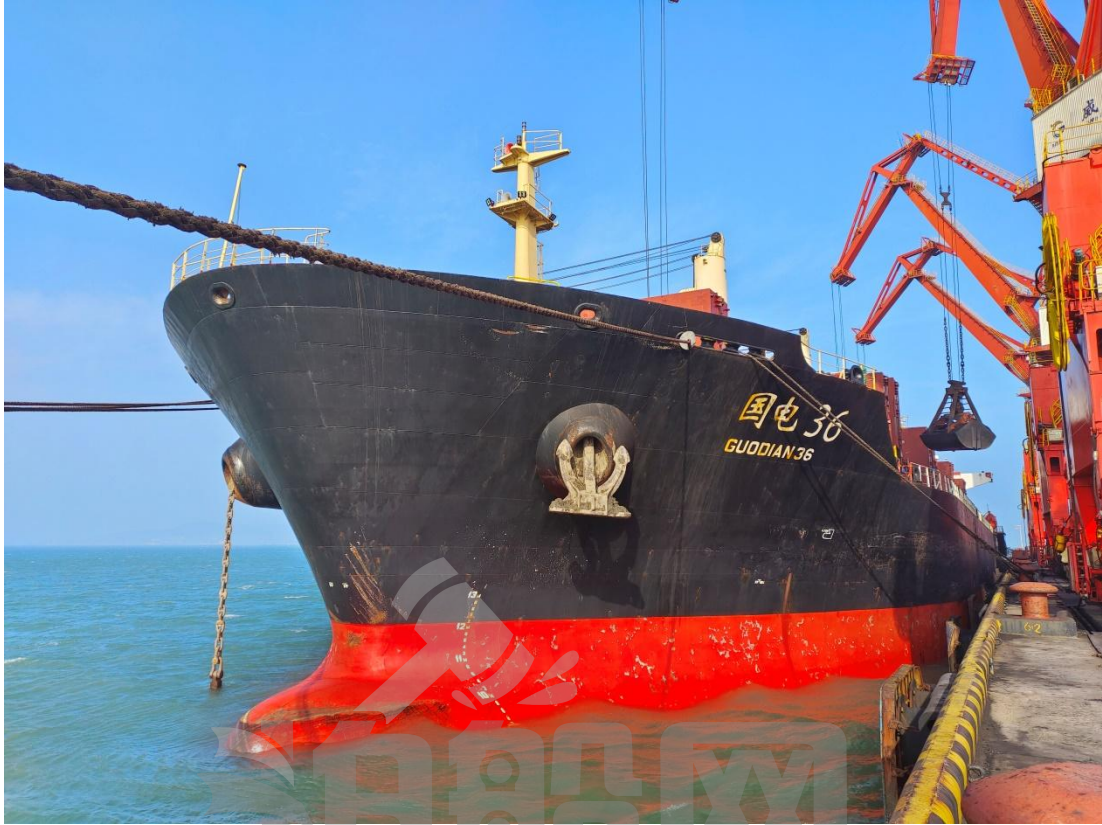
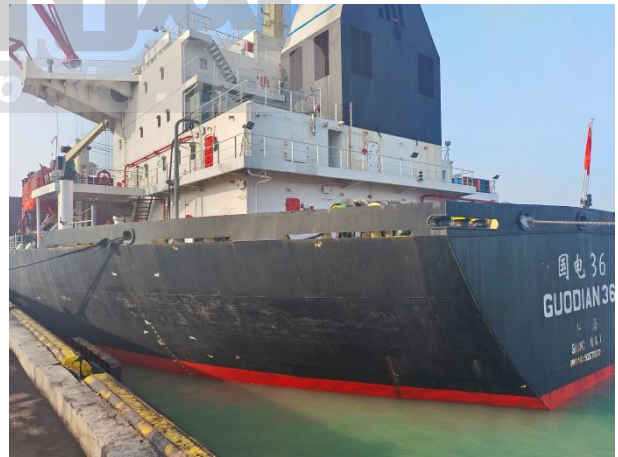
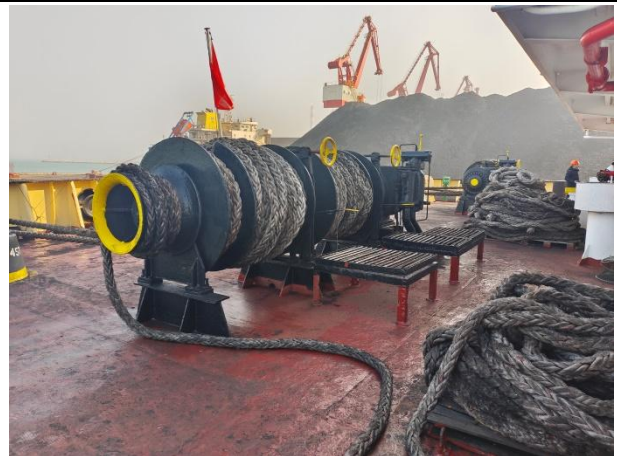
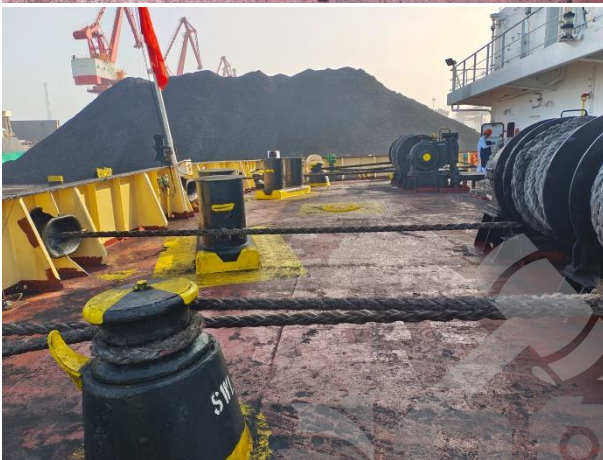
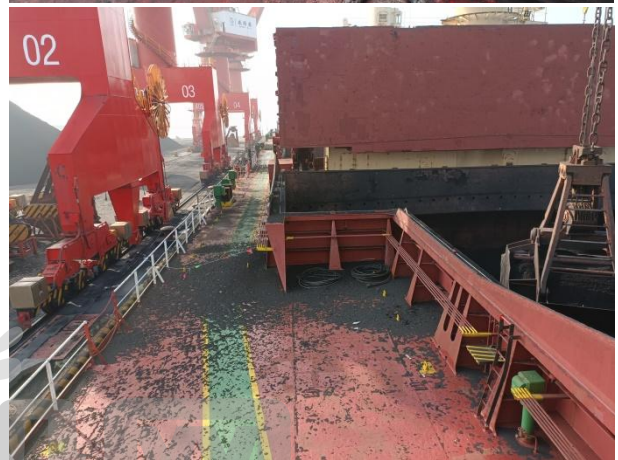
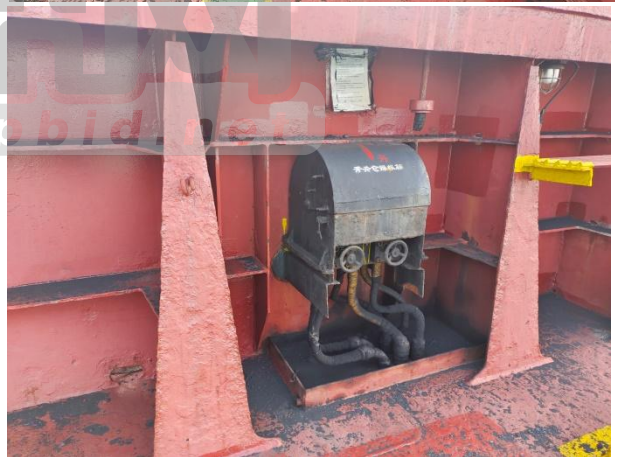
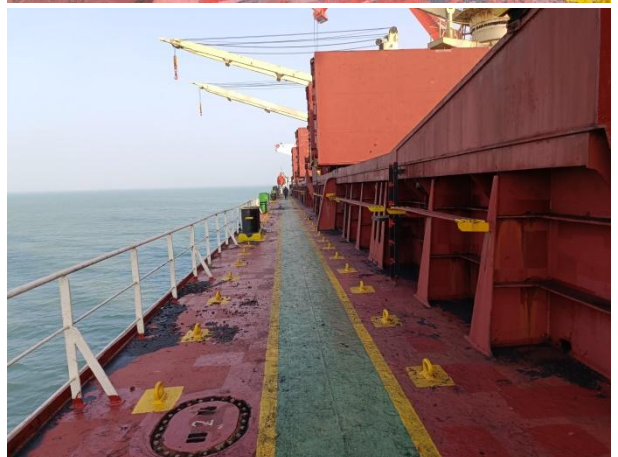
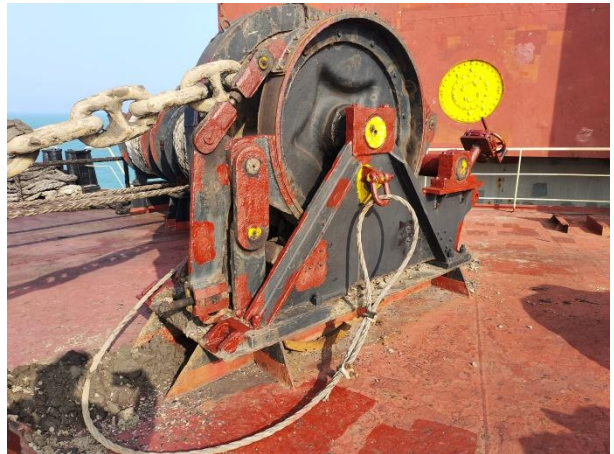
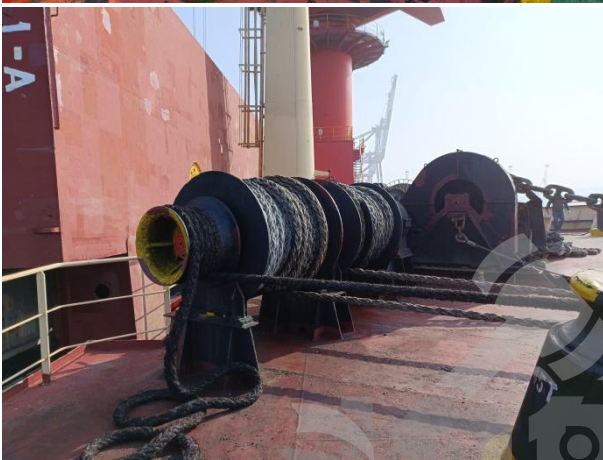
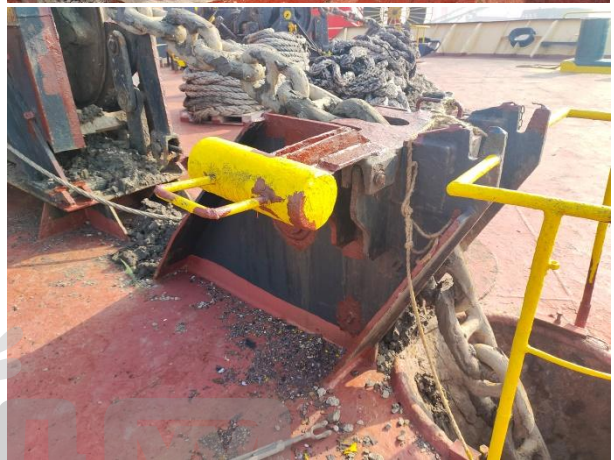
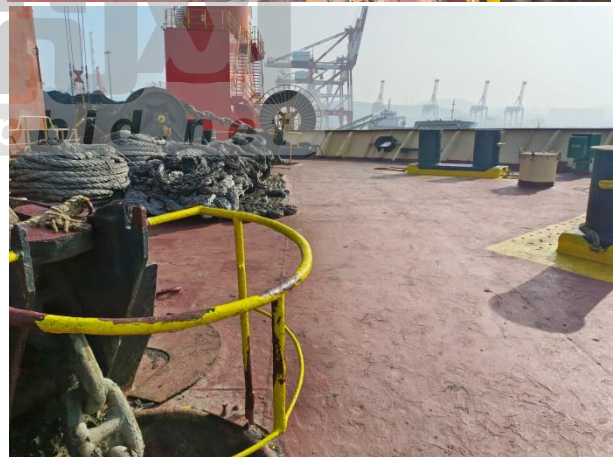
The scratches and local collision deformation were found on the hull shell.

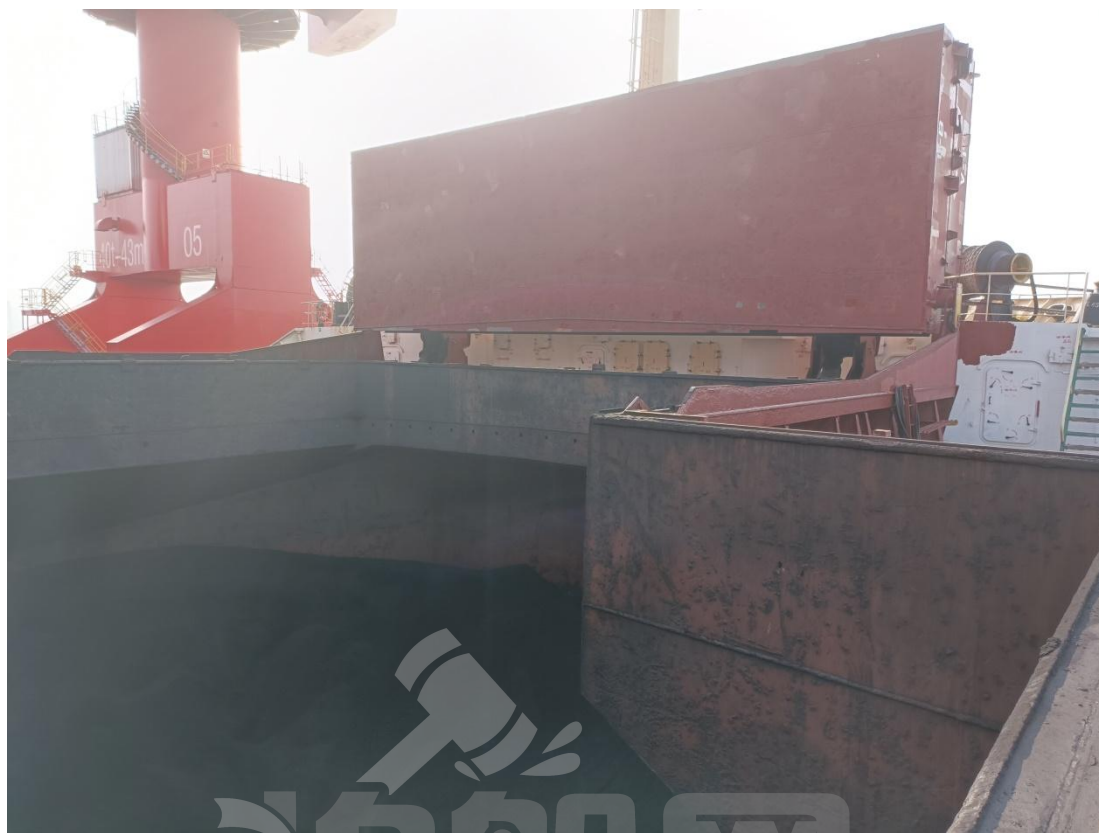
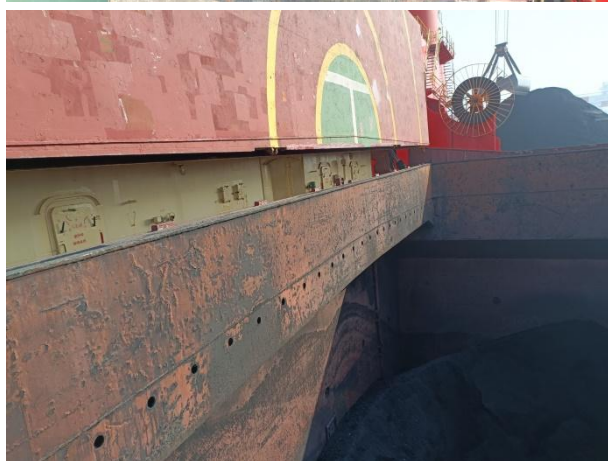
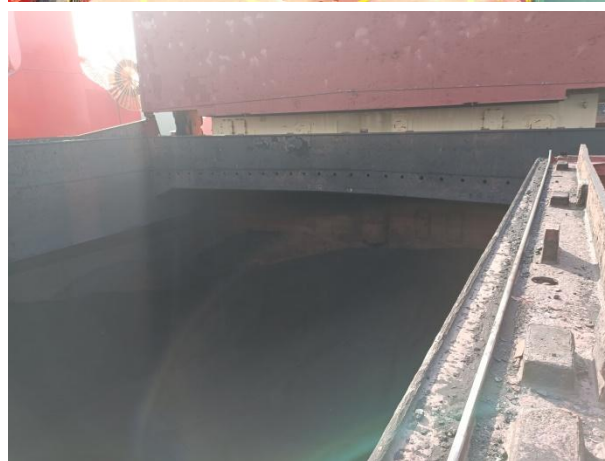
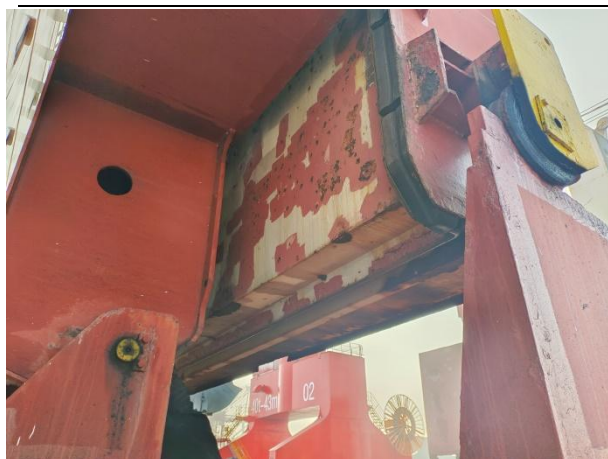
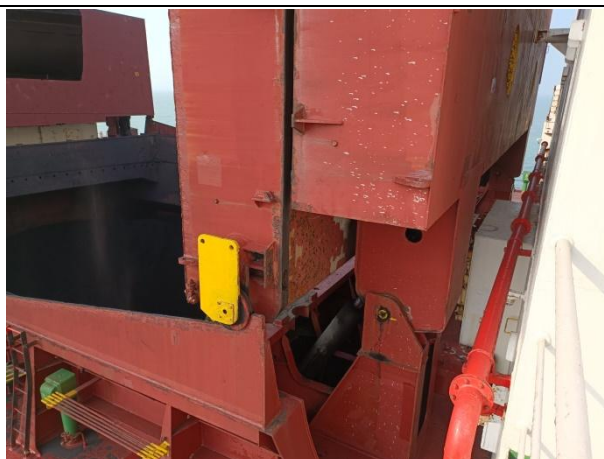
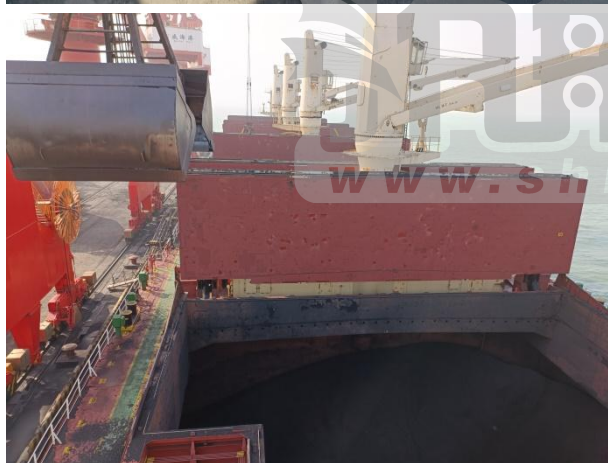
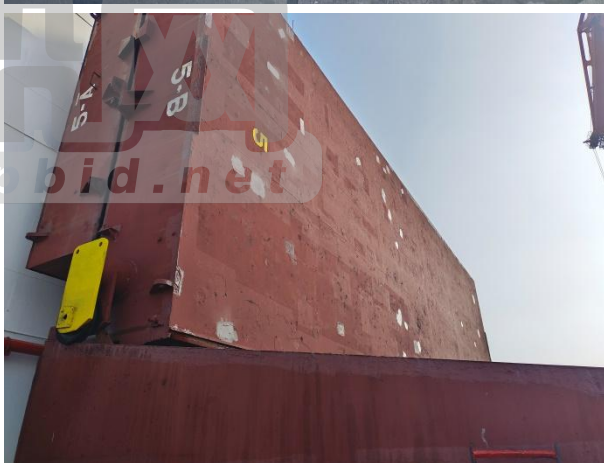
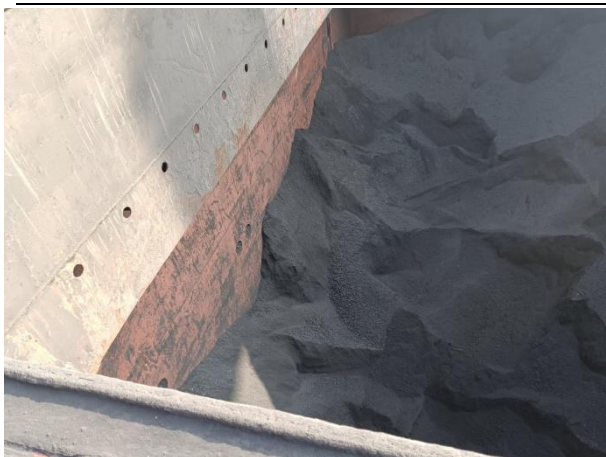
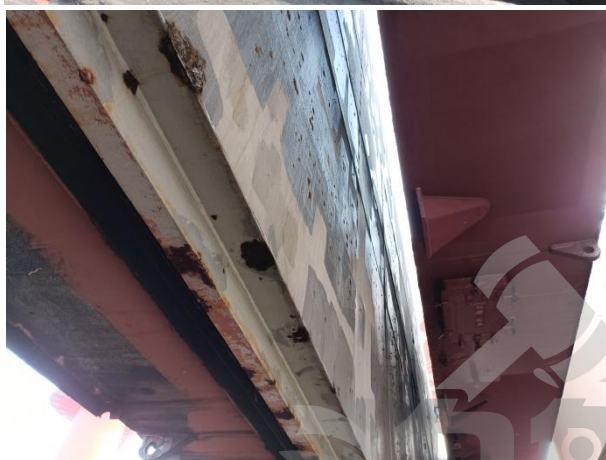
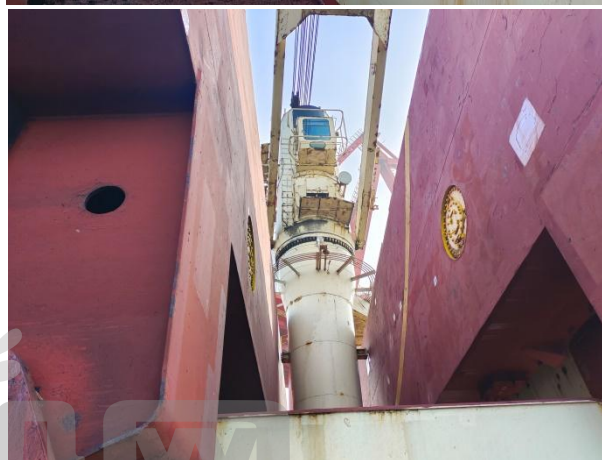
- 1.Large area of rust found on the inner side of the hatch coaming.
- 2.Large areas of rust were found in the structure of the cargo hold, as well collision marks caused by loading and unloading.
- 3.4 sets cranes with 30T have been deactivated.

9	Large areas of rust were found in the structure of the cargo hold, as well collision marks caused by loading and unloading.
10	Large area of rust found on the inner side of the hatch coaming.
11	4# Cylinder has been running for 390 hours since recent maintenance, while 1# cylinder has been running for 8224 hours since the last maintenance.
