# TECHNICAL REPORT

CJPG-JS-24-KY-630

## HAI XING YOU 606

## Technical Report

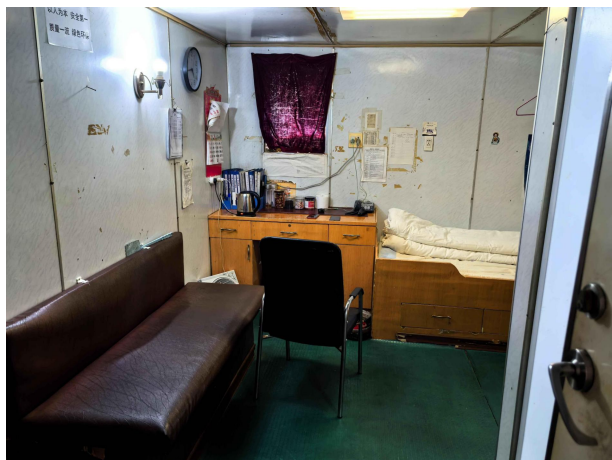
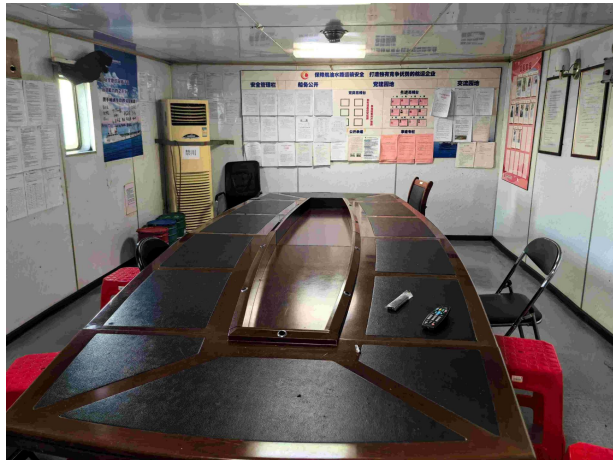
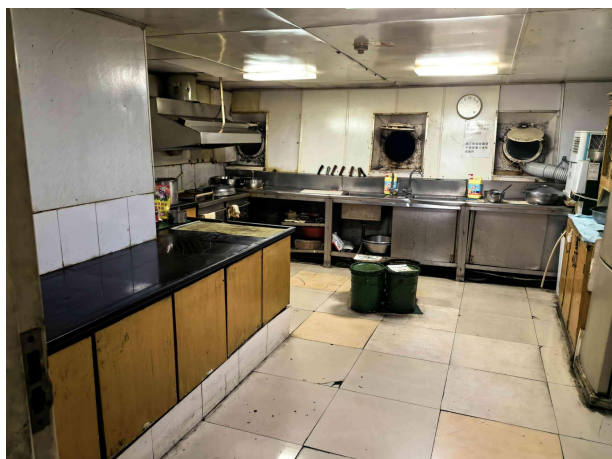
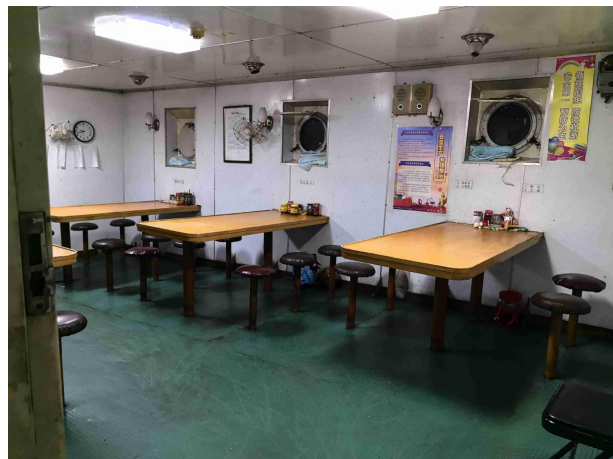
No.	Description	Good	Fair to good	Fair	Poor
1	The housekeeping in the crew quarters is neat and tidy and the waste water pipes from the toilet or sanitary unit are in a satisfactory condition.	<input type="checkbox"/>	<input type="checkbox"/>	<input checked="" type="checkbox"/>	<input type="checkbox"/>
2	Cabins are adequately lit and emergency lighting is in working order.	<input type="checkbox"/>	<input checked="" type="checkbox"/>	<input type="checkbox"/>	<input type="checkbox"/>
3	The dining room and galley are clean and tidy with utensils neatly arranged.	<input type="checkbox"/>	<input type="checkbox"/>	<input checked="" type="checkbox"/>	<input type="checkbox"/>
4	There are no significant drips or leaks from extractor hoods and ventilation ducts and no fire hazards.	<input type="checkbox"/>	<input type="checkbox"/>	<input checked="" type="checkbox"/>	<input type="checkbox"/>
5	Domestic waste is effectively segregated and stored in the designated area as required.	<input type="checkbox"/>	<input type="checkbox"/>	<input type="checkbox"/>	<input type="checkbox"/>

6	Refrigeration room door handles and alarms are in satisfactory condition and maintain appropriate refrigeration temperatures.	<input type="checkbox"/>	<input type="checkbox"/>	<input type="checkbox"/>	<input type="checkbox"/>
7	Cold store food is neatly arranged with clean surfaces and no expired food.	<input type="checkbox"/>	<input type="checkbox"/>	<input type="checkbox"/>	<input type="checkbox"/>
8	Insulation wrapping of cold store refrigeration pipework is complete and pipework joints are free from corrosion or leaks.	<input type="checkbox"/>	<input type="checkbox"/>	<input type="checkbox"/>	<input type="checkbox"/>

Note: The above inspection items were found in "Fair" level overall.

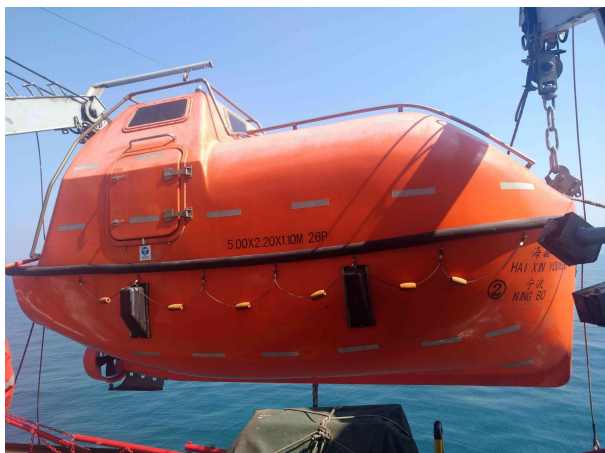
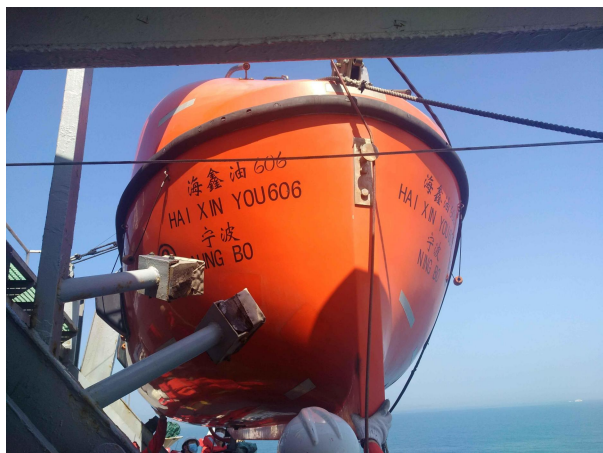
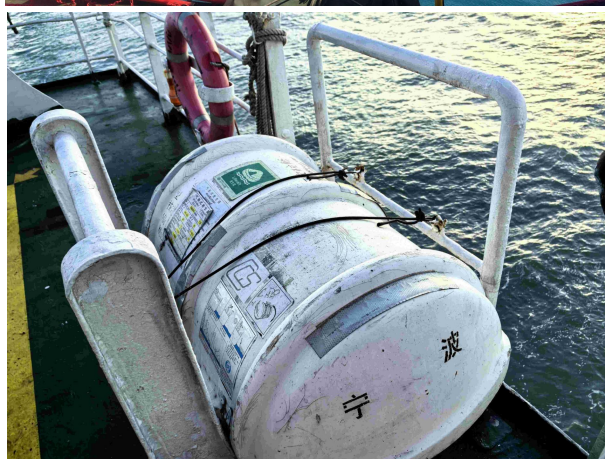
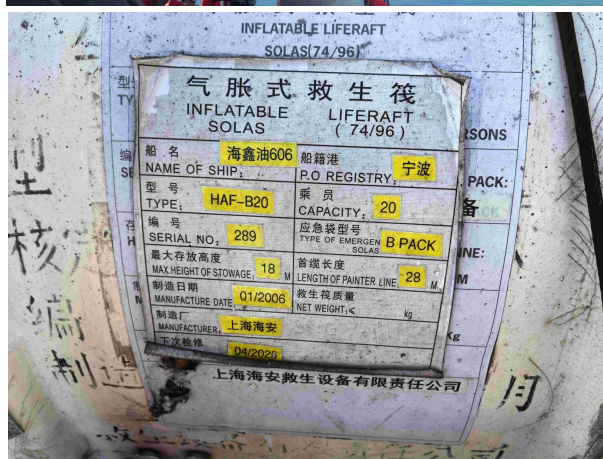
No.	Description	Good	Fair to good	Fair	Poor
1	The lifeboat has a good appearance, and the ship name, port of registry, and other markings were clear and stored correctly.	<input type="checkbox"/>	<input checked="" type="checkbox"/>	<input type="checkbox"/>	<input type="checkbox"/>
2	The frame structure has a good appearance and well lubricated	<input type="checkbox"/>	<input checked="" type="checkbox"/>	<input type="checkbox"/>	<input type="checkbox"/>
3	The motor of the lifeboat was well maintained, and was easy to start (check records of tests or manoeuvre).	<input type="checkbox"/>	<input type="checkbox"/>	<input type="checkbox"/>	<input type="checkbox"/>
4	The lifeboat was fully equipped with life-saving appliances, food and fresh water.	<input type="checkbox"/>	<input checked="" type="checkbox"/>	<input type="checkbox"/>	<input type="checkbox"/>
5	The operation procedures and maintenance manual of the lifeboat were posted, and lighting fixtures were equipped beside.	<input type="checkbox"/>	<input checked="" type="checkbox"/>	<input type="checkbox"/>	<input type="checkbox"/>

6	The life raft and hydrostatic pressure release device were properly fixed, and found in normal maintenance cycle.	<input type="checkbox"/>	<input checked="" type="checkbox"/>	<input type="checkbox"/>	<input type="checkbox"/>
7	Life rings, lights, smoke floats, etc. are in correct position and in satisfactory cosmetic condition.	<input type="checkbox"/>	<input type="checkbox"/>	<input type="checkbox"/>	<input type="checkbox"/>
8	Lifebuoys, lights, floats, etc. were in the correct position and in good appearance.	<input type="checkbox"/>	<input type="checkbox"/>	<input type="checkbox"/>	<input type="checkbox"/>
9	Flame parachutes, rope throwers, etc. are of approved type and properly stored.	<input type="checkbox"/>	<input type="checkbox"/>	<input type="checkbox"/>	<input type="checkbox"/>

Note: The above inspection items were found in "Fair to good" level overall.

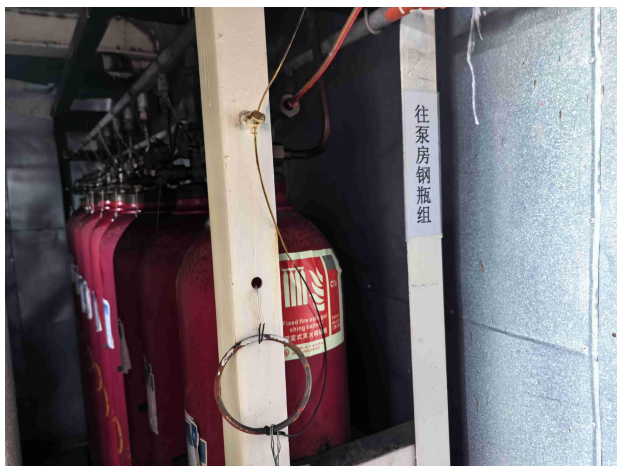
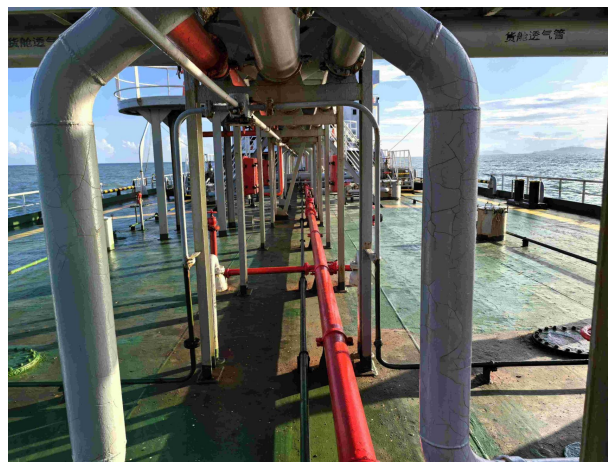
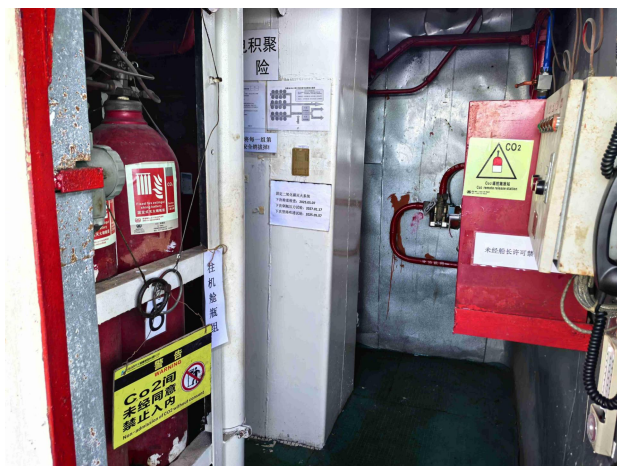
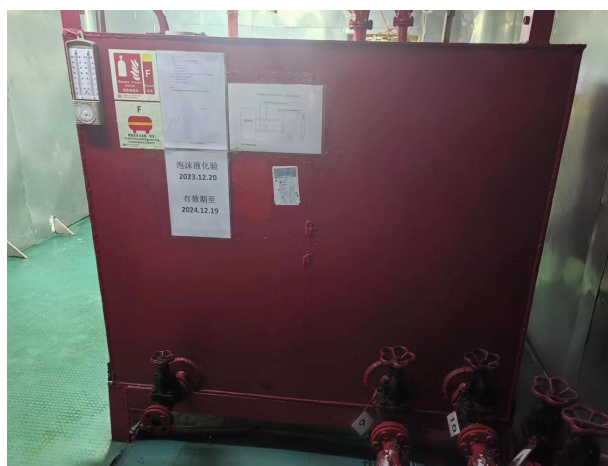
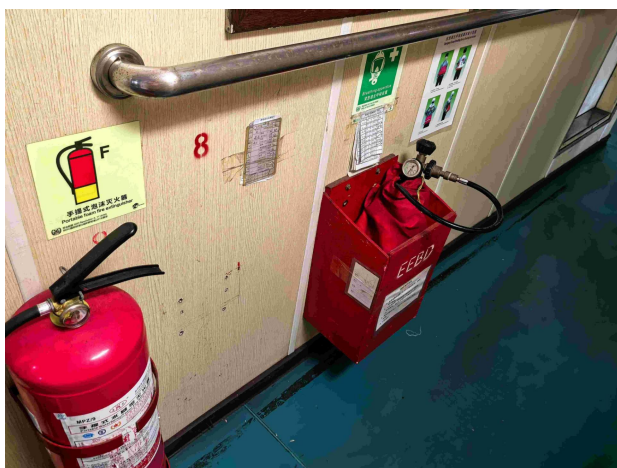
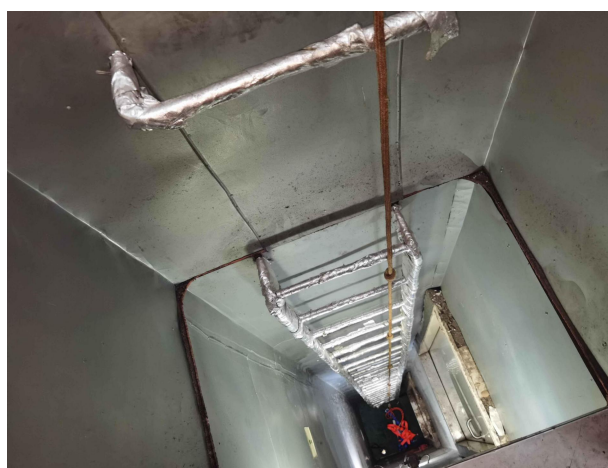
No.	Description	Good	Fair to good	Fair	Poor
1	The fire detection system is normally open and the manual alarm buttons are basically not broken or invalid.	<input type="checkbox"/>	<input checked="" type="checkbox"/>	<input type="checkbox"/>	<input type="checkbox"/>
2	Main fire pumps, fire isolation valves, emergency fire pumps and pipework are in good condition; emergency fire pump operating procedures are complete and regularly tested and operated.	<input type="checkbox"/>	<input checked="" type="checkbox"/>	<input type="checkbox"/>	<input type="checkbox"/>
3	Hydrant appearance is intact, handwheel switch is normal, no significant corrosion or leaks in pipework.	<input type="checkbox"/>	<input type="checkbox"/>	<input type="checkbox"/>	<input type="checkbox"/>
4	The hose reel is intact, the water hose and water pistol are of a type approved by the Marine Inspectorate and the nozzles are in good condition.	<input type="checkbox"/>	<input type="checkbox"/>	<input type="checkbox"/>	<input type="checkbox"/>

5	Portable fire extinguishers are correctly located and in good condition, with valid inspection marks, and a sufficient number of spare extinguishers are provided.	<input type="checkbox"/>	<input checked="" type="checkbox"/>	<input type="checkbox"/>	<input type="checkbox"/>
6	The CO2 cylinder and release device are within the inspection period, the automatic audible alarm is not faulty and the complete and correct operating instructions are displayed.	<input type="checkbox"/>	<input checked="" type="checkbox"/>	<input type="checkbox"/>	<input type="checkbox"/>
7	There is no looseness or leakage in the connection of the CO2 piping system; there is sufficient pressure in the starter cylinder; the safety pin packing lead wire of the head valve has been removed.	<input type="checkbox"/>	<input checked="" type="checkbox"/>	<input type="checkbox"/>	<input type="checkbox"/>
8	Vents, shutters and other closing devices are in good condition with clear and correct on/off markings.	<input type="checkbox"/>	<input checked="" type="checkbox"/>	<input type="checkbox"/>	<input type="checkbox"/>

9	All signs for safety equipment and escape routes are in place, reflective signs comply with IMO requirements, and main and emergency exits are clear.	<input type="checkbox"/>	<input checked="" type="checkbox"/>	<input type="checkbox"/>	<input type="checkbox"/>
10	Emergency escape routes are fireproof, clear and unobstructed; lighting, lifelines and escape ladders are complete; self-closing doors are in normal opening and closing condition, with no back hooks.	<input type="checkbox"/>	<input checked="" type="checkbox"/>	<input type="checkbox"/>	<input type="checkbox"/>

Note: The above inspection items were found in "Fair to good" level overall.

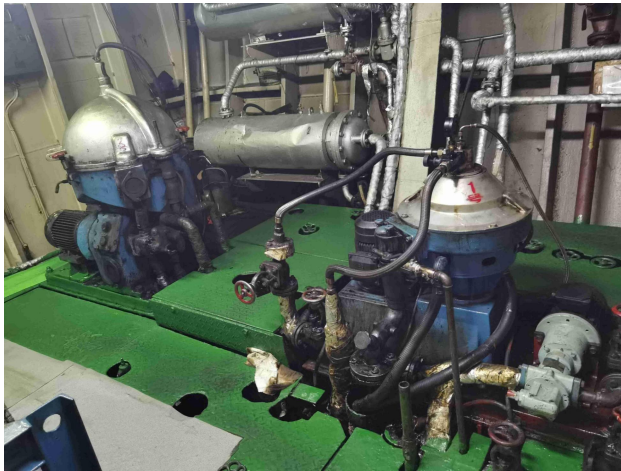
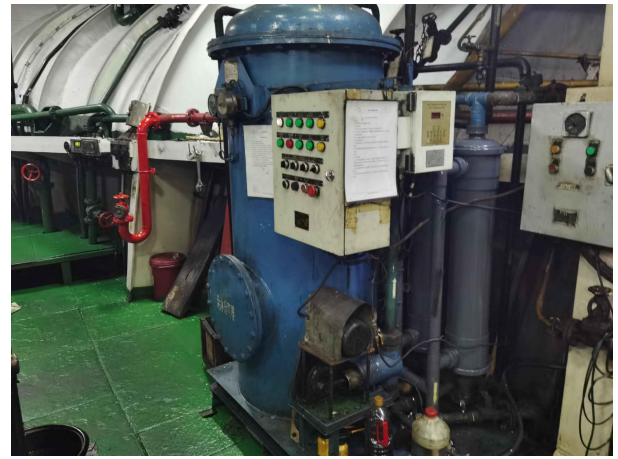
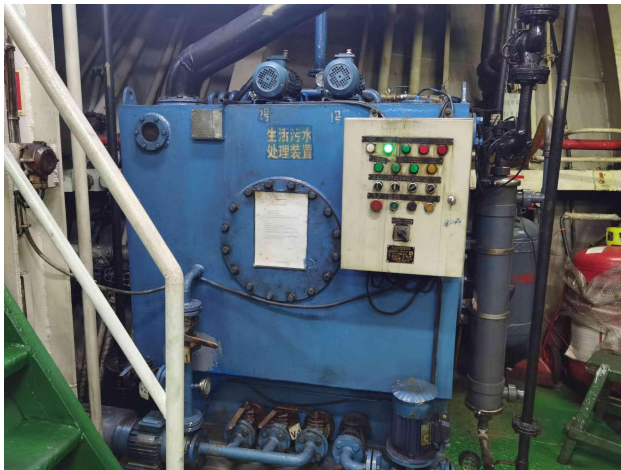
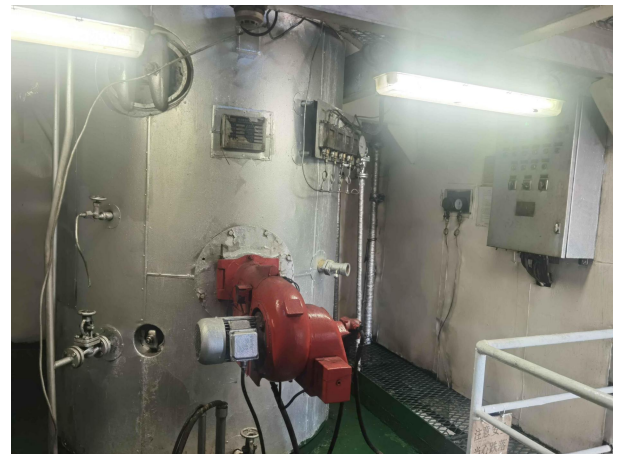
No.	Description	Good	Fair to good	Fair	Poor
1	The nameplate of the Oil/Water Separator is in accordance with the certificate, the surface of the equipment is clean, the direction and colour of the pipework and valves are clearly marked, and the operating instructions are posted nearby.	<input type="checkbox"/>	<input checked="" type="checkbox"/>	<input type="checkbox"/>	<input type="checkbox"/>
2	If the oil/water separator's 15ppm oil meter exceeds the standard, the oil discharge monitor alarms and automatically stops the discharge within the specified time (check the records in the oil/water record book).	<input type="checkbox"/>	<input type="checkbox"/>	<input type="checkbox"/>	<input type="checkbox"/>
3	The O/W Separator does not have an illegal bypass pipe or connection discharging directly to the outboard engine, and there is no significant dismantling mark on the flange bolts on the outlet pipe; the outboard engine discharge valve is in the closed and locked condition in port and there is a no-discharge warning sign.	<input type="checkbox"/>	<input checked="" type="checkbox"/>	<input type="checkbox"/>	<input type="checkbox"/>

4	The identification plate of the domestic sewage treatment plant is in accordance with the certificate; there is no rust through the body; the sewage pump, air compressor, etc. are not defective.	<input type="checkbox"/>	<input checked="" type="checkbox"/>	<input type="checkbox"/>	<input type="checkbox"/>
5	Domestic Sewage Treatment Plant High level alarm without fault; Discharge pump start and stop function failure; Bursting fan pressure gauge is normal; No direct discharge outside illegal bypass pipe or connection.	<input type="checkbox"/>	<input checked="" type="checkbox"/>	<input type="checkbox"/>	<input type="checkbox"/>
6	The boiler nameplate is in accordance with the certificate; and is regularly inspected.	<input type="checkbox"/>	<input checked="" type="checkbox"/>	<input type="checkbox"/>	<input type="checkbox"/>
7	Boiler body and flue show no signs of smoke and insulation is intact.	<input type="checkbox"/>	<input checked="" type="checkbox"/>	<input type="checkbox"/>	<input type="checkbox"/>

8	Boiler safety valves are intact, with no leaks in steam lines or valve parts, and complete insulation wrapping on external surfaces.	<input type="checkbox"/>	<input checked="" type="checkbox"/>	<input type="checkbox"/>	<input type="checkbox"/>
9	Boiler fuel supply lines are free of drips and there is an oil collecting tray under the combustion unit.	<input type="checkbox"/>	<input checked="" type="checkbox"/>	<input type="checkbox"/>	<input type="checkbox"/>
10	The format of the ballast water record book complies with the requirements of the	<input type="checkbox"/>	<input type="checkbox"/>	<input type="checkbox"/>	<input type="checkbox"/>

Convention and the ballast water management plan is approved by the flag state or classification society.				
11	The nameplate of the ballast water treatment system is in accordance with the certificate; the surface of the equipment is clean, pipework and colours and valves are clearly marked; operating instructions are posted near the equipment.	<input type="checkbox"/>	<input checked="" type="checkbox"/>	<input type="checkbox"/>	<input type="checkbox"/>

Note: The above inspection items were found in "Fair to good" level overall.

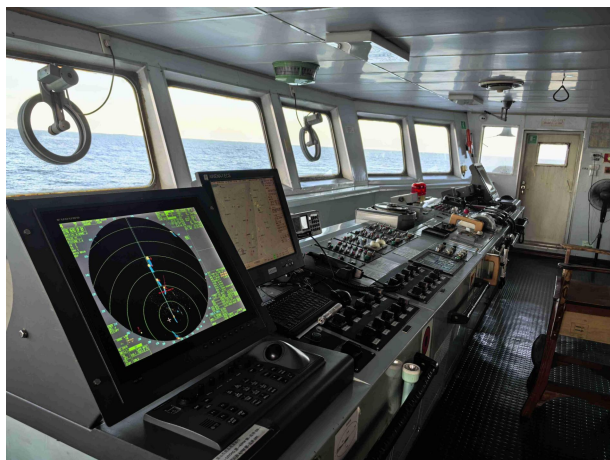
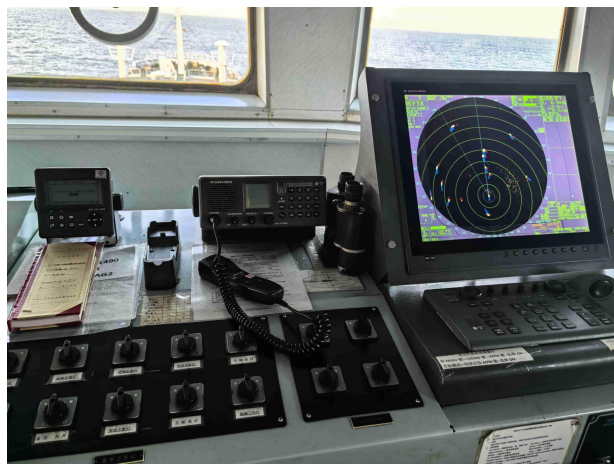
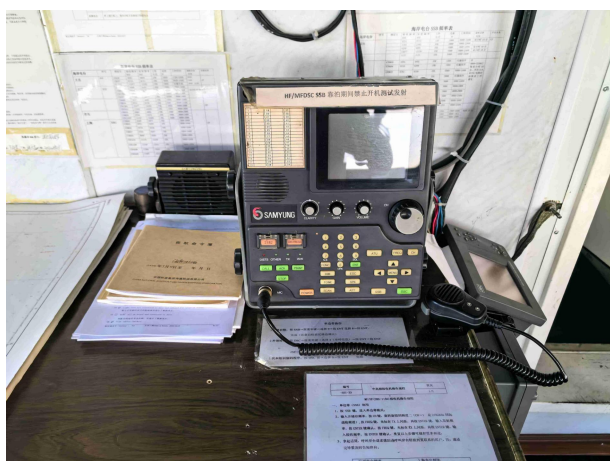
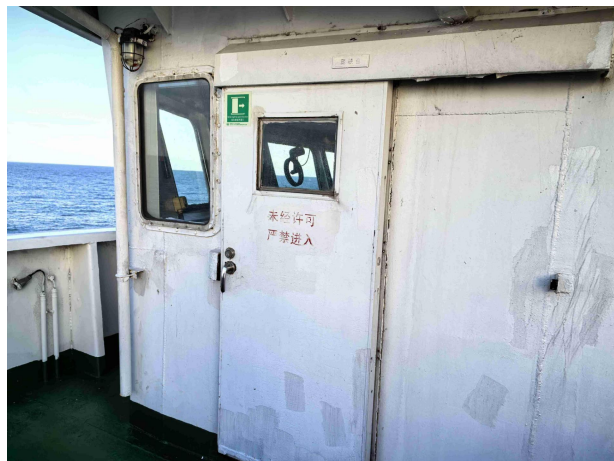
No.	Description	Good	Fair to good	Fair	Poor
1	Pilothouse layout and field of vision are in accordance with approved drawings, windscreen wipers or pivoting windows are installed as required and are working properly.	<input type="checkbox"/>	<input type="checkbox"/>	<input checked="" type="checkbox"/>	<input type="checkbox"/>
2	Equipped with the latest edition of nautical library materials, Notices to Mariners and Correction Notices are received in a timely manner, voyage plans and signatures are obtained before sailing.	<input type="checkbox"/>	<input type="checkbox"/>	<input type="checkbox"/>	<input type="checkbox"/>
3	All types of charts relating to safety management are displayed in the cockpit and updated to the latest edition.	<input type="checkbox"/>	<input type="checkbox"/>	<input checked="" type="checkbox"/>	<input type="checkbox"/>
4	The control box for the navigation lights is an approved product, the colour of the indicator light is the same as that of the signal light and the brightness of the indicator light can be adjusted.	<input type="checkbox"/>	<input type="checkbox"/>	<input type="checkbox"/>	<input type="checkbox"/>

5	The navigation lights are double sets of lamps; the inside of the port light cover is brushed with black paint without peeling; the surface of the number lights is clean, the spacing meets the requirement of 2 metres (when its display function can indicate the status of a vessel) and is in the same vertical line; the signal mast has a device for climbing and repairing.	<input type="checkbox"/>	<input type="checkbox"/>	<input type="checkbox"/>	<input type="checkbox"/>
6	The configuration of the main navigational equipment is essentially the same as that recorded in the certificate.	<input type="checkbox"/>	<input type="checkbox"/>	<input type="checkbox"/>	<input type="checkbox"/>
7	The main and sub compass readings do not exceed $\pm 0.5^\circ$ ; the compass case is free of large air bubbles or vapour; the self-contained compass light is free of defects; the operating instructions are displayed near the electric compass; and an up-to-date corrected self-correction table for the magnetic compass is displayed.	<input type="checkbox"/>	<input type="checkbox"/>	<input type="checkbox"/>	<input type="checkbox"/>

8	The effective diameter of the radar meets the regulatory requirements; the radar display echo is normal; the radar function buttons and knobs are normal; the radar power supply, display and operating system are fault-free; the radar is equipped with a Chinese operating manual and	<input type="checkbox"/>	<input type="checkbox"/>	<input checked="" type="checkbox"/>	<input type="checkbox"/>

instruction manual.				
9	The AIS is normally open, the displayed heading matches the actual heading, the static information matches the actual, and the nine-digit code matches the certificate MMSI.	<input type="checkbox"/>	<input checked="" type="checkbox"/>	<input type="checkbox"/>	<input type="checkbox"/>
10	ECS electronic charts are products approved by the Marine Inspectorate, the screen can be displayed normally, the function keys on the panel are normal and the electronic chart data is updated in real time.	<input type="checkbox"/>	<input checked="" type="checkbox"/>	<input type="checkbox"/>	<input type="checkbox"/>
11	The GMDSS radio station working day log is standardised, clear and complete.	<input type="checkbox"/>	<input type="checkbox"/>	<input type="checkbox"/>	<input type="checkbox"/>
12	VHF equipment power-on display identification code matches ship's MMSI; DSC transceiver functioning normally.	<input type="checkbox"/>	<input type="checkbox"/>	<input type="checkbox"/>	<input type="checkbox"/>

13	MF/HF radio equipment is not defective; DSC test is normal; emergency lighting is provided at the operating position.	<input type="checkbox"/>	<input type="checkbox"/>	<input type="checkbox"/>	<input type="checkbox"/>
	NAVTEX display is normal and recently printed paper data is clear.	<input type="checkbox"/>	<input type="checkbox"/>	<input type="checkbox"/>	<input type="checkbox"/>
	SART case is watertight, no missing or deteriorated buoyant short ropes and effective batteries.	<input type="checkbox"/>	<input type="checkbox"/>	<input type="checkbox"/>	<input type="checkbox"/>
	EPIRB housing is watertight, securely mounted, no rusted bolts, batteries functional, hydrostatic pressure relief functional.	<input type="checkbox"/>	<input type="checkbox"/>	<input type="checkbox"/>	<input type="checkbox"/>
	VDR-SAM/HIGHLANGER B2, tested and functioning properly, battery and beacon valid.	<input type="checkbox"/>	<input type="checkbox"/>	<input type="checkbox"/>	<input type="checkbox"/>

Note: The above inspection items were found in "Fair " level overall.

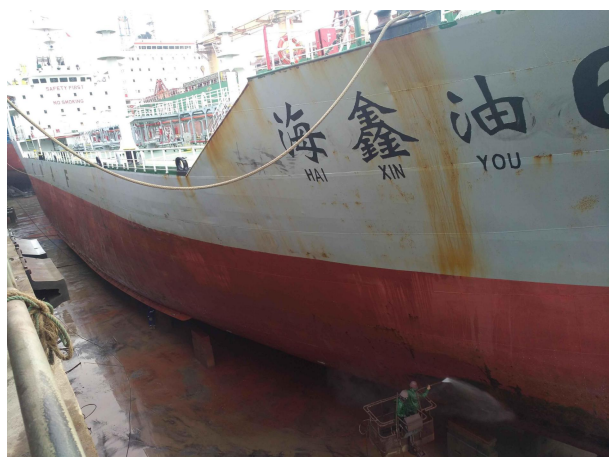
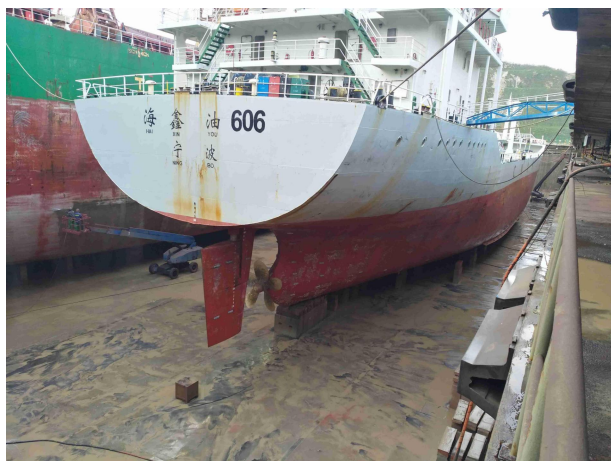
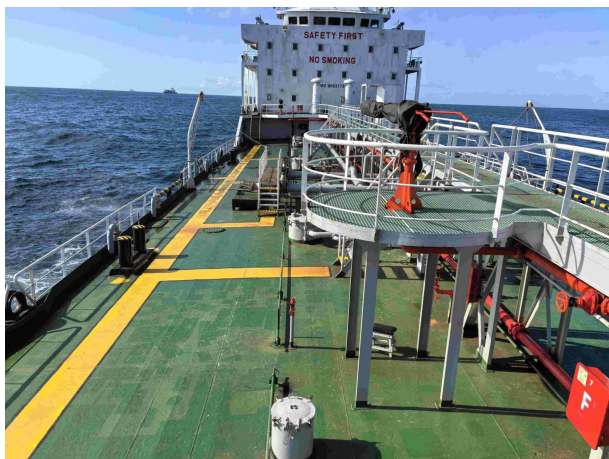
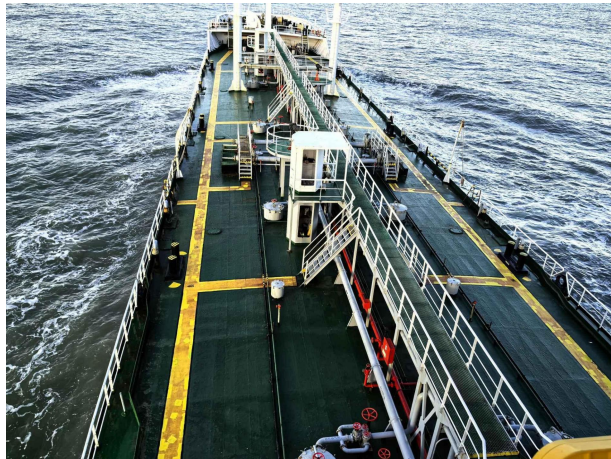
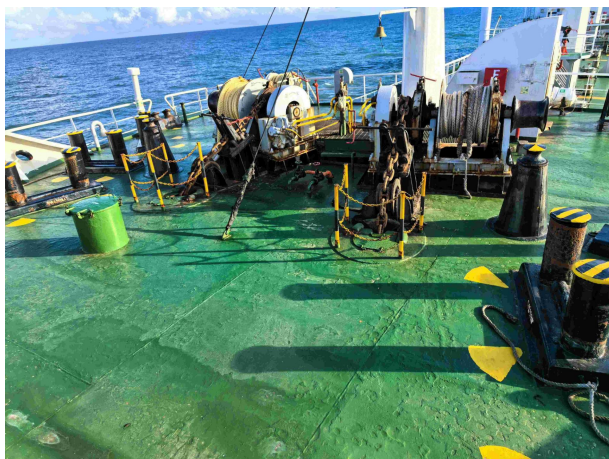
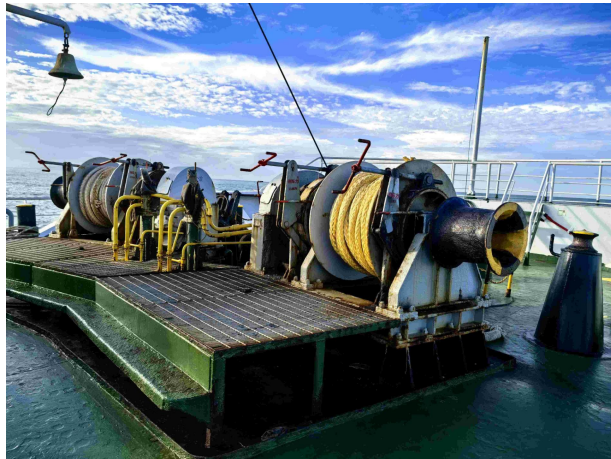
No.	Description	Good	Fair to good	Fair	Poor
1	Ship's name, port of registry and IMO marks are clear and complete.	<input type="checkbox"/>	<input checked="" type="checkbox"/>	<input type="checkbox"/>	<input type="checkbox"/>
2	Load line and water markings are clear and complete.	<input type="checkbox"/>	<input type="checkbox"/>	<input checked="" type="checkbox"/>	<input type="checkbox"/>
3	Partial coating condition is visible on the outer hull plate.	<input type="checkbox"/>	<input type="checkbox"/>	<input checked="" type="checkbox"/>	<input type="checkbox"/>
4	There is no significant deformation of the outer hull structure.	<input type="checkbox"/>	<input type="checkbox"/>	<input checked="" type="checkbox"/>	<input type="checkbox"/>
5	Partially coated upper deck.	<input type="checkbox"/>	<input type="checkbox"/>	<input checked="" type="checkbox"/>	<input type="checkbox"/>
6	No significant deformation of upper deck structure.	<input type="checkbox"/>	<input type="checkbox"/>	<input checked="" type="checkbox"/>	<input type="checkbox"/>

7	There are no deformations, cracks, missing cogwheels and no welding of the guardrails.	<input type="checkbox"/>	<input type="checkbox"/>	<input type="checkbox"/>	<input type="checkbox"/>
8	The position of the steel gangway, pilot's ladder and discharge port does not interfere with the embarkation and disembarkation of personnel.	<input type="checkbox"/>	<input type="checkbox"/>	<input checked="" type="checkbox"/>	<input type="checkbox"/>
9	Air ducts on the upper deck are in good condition, equipped with effective closing devices and all service compartments are clearly marked.	<input type="checkbox"/>	<input type="checkbox"/>	<input checked="" type="checkbox"/>	<input type="checkbox"/>
10	Anchors, winches and rope guides are in satisfactory condition.	<input type="checkbox"/>	<input type="checkbox"/>	<input checked="" type="checkbox"/>	<input type="checkbox"/>
11	Visible parts of anchor chain are in satisfactory condition.	<input type="checkbox"/>	<input type="checkbox"/>	<input checked="" type="checkbox"/>	<input type="checkbox"/>

12	Mooring bollards, cables and visible parts of cables are in satisfactory condition.	<input type="checkbox"/>	<input type="checkbox"/>	<input checked="" type="checkbox"/>	<input type="checkbox"/>
13	Walkway, deck and handrails are structurally sound.	<input type="checkbox"/>	<input type="checkbox"/>	<input checked="" type="checkbox"/>	<input type="checkbox"/>
14	Crane can be started and operated normally.	<input type="checkbox"/>	<input type="checkbox"/>	<input type="checkbox"/>	<input type="checkbox"/>

Note: The above inspection items were found in "Fair" level overall.

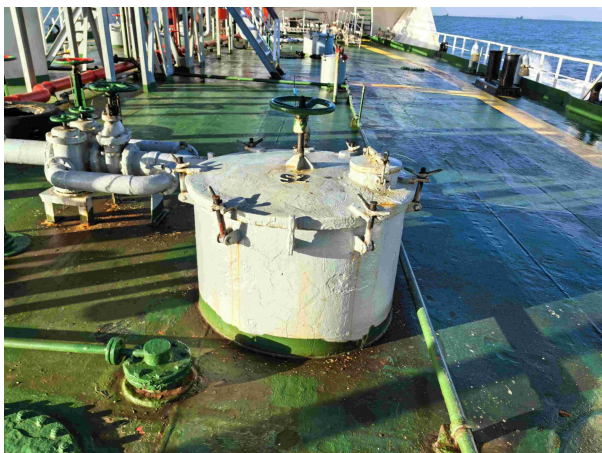
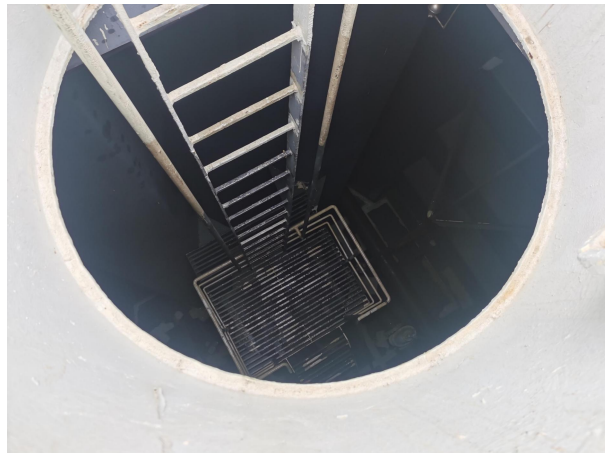
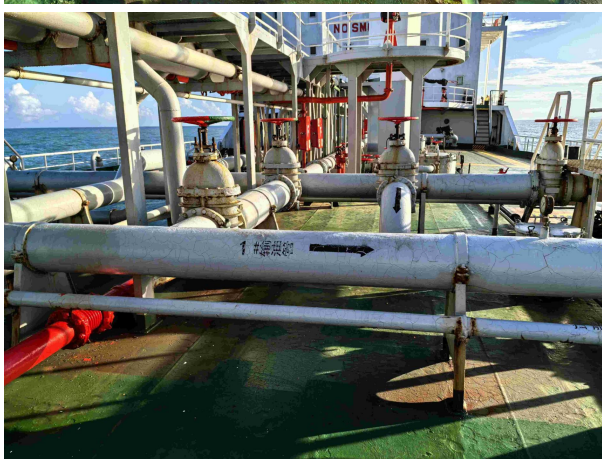
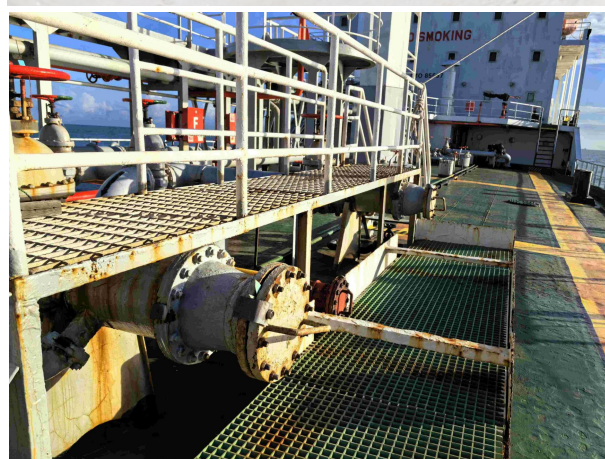
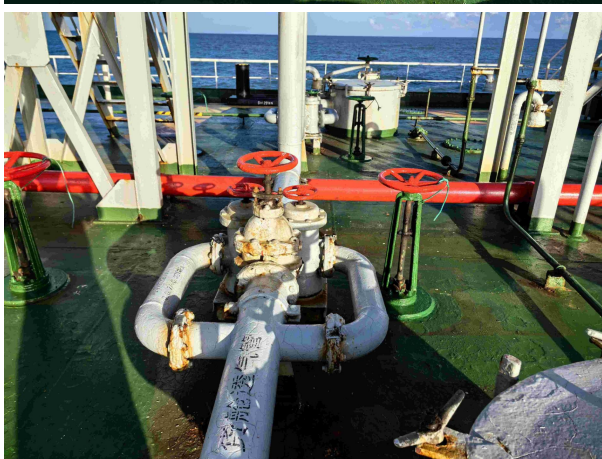
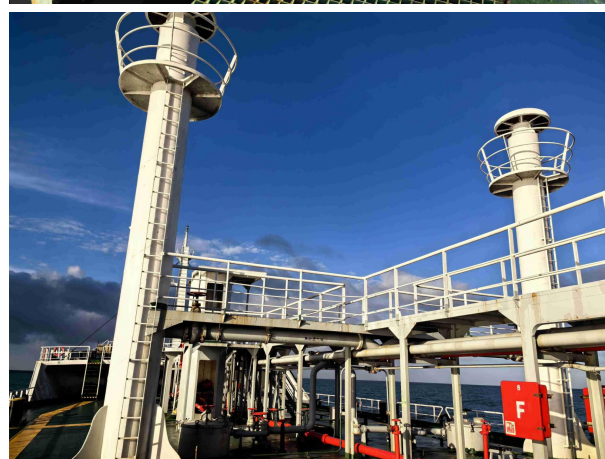
No.	Description	Good	Fair to good	Fair	Poor
1	Cargo tank area rotating fuel tank cover, grommets, rotating structure, paint is basically intact, no rust and corrosion, can open the tank smoothly.	<input type="checkbox"/>	<input type="checkbox"/>	<input checked="" type="checkbox"/>	<input type="checkbox"/>
2	Cargo oil tank area deck step bridge paint is intact, step bridge grating, both sides of railing structure is basically intact.	<input type="checkbox"/>	<input type="checkbox"/>	<input checked="" type="checkbox"/>	<input type="checkbox"/>
3	There is no damage to the insulation package of the deck pipe system in the cargo tank area, no leakage from the flange interface of the pipe system, and no corrosion of the fire fighting pipe.	<input type="checkbox"/>	<input type="checkbox"/>	<input checked="" type="checkbox"/>	<input type="checkbox"/>
4	The cargo oil tanks are well coated, the ladder rack structure is complete, the welds of the tank structure are still full and the bilge pipe is neatly arranged.	<input type="checkbox"/>	<input type="checkbox"/>	<input checked="" type="checkbox"/>	<input type="checkbox"/>

5	The screen of the cargo control room console can be displayed normally and the function buttons on the panel are normal.	<input type="checkbox"/>	<input checked="" type="checkbox"/>	<input type="checkbox"/>	<input type="checkbox"/>
6	Pump room door opens and closes with cabin fan, light chain; pump room ventilation louvres without rust, cabin ventilation can be closed from outside, fire door puller intact.	<input type="checkbox"/>	<input type="checkbox"/>	<input checked="" type="checkbox"/>	<input type="checkbox"/>
7	The watertight bulkhead of the pump compartment and the cabin boundary interface are fitted with fireproof thermal insulation, the material has no significant damage and the nail cover has not fallen off.	<input type="checkbox"/>	<input type="checkbox"/>	<input type="checkbox"/>	<input type="checkbox"/>
8	The pump body in the pump compartment has intact paint and no significant corrosion; the pipeline flange seal is intact, with no large gap and no significant corrosion on the bolts.	<input type="checkbox"/>	<input checked="" type="checkbox"/>	<input type="checkbox"/>	<input type="checkbox"/>

9	Inside the pump room, the lubrication of the hand wheel screw of the submarine door is still good and the submarine valve box has a small amount of corrosion.	<input type="checkbox"/>	<input type="checkbox"/>	<input type="checkbox"/>	<input type="checkbox"/>
10	No oil stains on the steel plate in the pump room, no leakage along the lower edge of the bulkhead and no large oil stains in the bilge.	<input type="checkbox"/>	<input type="checkbox"/>	<input checked="" type="checkbox"/>	<input type="checkbox"/>

Note: The above inspection items were found in "Fair " level overall.

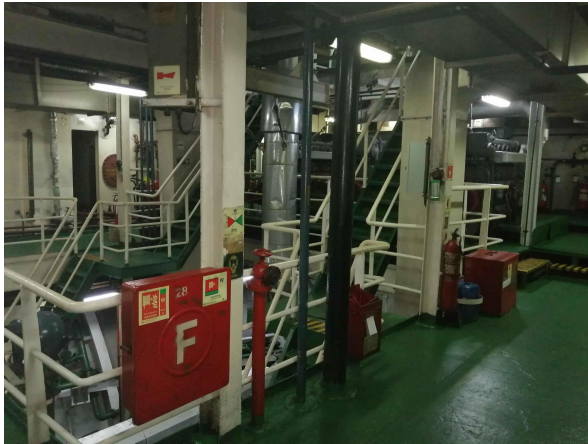
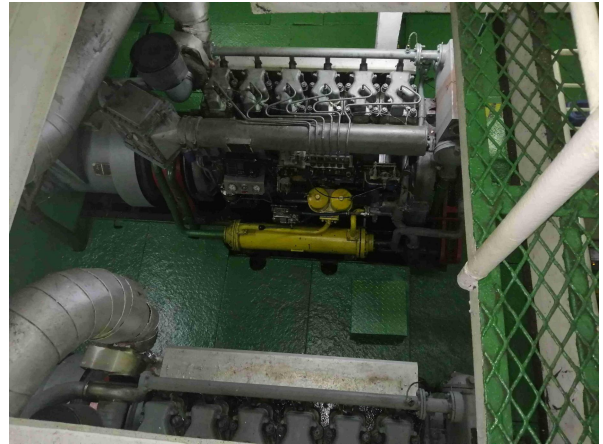
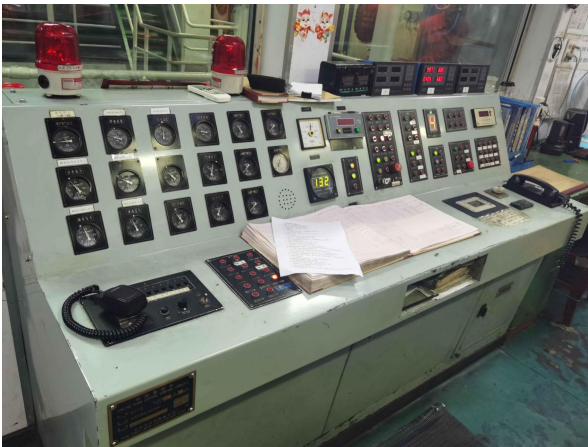
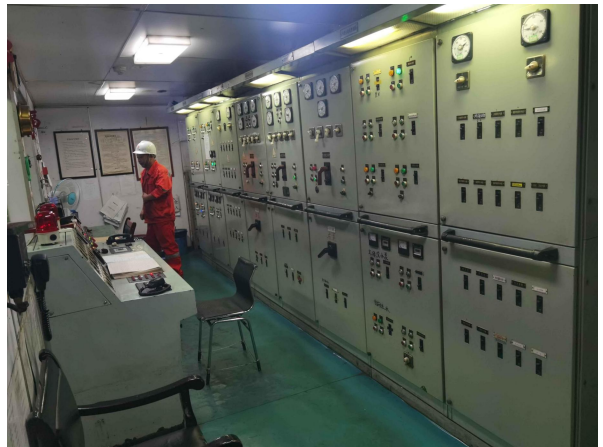
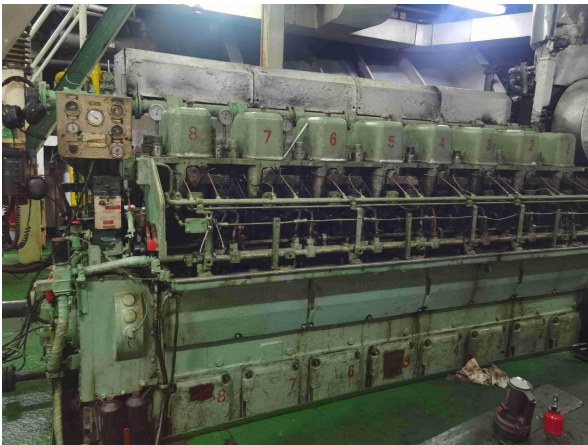
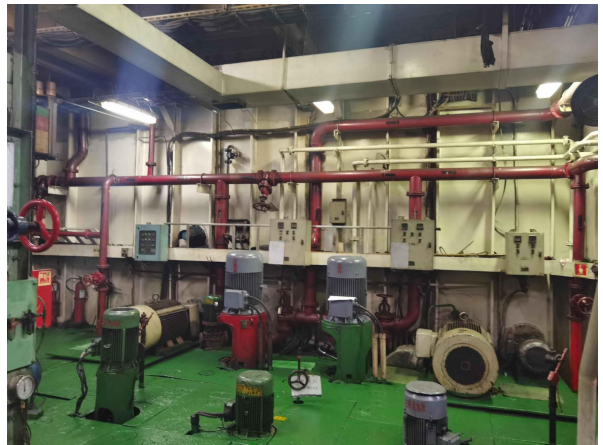
No.	Description	Good	Fair to good	Fair	Poor
1	The cabin platforms and bilges are kept in a clean and tidy condition, with no significant oil stains or flammable materials present.	<input type="checkbox"/>	<input type="checkbox"/>	<input checked="" type="checkbox"/>	<input type="checkbox"/>
2	The cabin lighting and emergency lighting are fully functional and in good condition.	<input type="checkbox"/>	<input checked="" type="checkbox"/>	<input type="checkbox"/>	<input type="checkbox"/>
3	The main electrical and mechanical equipment is in good condition, with no significant oil or water leakage or temporary drainage.	<input type="checkbox"/>	<input type="checkbox"/>	<input checked="" type="checkbox"/>	<input type="checkbox"/>
4	The main mechanical and electrical equipment is effectively maintained in accordance with the manufacturer's specified intervals (please refer to the monthly turbine report and equipment operating hours, maintenance records, etc.).	<input type="checkbox"/>	<input checked="" type="checkbox"/>	<input type="checkbox"/>	<input type="checkbox"/>

5	The main and auxiliary engine monitoring devices are complete and in a normally open condition, as well as regularly tested.	<input type="checkbox"/>	<input checked="" type="checkbox"/>	<input type="checkbox"/>	<input type="checkbox"/>
6	The high-pressure fuel pipes for the main and auxiliary engines are protected by double casing and a leakage alarm device or splash baffle.	<input type="checkbox"/>	<input type="checkbox"/>	<input type="checkbox"/>	<input type="checkbox"/>
7	The exhaust pipes of the main and auxiliary engines are free of any leakage and the insulation is fully intact.	<input type="checkbox"/>	<input type="checkbox"/>	<input type="checkbox"/>	<input type="checkbox"/>
8	The surfaces of the fuel/slick oil dispenser and fuel supply unit are free of large amounts of oil and in good condition.	<input type="checkbox"/>	<input type="checkbox"/>	<input checked="" type="checkbox"/>	<input type="checkbox"/>

9	The nameplate for the rudder equipment is consistent with the certificate and bears a product approval certificate.	<input type="checkbox"/>	<input type="checkbox"/>	<input type="checkbox"/>	<input type="checkbox"/>
10	The inspection found no evidence of leakage at the rudder pipe system joints, valves or cylinder disc root. The cylinder is equipped with bleeder valves at both ends, and the pressure gauge is in good working order.	<input type="checkbox"/>	<input type="checkbox"/>	<input checked="" type="checkbox"/>	<input type="checkbox"/>
11	The rudder is equipped with anti-skid measures for personnel protection.	<input type="checkbox"/>	<input checked="" type="checkbox"/>	<input type="checkbox"/>	<input type="checkbox"/>
12	The rudder room is divided into three sections: compass, rudder angle device and driving station. All equipment is consistent and clear, and communication with the driving station is normal.	<input type="checkbox"/>	<input type="checkbox"/>	<input type="checkbox"/>	<input type="checkbox"/>

The room is also equipped with a diagram of the equipment and operating procedures.				
13	Insulation measures are in place for the location of and around the main switchboard, and the ground fault monitoring device is fully operational.	<input type="checkbox"/>	<input checked="" type="checkbox"/>	<input type="checkbox"/>	<input type="checkbox"/>
14	The emergency generator sets, their associated feeder wires and the enclosures of the distribution boards have been fitted with protective ground wires.	<input type="checkbox"/>	<input type="checkbox"/>	<input type="checkbox"/>	<input type="checkbox"/>
15	Please be advised that the level of fuel or oil in the emergency generator tank is between two-thirds and three-quarters full.	<input type="checkbox"/>	<input type="checkbox"/>	<input type="checkbox"/>	<input type="checkbox"/>
16	The voltage of the starting battery for the emergency generator set is within the normal range and displays a new or test mark.	<input type="checkbox"/>	<input type="checkbox"/>	<input type="checkbox"/>	<input type="checkbox"/>

17	The emergency power distribution board is functioning correctly, with all indicator lights and panel displays showing a normal open state.	<input type="checkbox"/>	<input type="checkbox"/>	<input type="checkbox"/>	<input type="checkbox"/>
18	The cabin pipework, subsea valves and outboard valves are free of significant corrosion, leakage, temporary repairs or cement boxes.	<input type="checkbox"/>	<input type="checkbox"/>	<input checked="" type="checkbox"/>	<input type="checkbox"/>
19	The cabin is supplied with the necessary spare parts for the main and auxiliary engines, and the machine shop is equipped with the appropriate repair tools and replacement parts.	<input type="checkbox"/>	<input checked="" type="checkbox"/>	<input type="checkbox"/>	<input type="checkbox"/>

Note: The above inspection items were found in "Fair" level overall.
