TECHNICAL REPORT

No. : CJPG-JS-24-KY-0624

GUO HONG 17

Inspection date September 28th, 2024

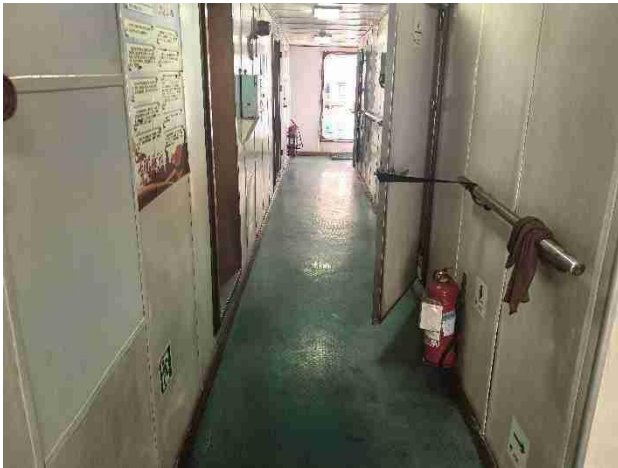
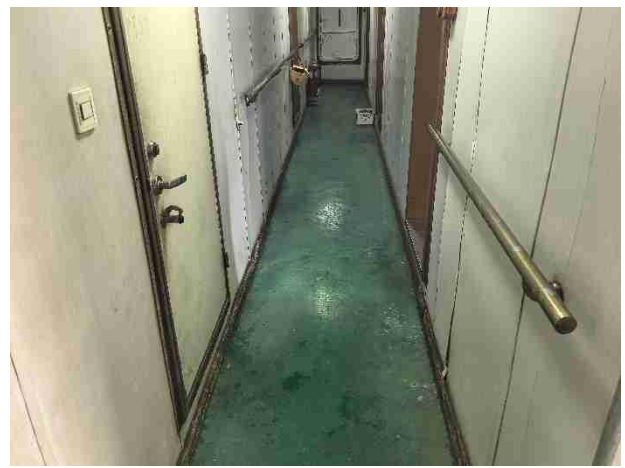
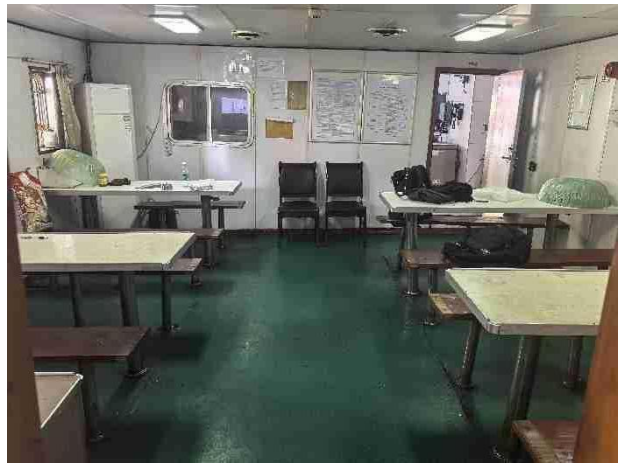
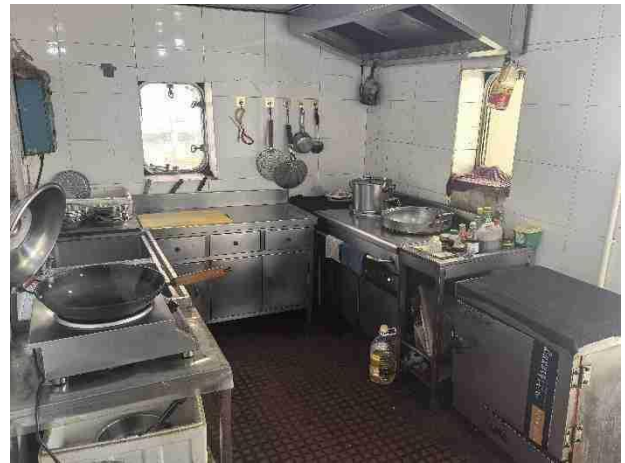
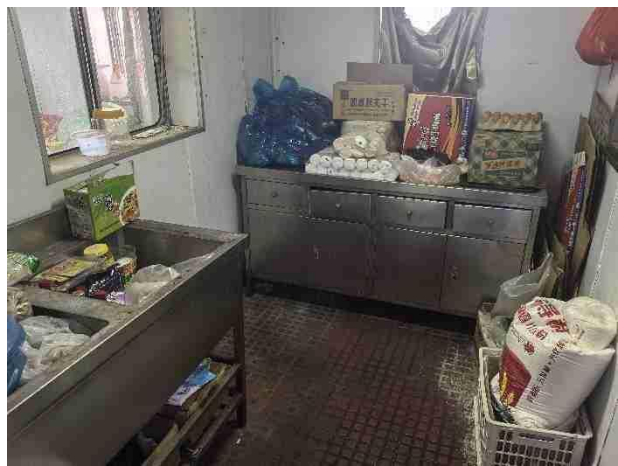
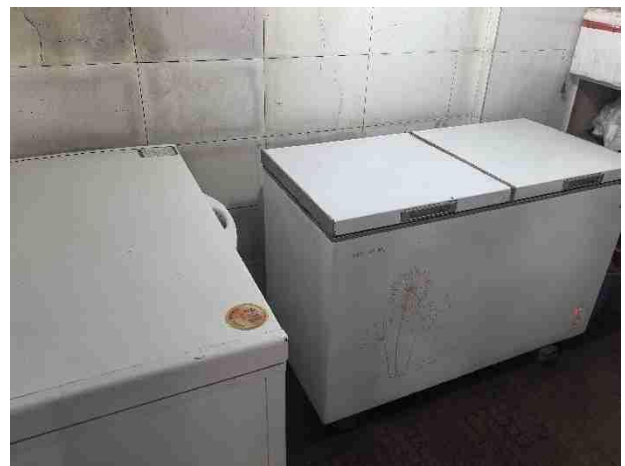
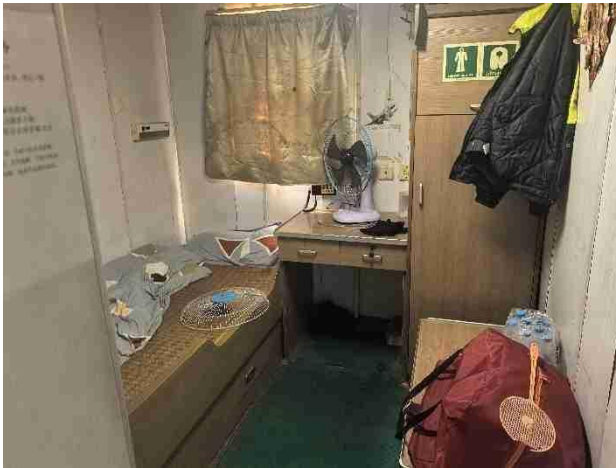
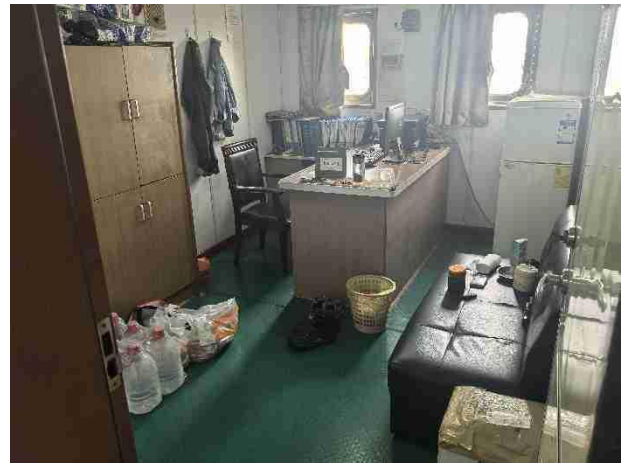
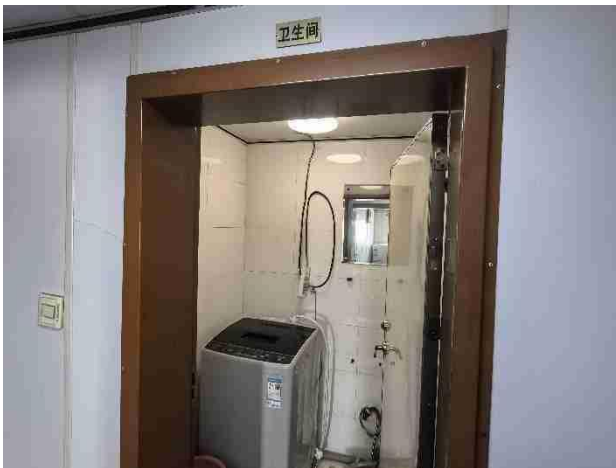
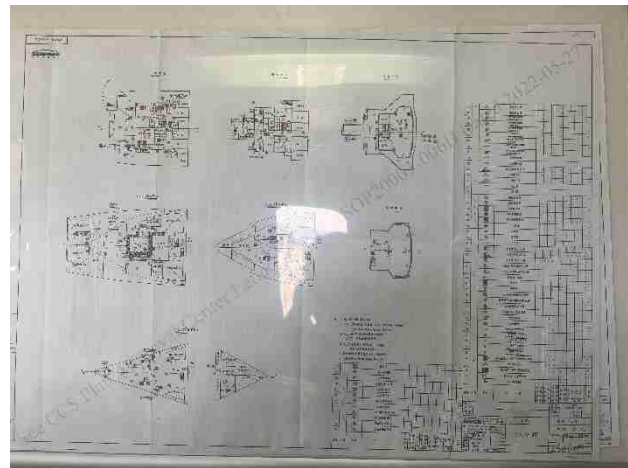
1. The fireproof material in the accommodation has cracked and rolled up.
2. The cleanliness of the galley was found good, without obvious oil stains, and the dining room floor was partially worn.
