TECHNICAL REPORT

编号: CJPG-JS-23-KY-199

Place of Inspection: Panzhi Island, Zhoushan Port

Technical Report of MV “PU HUI 2”

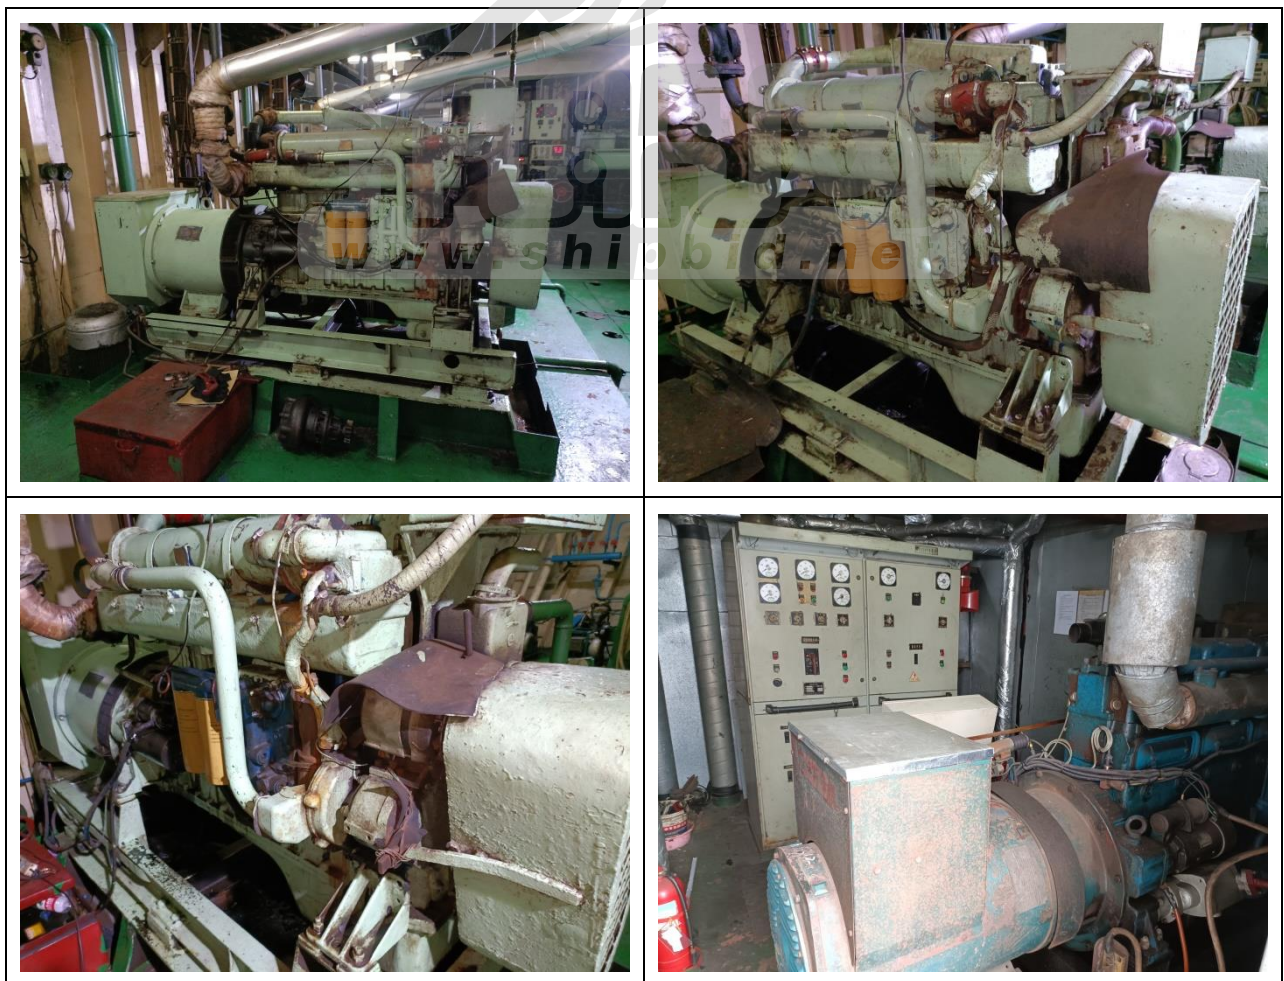
6.5.3 Generator Set

3 sets main generators, the model is MP-H-150-4, 150kW*400V. The model of the diesel is G128ZLCaf1, 193kW*1500r/min. 1 set emergency generator, the model is MP-H-64-4, 64kW*400V. The model of the diesel is 6135Caf, 77kW*1500r/min.
