TECHNICAL REPORT

编号: CJPG-JS-23-KY-236

Place of Inspection: Tianjin, China

Technical Report of MV "HAI XING CHUANG XIN"

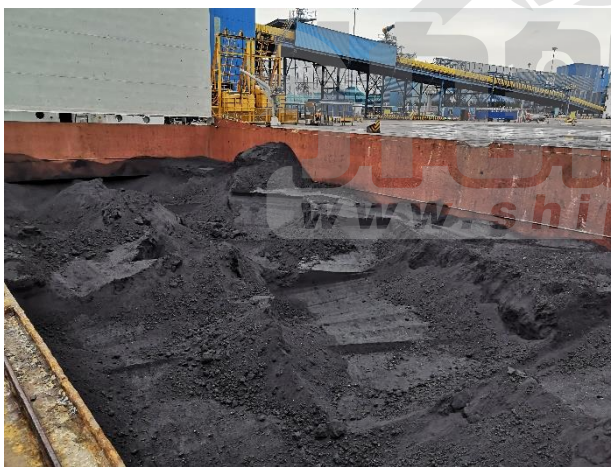
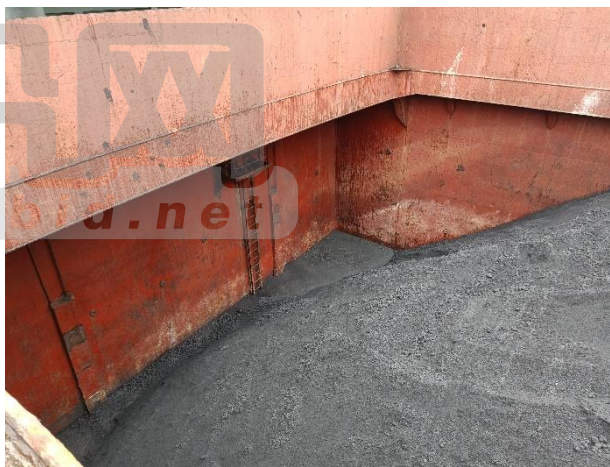
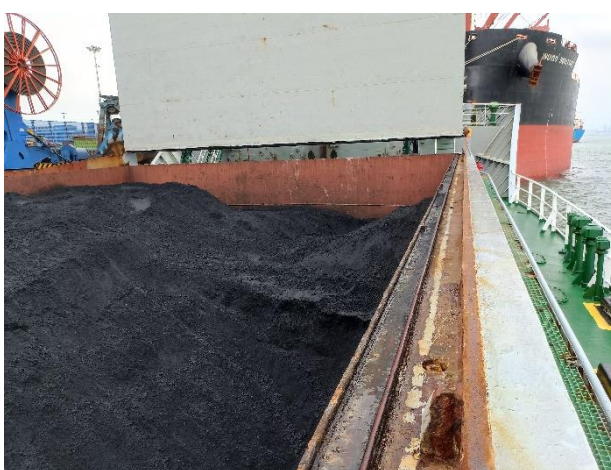
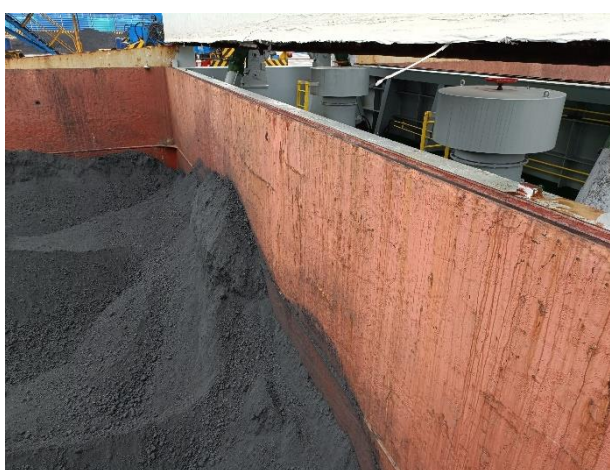
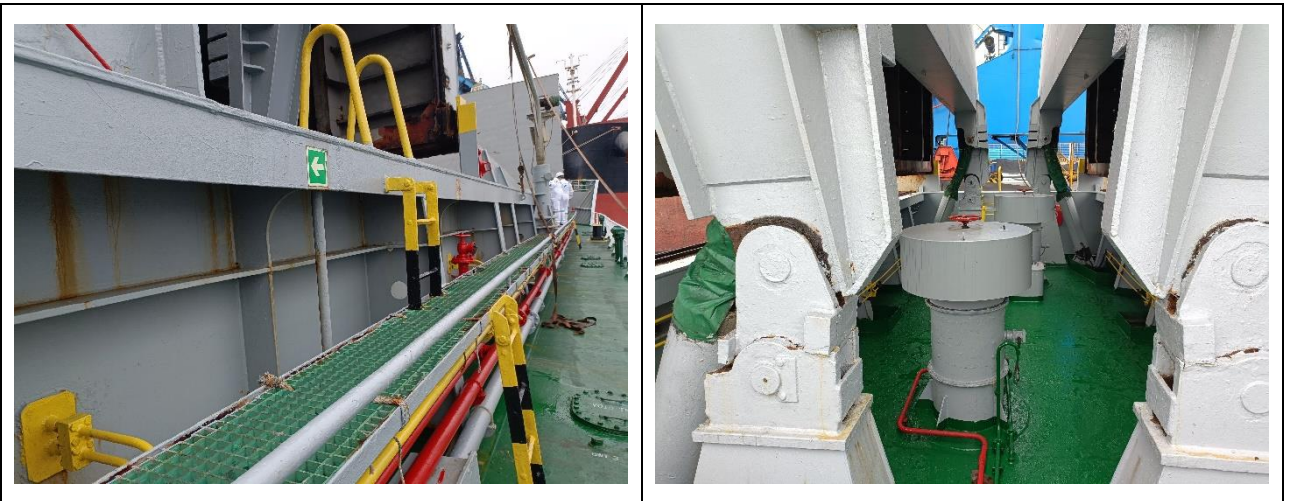
The ship has 2 cargo holds with double bottom and double hull, and equipped with folding hatch cover. No significant corrosion was found on the top plate of hatch cover, but the edges of the reinforcement stiffeners were found corroded. The watertight adhesive strip groove was found rust and thinning. The fastening wedge and wedge ear of the hatch cover were found slightly rusted. The hydraulic cylinder is equipped with a protective cloth cover, and the hydraulic cylinder support was found free of rust and no significant leakage in the hydraulic pipeline.

The hatch corner structure was found intact, and the rust mark was found on the pressure strips and water guide channel on the top plate of the hatch coaming.

The welding condition of the hatch coaming was found in generally good condition, and the rust was found on the local welding seam of the reinforced bracket. The faceplate of the reinforced bracket was welded to the deck with a chamfer, without significant rust

At the time of the inspection, the ship was unloading, and the visible coating on the bulkhead of the cargo hold was found basically intact, and no deformation on the access ladder.

The fire pipelines around the hatch coaming were found well painted, and the fire hydrants were arranged intact and undamaged. The paint of the cargo hold ventilation pipe was found intact, the fireproof net was complete, and the fire damper handwheel was found no significantly blocked.

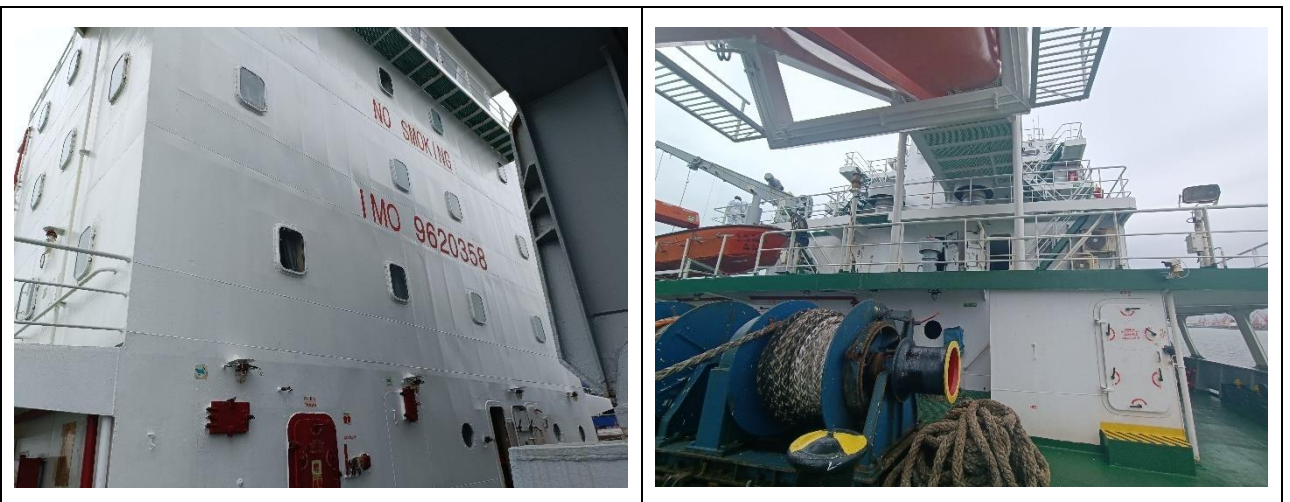
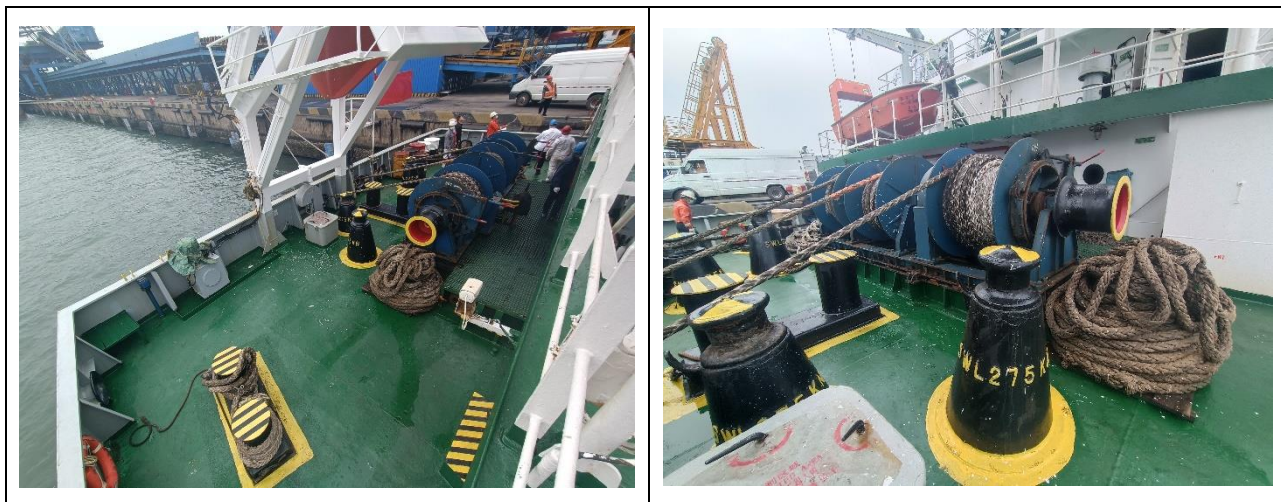
The condition of the main deck was found generally good, and the paint was basically intact. No rust was found on the manhole covers on both sides of the deck.

The condition of the forecastle deck was found to be general, without significant damaged on paint and deformation on the bulwark bracket. The body structure of the two windlasses were found basically intact, with paint damaged on the local of base. The structure of mooring equipment such as bollard was found complete, with basically intact coating.

There is 1 set winch installed on the main deck aft, and the paint was found basically intact. The bracket of the base was found significant rust. No significant corrosion or thinning was found on the guide pulley, without significant breakage on the rope.

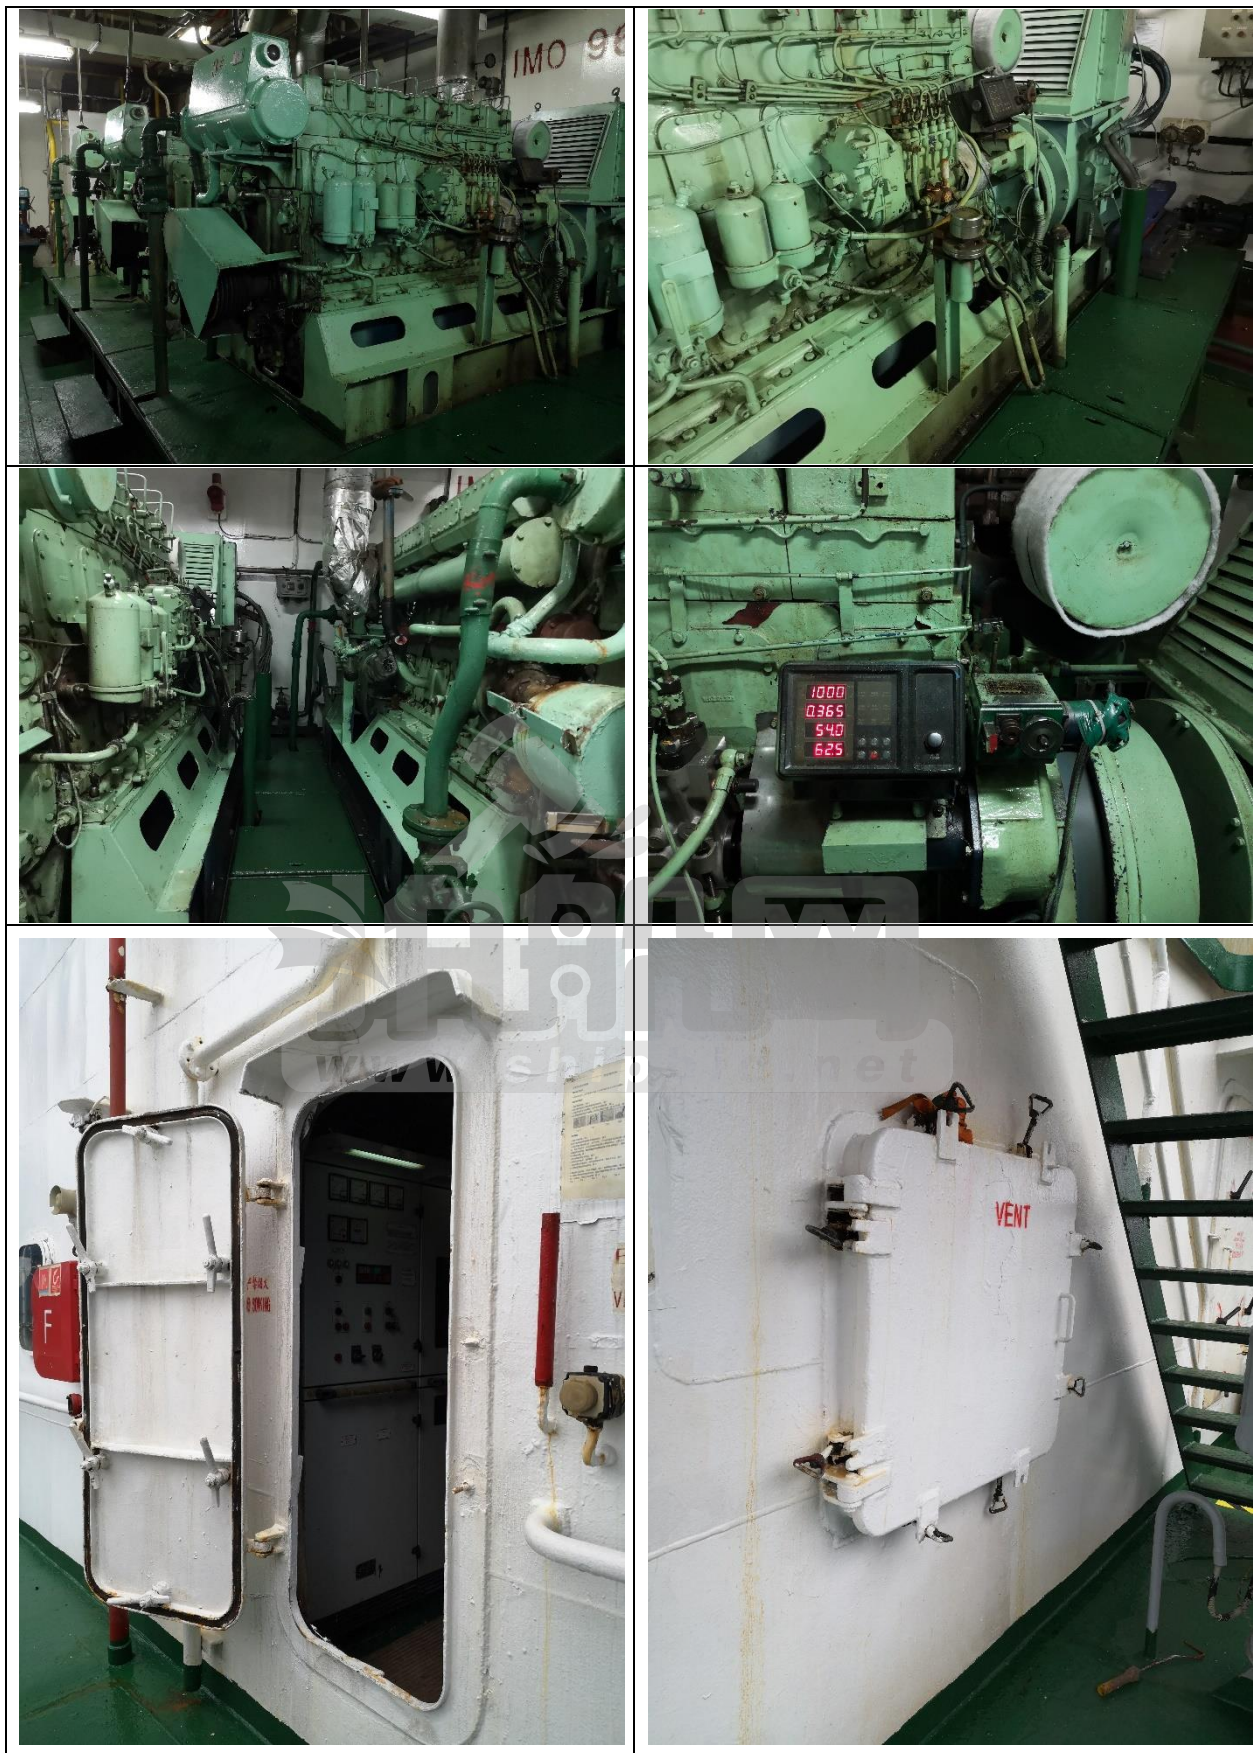
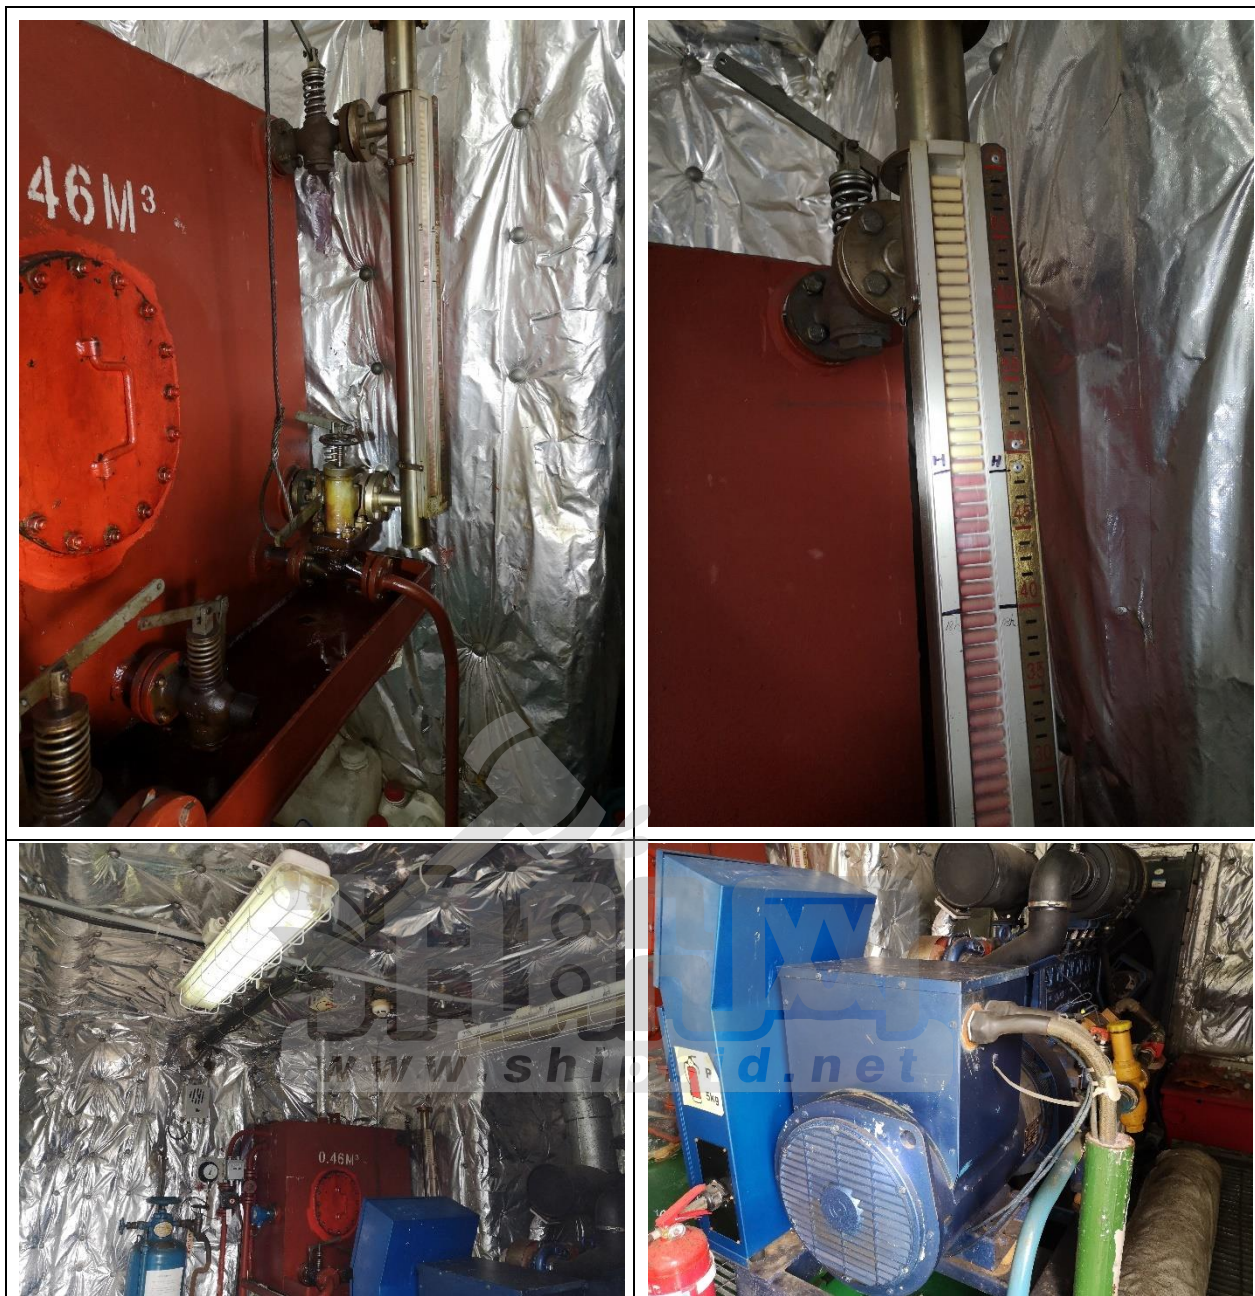
The auxiliary engine of the emergency generator adopts two starting modes as required, namely air bottle and storage battery, with the storage battery being replaced on November 3rd, 2021.

The emergency switchboard was found to be in a normally open state, with no abnormalities in the appearance of the switch, indicator light, and instrument.
