TECHNICAL REPORT

Number: CJPG-JS-23-K Y-285

XING XIANG 7

Inspection Place: Zhoushan Jinzhou Shipyard

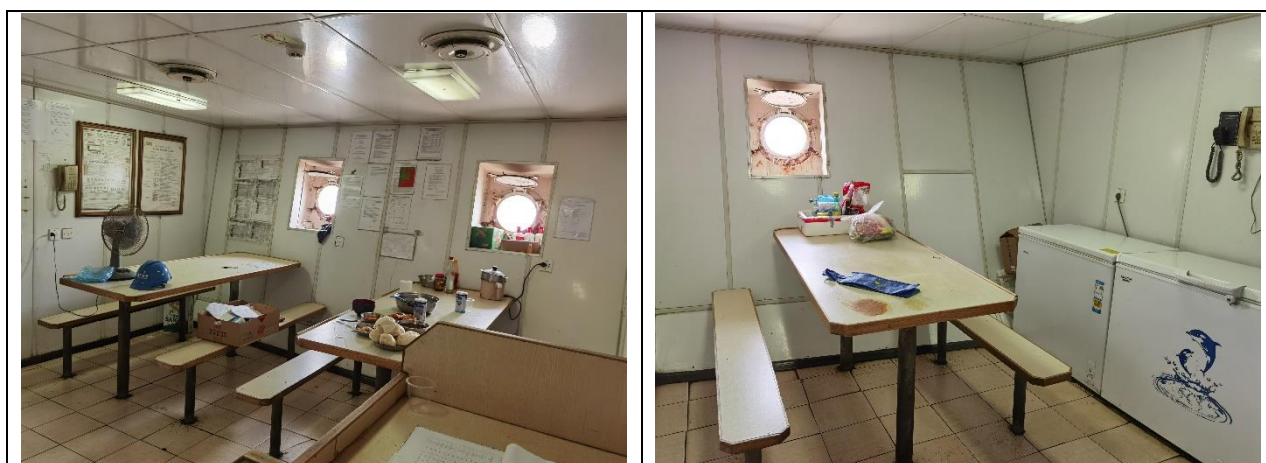
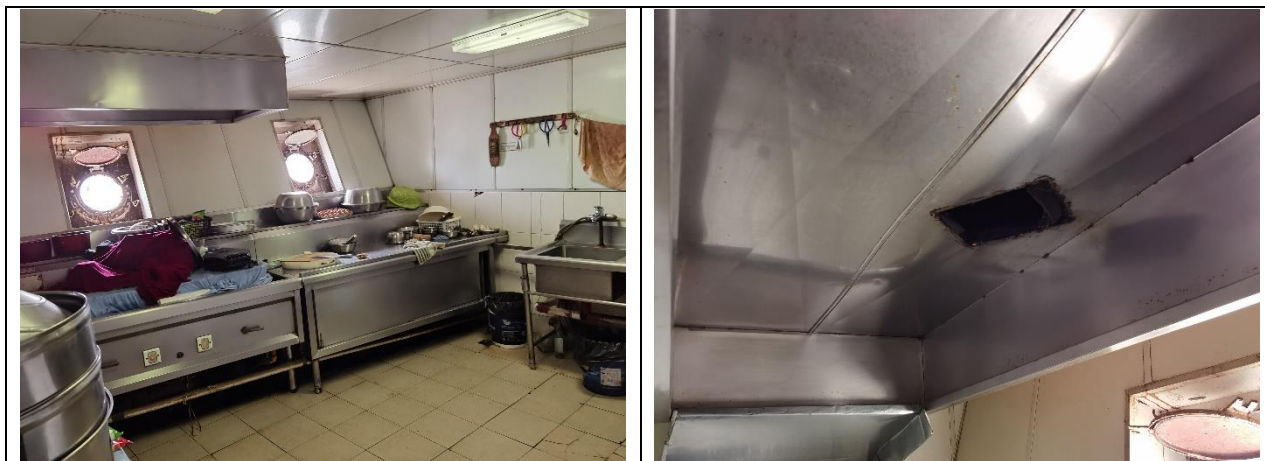
This ship has a crew cafeteria and a senior crew cafeteria. The indoor lighting was found intact, the decoration materials were found to be free of deformed or damaged, the side window was found no cracked, the storm cover was found watertight with intact bolts.

This ship has a kitchen located adjacent to the cafeteria, with good indoor cleanliness and complete kitchen facilities. The stove, pantry, and sink are all made of stainless steel, and the range hood is a mechanical exhaust type.

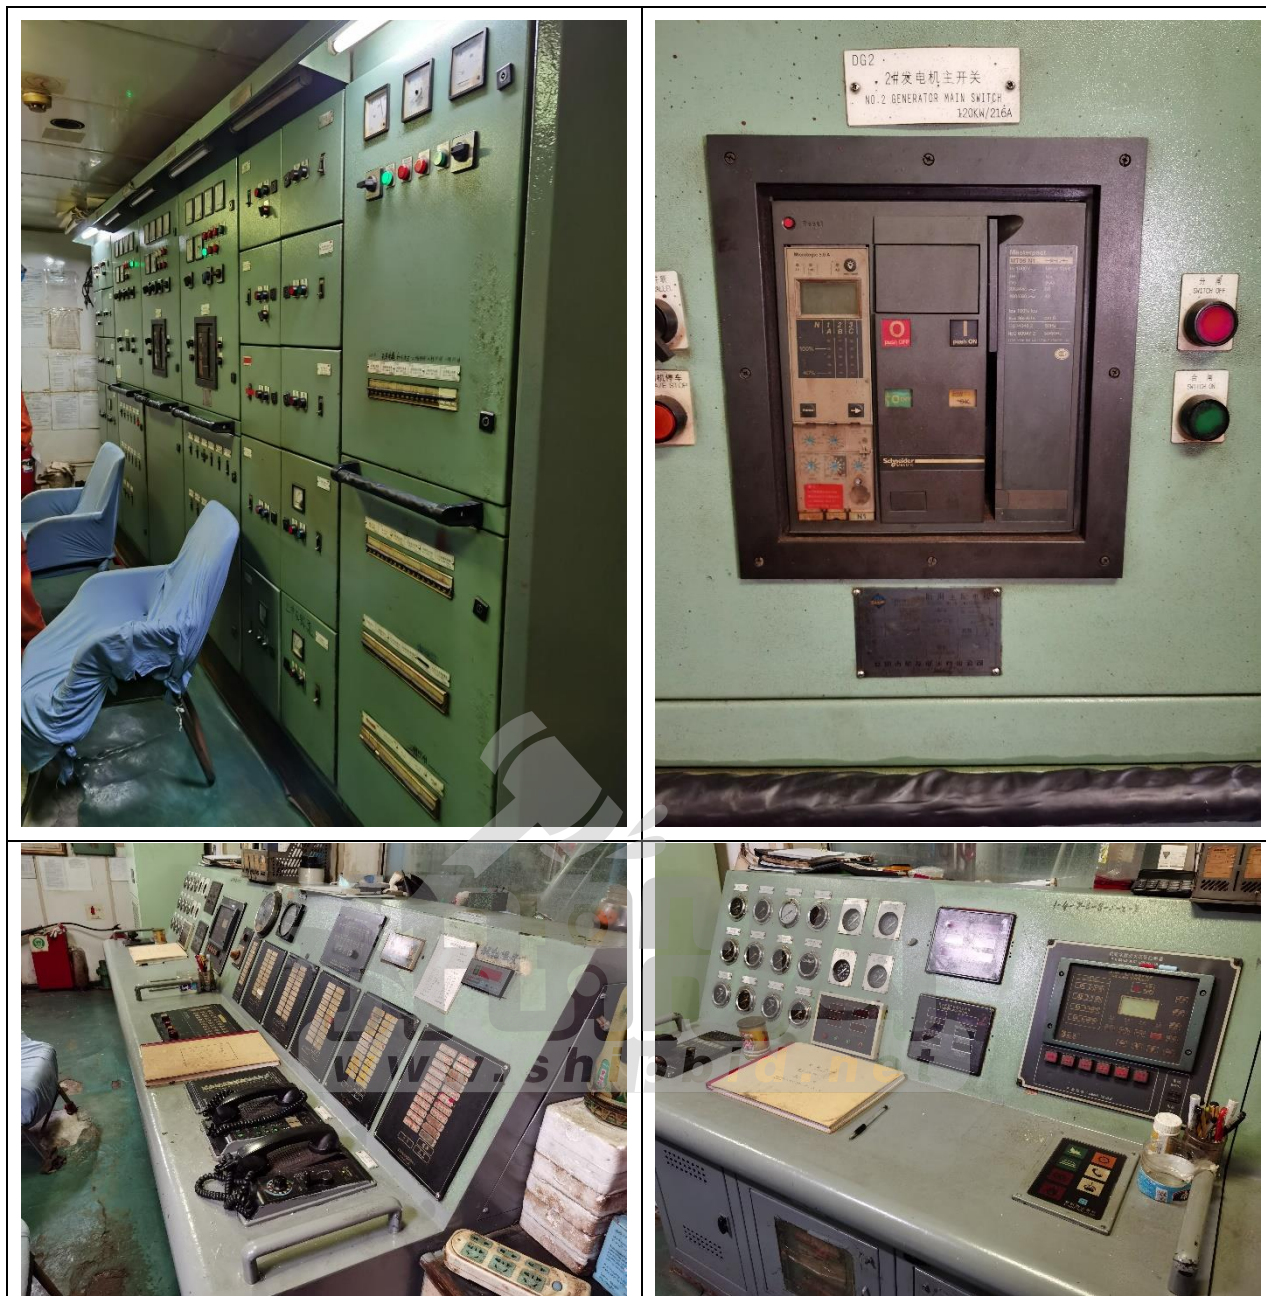
The self closing door, indoor lighting fixtures, and fire insulation laying of the engine control room were found in good condition.

There are 6 main distribution panels in total, which are produced by Anyang Shipfriends Electric Appliance Co., Ltd, and the brand of the main switch is Schneider.

The appearance of each switch, indicator light, and instrument on the main distribution board was found normal, and as well as the appearance of each alarm light and monitoring instrument panel on the console.

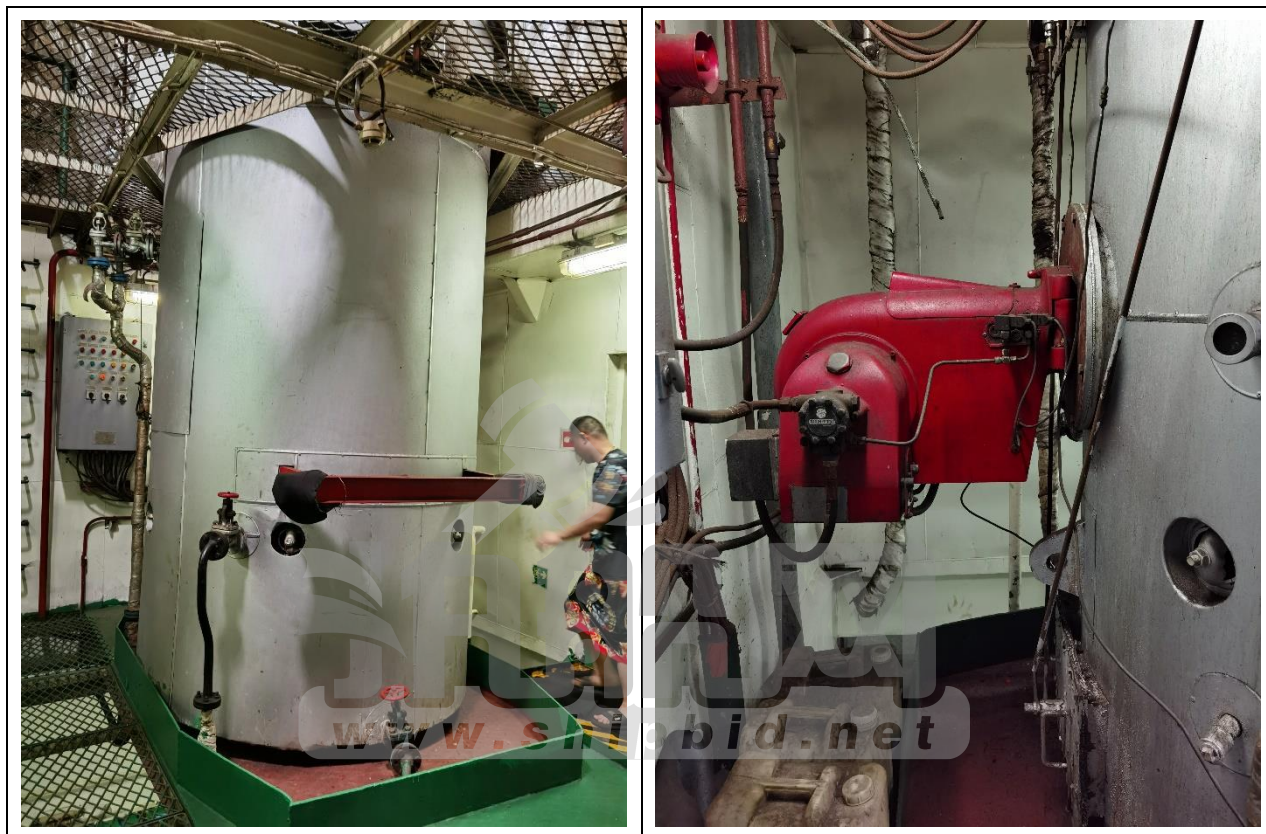
The exterior of the boiler body, exhaust pipe, and steam pipe were insulated and wrapped without obvious damage.

The boiler valve components was found to be free of significant signs of water leakage, and the water supply pipeline has no significant leakage.

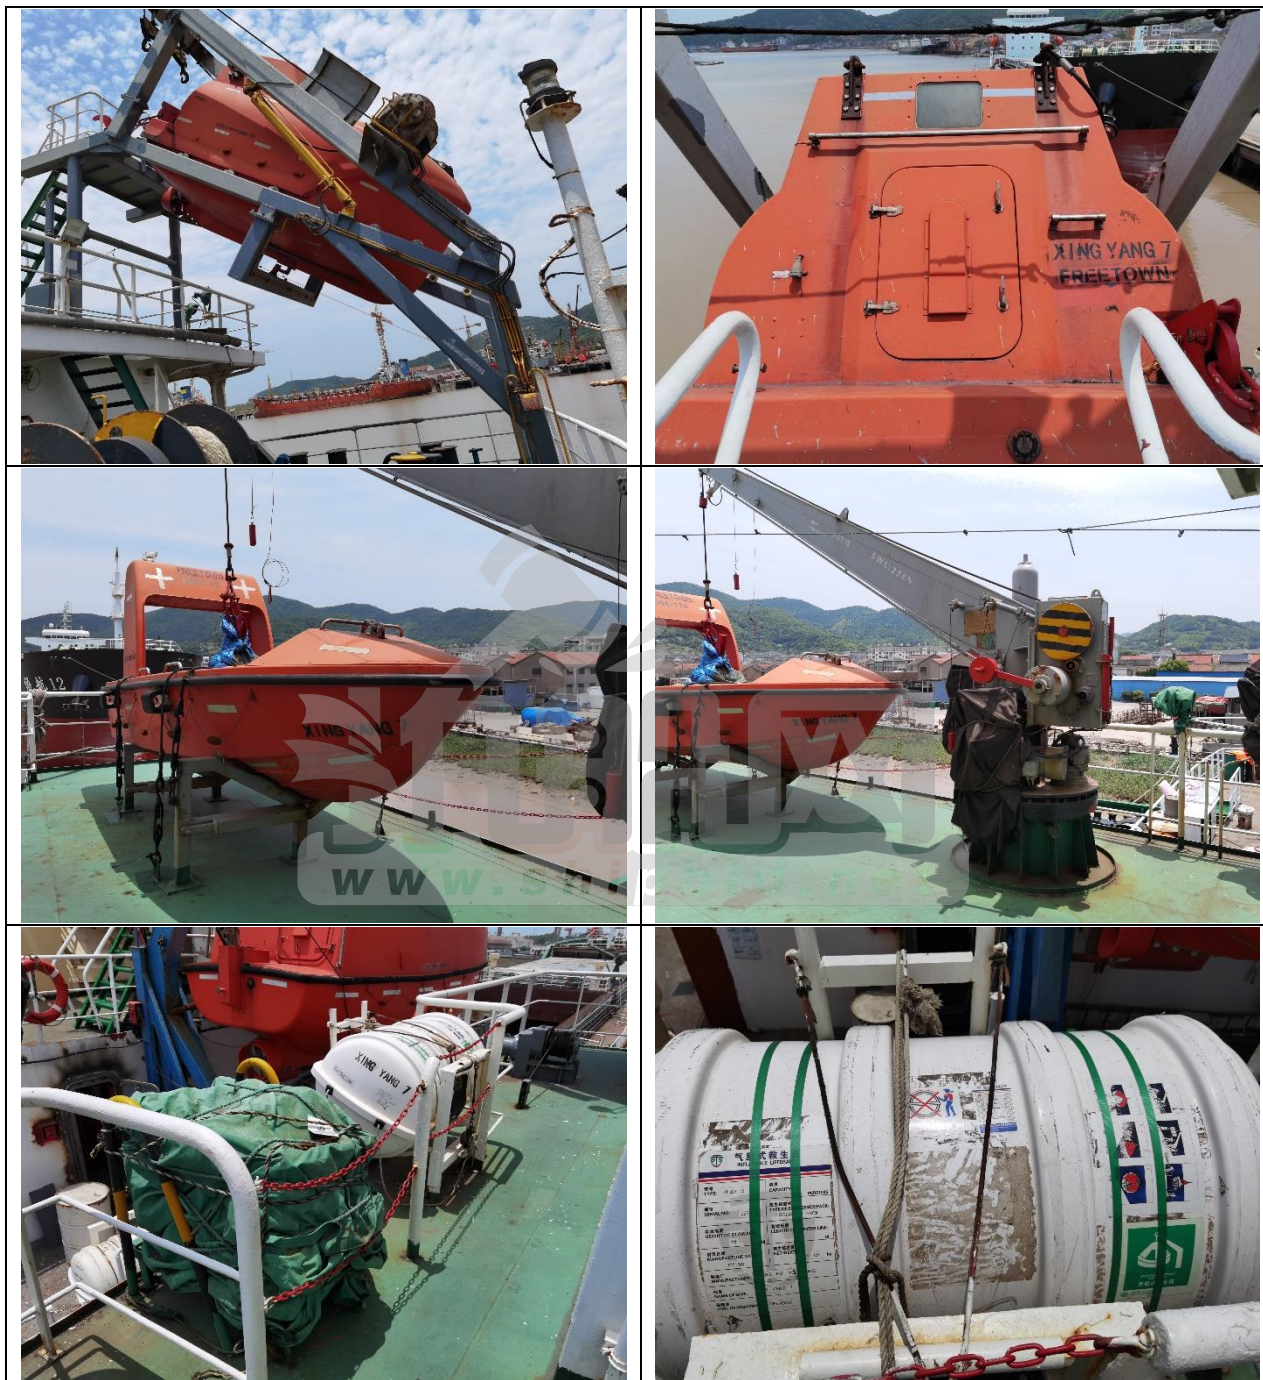
The roller groove of the lifeboat frame was found to be free of significant rust or thinning, without damage on the steel wire, and no rust on the lifting roller and release hook.

This ship is equipped with one davit-launched liferaft with 15-person and one throw-overboard life raft with 15-person. The release device of the life raft was found complete, the inspection marks were found clear and complete.
