# TECHNICAL REPORT

CJPG-JS-23-KY-692

## HAO YING YUN 7

Inspection date      December 6th, 2023

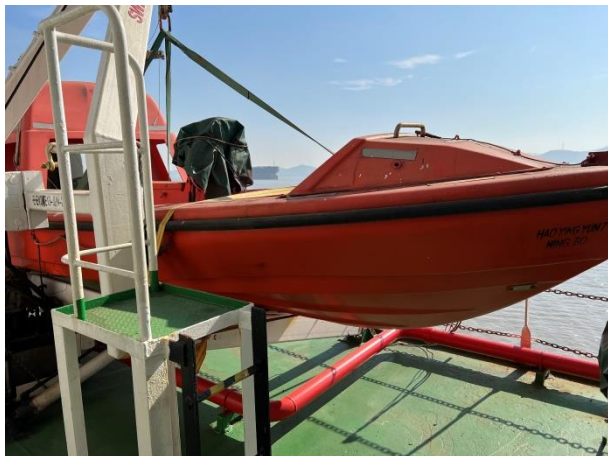
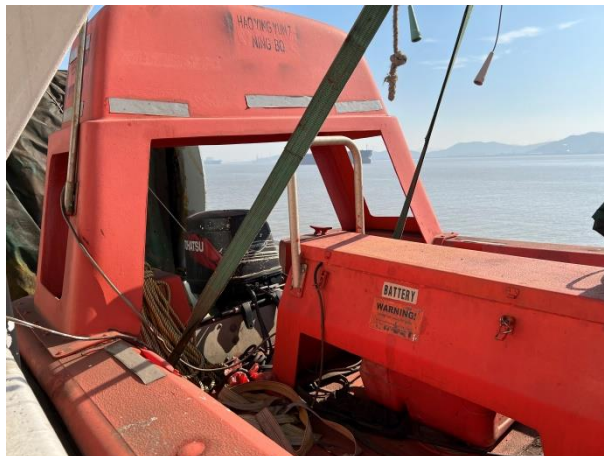
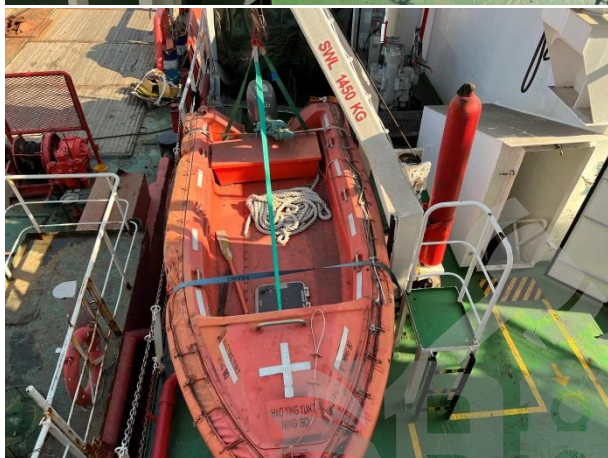
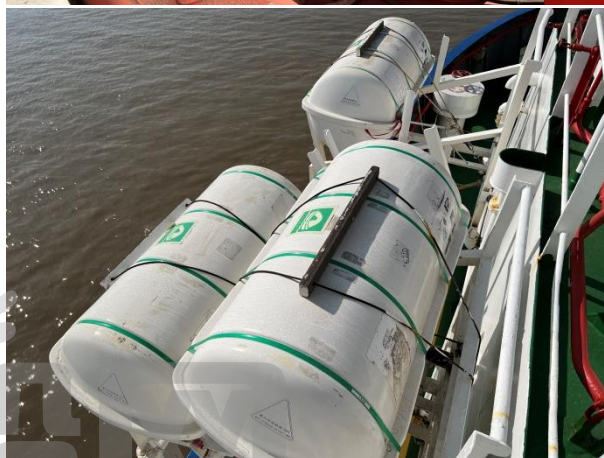
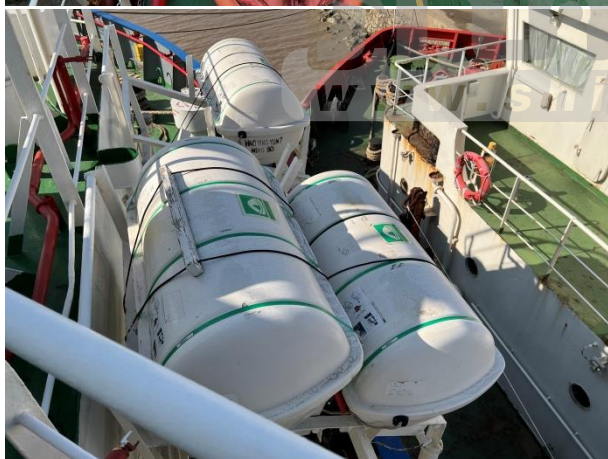
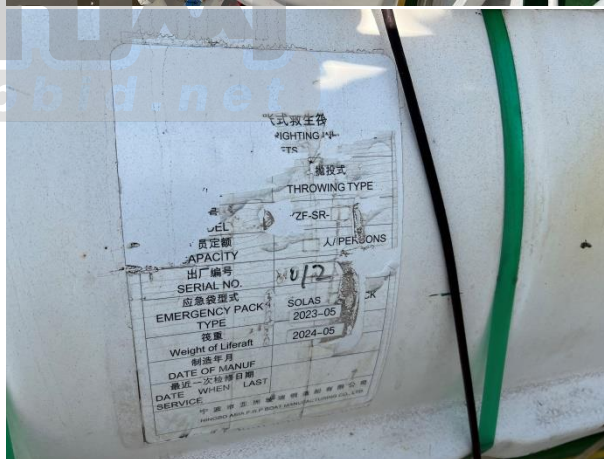
Note: The above inspection items were found in "Fair to good" level overall.

1. The next inspection date for inflatable life rafts is May 2024.
2. The steel wire of the rescue boat needs to be replaced before September 2027.

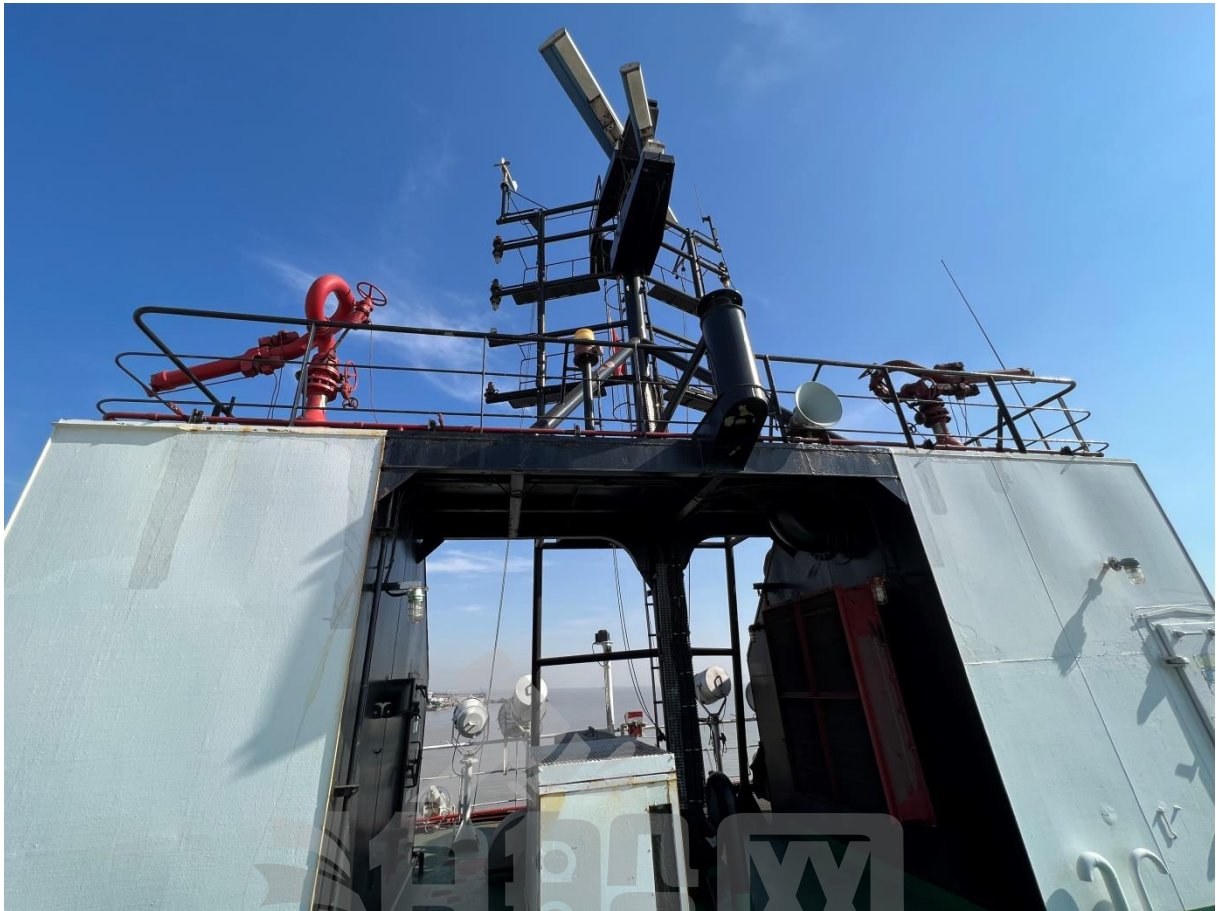
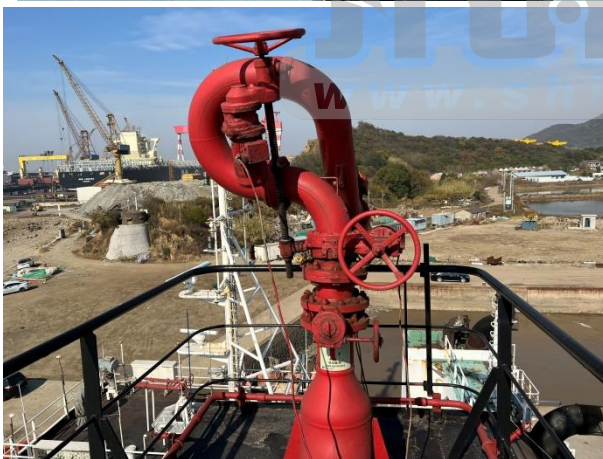
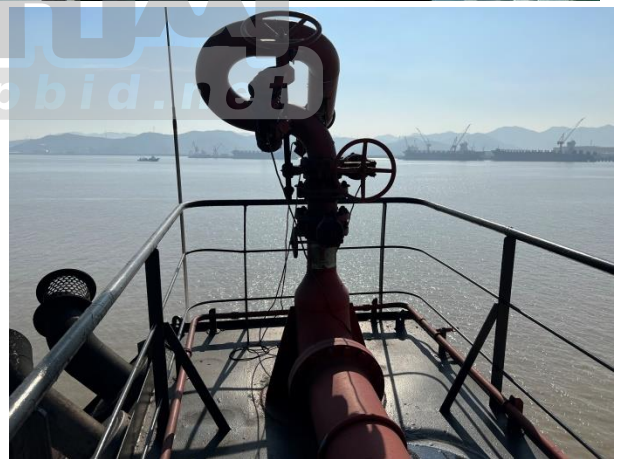
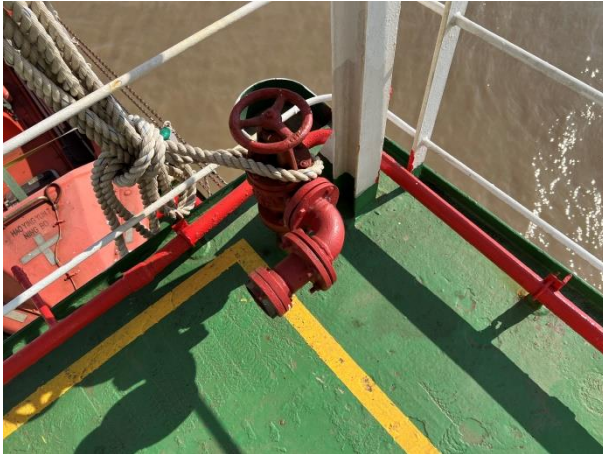
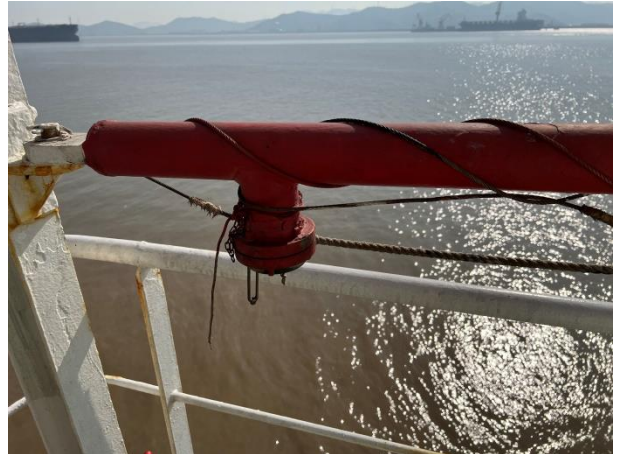
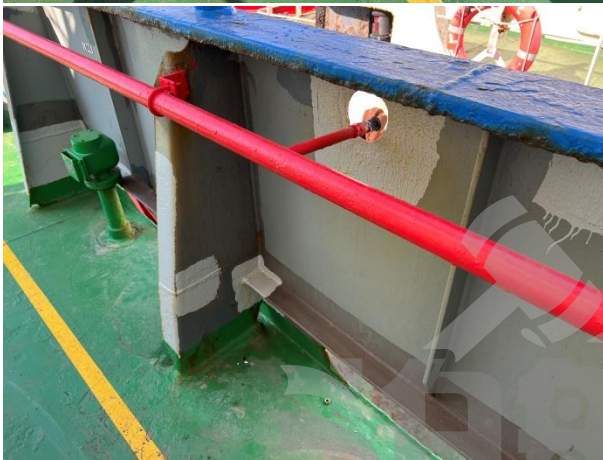
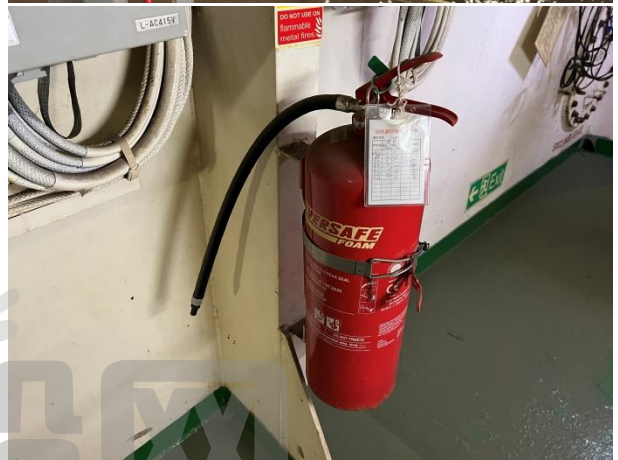
Note: The above inspection items were found in "Fair to good" level overall.

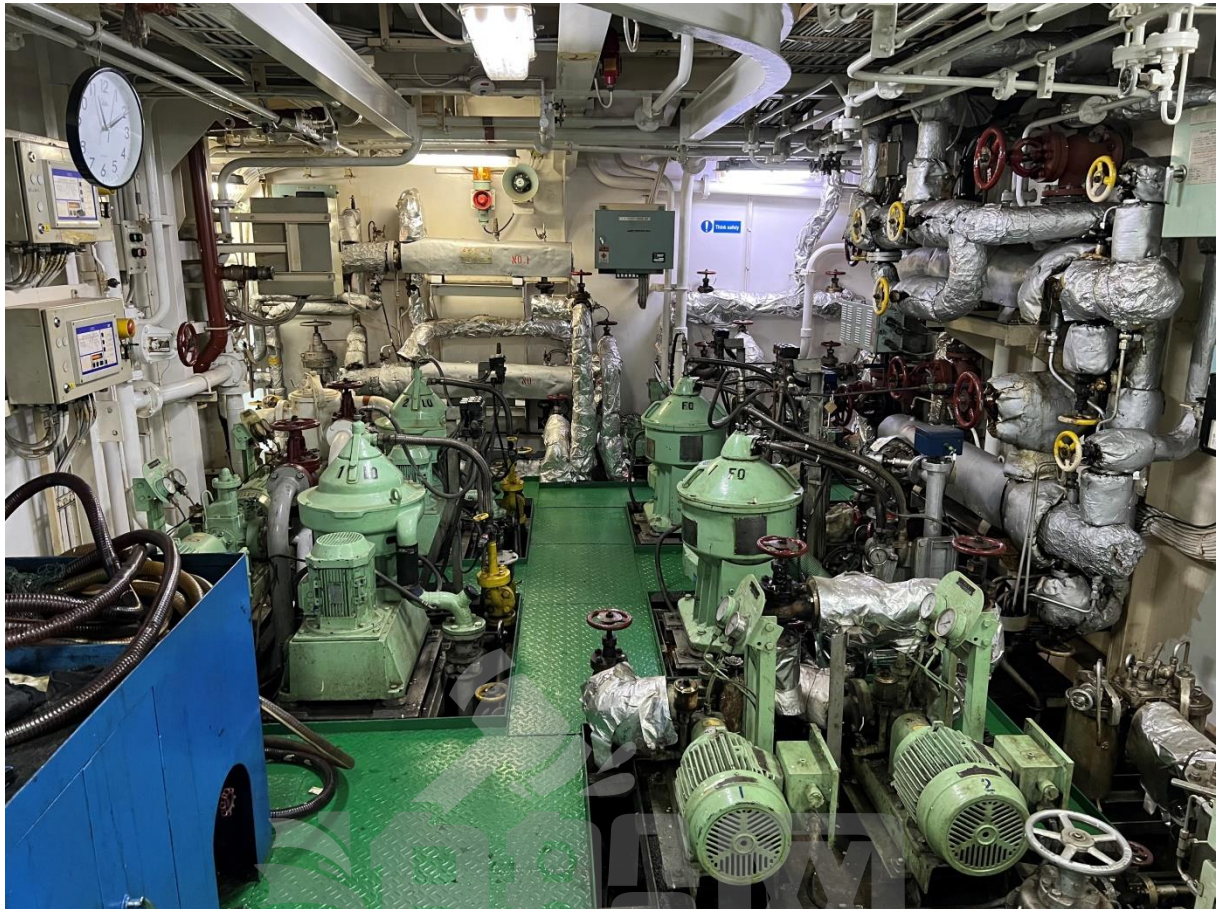
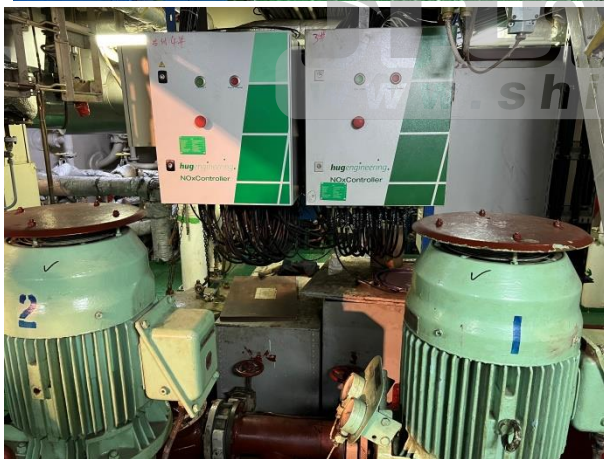
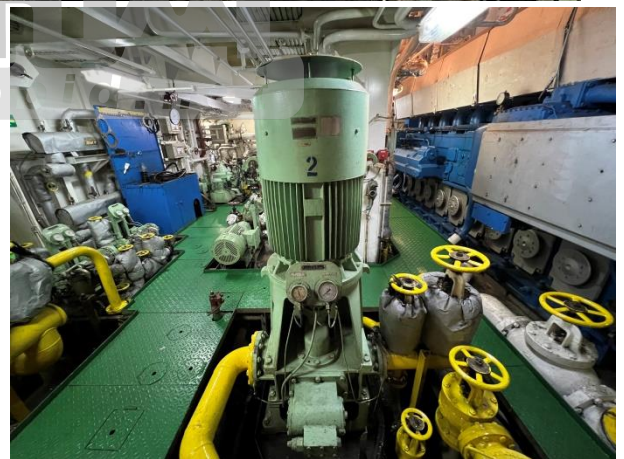
Note: The above inspection items were found in "Fair to good" level overall.

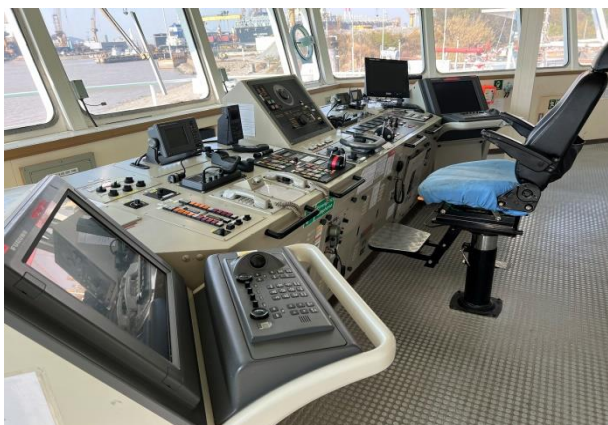
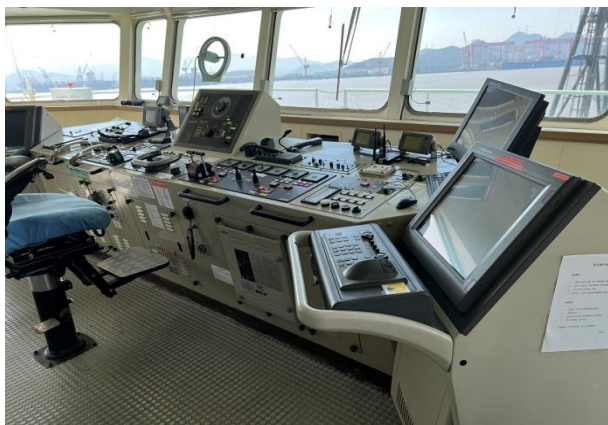
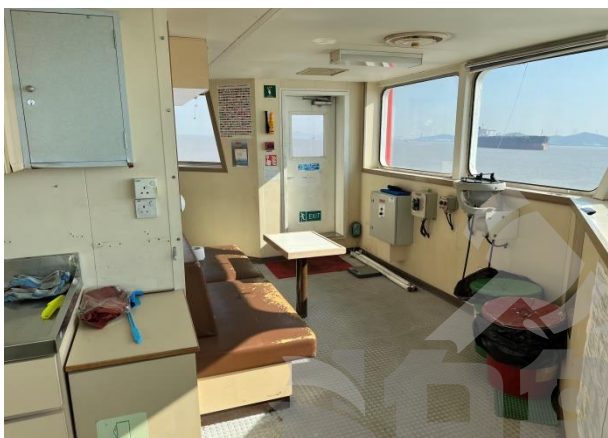
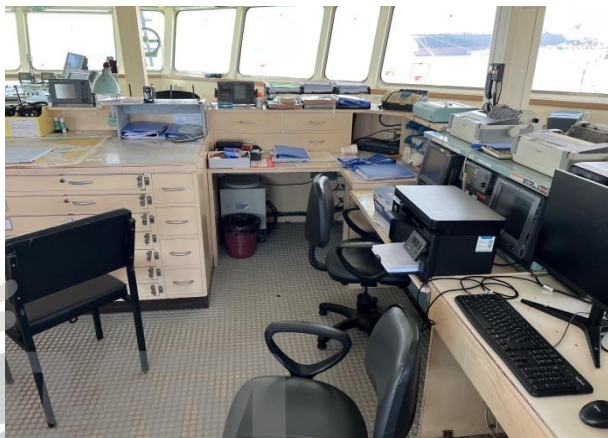
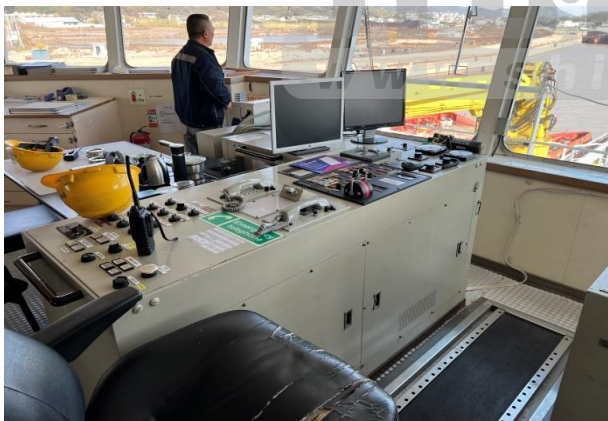
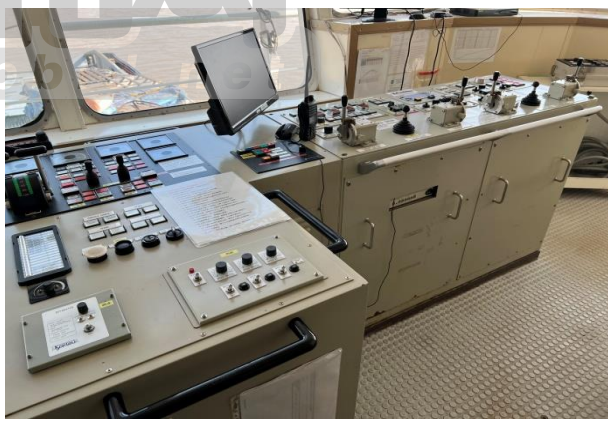
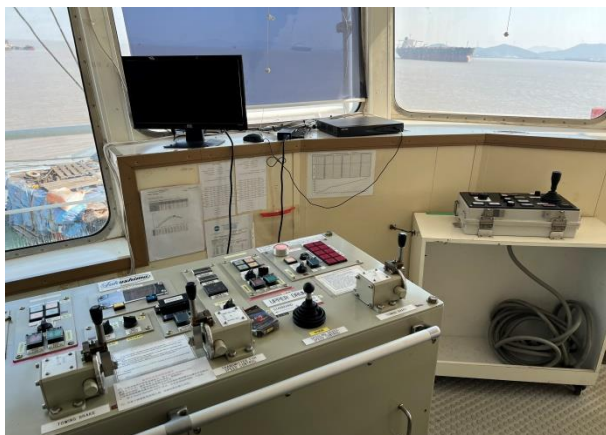
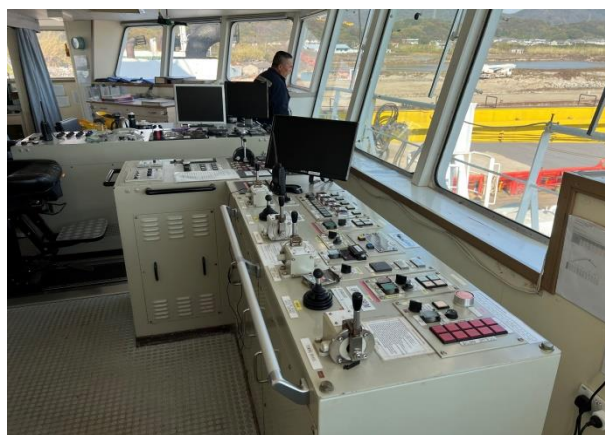
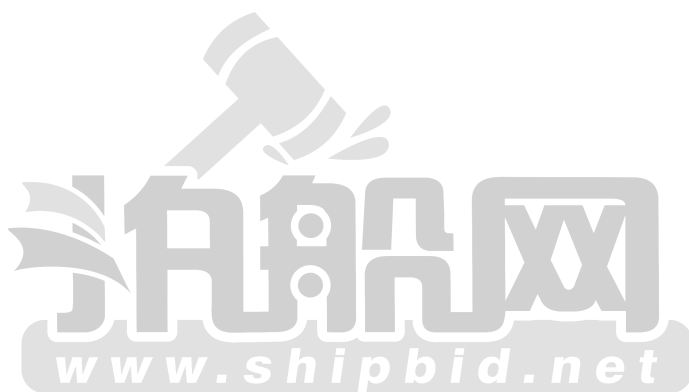
Note: The above inspection items were found in "Fair to good" level overall.

This ship is equipped with front and rear driving control systems, and the rear driving can be operated by 2 people simultaneously (1 person controls the ship, and 1 person controls the towing winch and deck machinery).

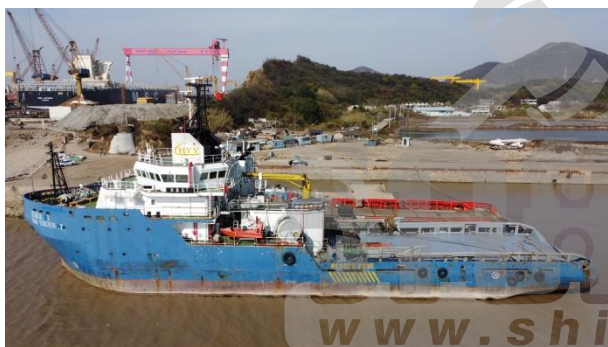
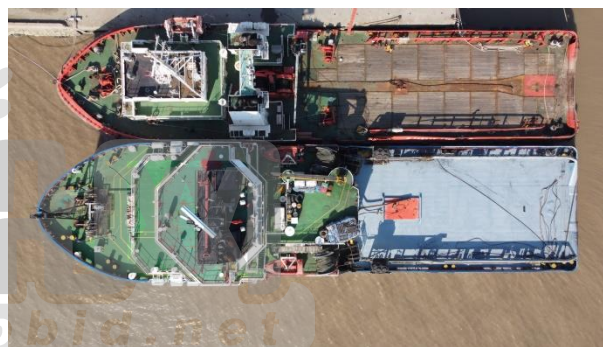
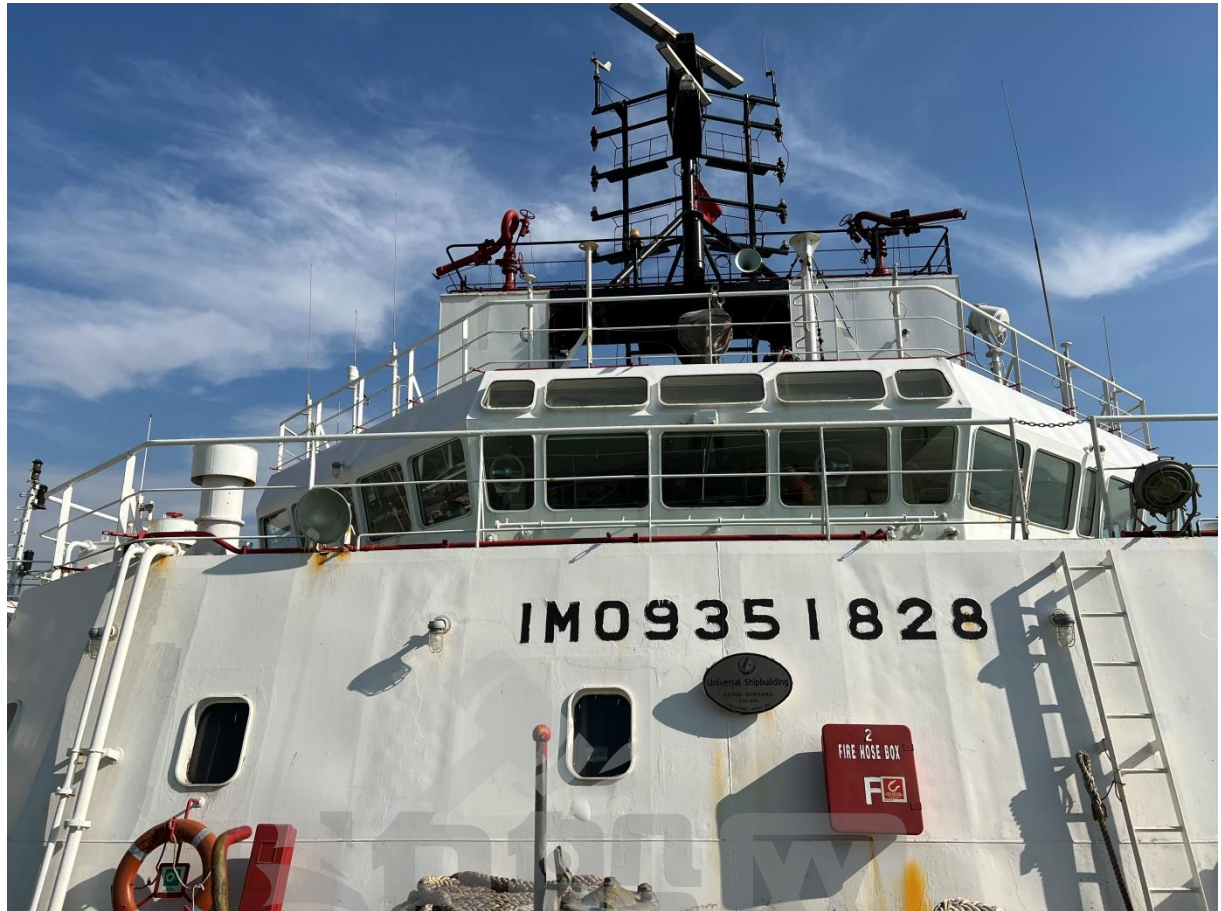
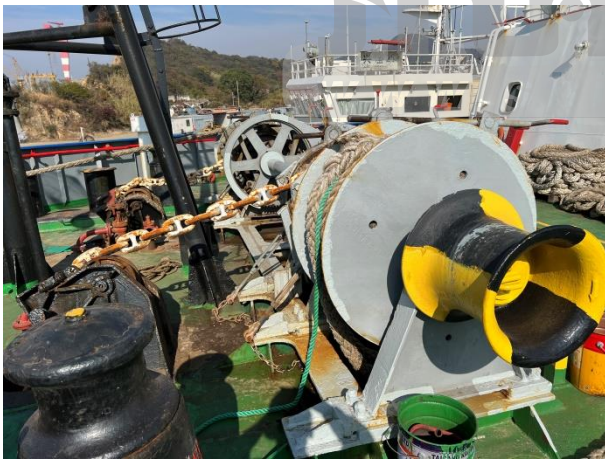
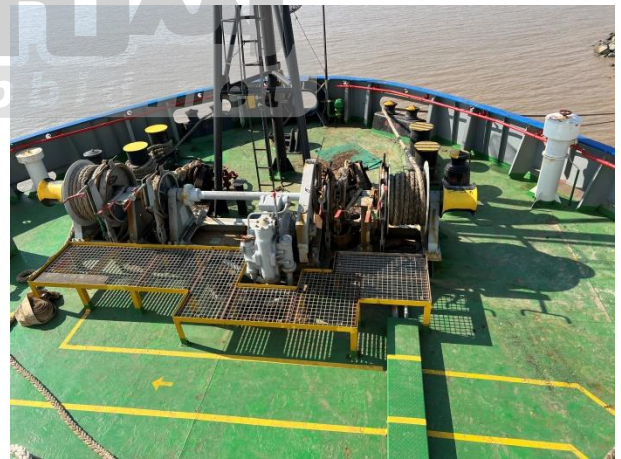
Note: The above inspection items were found in "Fair to good" level overall.

The larger corrosion rate for hull thickness measurement is 14.4% at the starboard side of the midship bottom, while the corrosion rate for other structures is basically 5% or less.

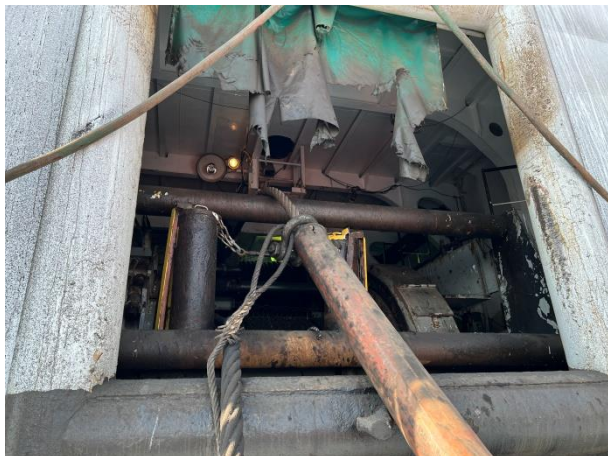
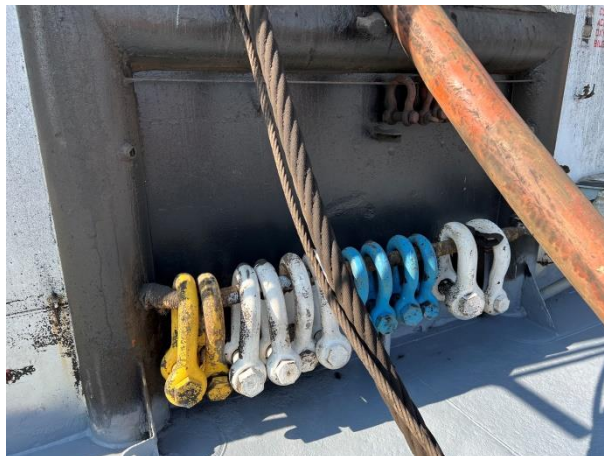
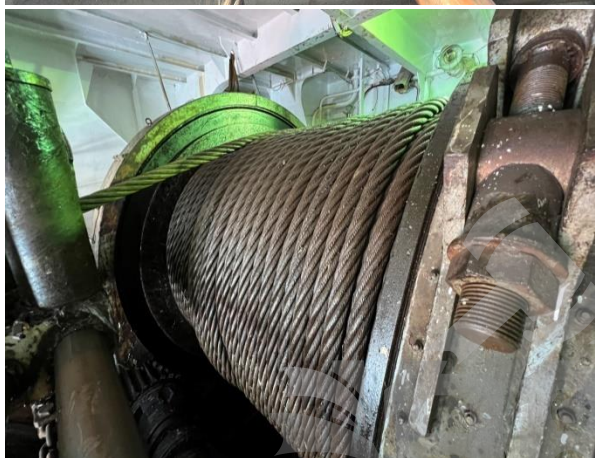
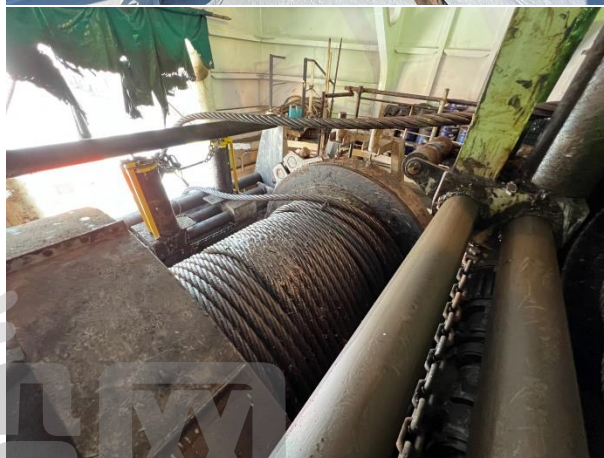
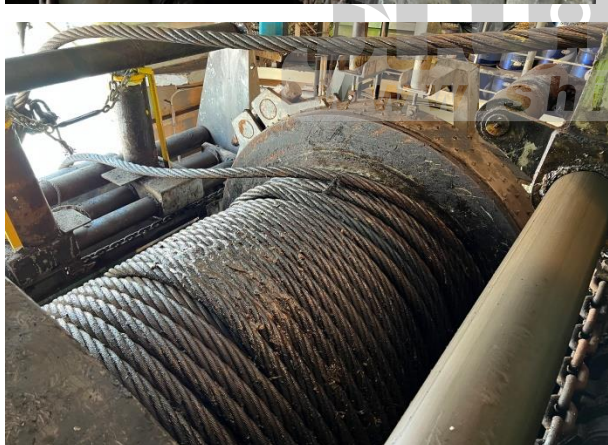
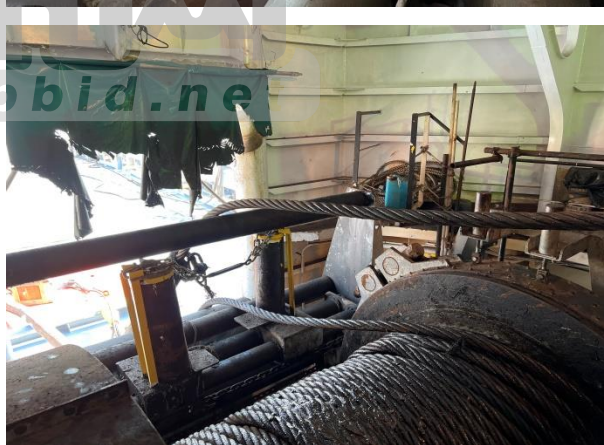
## 9. Towing Equipment

No.	Description	Good	Fair to good	Fair	Poor
1	The towing winch was found in good condition.	<input type="checkbox"/>	<input checked="" type="checkbox"/>	<input type="checkbox"/>	<input type="checkbox"/>
2	The towing rope was found in good condition with the records of regular inspection and maintenance.	<input type="checkbox"/>	<input checked="" type="checkbox"/>	<input type="checkbox"/>	<input type="checkbox"/>
3	The appearance of the stern drum was found in good condition, without deformation, crack, rust.	<input type="checkbox"/>	<input checked="" type="checkbox"/>	<input type="checkbox"/>	<input type="checkbox"/>
4	The towing pin and shark jaw were found in good condition.	<input type="checkbox"/>	<input checked="" type="checkbox"/>	<input type="checkbox"/>	<input type="checkbox"/>
5	The hydraulic cylinder of the shark jaw and towing pin was well lubricated, and the hydraulic pipeline was free of rust or leakage.	<input type="checkbox"/>	<input checked="" type="checkbox"/>	<input type="checkbox"/>	<input type="checkbox"/>

6	The nameplate of the towing winch motor was clear, the casing was free from rust or damage, and the wiring harness was free from aging and cracking.	<input type="checkbox"/>	<input checked="" type="checkbox"/>	<input type="checkbox"/>	<input type="checkbox"/>

Note: The above inspection items were found in "Fair to good" level overall.

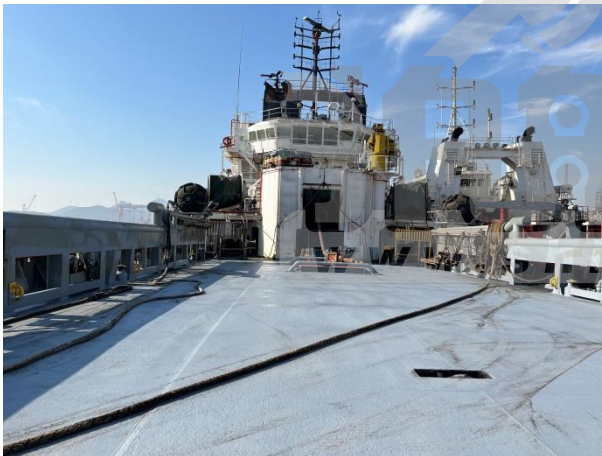
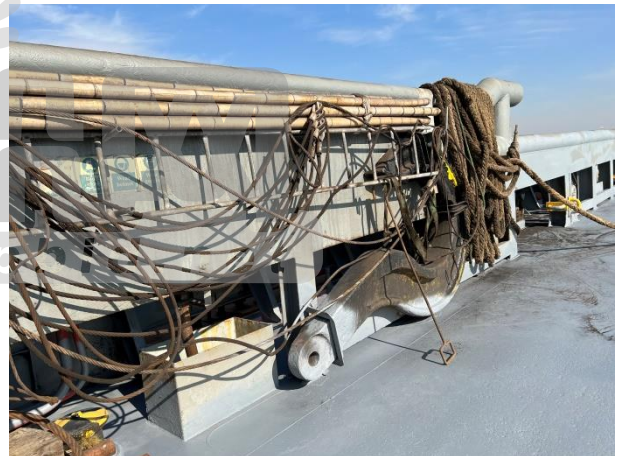
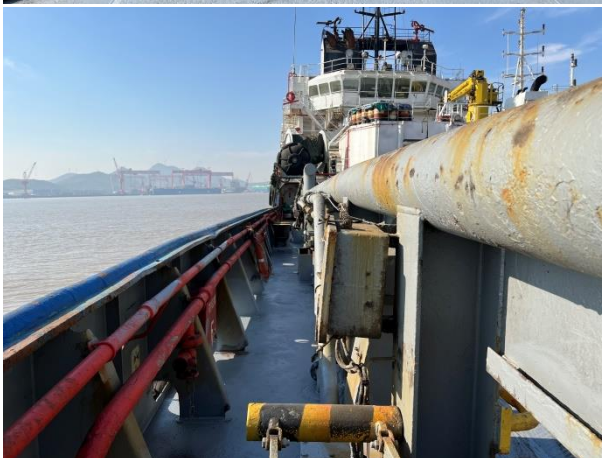
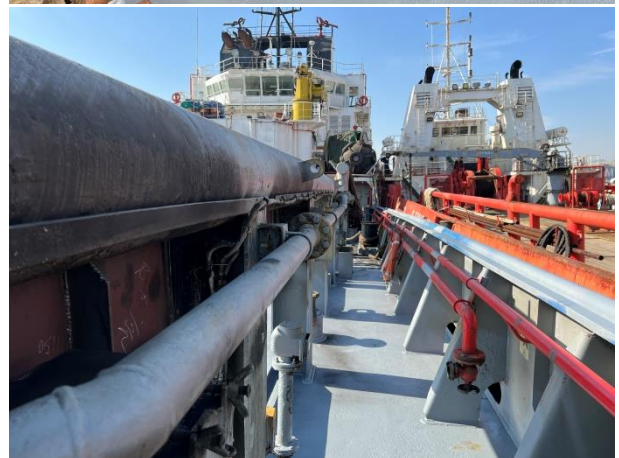
## 10. Cargo Systems

No.	Description	Good	Fair to good	Fair	Poor
1	No obvious damage was found on the cargo fence, wooden deck, binding points, and binding devices	<input type="checkbox"/>	<input checked="" type="checkbox"/>	<input type="checkbox"/>	<input type="checkbox"/>
2	The dangerous cargo area, personnel safety passage, and towing area on the main deck were clearly marked.	<input type="checkbox"/>	<input checked="" type="checkbox"/>	<input type="checkbox"/>	<input type="checkbox"/>
3	The cargo system was found in good condition (fuel, fresh water, base oil, drilling water/mud tank, dry bulk tank).	<input type="checkbox"/>	<input type="checkbox"/>	<input type="checkbox"/>	<input type="checkbox"/>
4	All couplings, hoses, reducers, and vent valves were in good condition.	<input type="checkbox"/>	<input checked="" type="checkbox"/>	<input type="checkbox"/>	<input type="checkbox"/>

Note: The above inspection items were found in "Fair to good" level overall.
