TECHNICAL REPORT

CJPG-JS-24-KY-0438

NING FENG YOU 1

Technical Report

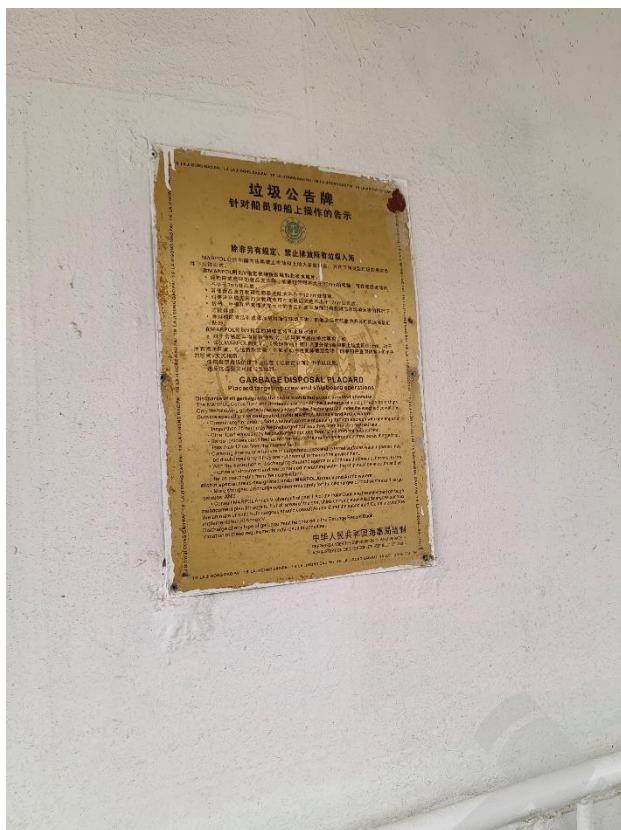
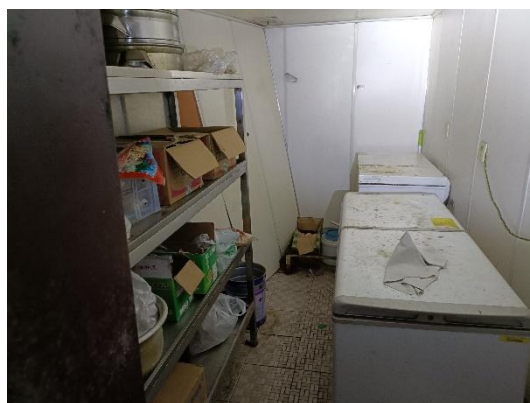
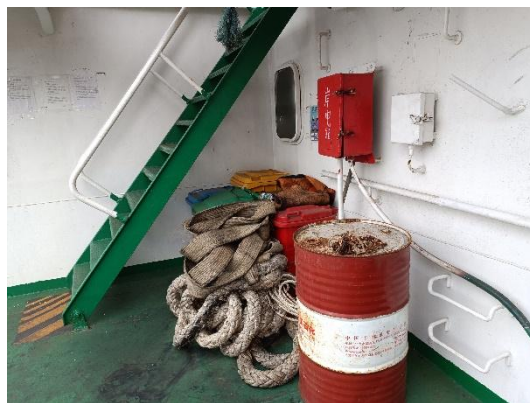
The cleanliness of the galley is poor, with cracked floor tiles and heavy oil stains on the range hood filter.

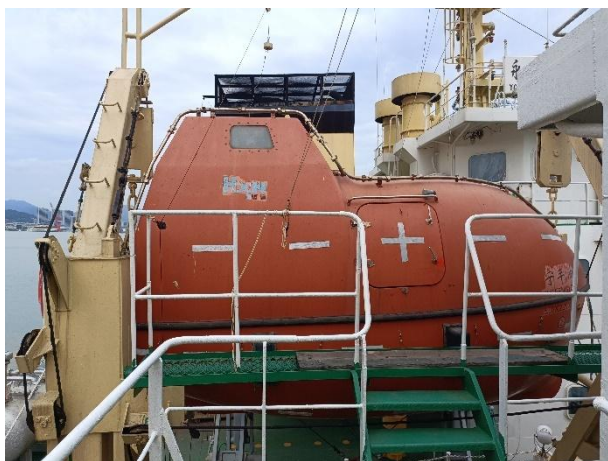
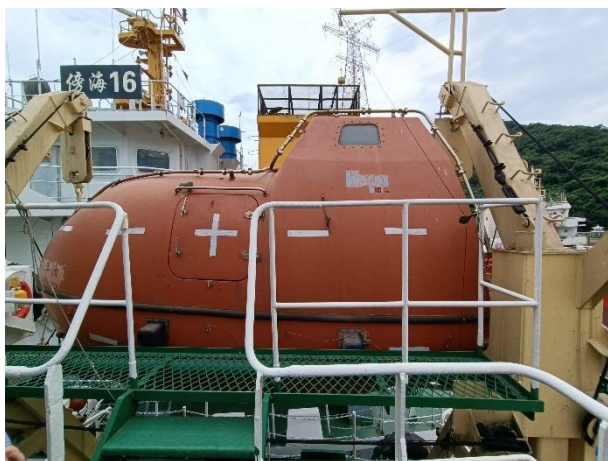
There is a large amount of accumulated water near the seawater pipe in the engine compartment of the starboard lifeboat.

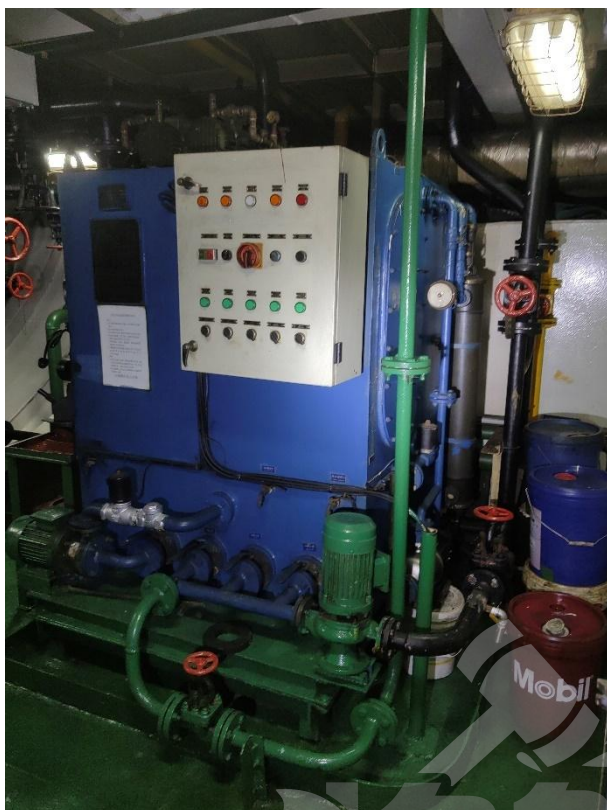
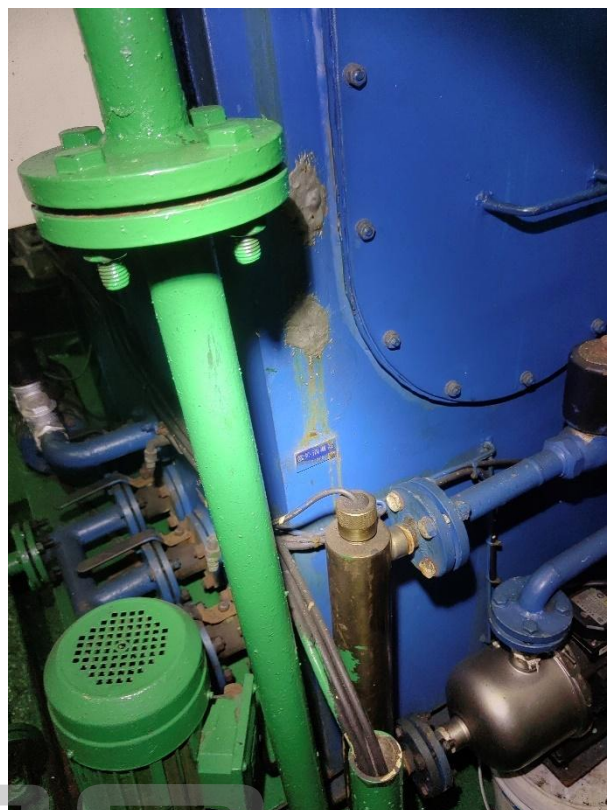
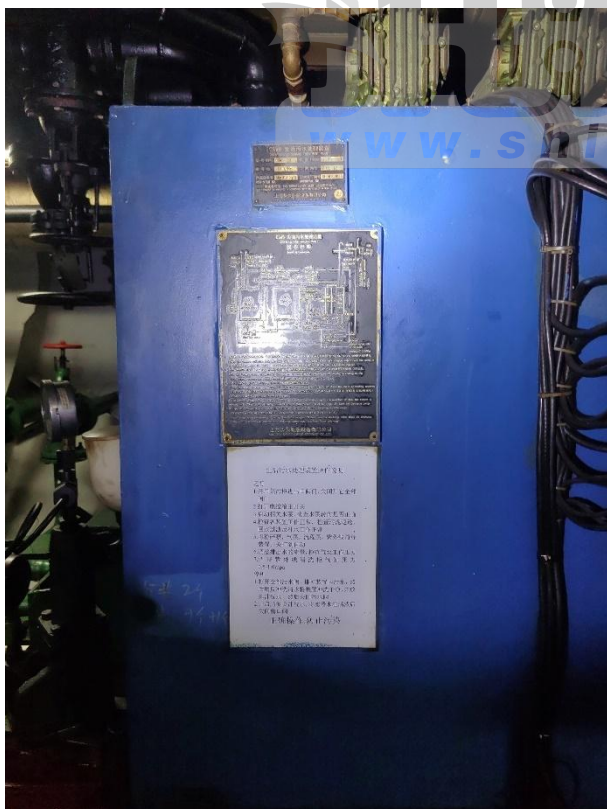
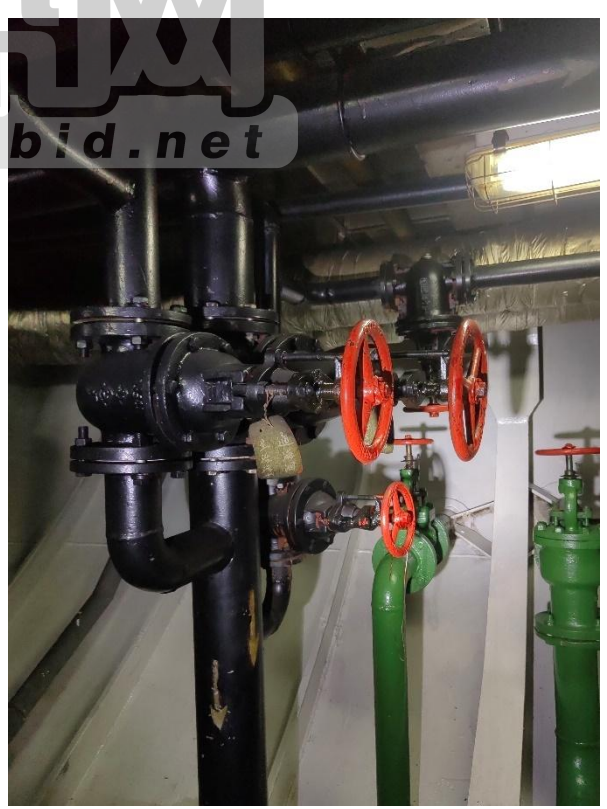
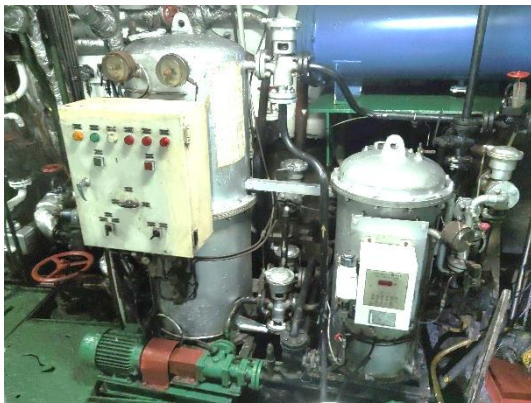
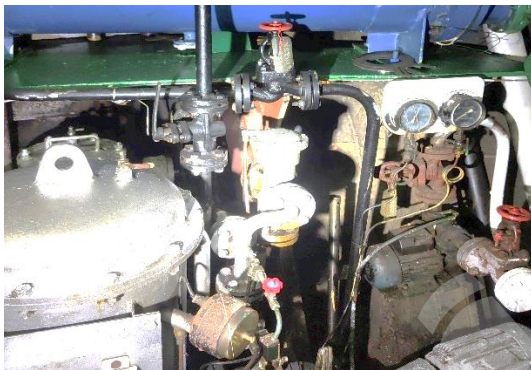
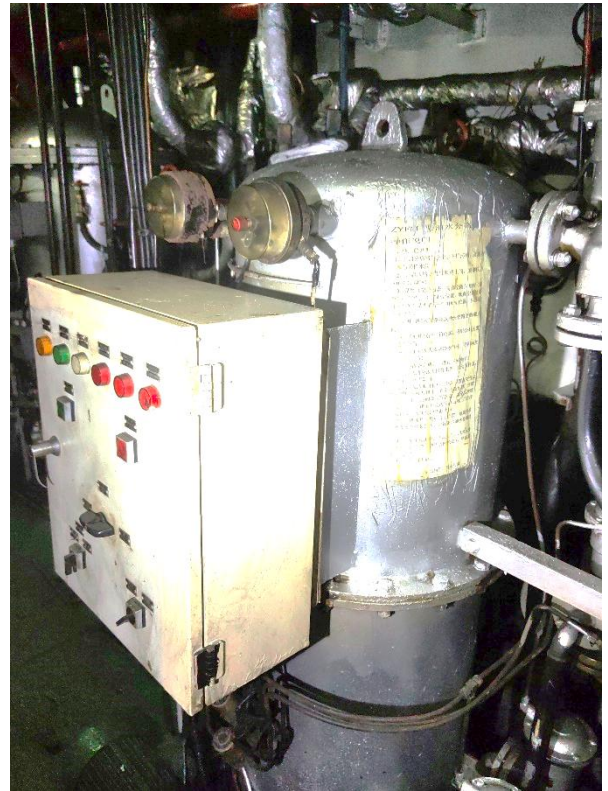
No discharge rate table has been posted near the domestic sewage treatment plant.

The sea valve of the oil-water separator is not locked and there is no sign prohibiting discharge in the port.

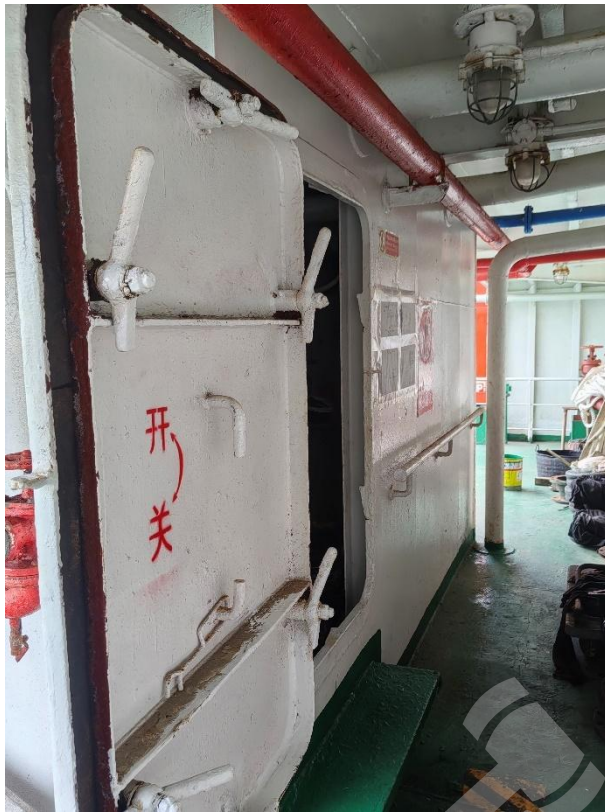
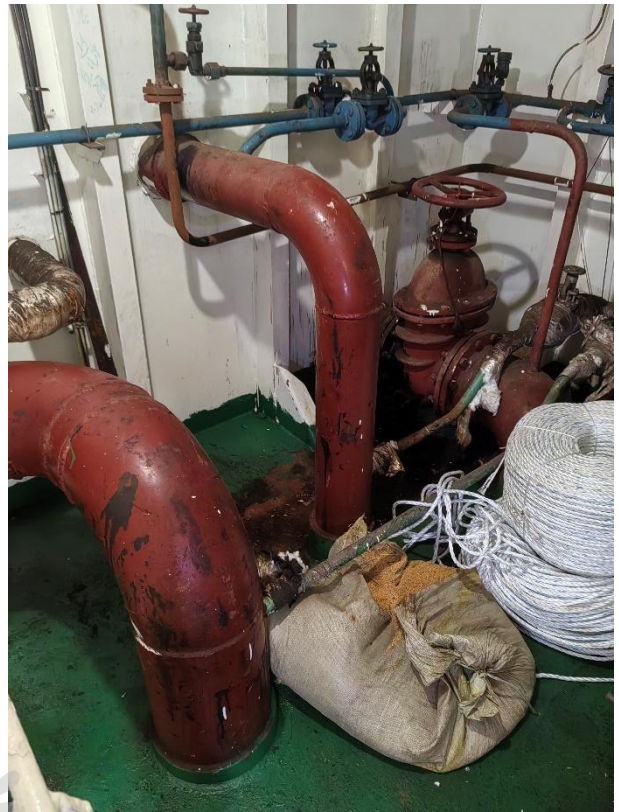
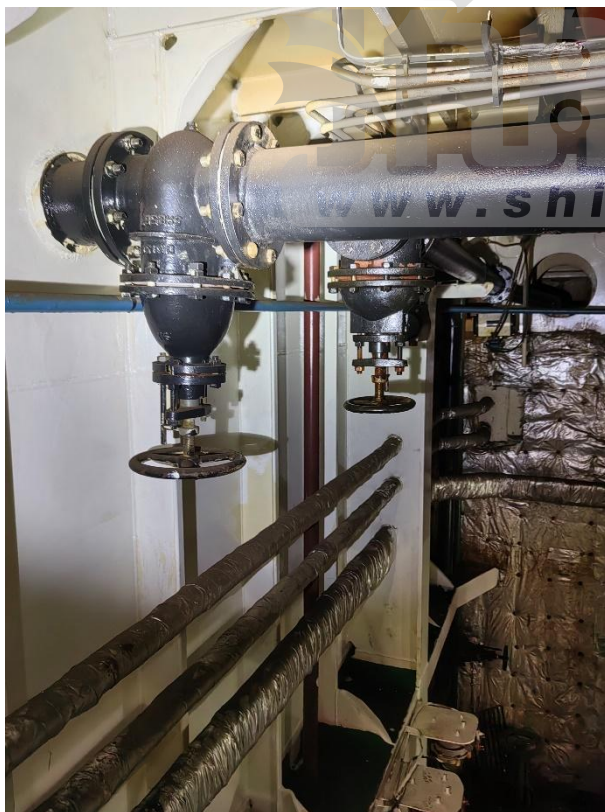
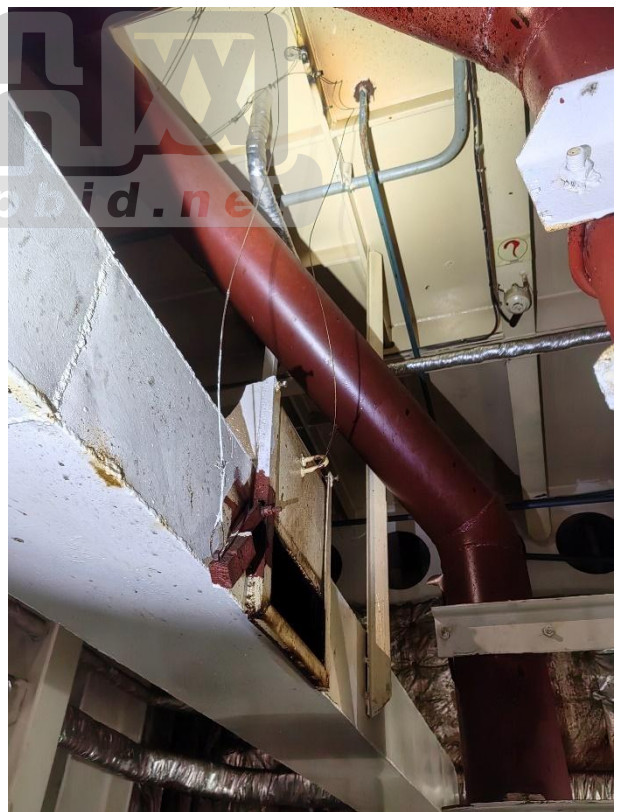
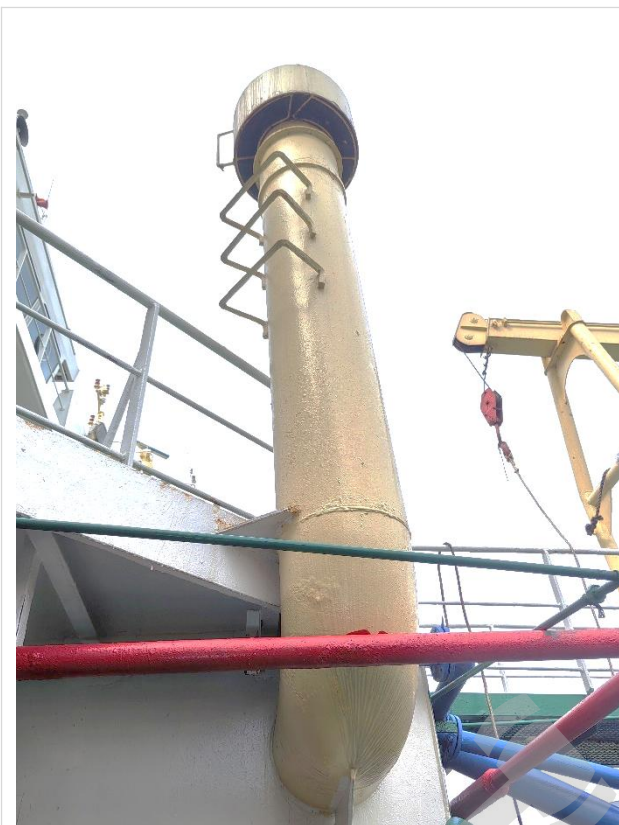
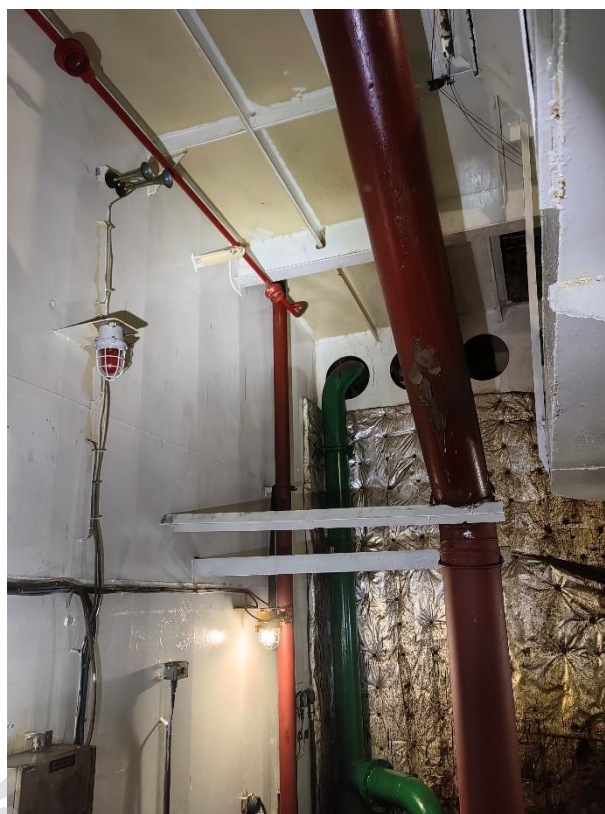
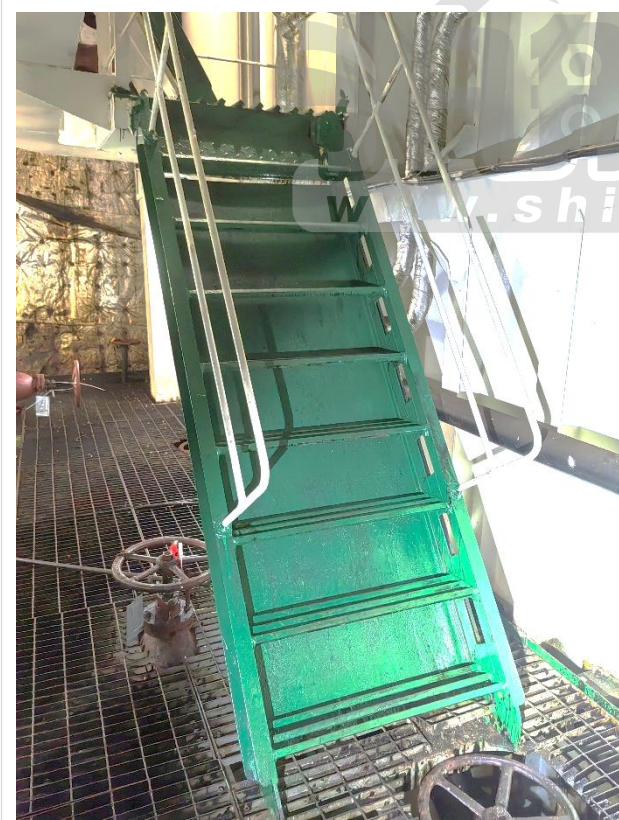
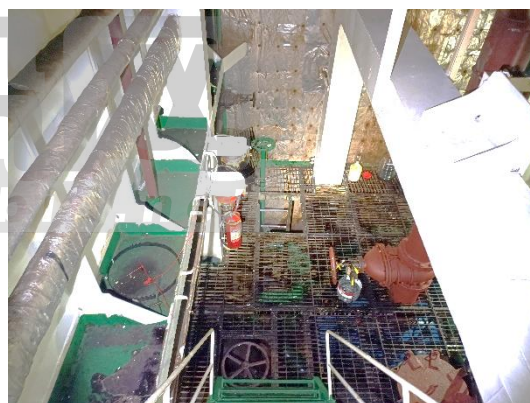
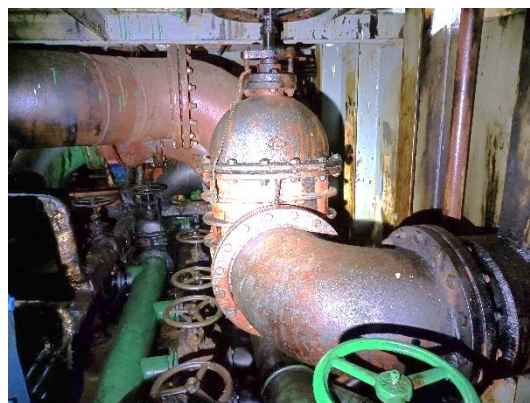
The cargo oil tank has not been cleared and no inspection has been conducted. The specific situation inside the tank is unknown.

The insulation material of the residual oil pipeline of the cargo oil screw pump in the cargo pump compartment is damaged.
