TECHNICAL REPORT

CJPG-JS-24-KY-0617

HE TAI TONG 2

Inspection date September 26th, 2024

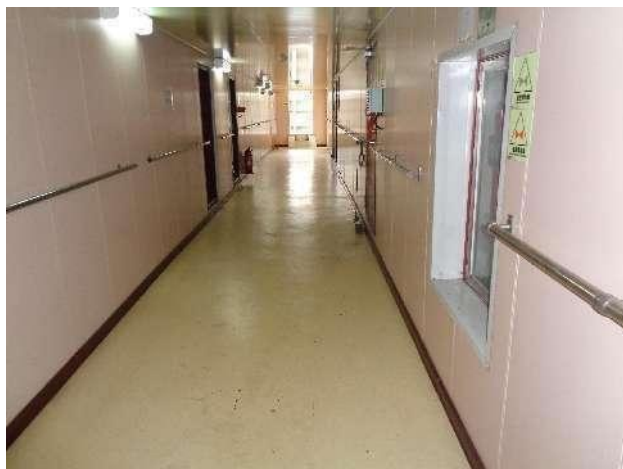
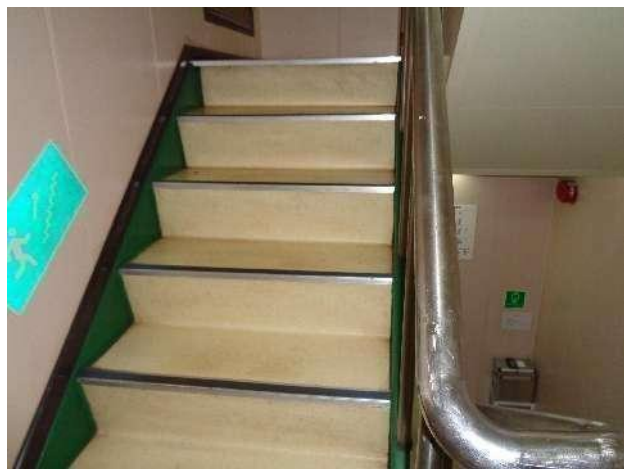
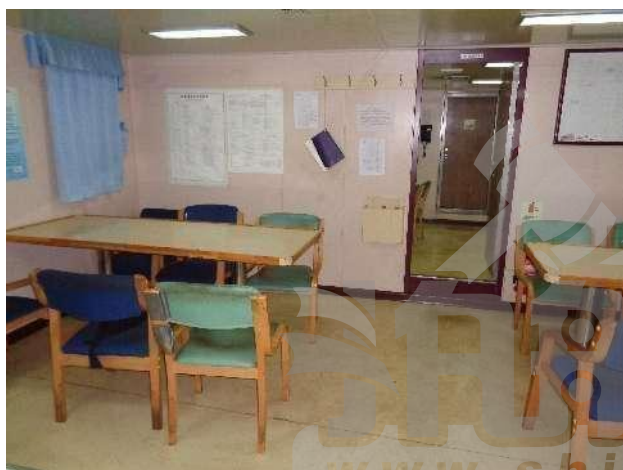
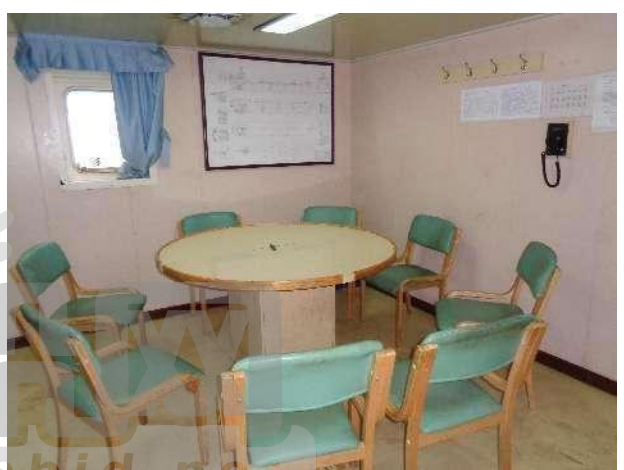
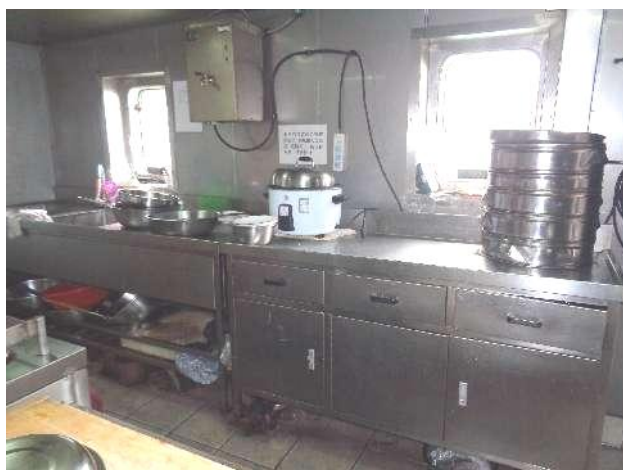
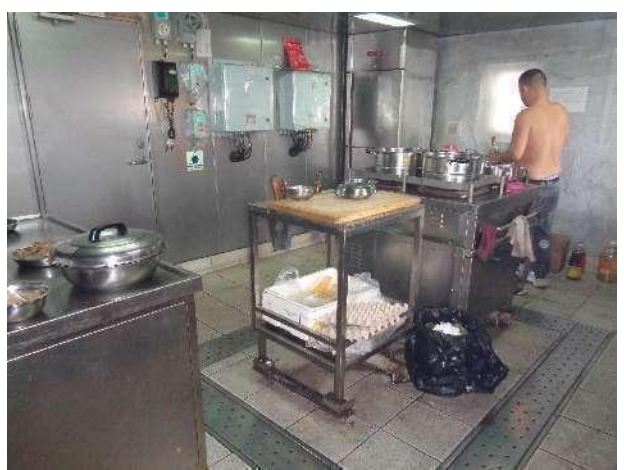
5. GALLEY & ACCOMMODATION

No.	Description	Good	Fair to good	Fair	Poor
1	No significant damage was found on the stairway, and without deformation or missing on the railing.	<input type="checkbox"/>	<input checked="" type="checkbox"/>	<input type="checkbox"/>	<input type="checkbox"/>
2	The light facilities in the crew room.	<input type="checkbox"/>	<input checked="" type="checkbox"/>	<input type="checkbox"/>	<input type="checkbox"/>
3	The fireproof materials in the living area hallway were found undamaged, and the fire doors can work normally.	<input type="checkbox"/>	<input checked="" type="checkbox"/>	<input type="checkbox"/>	<input type="checkbox"/>
4	The bathroom facilities in the crew room.	<input type="checkbox"/>	<input checked="" type="checkbox"/>	<input type="checkbox"/>	<input type="checkbox"/>
5	Cleanliness of mess room and galley.	<input type="checkbox"/>	<input checked="" type="checkbox"/>	<input type="checkbox"/>	<input type="checkbox"/>

6	No significant oil stain was found on the galley range hood and ventilation ducts, and classify garbage and store it in designated areas. The Portable fire extinguishers were inspected on schedule.	<input type="checkbox"/>	<input checked="" type="checkbox"/>	<input type="checkbox"/>	<input type="checkbox"/>
7	The lighting in the freezer room was found intact, without damp or cracked on the enclosure and ceiling.	<input type="checkbox"/>	<input checked="" type="checkbox"/>	<input type="checkbox"/>	<input type="checkbox"/>
8	The appearance of the freezer was found intact, without dirt or stains. There was no sign of water leakage or rust on the floor. The power supply is powered on and the refrigeration is normal.	<input type="checkbox"/>	<input checked="" type="checkbox"/>	<input type="checkbox"/>	<input type="checkbox"/>
9	The freezer can be used normally. The food was found neatly arranged and clean.	<input type="checkbox"/>	<input checked="" type="checkbox"/>	<input type="checkbox"/>	<input type="checkbox"/>

Note: The above inspection items were found in "Fair to good" level overall.

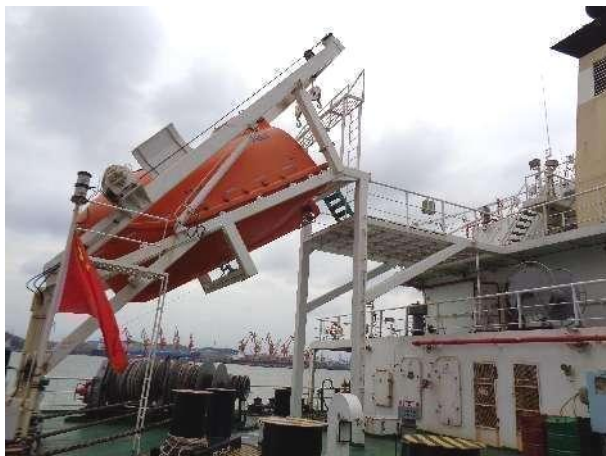
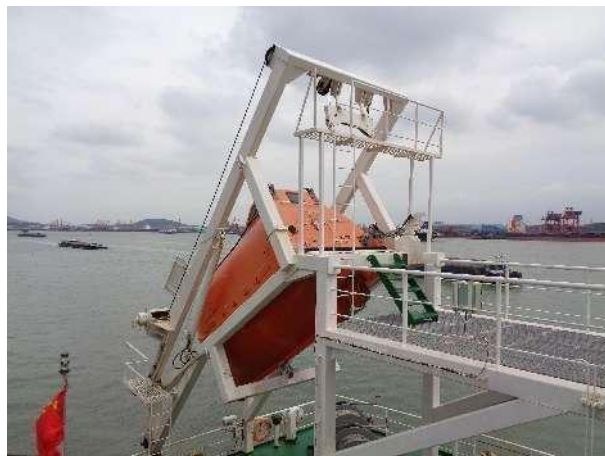
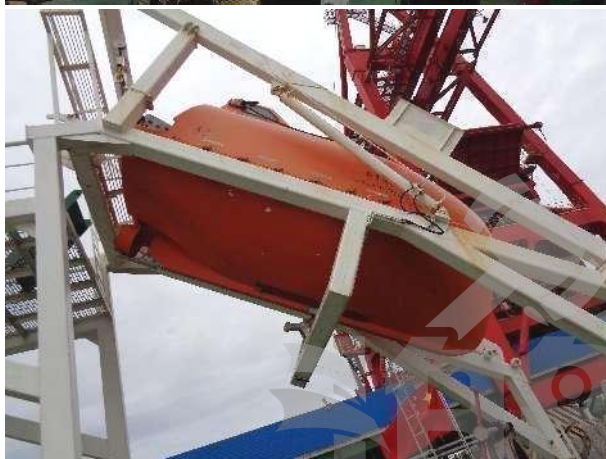
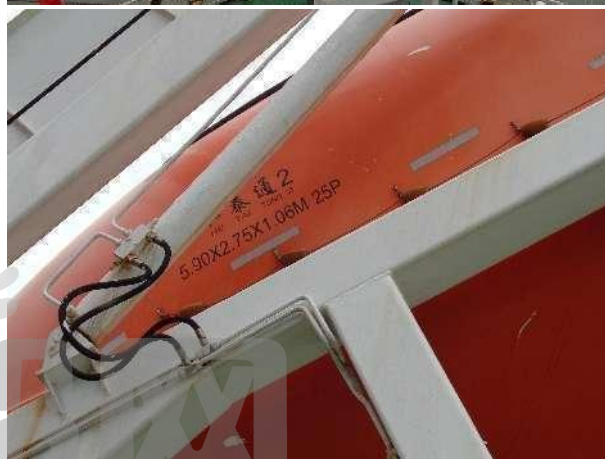
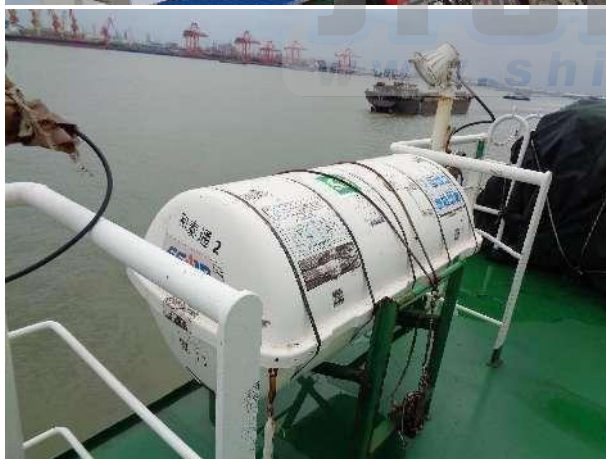
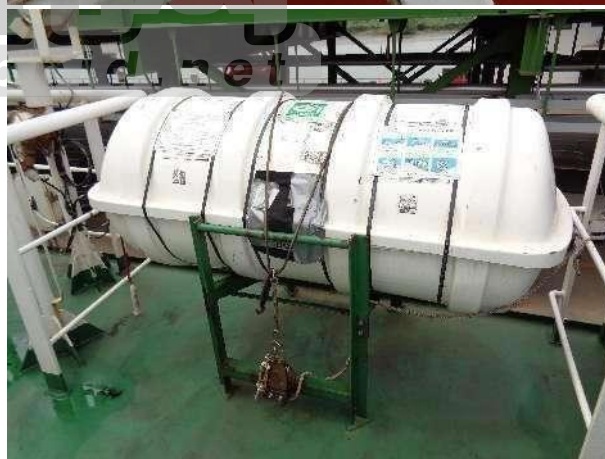
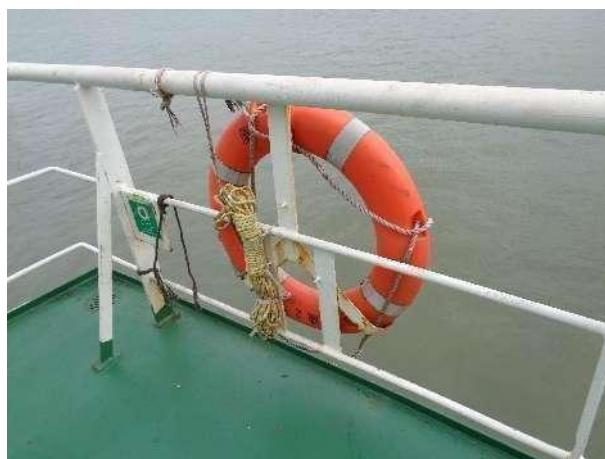
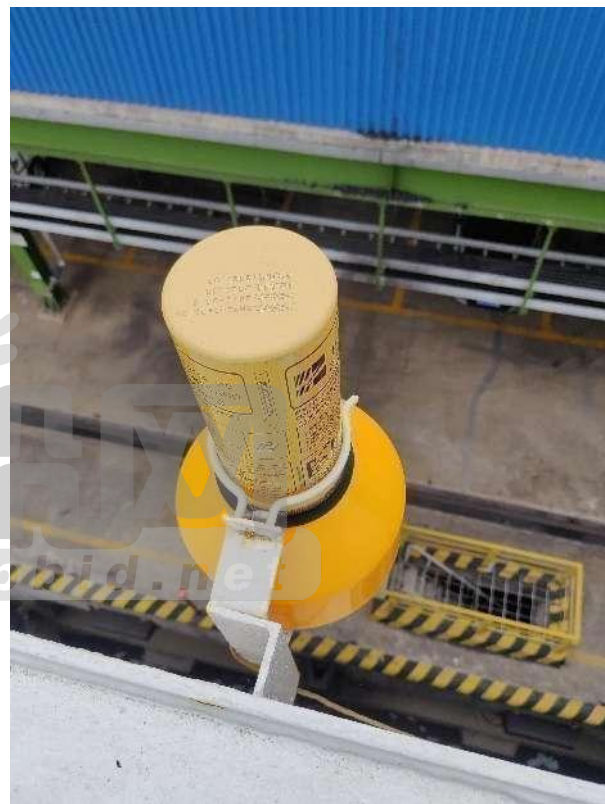
6. Lifesaving Equipment

No.	Description	Good	Fair to good	Fair	Poor
1	The lifeboat has a good appearance, and the ship name, port of registry, and other markings were clear and stored correctly.	<input type="checkbox"/>	<input checked="" type="checkbox"/>	<input type="checkbox"/>	<input type="checkbox"/>
2	The frame structure has a good appearance and well lubricated	<input type="checkbox"/>	<input checked="" type="checkbox"/>	<input type="checkbox"/>	<input type="checkbox"/>
3	The motor of the lifeboat was well maintained, and was easy to start (check records of tests or manoeuvre).	<input type="checkbox"/>	<input checked="" type="checkbox"/>	<input type="checkbox"/>	<input type="checkbox"/>
4	The lifeboat was fully equipped with life-saving appliances, food and fresh water.	<input type="checkbox"/>	<input checked="" type="checkbox"/>	<input type="checkbox"/>	<input type="checkbox"/>
5	The operation procedures and maintenance manual of the lifeboat were posted, and lighting fixtures were equipped beside.	<input type="checkbox"/>	<input checked="" type="checkbox"/>	<input type="checkbox"/>	<input type="checkbox"/>

6	The life raft and hydrostatic pressure release device were properly fixed, and found in normal maintenance cycle.	<input type="checkbox"/>	<input checked="" type="checkbox"/>	<input type="checkbox"/>	<input type="checkbox"/>
7	No cracks or damages were found on the wooden steps and no significant rust on the binding facilities at the entrance of the pilot ladder, and there was no missing on anti fall chains.	<input type="checkbox"/>	<input checked="" type="checkbox"/>	<input type="checkbox"/>	<input type="checkbox"/>
8	Lifebuoys, lights, floats, etc. were in the correct position and in good appearance.	<input type="checkbox"/>	<input checked="" type="checkbox"/>	<input type="checkbox"/>	<input type="checkbox"/>
9	Lifejackets, insulation suits, diving suits, etc. were approved by the class, properly stored, and in sufficient quantities.	<input type="checkbox"/>	<input type="checkbox"/>	<input type="checkbox"/>	<input type="checkbox"/>

10	All signs for safety equipment and escape routes have been posted in place, reflective signs comply with IMO requirement, and the main/emergency exits were found unobstructed.	<input type="checkbox"/>	<input checked="" type="checkbox"/>	<input type="checkbox"/>	<input type="checkbox"/>
11	The configuration of flame parachutes, rope throwers, etc. complies with regulatory requirements and was stored correctly.	<input type="checkbox"/>	<input type="checkbox"/>	<input type="checkbox"/>	<input type="checkbox"/>

Note: The above inspection items were found in "Fair to good" level overall.

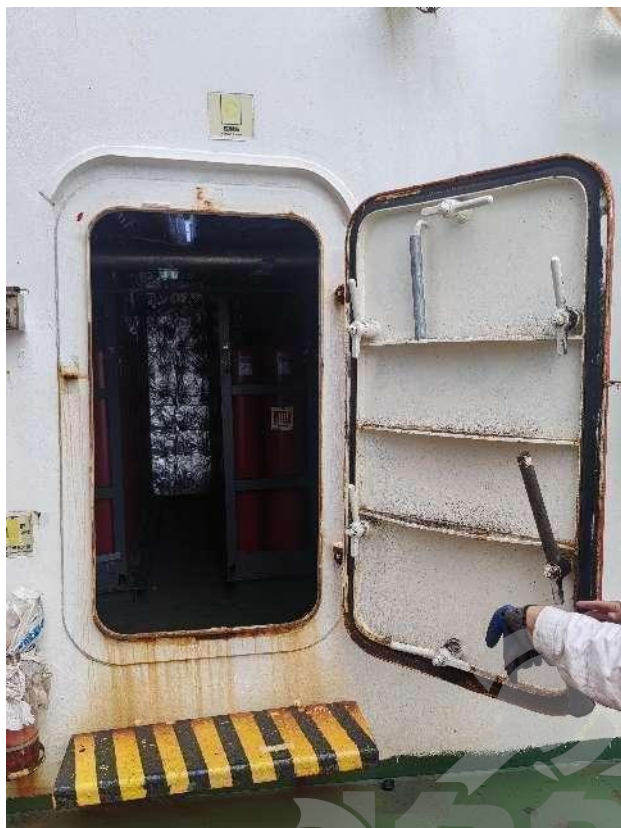
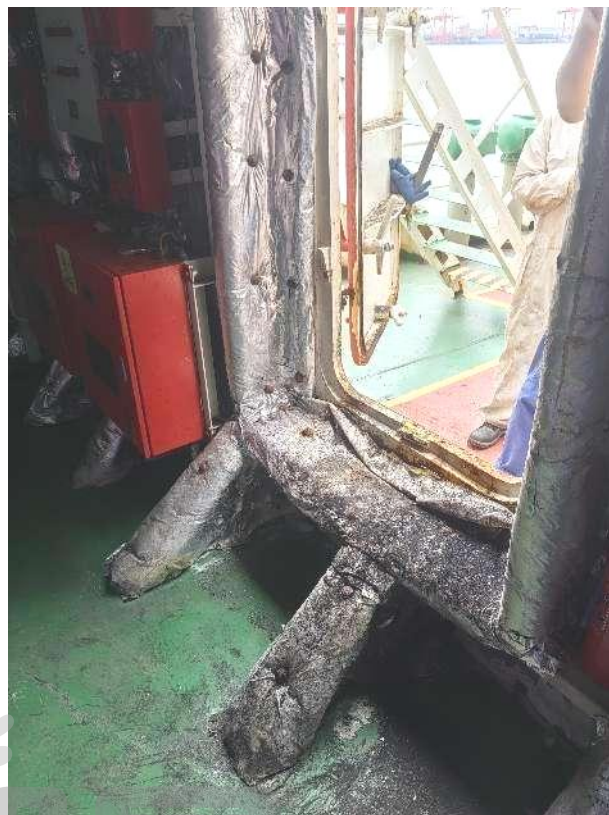
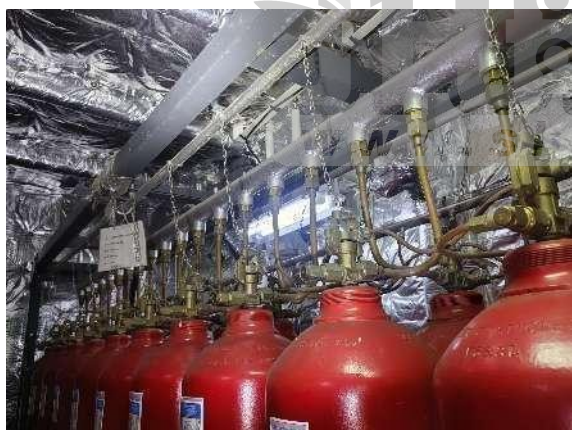
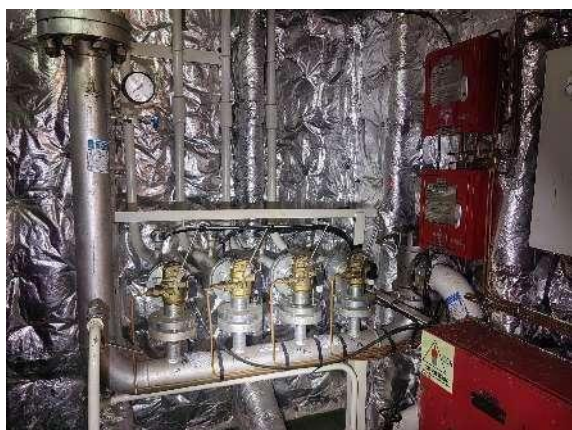
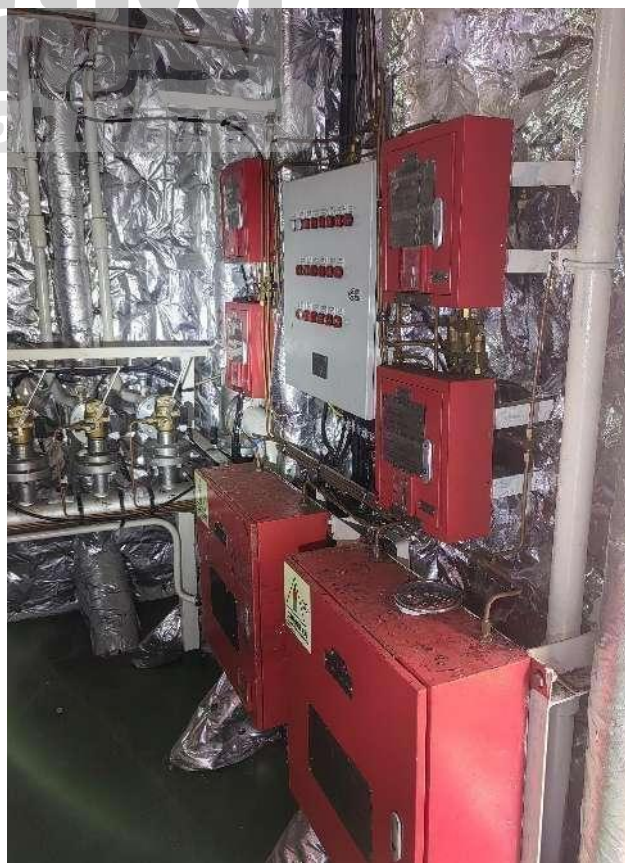
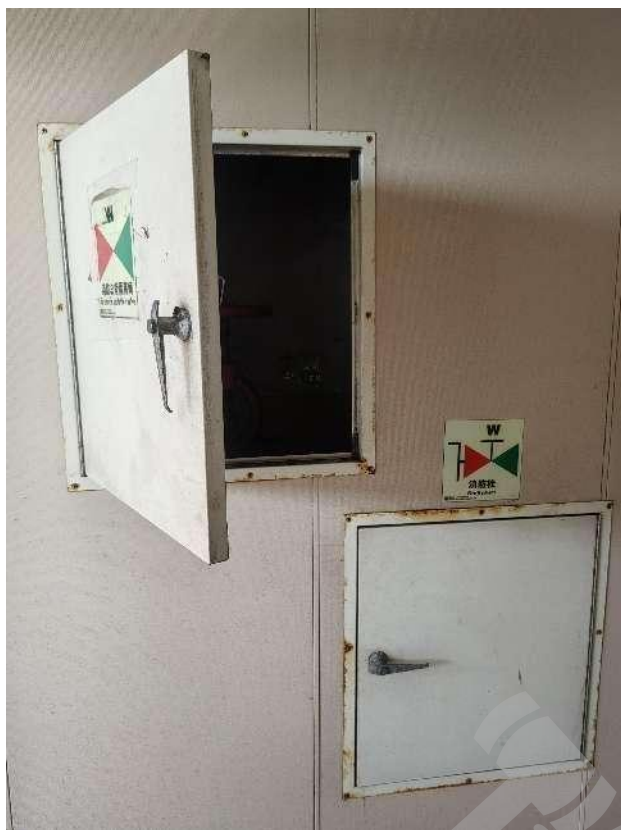
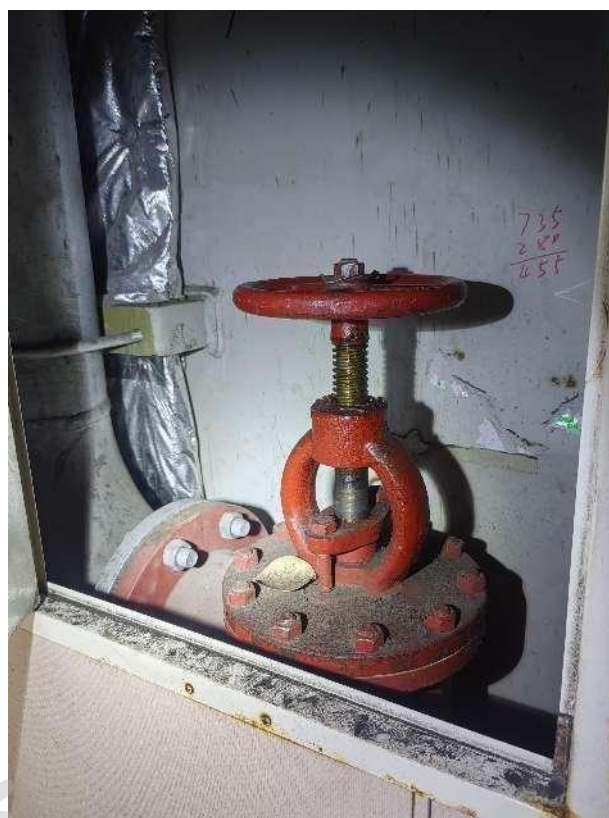
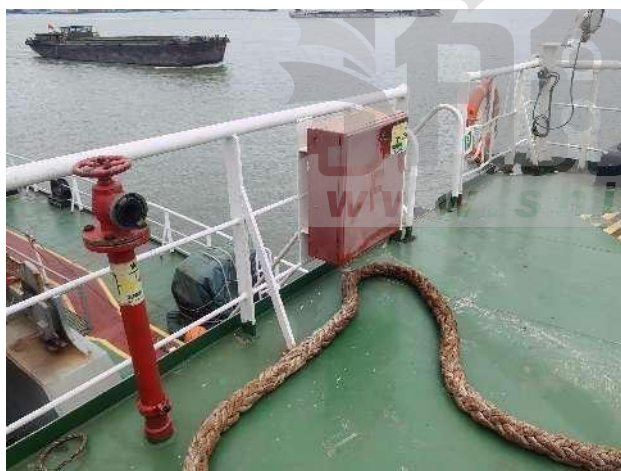
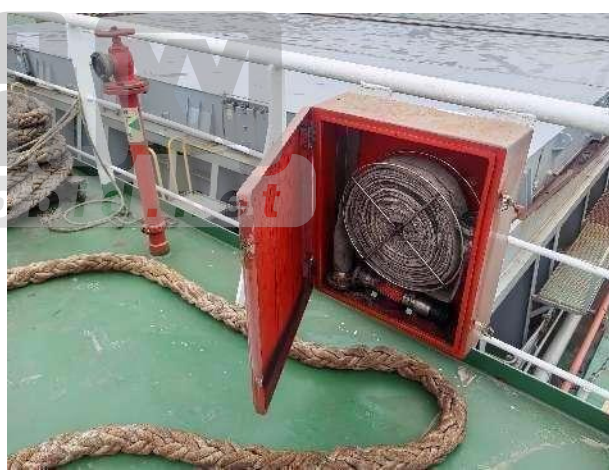
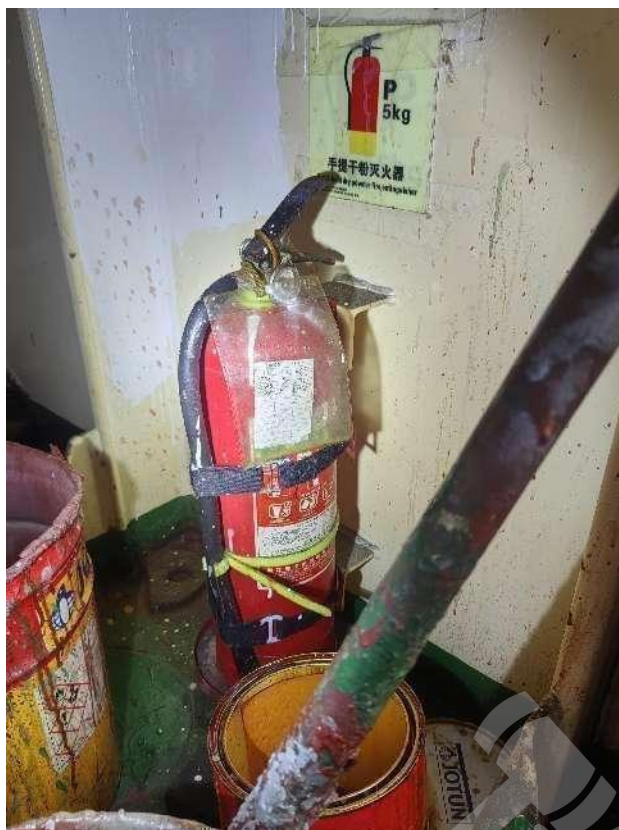
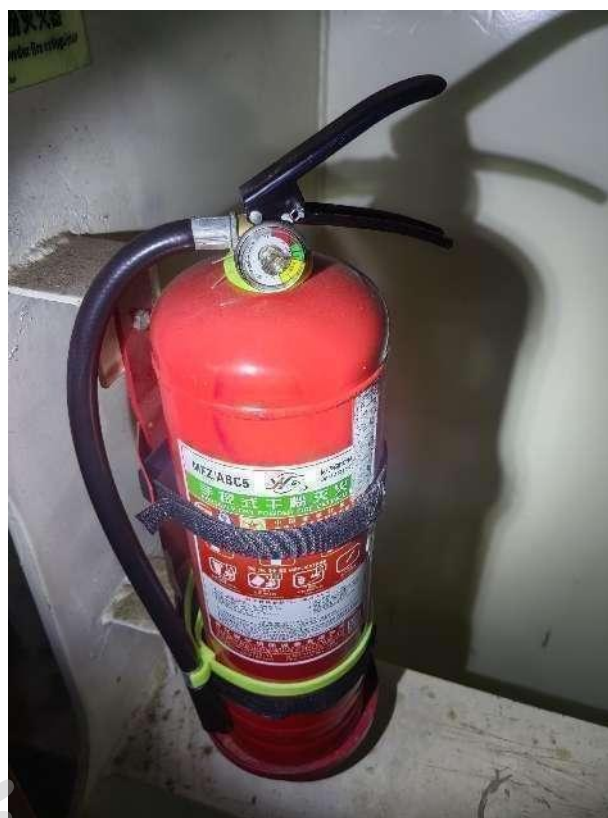
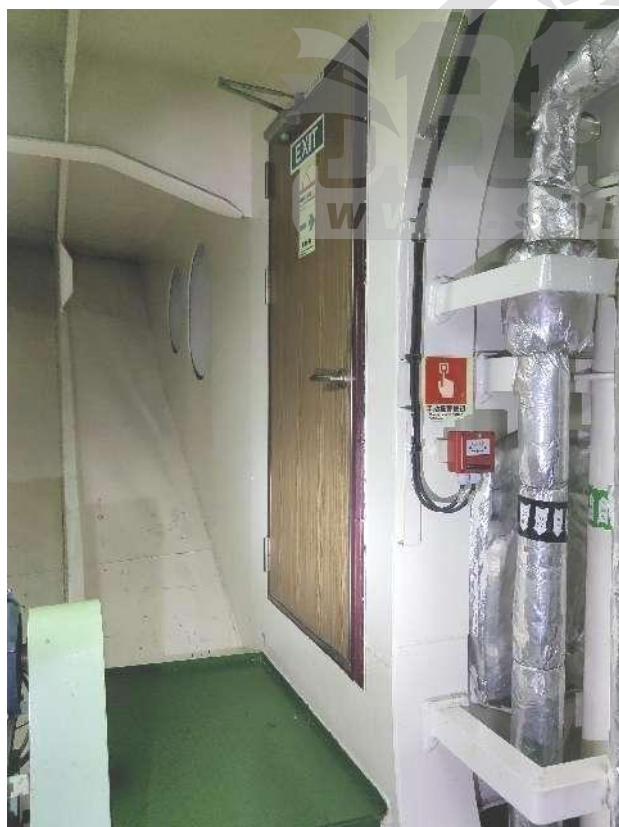
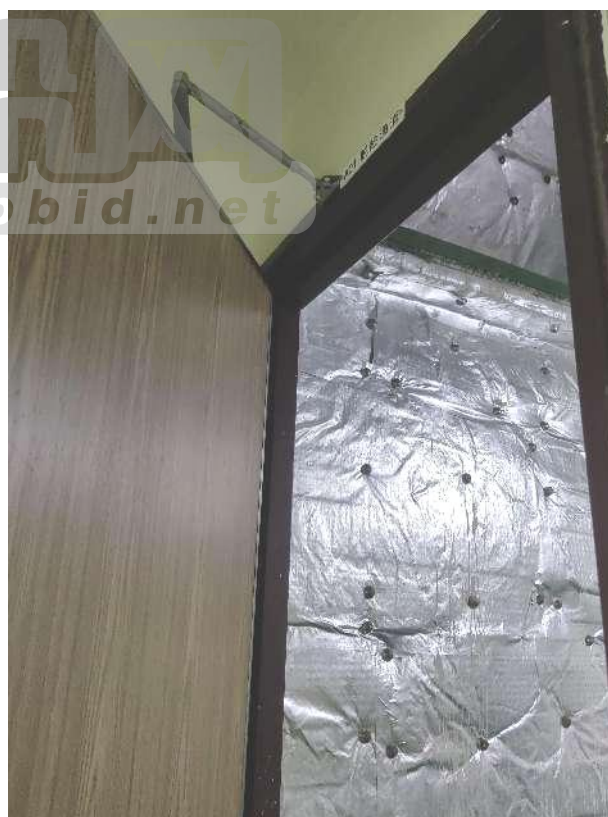
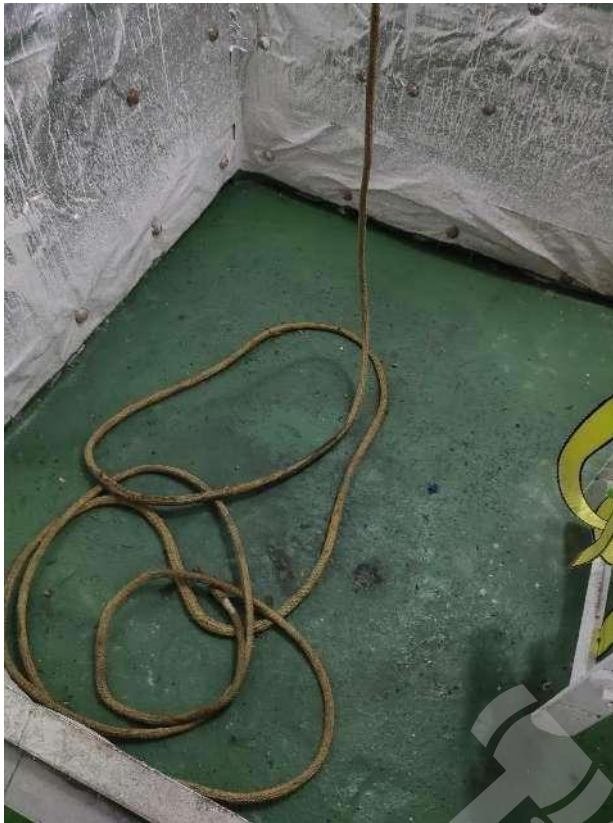
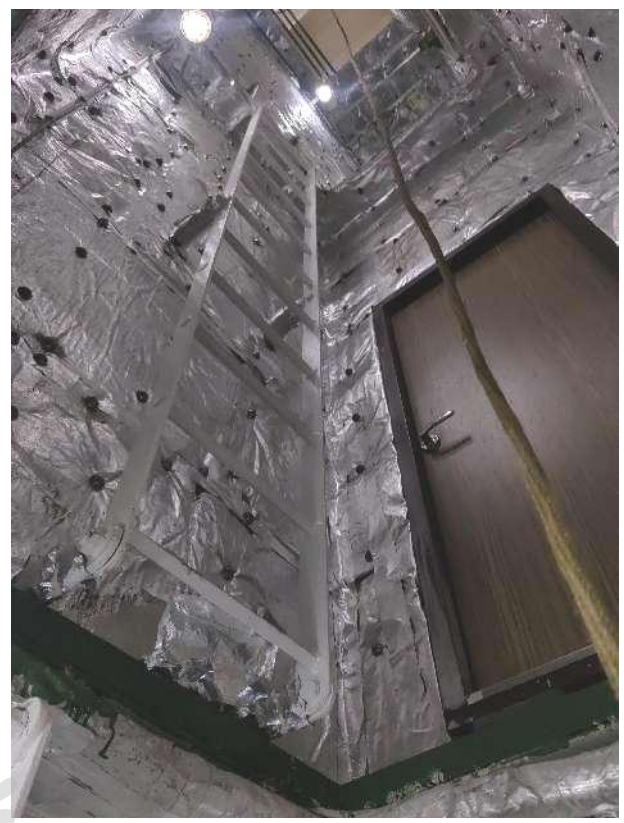
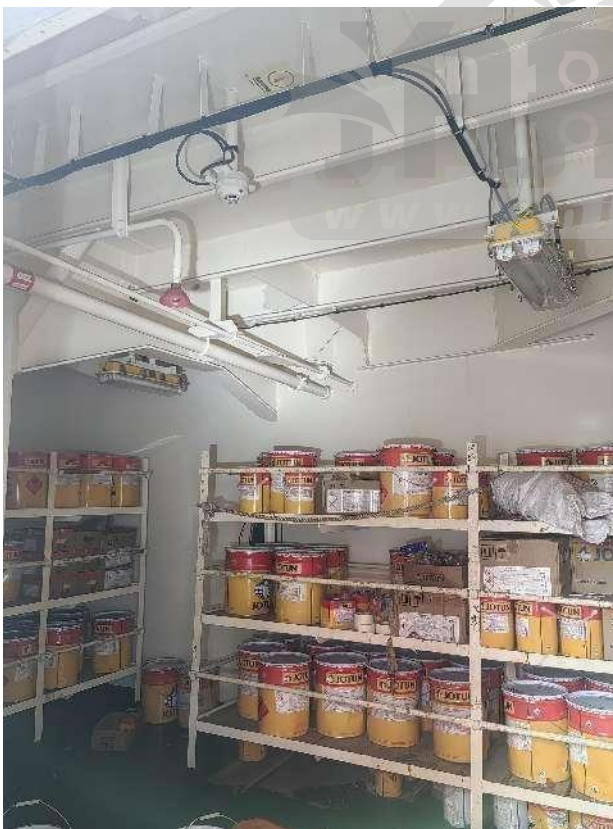
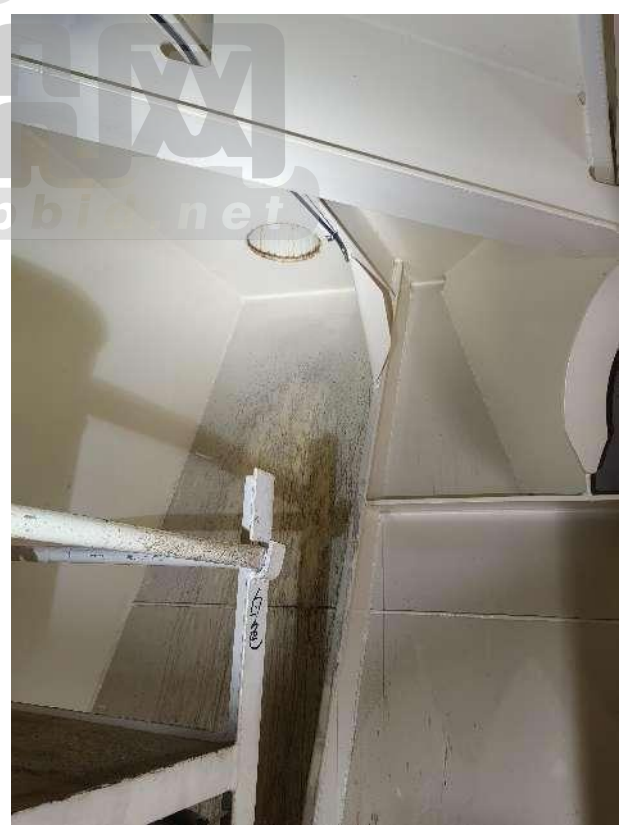
7. Fire & Safety Appliance

No.	Description	Good	Fair to good	Fair	Poor
1	The CO2 cylinders and release devices were found within the validity period of inspection, the automatic sound alarm was not faulty, and the operation regulations were posted.	<input type="checkbox"/>	<input checked="" type="checkbox"/>	<input type="checkbox"/>	<input type="checkbox"/>
2	No looseness or leakage was found on the connection of CO2 pipe system, and the starting cylinder pressure was sufficient.	<input type="checkbox"/>	<input checked="" type="checkbox"/>	<input type="checkbox"/>	<input type="checkbox"/>
3	The appearance of the fire isolation valve was found intact, and the appearance of the main fire pump and pipeline was intact.	<input type="checkbox"/>	<input checked="" type="checkbox"/>	<input type="checkbox"/>	<input type="checkbox"/>
4	Hydrant appearance was found intact, the hand-wheel switch was normal. No significant corrosion and leakage was found on pipelines.	<input type="checkbox"/>	<input checked="" type="checkbox"/>	<input type="checkbox"/>	<input type="checkbox"/>

5	The appearance of the hose box was found intact, and the water hose and water gun were approved type, with nozzles in good condition.	<input type="checkbox"/>	<input checked="" type="checkbox"/>	<input type="checkbox"/>	<input type="checkbox"/>
6	Portable fire extinguishers were correctly placed and in good condition, with inspection markings. The sufficient number of spare fire extinguishers were provided.	<input type="checkbox"/>	<input checked="" type="checkbox"/>	<input type="checkbox"/>	<input type="checkbox"/>
7	The fire protection of the emergency escape passage was found complete. The lighting, life rope, and life ladder were in good condition with normal self closing door.	<input type="checkbox"/>	<input checked="" type="checkbox"/>	<input type="checkbox"/>	<input type="checkbox"/>
8	The fire protection structure of the paint room was intact, as well the temperature sensing probe. The water mist pipeline was free of rust, and the ventilation facilities were intact.	<input type="checkbox"/>	<input checked="" type="checkbox"/>	<input type="checkbox"/>	<input type="checkbox"/>

9	Emergency fire pumps operating procedures were regularly tested and operated.	<input type="checkbox"/>	<input checked="" type="checkbox"/>	<input type="checkbox"/>	<input type="checkbox"/>

Note: The above inspection items were found in "Fair to good" level overall.

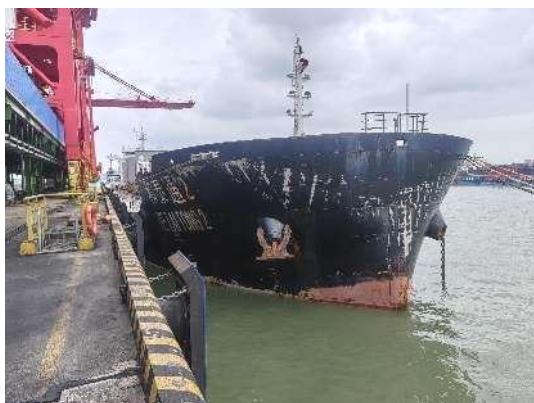
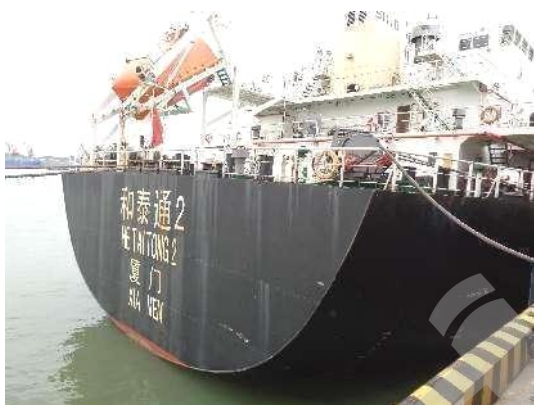
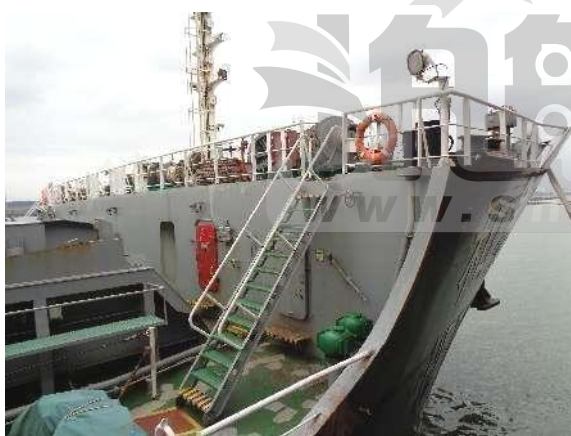
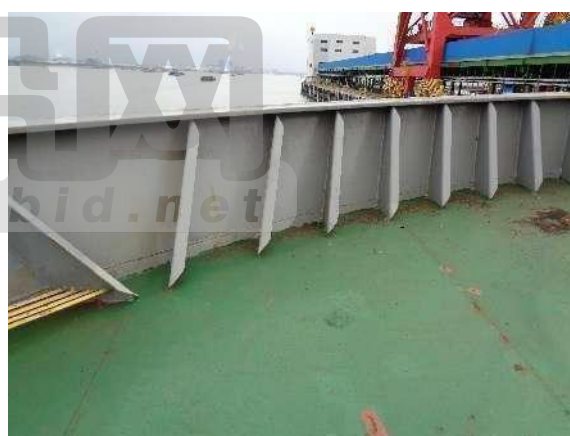
There were multiple rust spots on the weld seam of the bow shell plate, and there were obvious scratches on the paint.

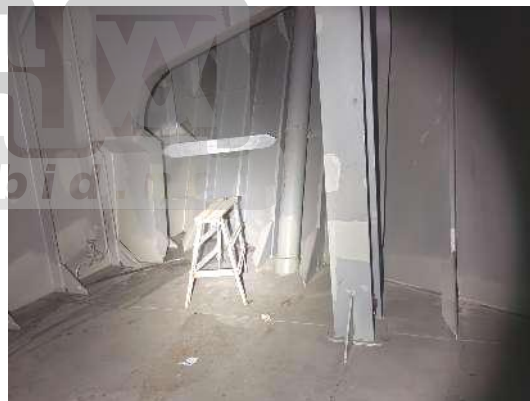
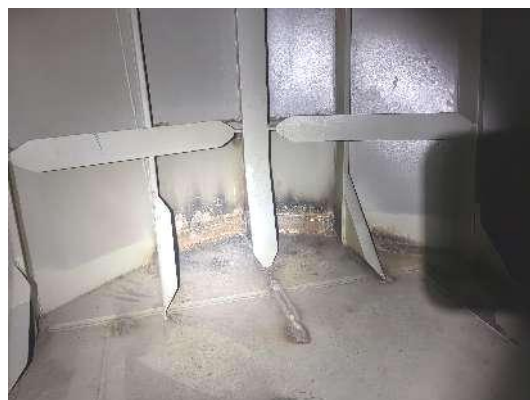
1. Due to the presence of ballast water in the ballast tank and the lack of ventilation in the void space, the surveyor is unable to enter for inspection.
2. No rotation direction mark was found on the derailleur wheel of chain gear in the chain locker.
3. The deformation bulge was found on the platform of fore void space, and there was a 1m * 30cm repair welding plate near the platform on the shell plate of the bow column in the void space.

8	The deformation bulge was found on the platform of fore void space, and there was a 1m * 30cm repair welding plate near the platform on the shell plate of the bow column in the void space.
9	The lifesaving and firefighting appliance, mechanical equipment, and deck machinery on this ship were found in good condition, and the mechanical equipment can be checked before departure.
10	The defects found in the last FSCO inspection have been corrected and closed, only one of them needs to closed after re-inspection without any detained items.

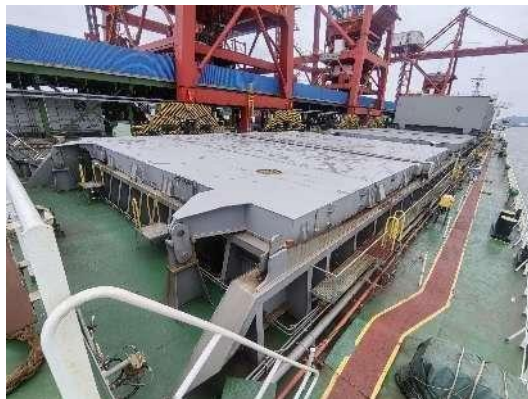
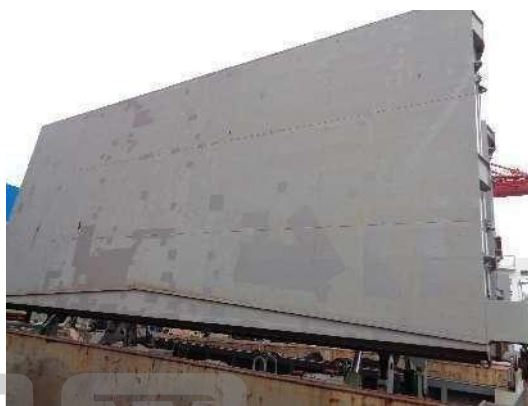
During the inspection, all of 4 cargo holds were in a state of waiting to be unloaded, and the condition of the watertight bulkheads and inner bottom plates was unknown.
