TECHNICAL REPORT

CJPG-JS-24-KY-0617

HE TAI TONG 2

Inspection date September 26th, 2024

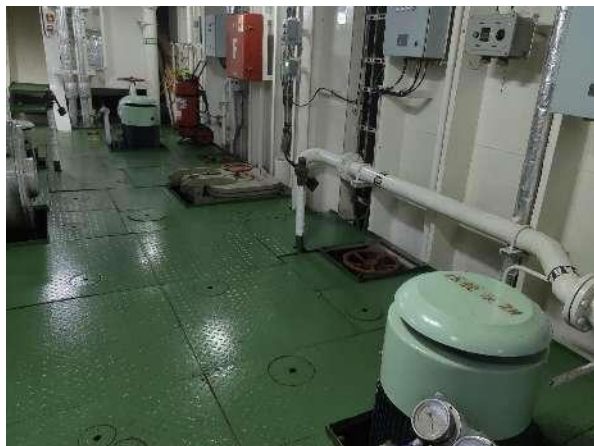
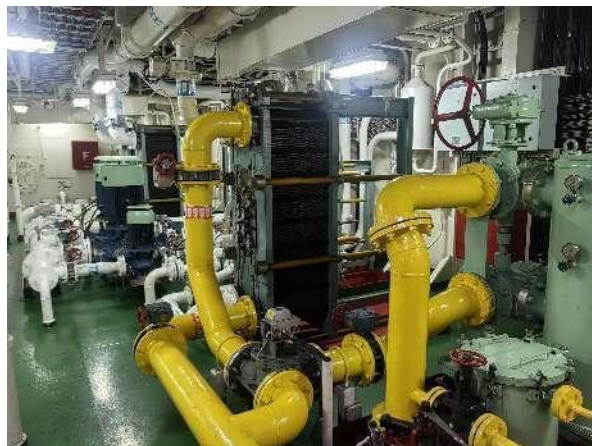
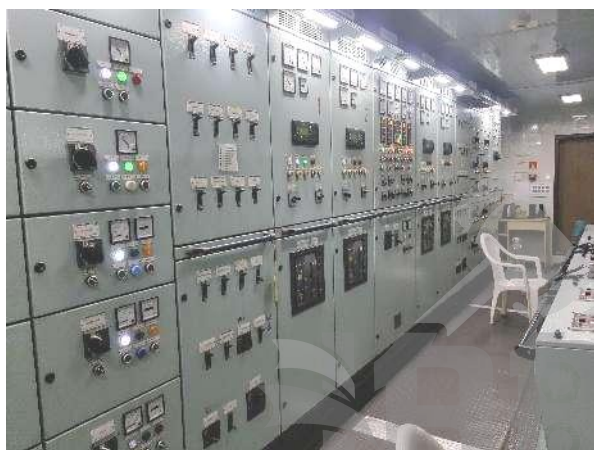
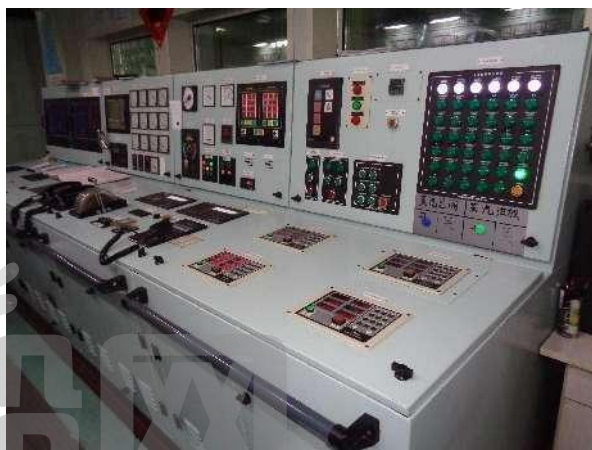
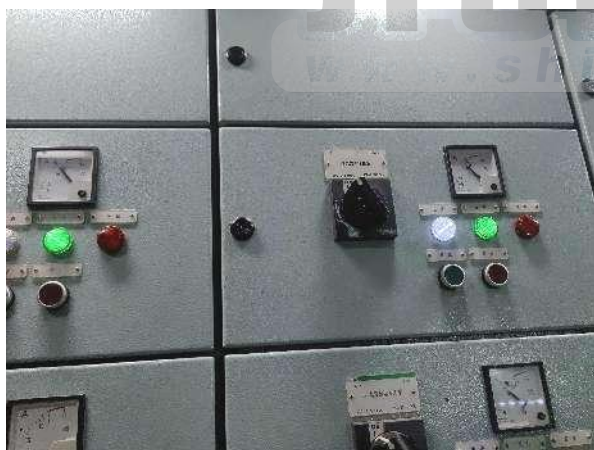
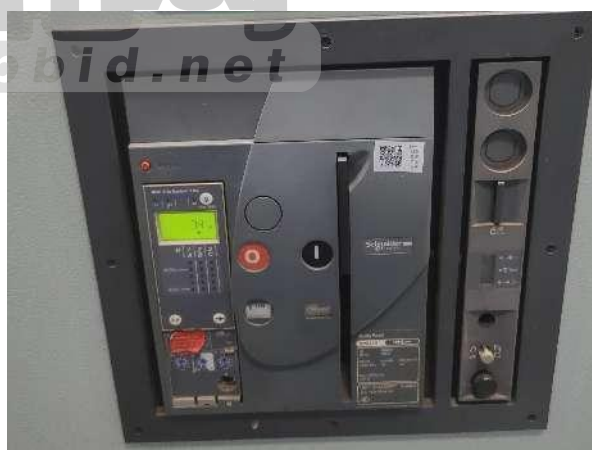
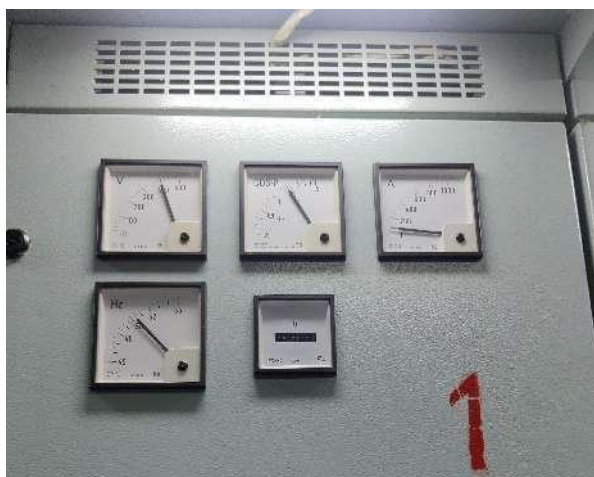
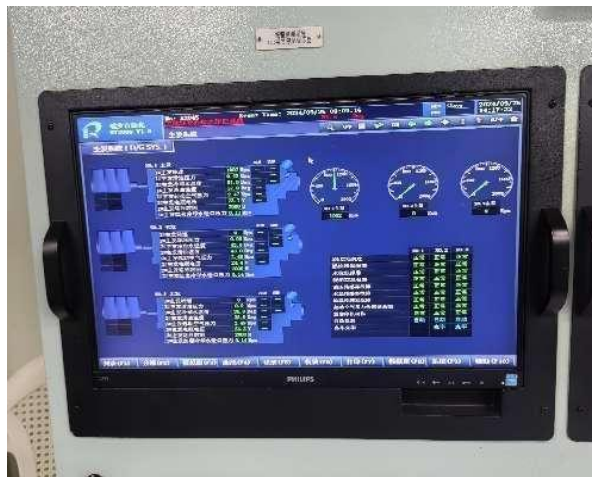
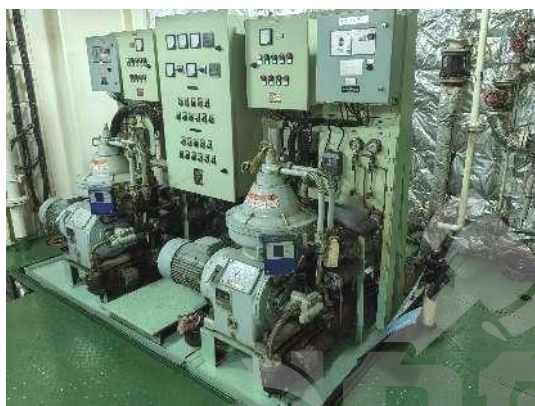
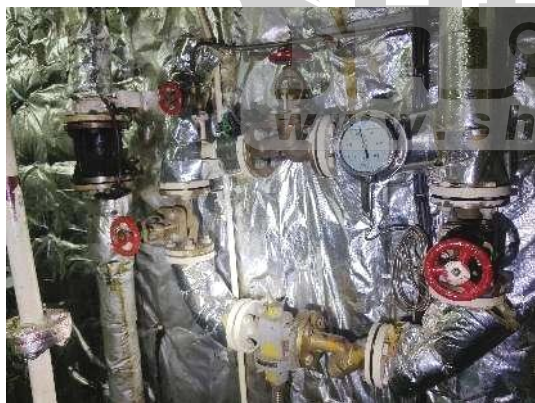
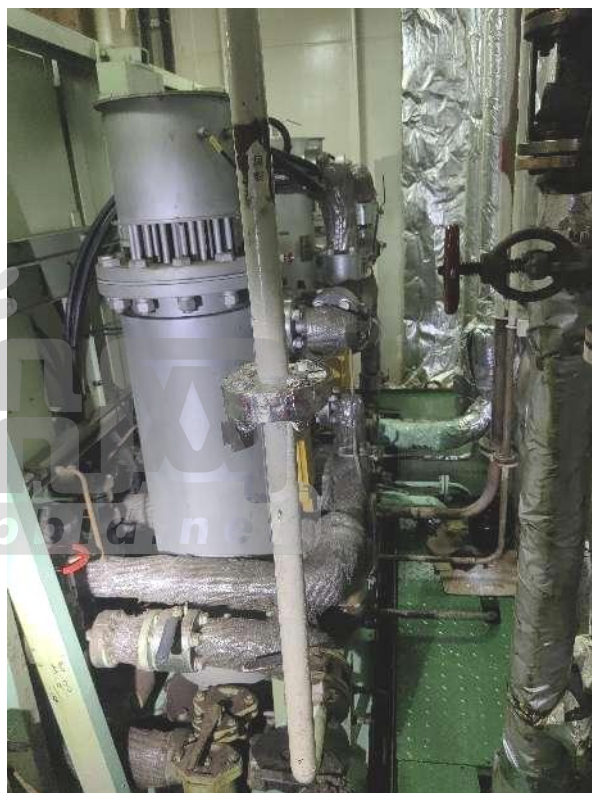
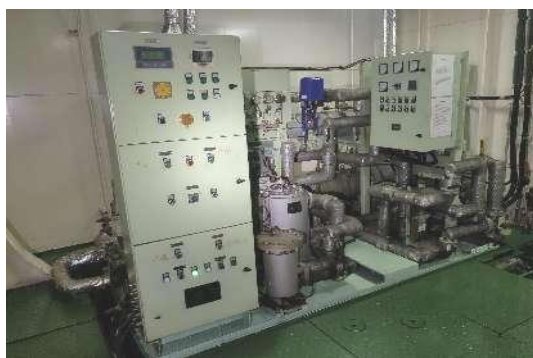
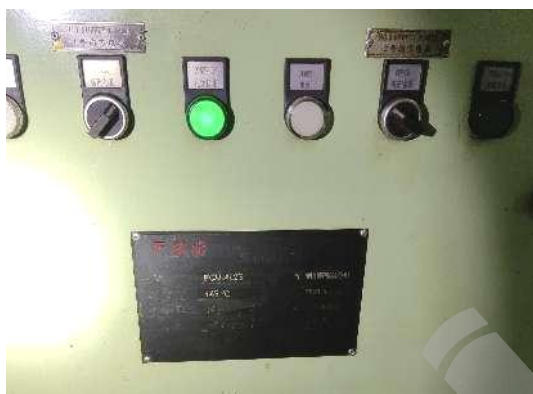
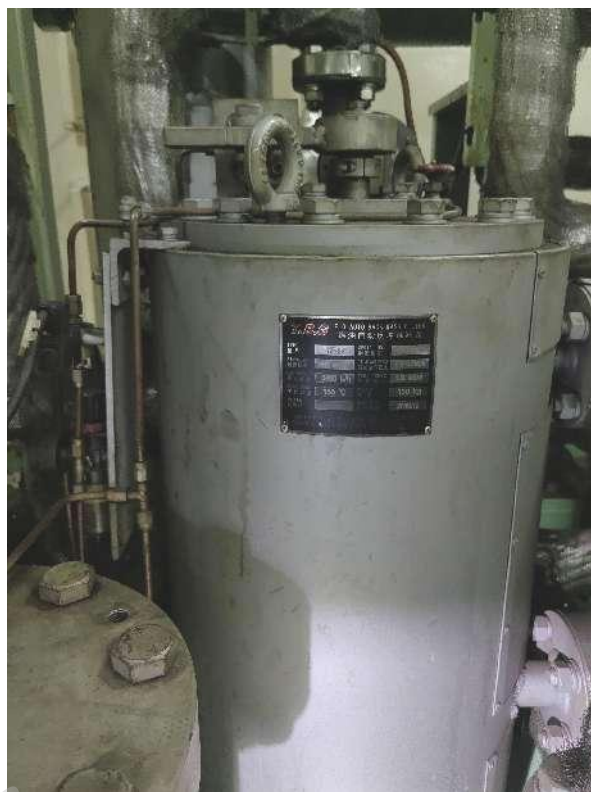
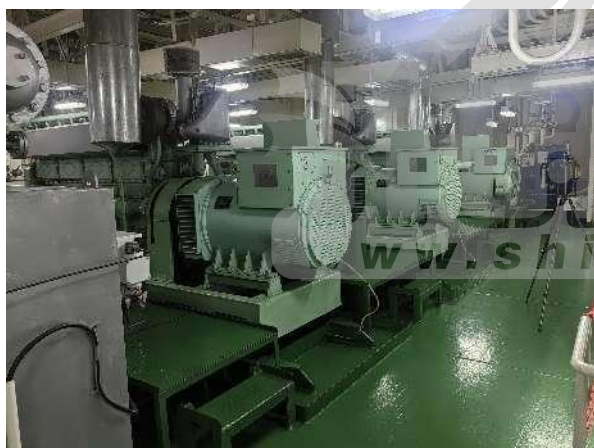
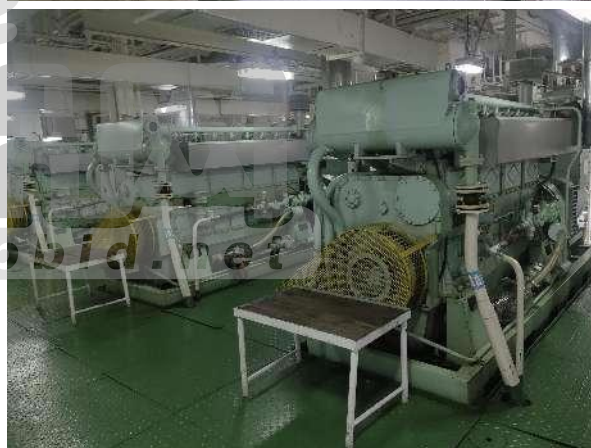
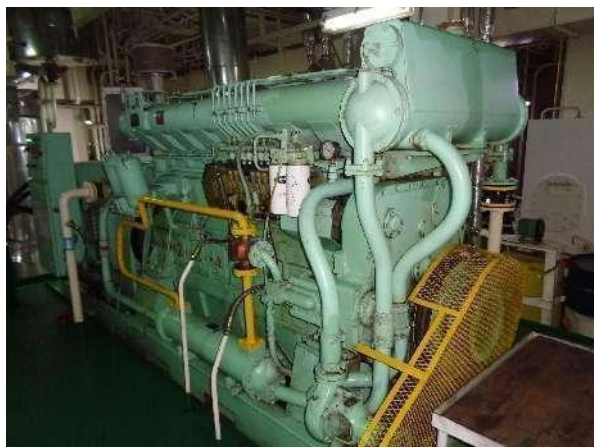
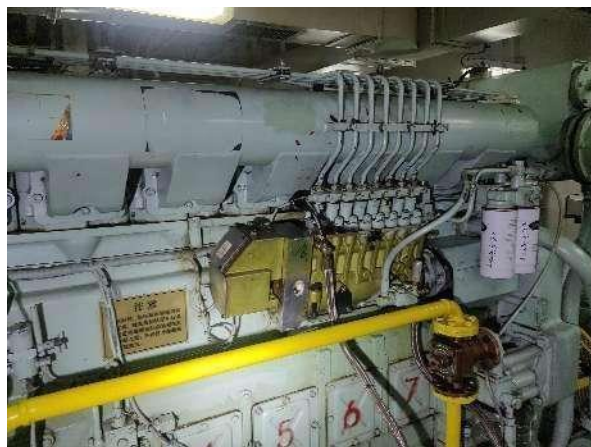
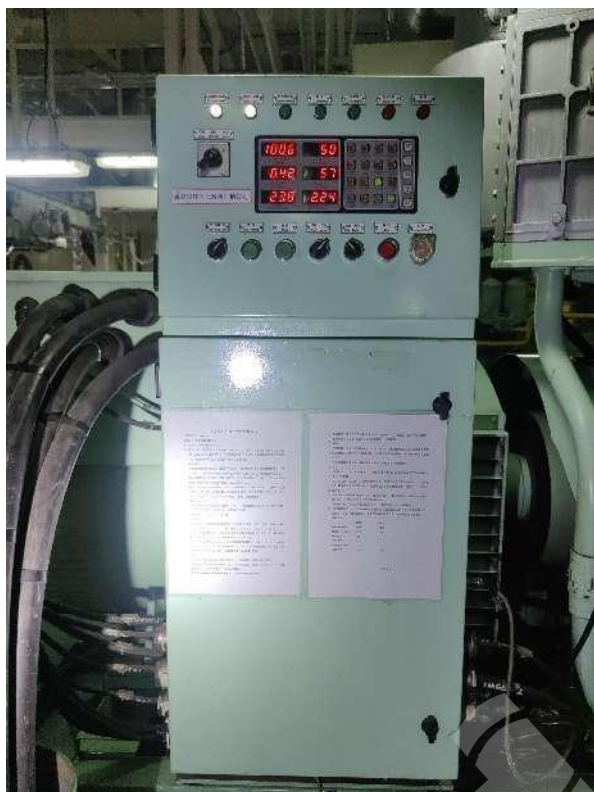
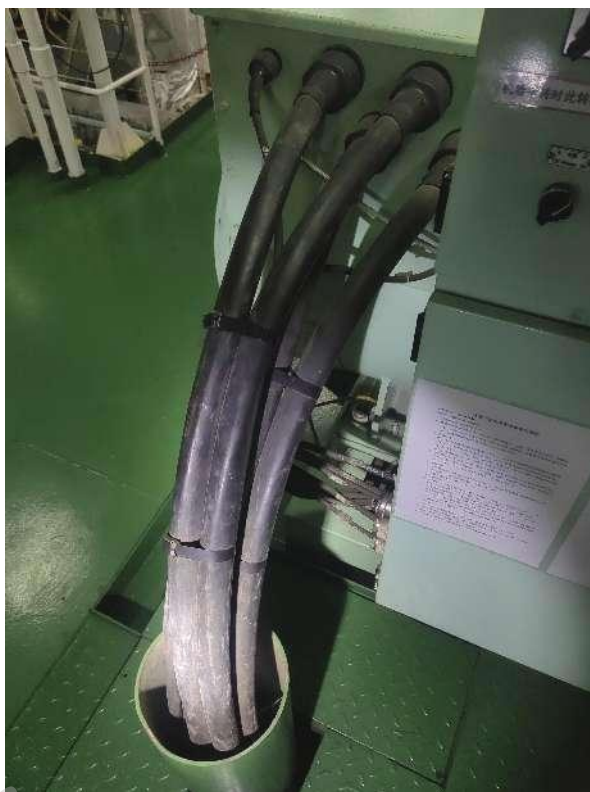
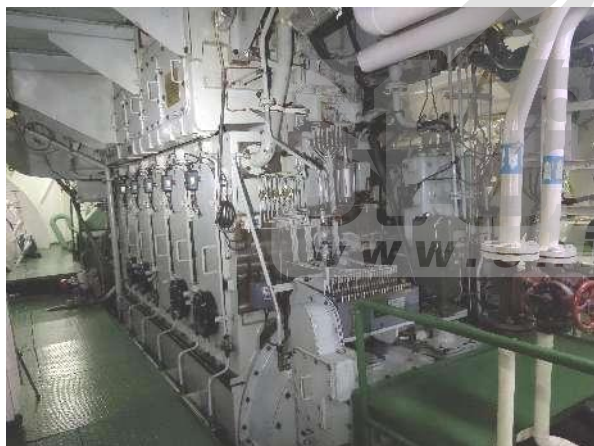
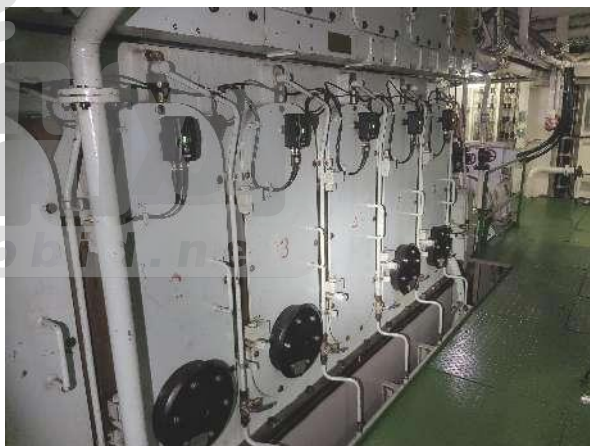
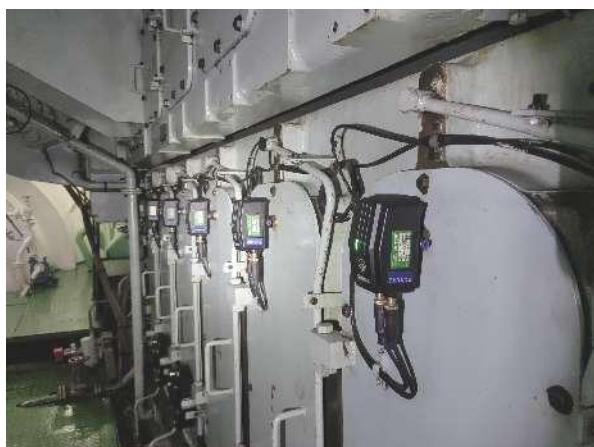
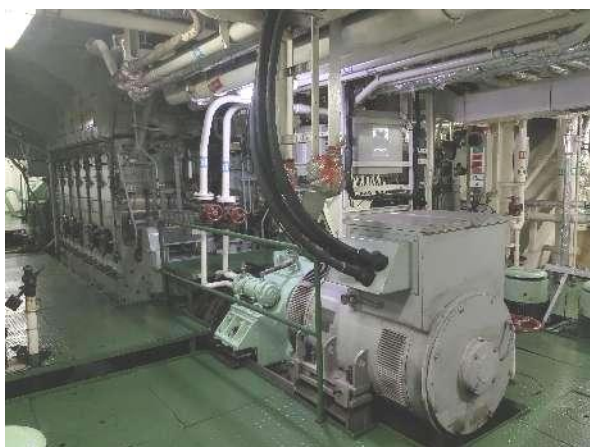
- 1.As of September 26th, 2024, the main engine has been running continuously for 10072 hours, and the high-pressure oil pump has been running for 2722 hours after the annual maintenance in October last year.
- 2.As of September 26th, 2024, the auxiliary generators have been running continuously for 6671h, 7724h, and 6762h respectively.
- 3.During the inspection, the NO.1 main generator was found in operation, and according to the parameters monitored in the ECR and the control equipment nearby, it was in good working condition.
