# TECHNICAL REPORT

CJPG-JS-24-KY-028

## GUO DIAN 36

Inspection date      January 4th, 2024

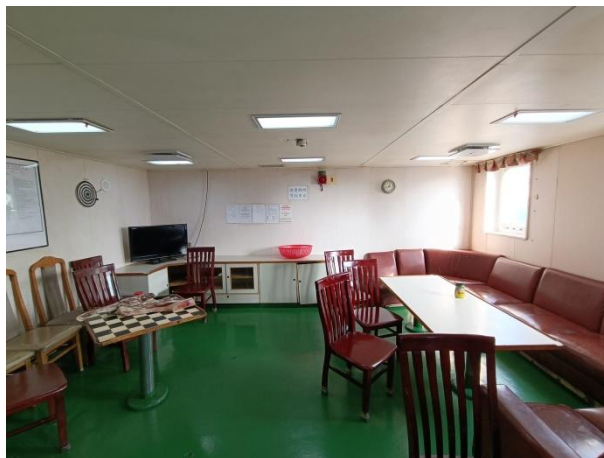
Wear and tear found on the accommodation area floor.

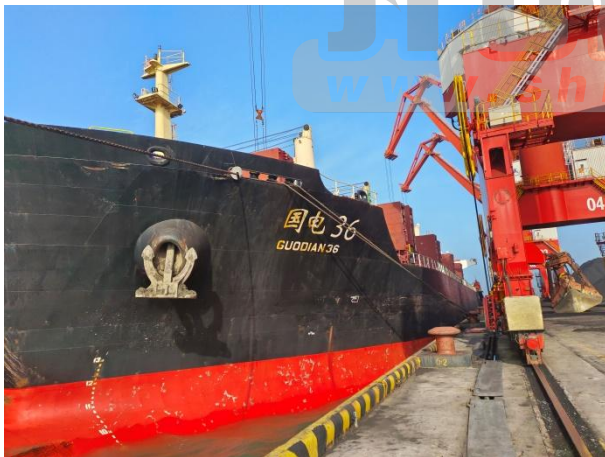
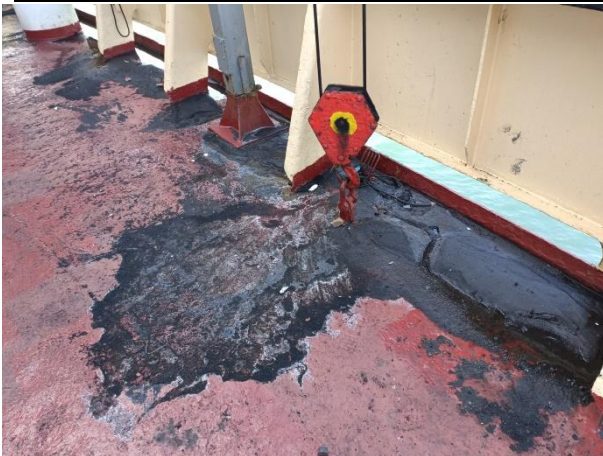
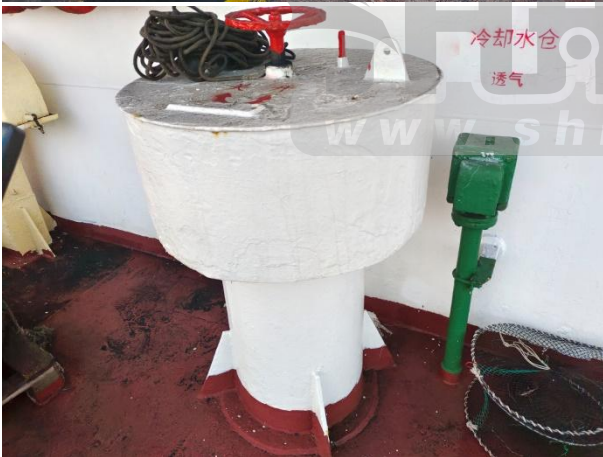
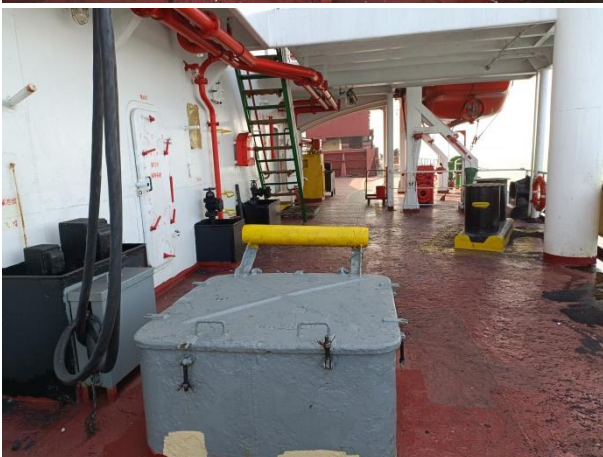
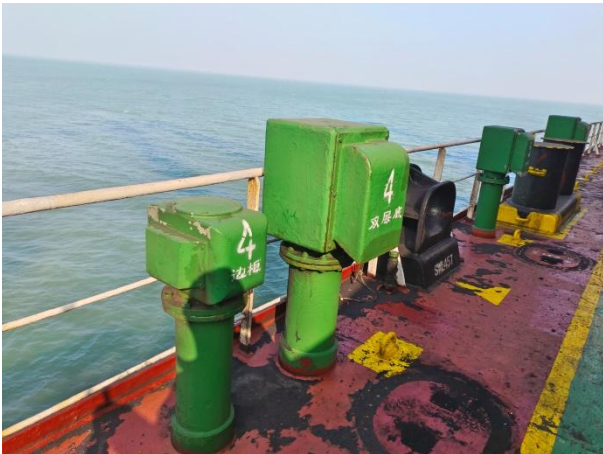
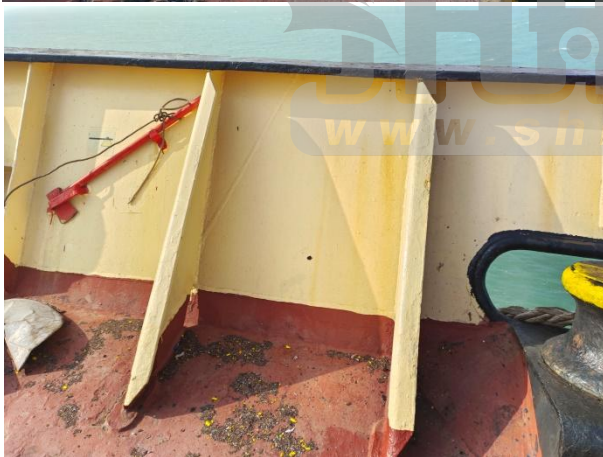
The scratches and local collision deformation were found on the hull shell.

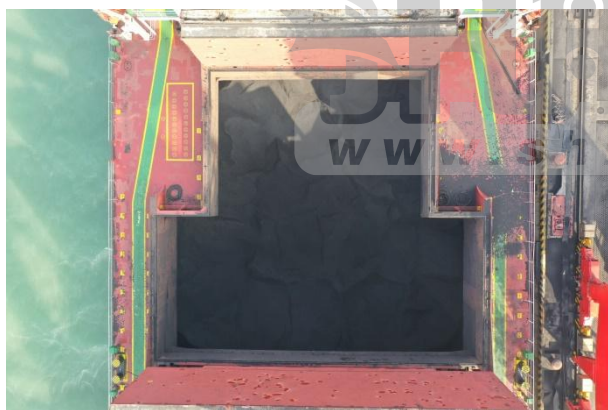
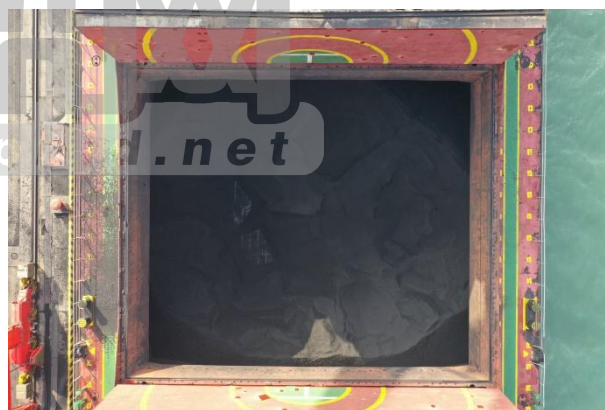
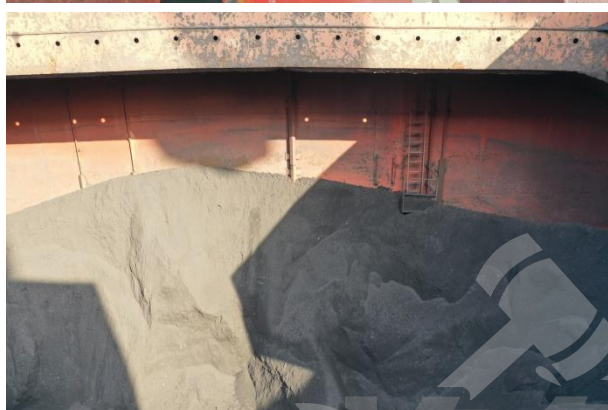
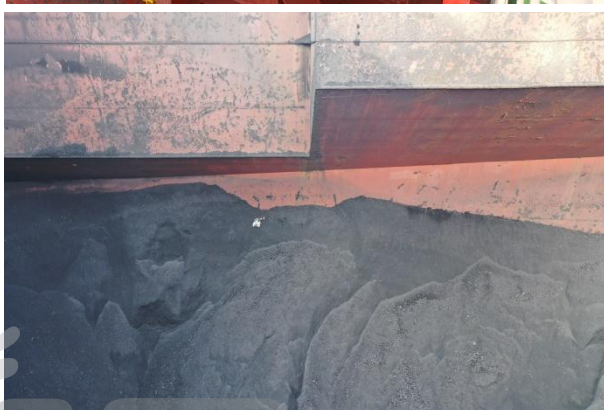
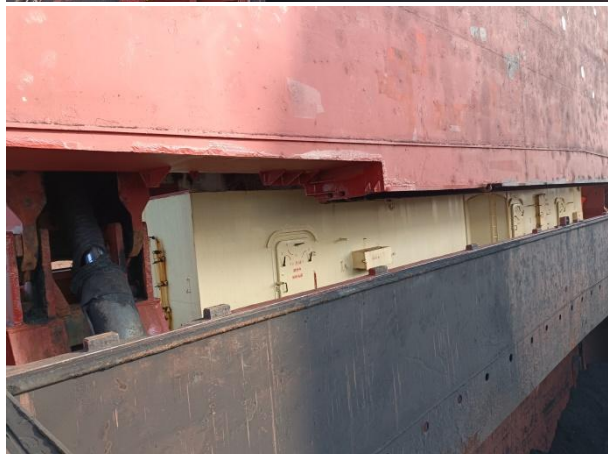
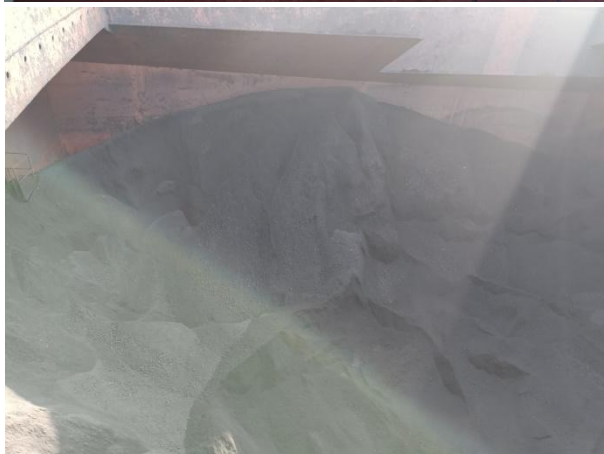
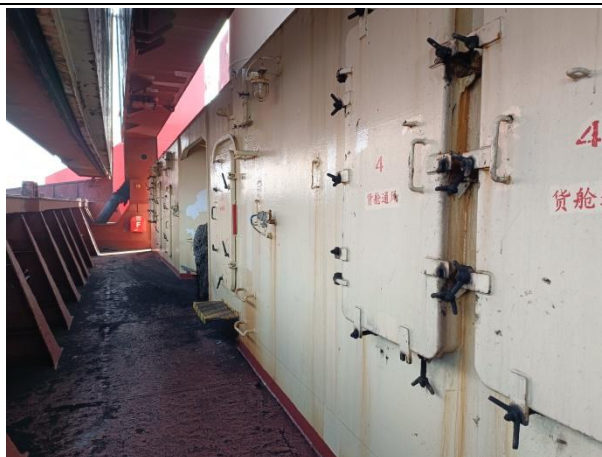
- 1.Large area of rust found on the inner side of the hatch coaming.
- 2.Large areas of rust were found in the structure of the cargo hold, as well collision marks caused by loading and unloading.
- 3.4 sets cranes with 30T have been deactivated.

9	Large areas of rust were found in the structure of the cargo hold, as well collision marks caused by loading and unloading.
10	Large area of rust found on the inner side of the hatch coaming.
11	4# Cylinder has been running for 390 hours since recent maintenance, while 1# cylinder has been running for 8224 hours since the last maintenance.

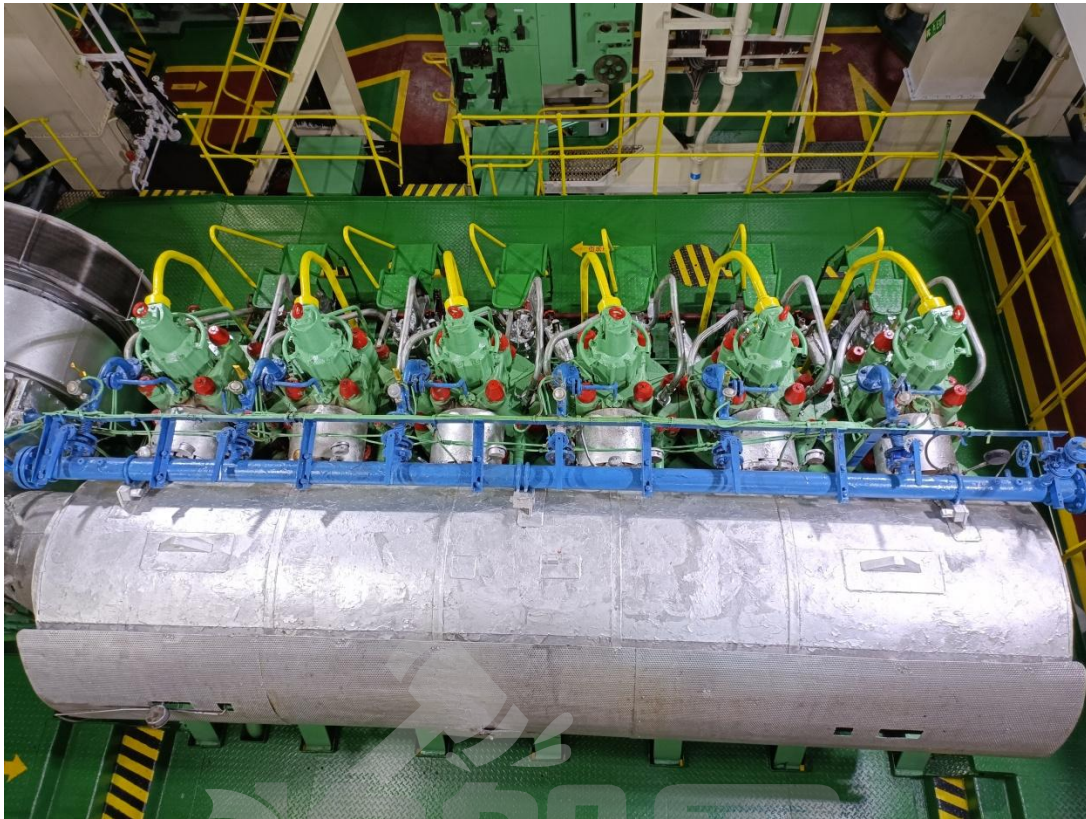
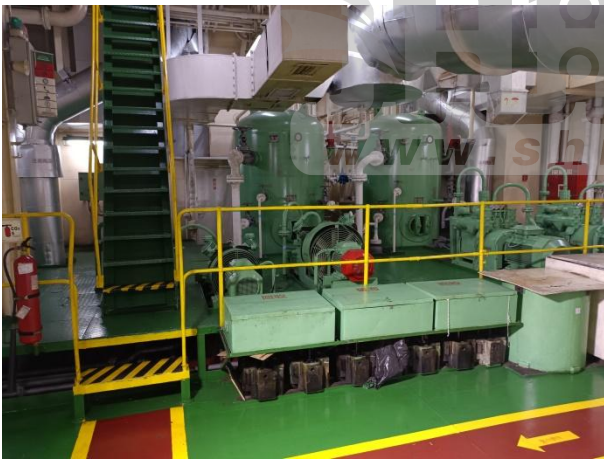
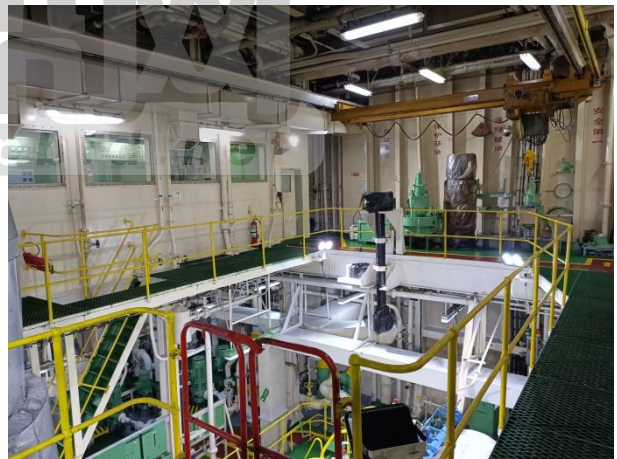
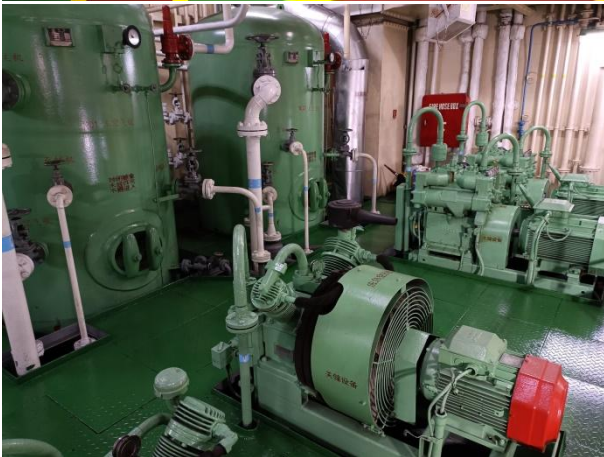
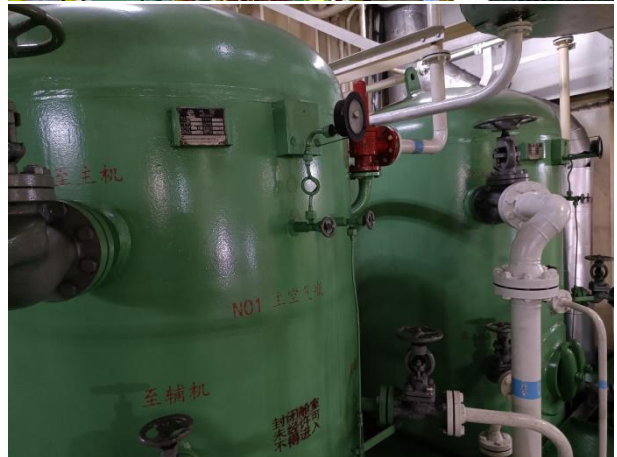
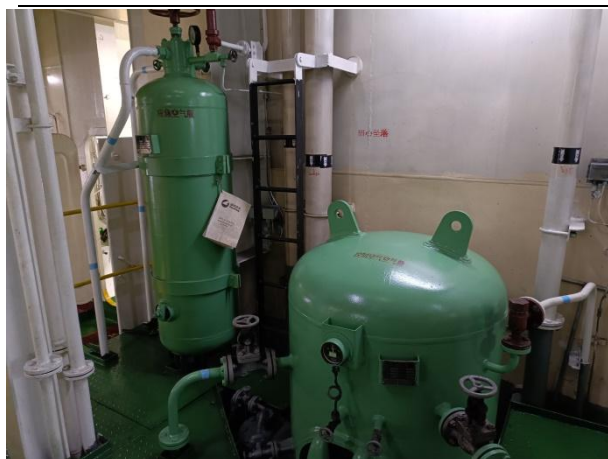
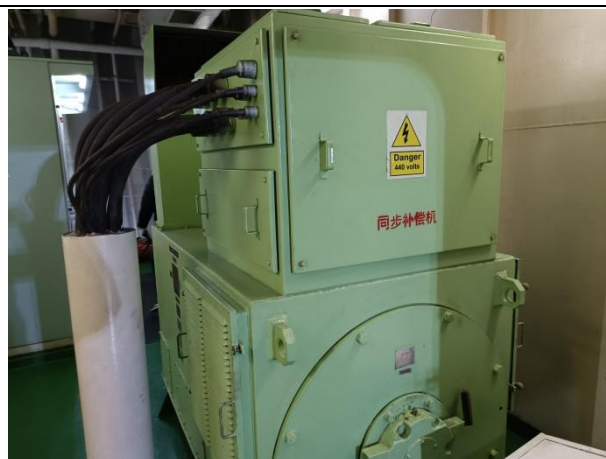
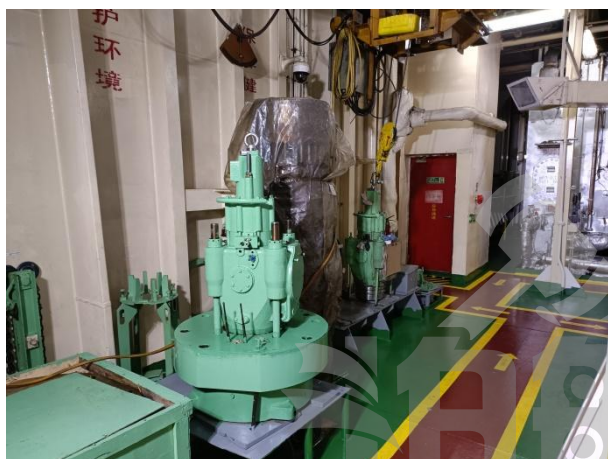
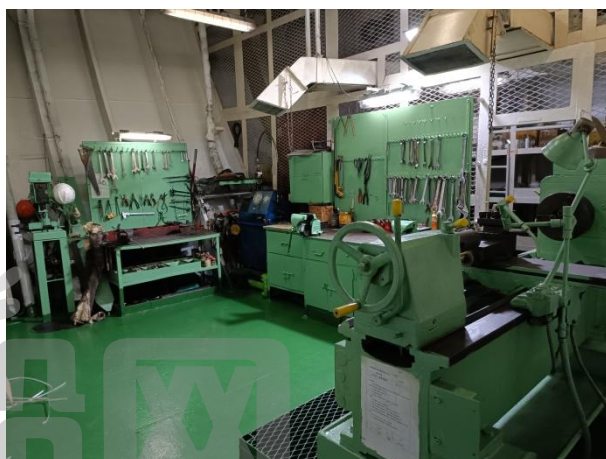
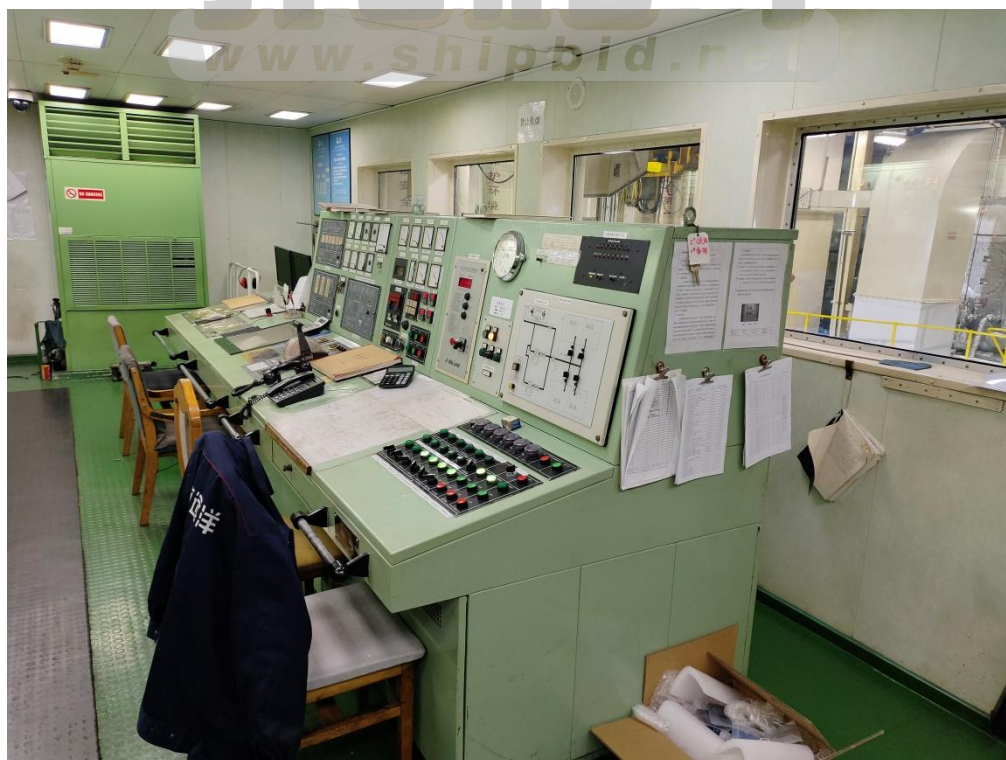
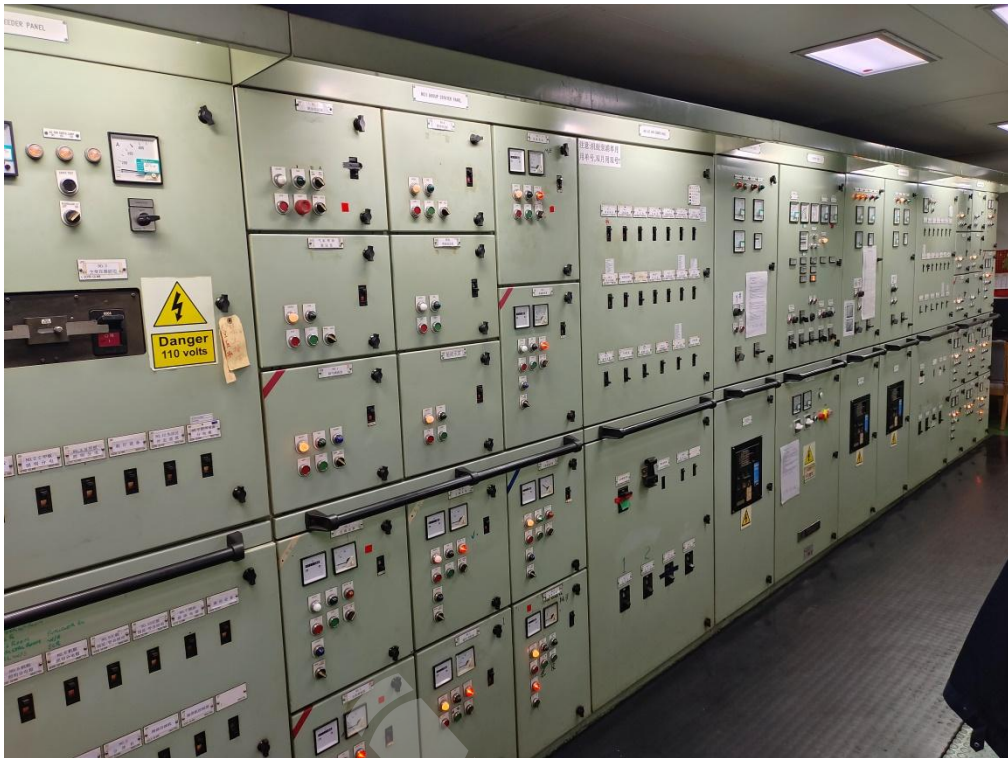
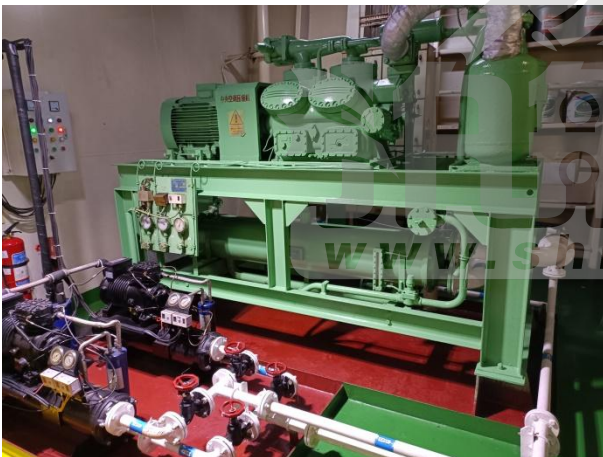
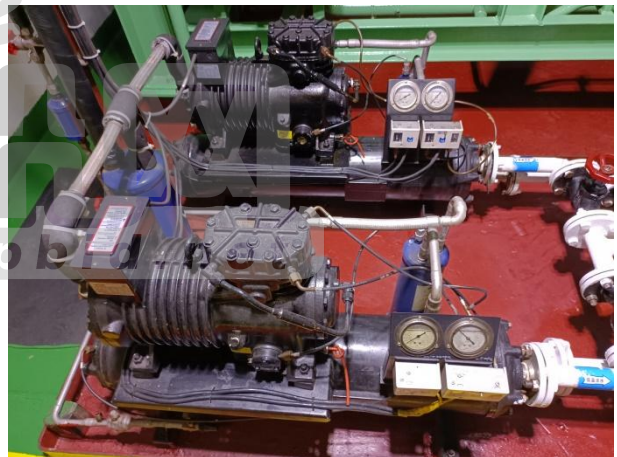
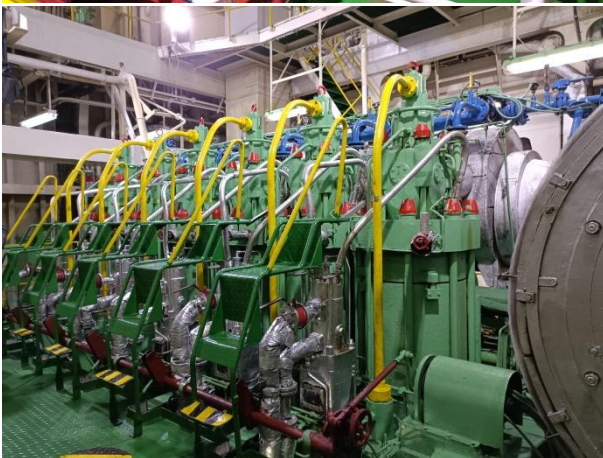
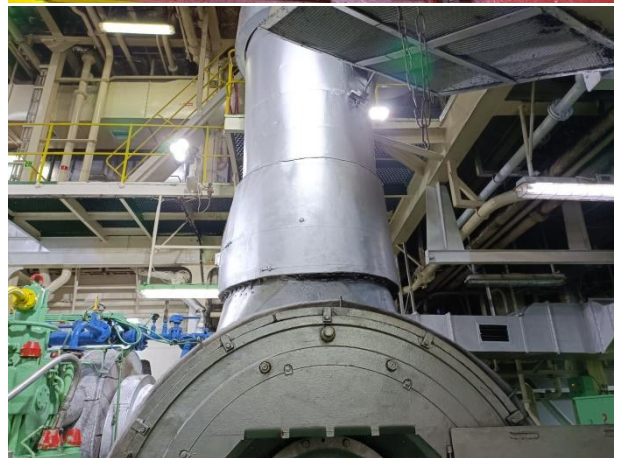
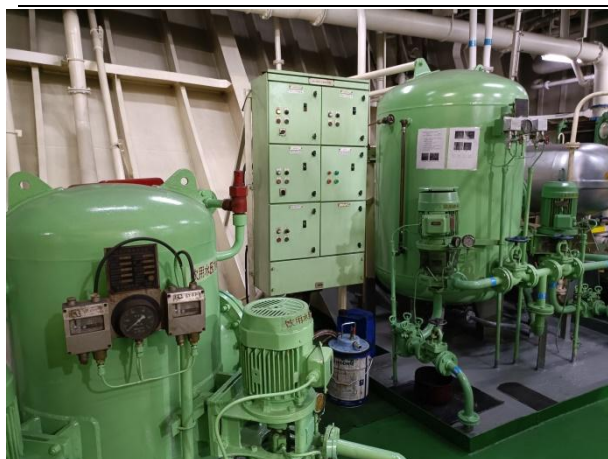
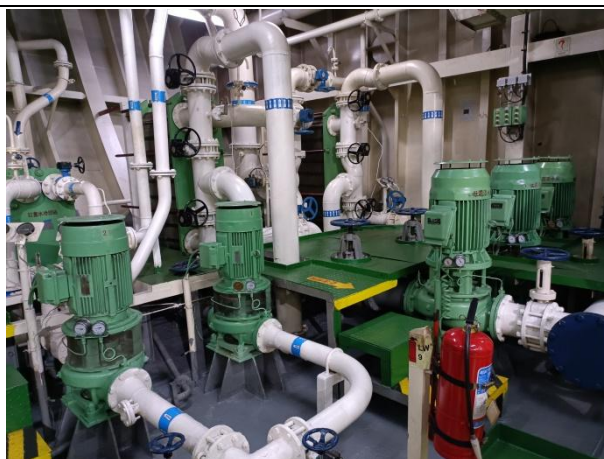
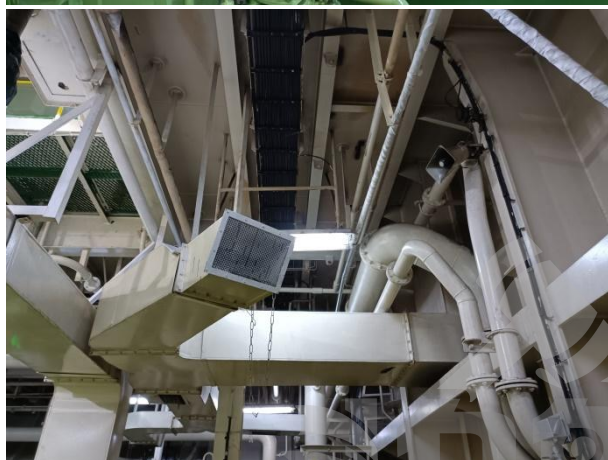
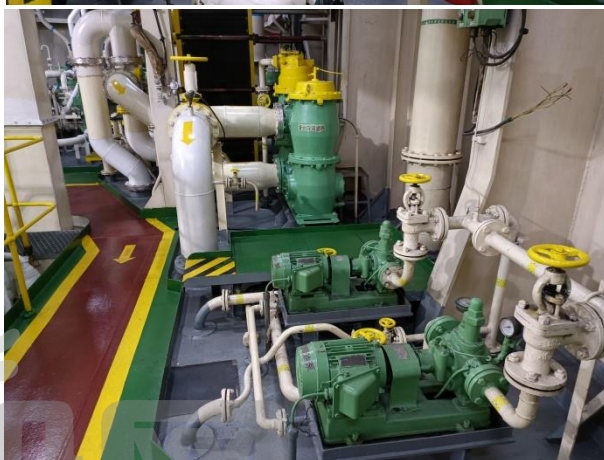
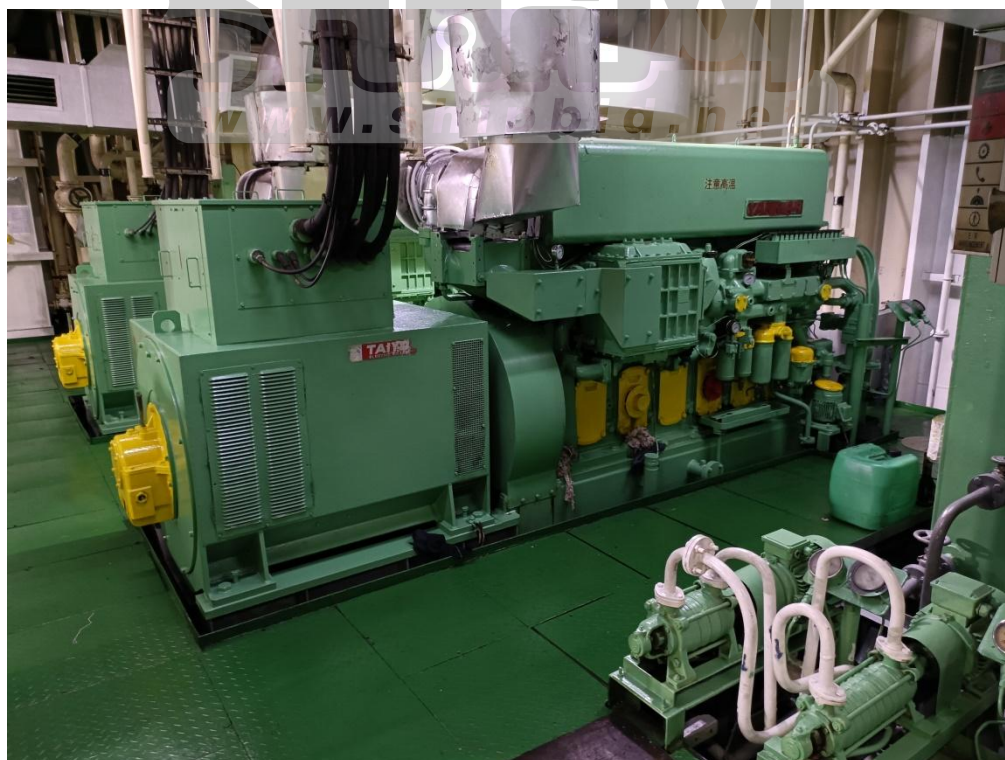
The running time of the M/E since the last maintenance.

Cylinder No.	High pressure oil pump (hours)	After lifting cylinder (hours)
1	4705.9	8224.7
2	1199.7	1544.3
3	4327.4	1917
4	1258.3	390.7
5	4921.4	2775.3
6	5475.2	3101.6
