TECHNICAL REPORT

No. : CJPG-JS-24-KY-0624

GUO HONG 17

Inspection date September 28th, 2024

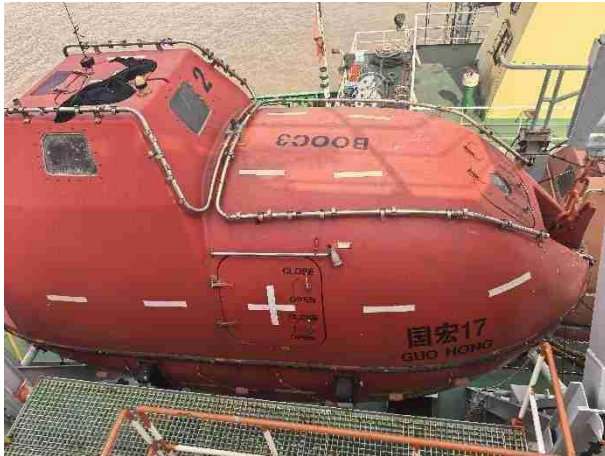
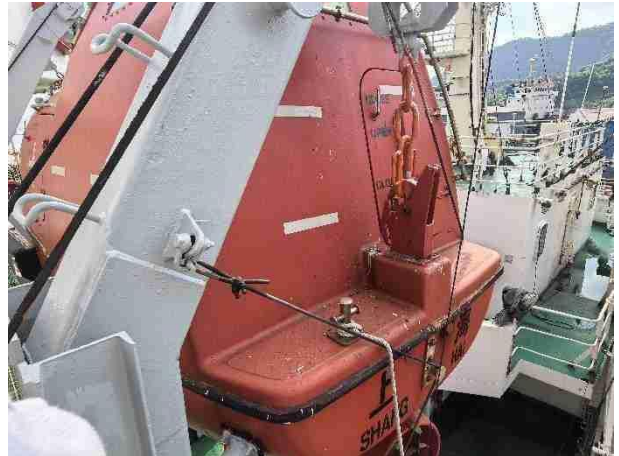
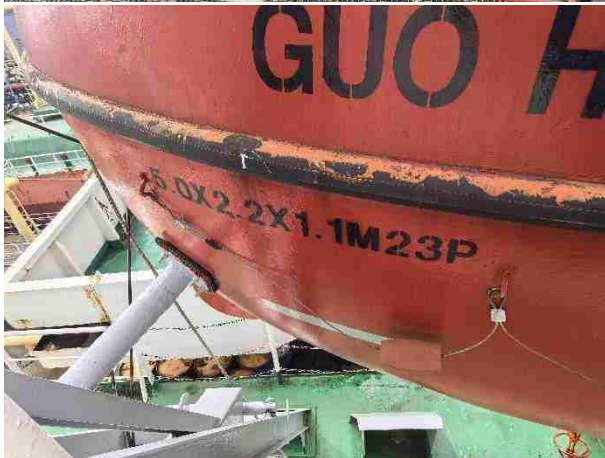
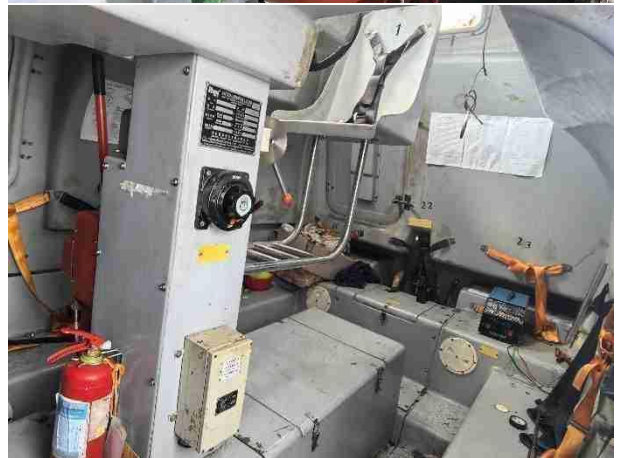
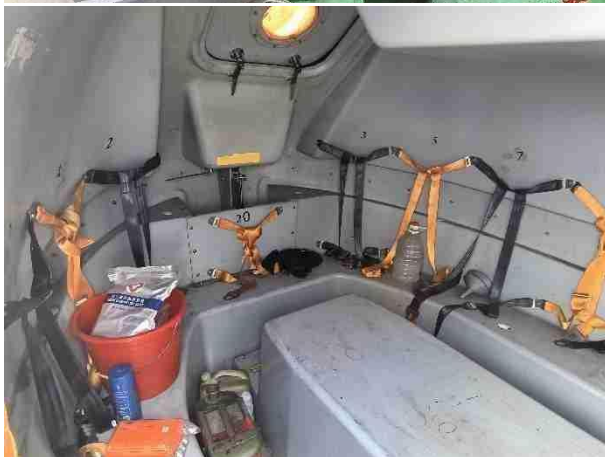
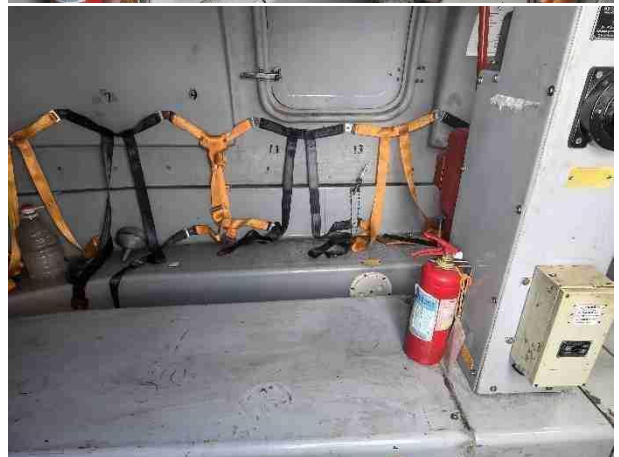
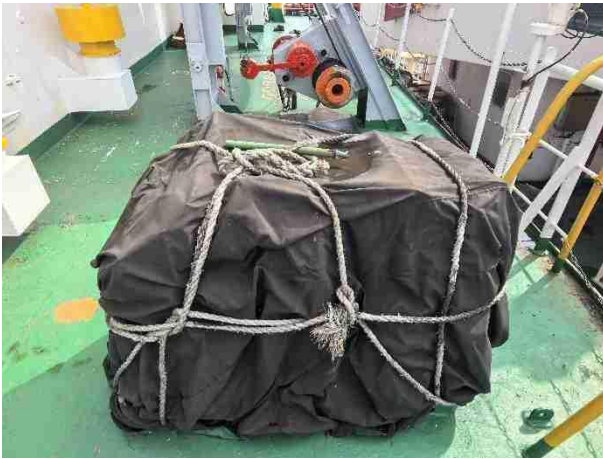
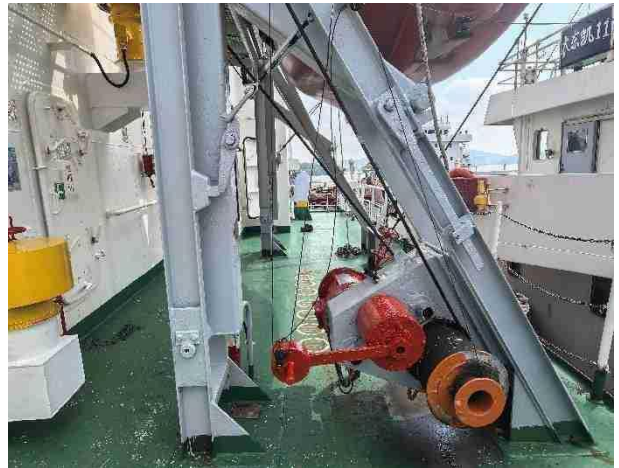
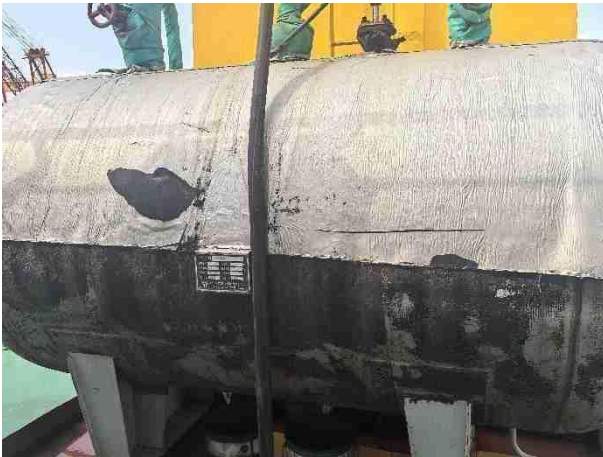
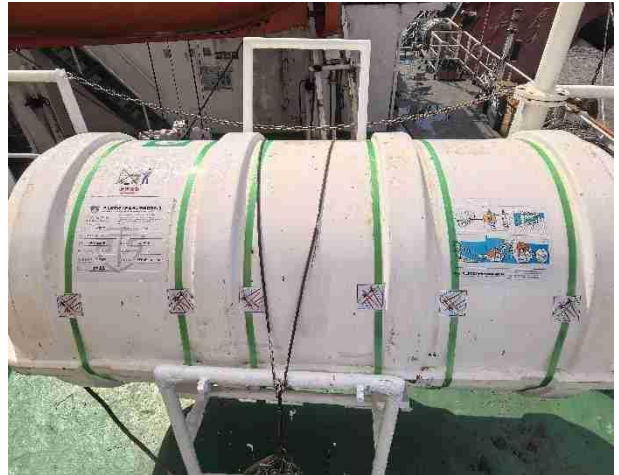
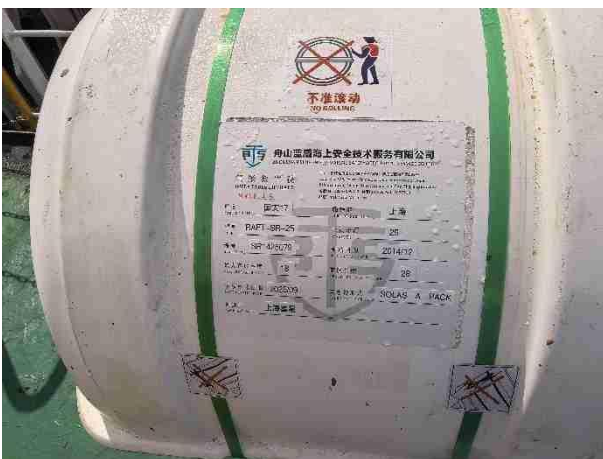
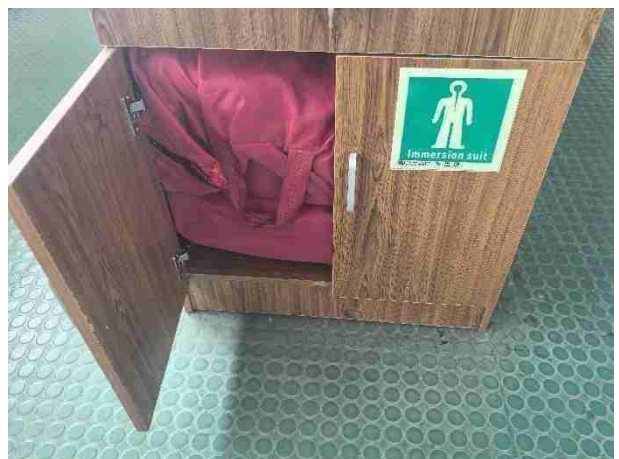
No.	Description	Good	Fair to good	Fair	Poor
1	The lifeboat has a good appearance, and the ship name, port of registry, and other markings were clear and stored correctly.	<input type="checkbox"/>	<input checked="" type="checkbox"/>	<input type="checkbox"/>	<input type="checkbox"/>
2	The frame structure has a good appearance and well lubricated	<input type="checkbox"/>	<input checked="" type="checkbox"/>	<input type="checkbox"/>	<input type="checkbox"/>
3	The rotating mechanism of the lifeboat crane was well lubricated, and without damaged on the motor casing. No leakage was found in the hydraulic oil tank and pipelines.	<input type="checkbox"/>	<input checked="" type="checkbox"/>	<input type="checkbox"/>	<input type="checkbox"/>
4	The motor of the lifeboat was well maintained, and was easy to start (check records of tests or manoeuvre).	<input type="checkbox"/>	<input type="checkbox"/>	<input type="checkbox"/>	<input type="checkbox"/>

5	The lifeboat was fully equipped with life-saving appliances, food and fresh water.	<input type="checkbox"/>	<input checked="" type="checkbox"/>	<input type="checkbox"/>	<input type="checkbox"/>
6	The operation procedures and maintenance manual of the lifeboat were posted, and lighting fixtures were equipped beside.	<input type="checkbox"/>	<input checked="" type="checkbox"/>	<input type="checkbox"/>	<input type="checkbox"/>
7	The life raft and hydrostatic pressure release device were properly fixed, and found in normal maintenance cycle.	<input type="checkbox"/>	<input checked="" type="checkbox"/>	<input type="checkbox"/>	<input type="checkbox"/>
8	The life raft boarding ladder was equipped with handrails, and the pedals are not cracked, rotten, or loose, with no significant corrosion on the connecting ground.	<input type="checkbox"/>	<input checked="" type="checkbox"/>	<input type="checkbox"/>	<input type="checkbox"/>

9	Lifebuoys, lights, floats, etc. were in the correct position and in good appearance.	<input type="checkbox"/>	<input checked="" type="checkbox"/>	<input type="checkbox"/>	<input type="checkbox"/>
10	Lifejackets, insulation suits, diving suits, etc. were approved by the class, properly stored, and in sufficient quantities.	<input type="checkbox"/>	<input checked="" type="checkbox"/>	<input type="checkbox"/>	<input type="checkbox"/>
11	The configuration of flame parachutes, rope throwers, etc. complies with regulatory requirements and was stored correctly.	<input type="checkbox"/>	<input checked="" type="checkbox"/>	<input type="checkbox"/>	<input type="checkbox"/>

Note: The above inspection items were found in "Fair to good" level overall.

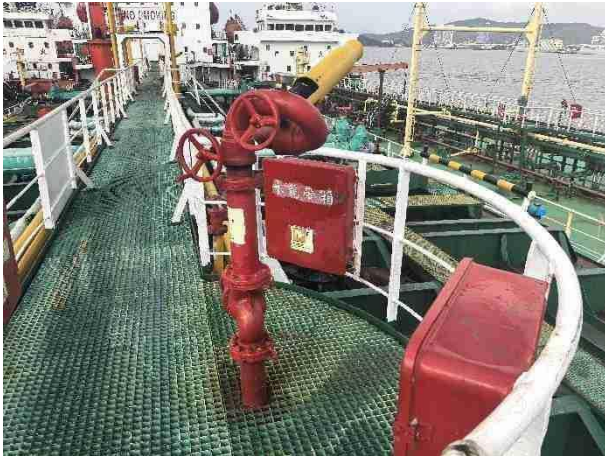
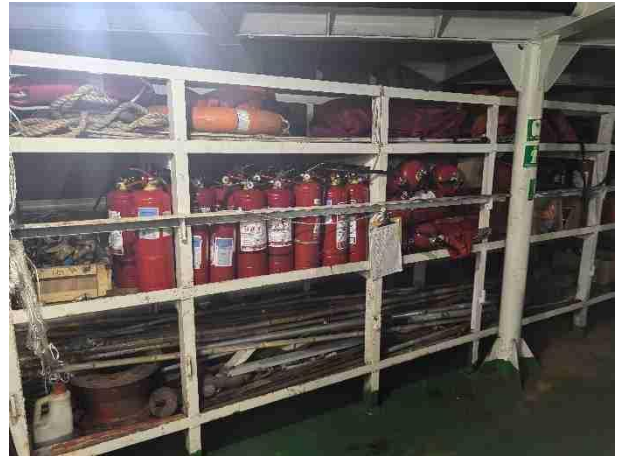
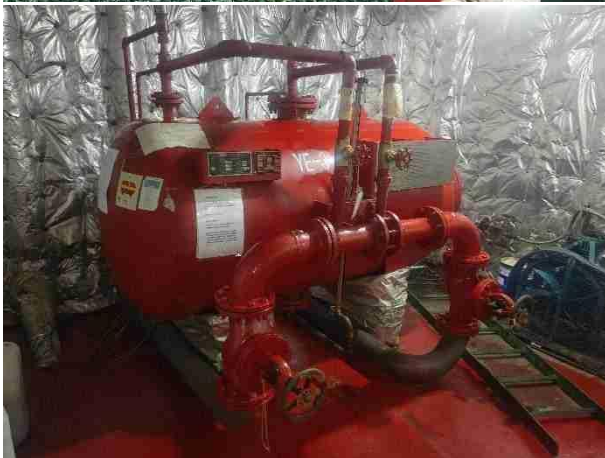
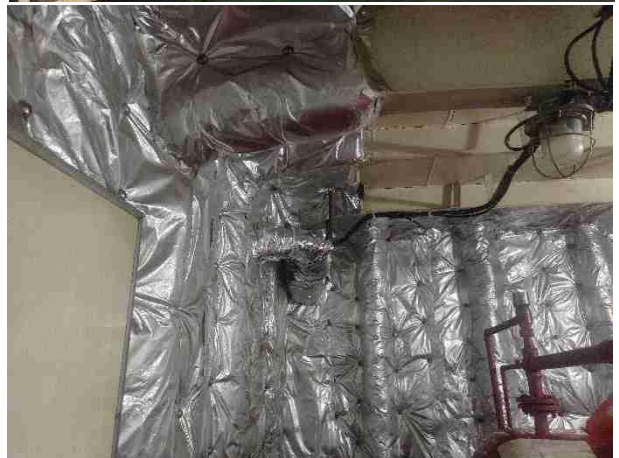
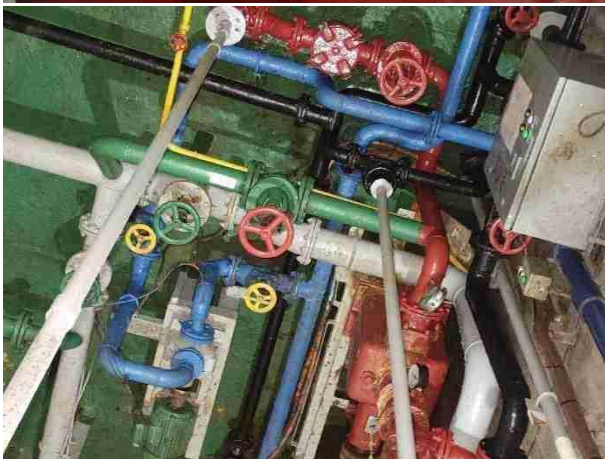
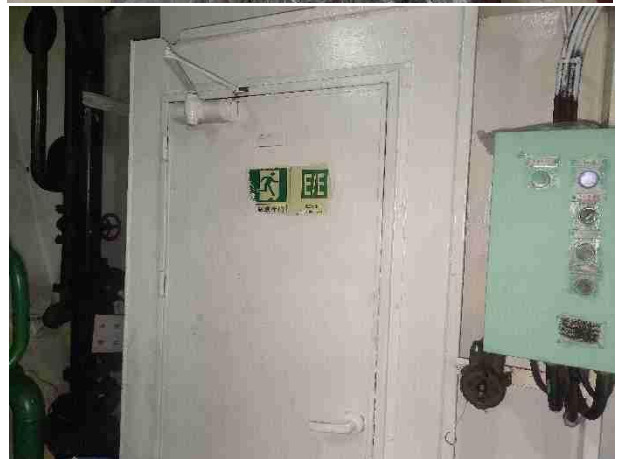
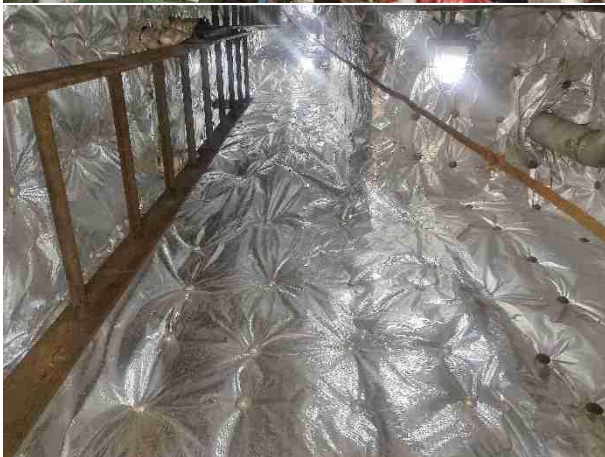
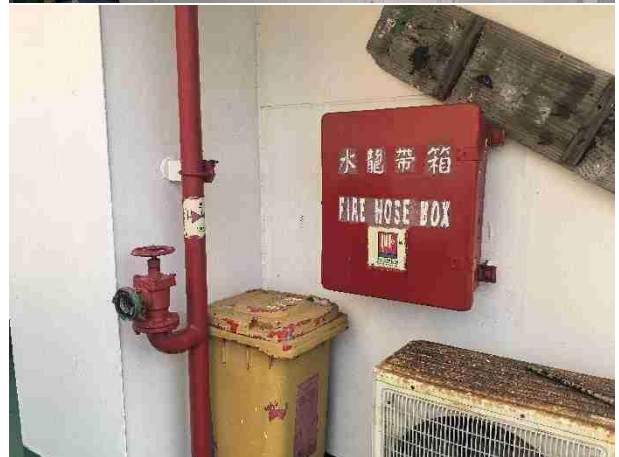
8. Fire & Safety Appliance

No.	Description	Good	Fair to good	Fair	Poor
1	The CO2 cylinders and release devices were found within the validity period of inspection, the automatic sound alarm was not faulty, and the operation regulations were posted.	<input type="checkbox"/>	<input checked="" type="checkbox"/>	<input type="checkbox"/>	<input type="checkbox"/>
2	No looseness or leakage was found on the connection of CO2 pipe system, and the starting cylinder pressure was sufficient.	<input type="checkbox"/>	<input checked="" type="checkbox"/>	<input type="checkbox"/>	<input type="checkbox"/>
3	The fire separation material of foam room was intact, and without damaged on the wrapping material. The direction of foam pipeline shall be clearly marked, and the pipeline and valve shall be free of rust.	<input type="checkbox"/>	<input checked="" type="checkbox"/>	<input type="checkbox"/>	<input type="checkbox"/>
4	The pressure gauge of the foam generator was intact, and the schematic diagram, operating instructions, and inspection marks were completely posted.	<input type="checkbox"/>	<input checked="" type="checkbox"/>	<input type="checkbox"/>	<input type="checkbox"/>

5	Hydrant appearance was found intact, the handwheel switch was normal. No significant corrosion and leakage was found on pipelines.	<input type="checkbox"/>	<input checked="" type="checkbox"/>	<input type="checkbox"/>	<input type="checkbox"/>
6	The appearance of the hose box was found intact, and the water hose and water gun were approved type, with nozzles in good condition.	<input type="checkbox"/>	<input checked="" type="checkbox"/>	<input type="checkbox"/>	<input type="checkbox"/>
7	The water spray system in the cargo oil area was found complete and in good condition.	<input type="checkbox"/>	<input checked="" type="checkbox"/>	<input type="checkbox"/>	<input type="checkbox"/>
8	The emergency fire pump compartment access ladder and lighting fixtures were intact. Post operating procedures and hang regular operation test records.	<input type="checkbox"/>	<input checked="" type="checkbox"/>	<input type="checkbox"/>	<input type="checkbox"/>

9	The emergency fire pump and pipelines were found intact, and the pressure instruments were intact. The inlet valve should be kept normally open and clearly marked. The casing of the emergency fire pump motor was free from rust and damage.	<input type="checkbox"/>	<input checked="" type="checkbox"/>	<input type="checkbox"/>	<input type="checkbox"/>

10	Portable fire extinguishers were correctly placed and in good condition, with inspection markings. The sufficient number of spare fire extinguishers were provided.	<input type="checkbox"/>	<input checked="" type="checkbox"/>	<input type="checkbox"/>	<input type="checkbox"/>
11	The fire protection of the emergency escape passage was found complete. The lighting, life rope, and life ladder were in good condition with normal self closing door.	<input type="checkbox"/>	<input checked="" type="checkbox"/>	<input type="checkbox"/>	<input type="checkbox"/>
12	The fire protection structure of the paint room was intact, as well the temperature sensing probe. The water mist pipeline was free of rust, and the ventilation facilities were intact.	<input type="checkbox"/>	<input checked="" type="checkbox"/>	<input type="checkbox"/>	<input type="checkbox"/>

Note: The above inspection items were found in "Fair to good" level overall.

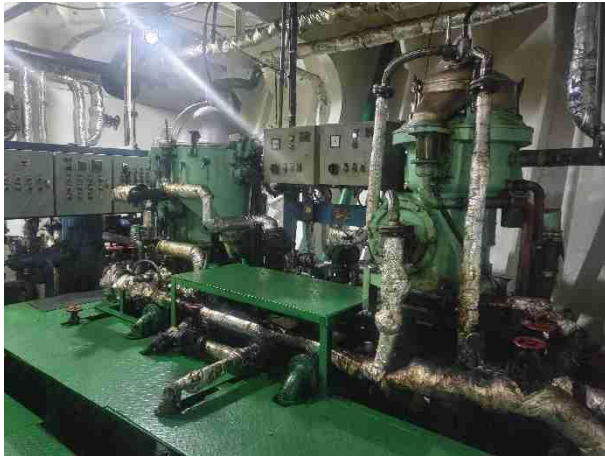
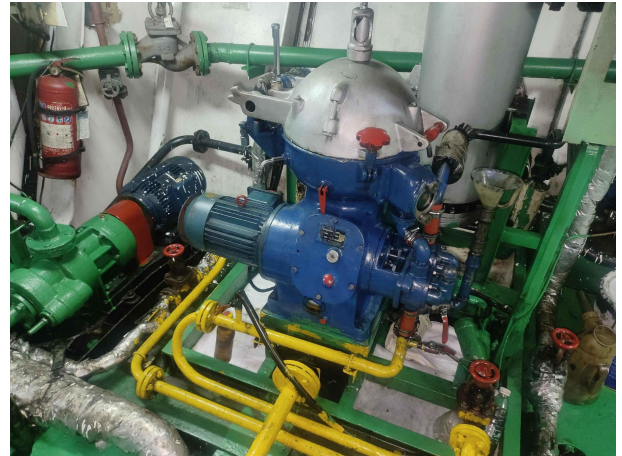
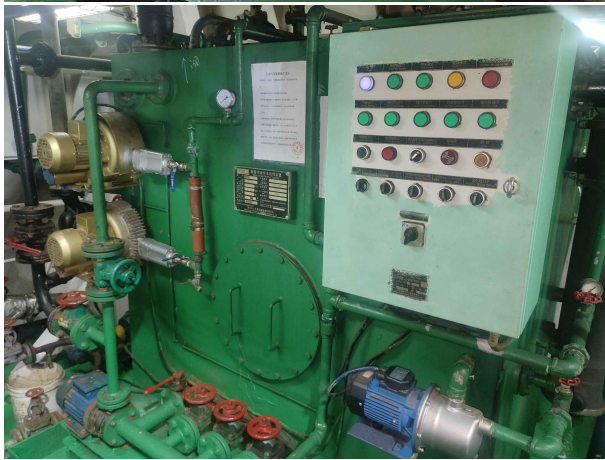
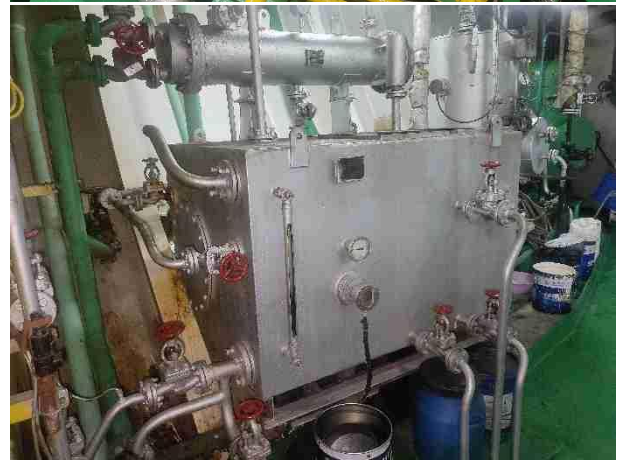
9. Pollution Control

No.	Description	Good	Fair to good	Fair	Poor
1	The nameplate of the domestic sewage treatment plant was found consistent with the certificate. The sewage pump, air compressor, etc.were not faulty.	<input type="checkbox"/>	<input checked="" type="checkbox"/>	<input type="checkbox"/>	<input type="checkbox"/>
2	The appearance of the domestic sewage treatment device was found in good condition, and the pressure gauge was normal. No illegal bypass pipelines or joints, the discharge valve was locked and warning signs were hung.	<input type="checkbox"/>	<input checked="" type="checkbox"/>	<input type="checkbox"/>	<input type="checkbox"/>
3	The nameplate of the bilge oil-water separator was found consistent with the certificate, the surface of the equipment was clean. The operating instructions were posted near the equipment.	<input type="checkbox"/>	<input checked="" type="checkbox"/>	<input type="checkbox"/>	<input type="checkbox"/>

4	The bilge oil-water separator has no illegal by-pass pipeline or connector discharging directly to the outboard side, and without significant dismantling trace of the flange bolts on the outlet pipeline. The outboard discharge valve was in a closed and locked status, with a warning sign for prohibiting discharging.	<input type="checkbox"/>	<input checked="" type="checkbox"/>	<input type="checkbox"/>	<input type="checkbox"/>

Note: The above inspection items were found in "Fair to good" level overall.

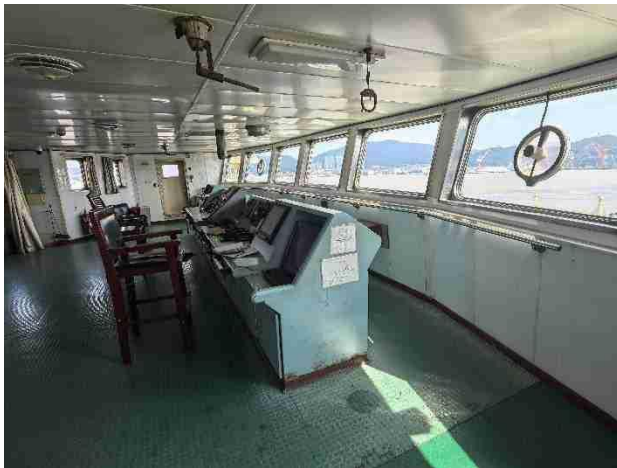
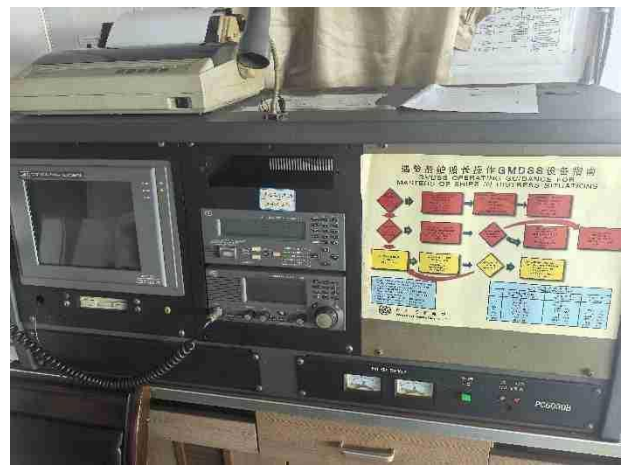
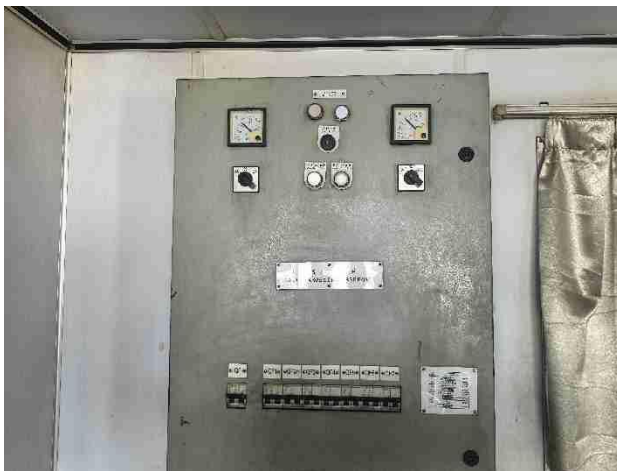
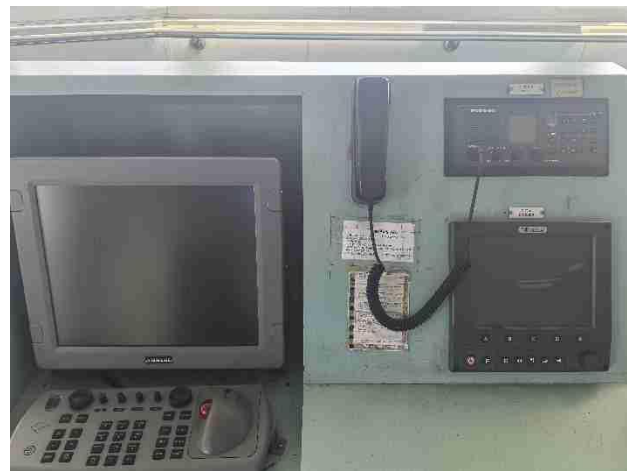
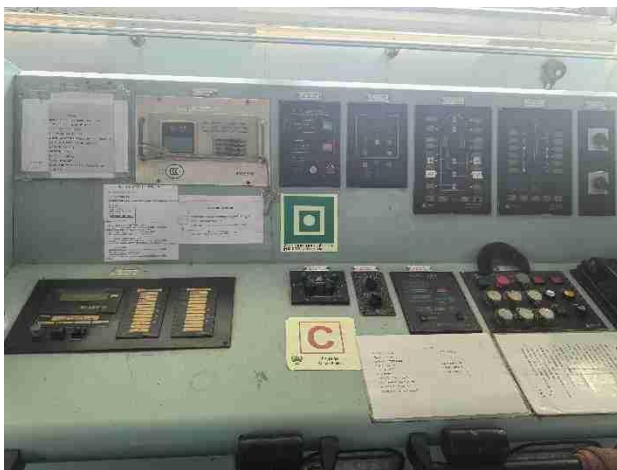
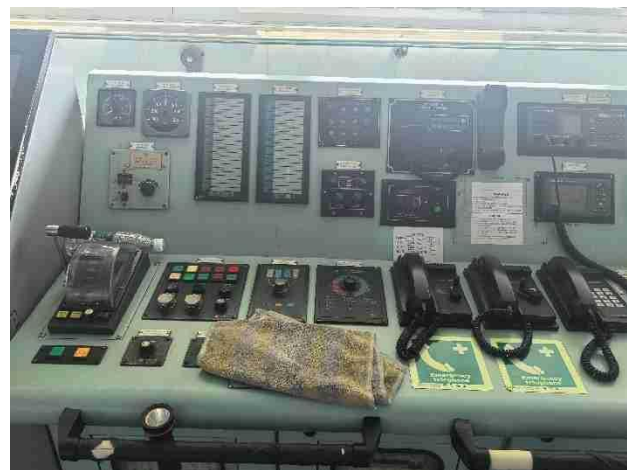
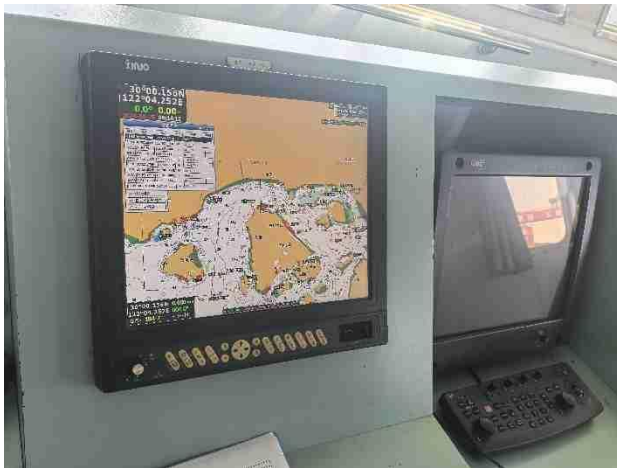
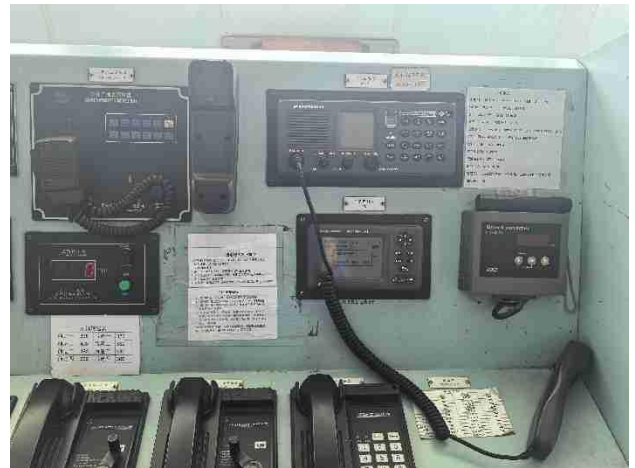
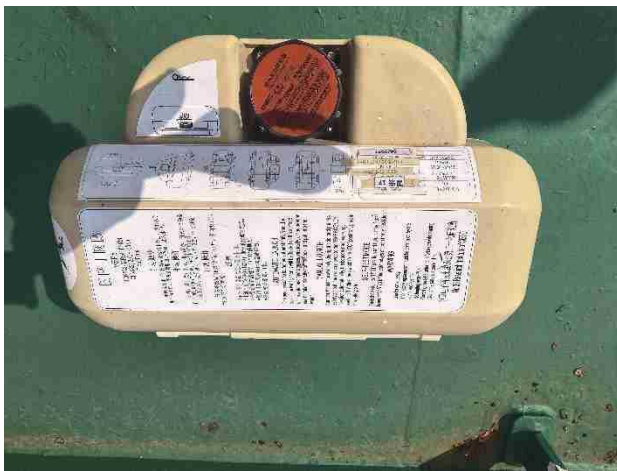
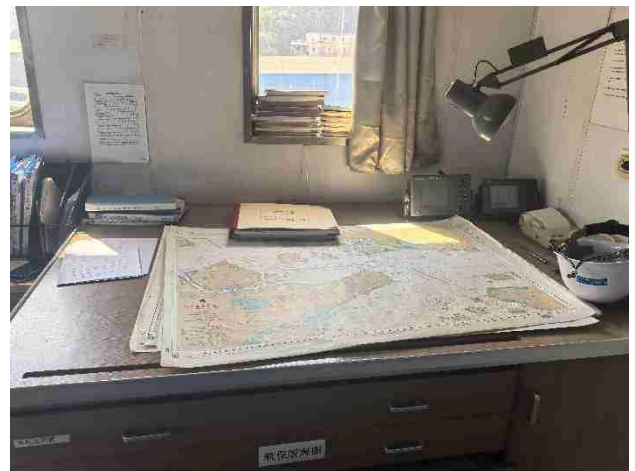
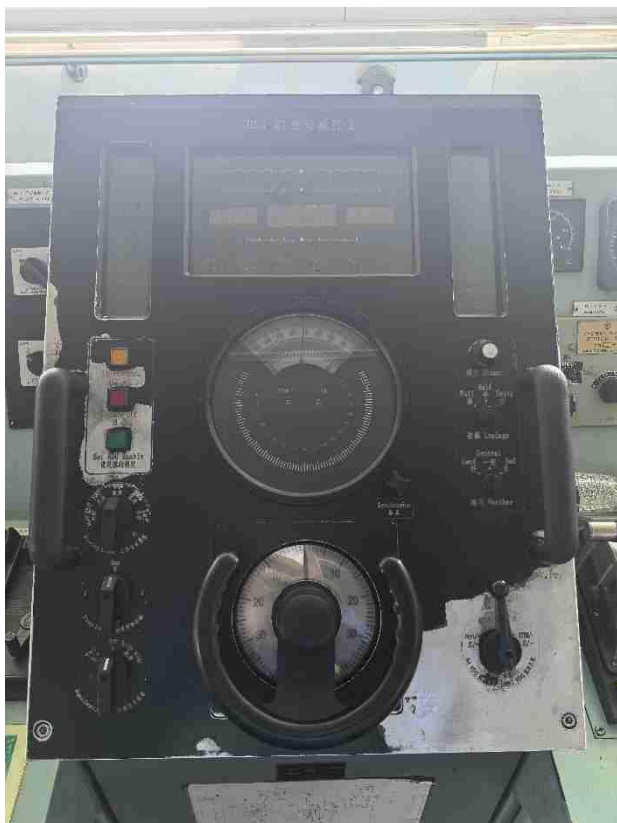
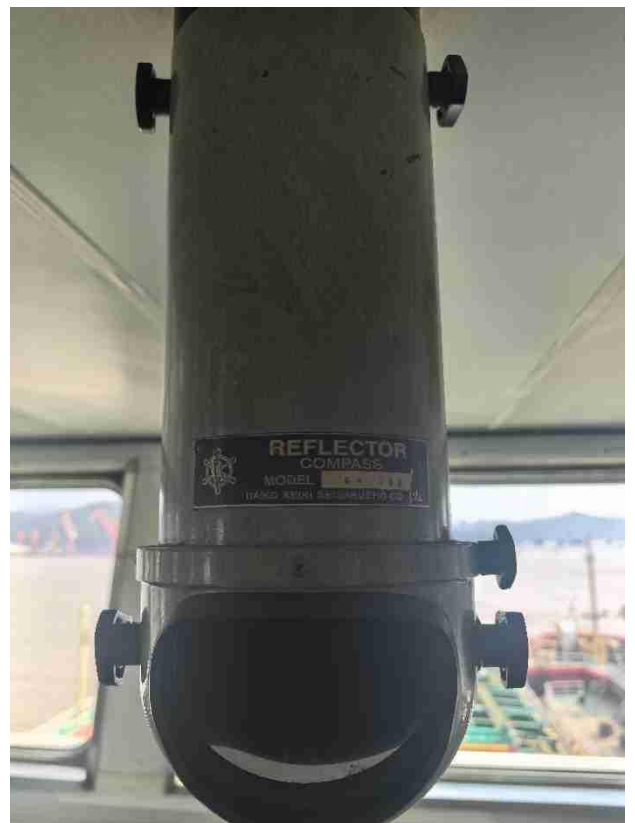
10. Navigating Bridge & Communications Equipment

No.	Description	Good	Fair to good	Fair	Poor
1	The fire and heat insulation partitions in the bridge were intact, and the front window is equipped with wipers or rotating windows.	<input type="checkbox"/>	<input checked="" type="checkbox"/>	<input type="checkbox"/>	<input type="checkbox"/>
2	The ship was equipped with the latest version of navigation books. The various charts related to safety management were posted and updated to the latest version.	<input type="checkbox"/>	<input checked="" type="checkbox"/>	<input type="checkbox"/>	<input type="checkbox"/>
3	The main communication devices were consistent with the certificate record.	<input type="checkbox"/>	<input checked="" type="checkbox"/>	<input type="checkbox"/>	<input type="checkbox"/>
4	The readings of the steering compass and the standard compass were found basically consistent and no large bubbles or steam inside the compass disc.	<input type="checkbox"/>	<input checked="" type="checkbox"/>	<input type="checkbox"/>	<input type="checkbox"/>

equipment was consistent with MMSI code, and the DSC transceiver function was normal.				
9	MF/HF radio device had no faults and DSC test was normal. The Emergency lighting installed at the operation area.	<input type="checkbox"/>	<input checked="" type="checkbox"/>	<input type="checkbox"/>	<input type="checkbox"/>
10	The NAVTEX display was normal and the recently printed data was clear.	<input type="checkbox"/>	<input checked="" type="checkbox"/>	<input type="checkbox"/>	<input type="checkbox"/>
11	The image display of the echo sounder was found clear, with normally brightness adjustment.	<input type="checkbox"/>	<input checked="" type="checkbox"/>	<input type="checkbox"/>	<input type="checkbox"/>
12	The water tightness of the SART casing was found intact, and the battery was effective.	<input type="checkbox"/>	<input checked="" type="checkbox"/>	<input type="checkbox"/>	<input type="checkbox"/>

13	The EPIRB casing had good water tightness and firmly installed, the battery and hydrostatic pressure release device were effective.	<input type="checkbox"/>	<input checked="" type="checkbox"/>	<input type="checkbox"/>	<input type="checkbox"/>

Note: The above inspection items were found in "Fair to good" level overall.

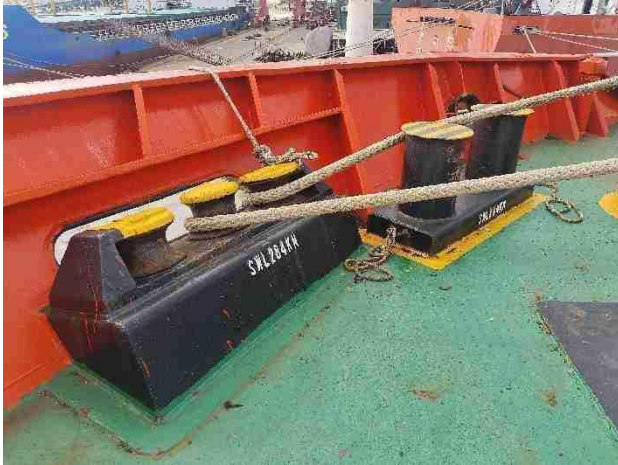
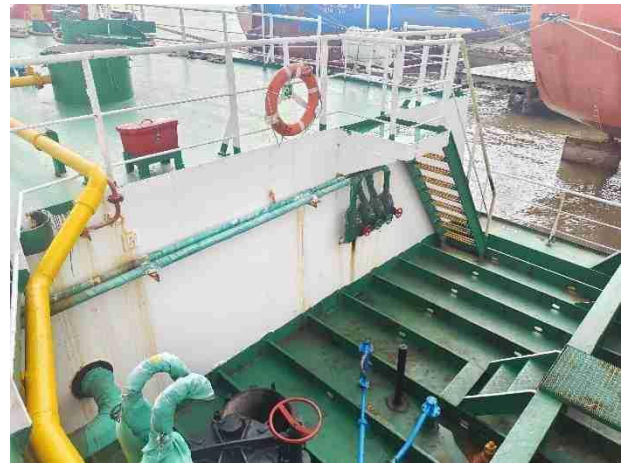
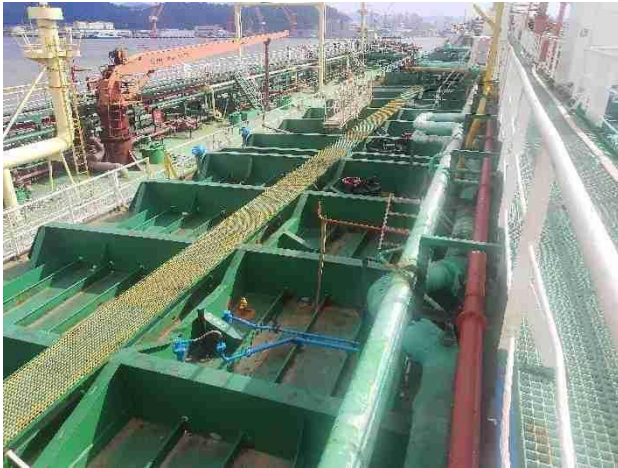
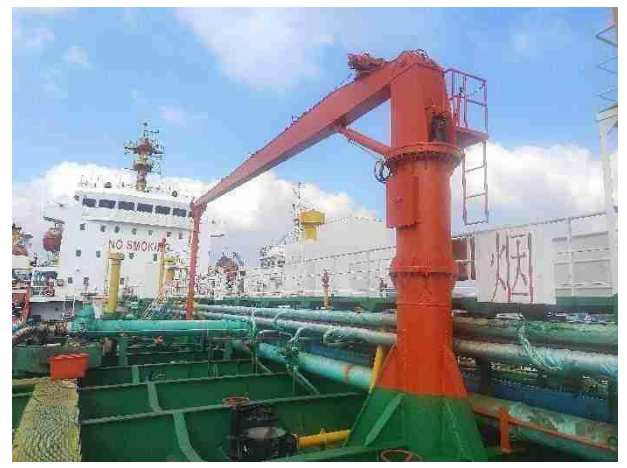
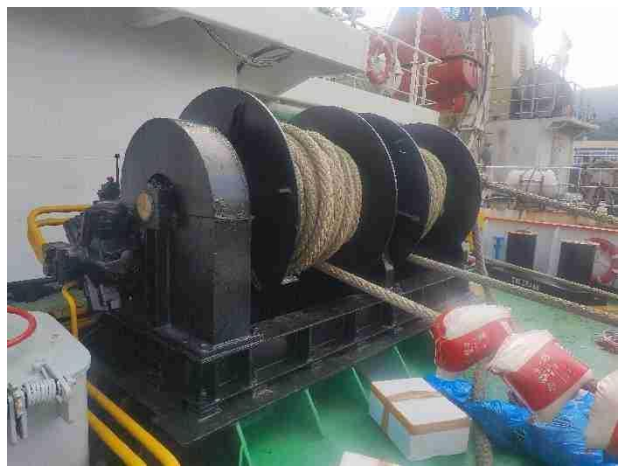
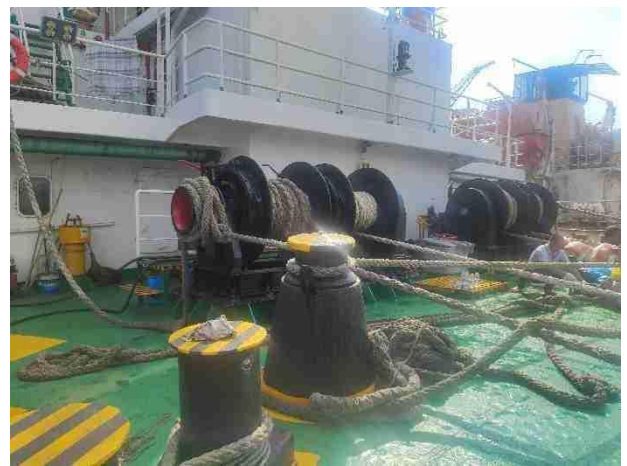
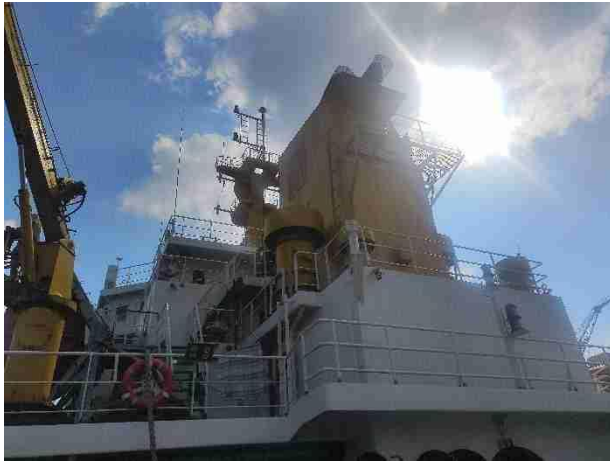
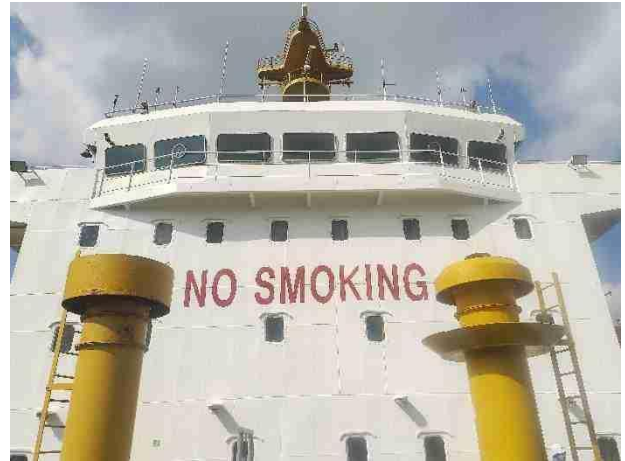
12. Ballast tank and Void tank

No.	Description	Good	Fair to good	Fair	Poor
1	The manhole cover of the ballast tank was not deformed or corroded, the sealing gasket was not damaged.	<input type="checkbox"/>	<input checked="" type="checkbox"/>	<input type="checkbox"/>	<input type="checkbox"/>
2	The ventilation pipe of the ballast tank was in good condition, equipped with effective shut-off devices.	<input type="checkbox"/>	<input checked="" type="checkbox"/>	<input type="checkbox"/>	<input type="checkbox"/>
3	The structure inside the ballast tank has no buckling/fracture/crack/significant corrosion/anti-corrosion anode.	<input type="checkbox"/>	<input type="checkbox"/>	<input type="checkbox"/>	<input type="checkbox"/>
4	The watertight collar plate in the ballast tank has no leakage or welding cracks.	<input type="checkbox"/>	<input type="checkbox"/>	<input type="checkbox"/>	<input type="checkbox"/>

Note: The above inspection items were found in "Fair to good" level overall.

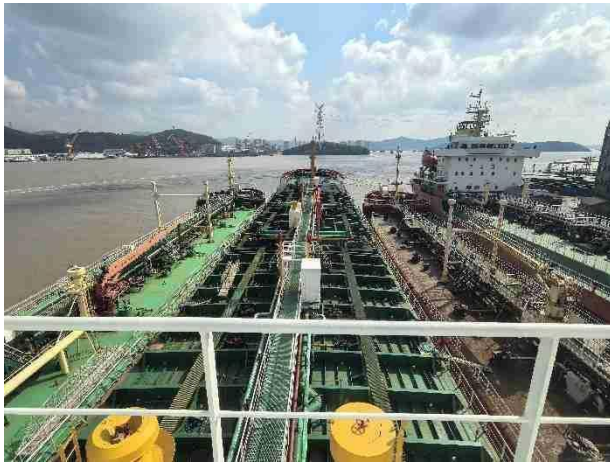
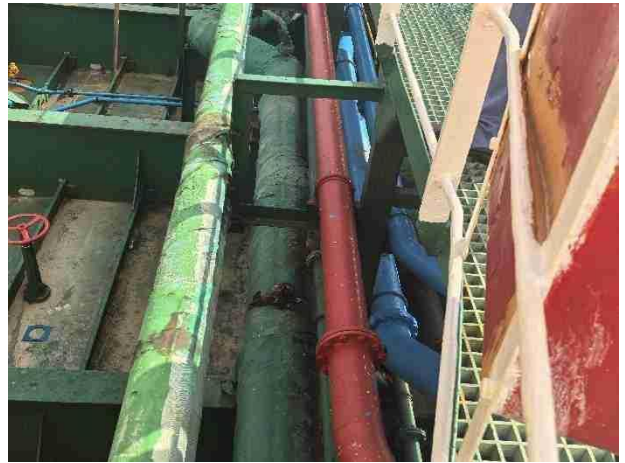
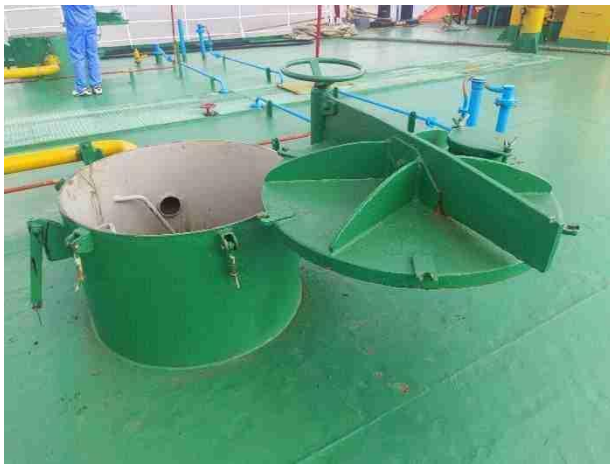
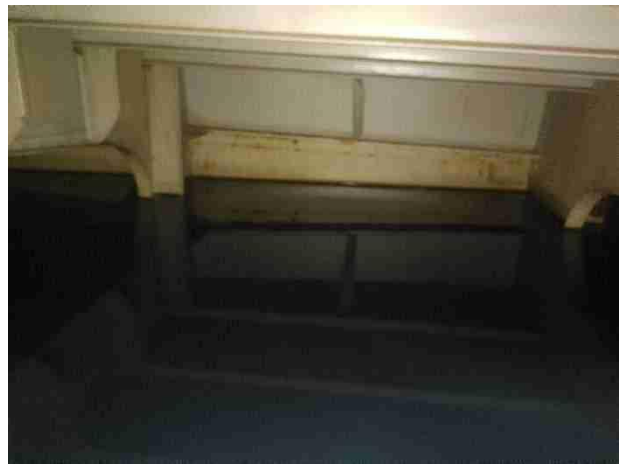
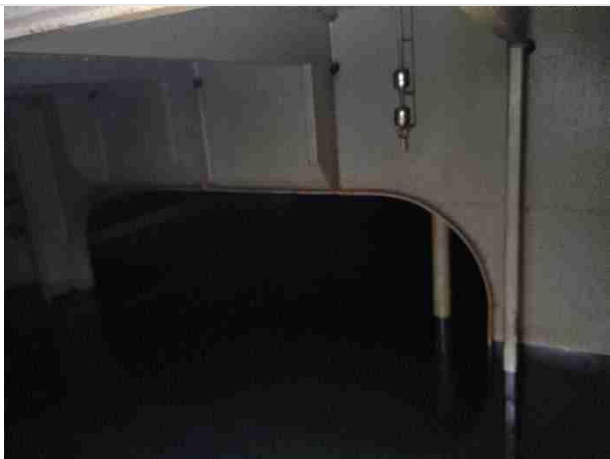
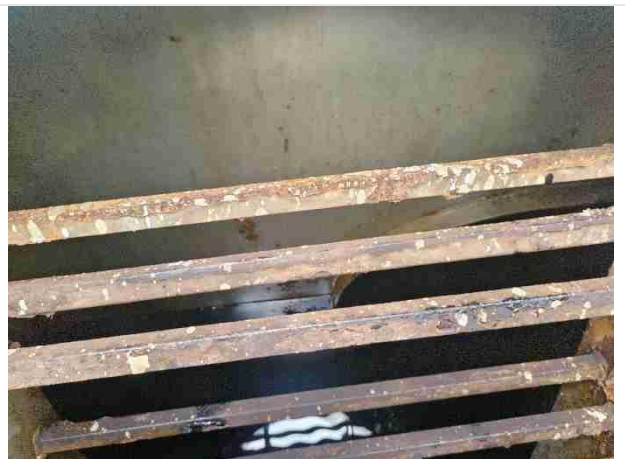
No.	Description	Good	Fair to good	Fair	Poor
1	The ventilation pipe of the cargo tank was found without corroded, and the shut-off valve on the pipeline was in good condition.	<input type="checkbox"/>	<input checked="" type="checkbox"/>	<input type="checkbox"/>	<input type="checkbox"/>
2	The insulation package of the hot oil pipeline on the deck of the cargo tank area was found intact, the valve hand-wheel was not loose, and the connecting flange was not corroded.	<input type="checkbox"/>	<input checked="" type="checkbox"/>	<input type="checkbox"/>	<input type="checkbox"/>
3	The paint on the oil conveying pipe was intact and there is no oil or gas leakage at the flange interface, the threaded rod of the pipeline valves was not corroded, the enclosure of the drip tray was intact.	<input type="checkbox"/>	<input checked="" type="checkbox"/>	<input type="checkbox"/>	<input type="checkbox"/>
4	No significant rust was found on the cargo tank cover clamp, hand-wheel, and screw rod. The cargo cover and observation cover have no significant oil or gas, and the tightness was intact.	<input type="checkbox"/>	<input checked="" type="checkbox"/>	<input type="checkbox"/>	<input type="checkbox"/>

5	The cargo tank access ladder was intact, the cargo tank condition of special coating was in good condition. There were no rust spots on the weld joints.	<input type="checkbox"/>	<input checked="" type="checkbox"/>	<input type="checkbox"/>	<input type="checkbox"/>
6	The pipelines and flanges inside the cargo tank were found rust free, and the radar level gauge pipeline was intact.	<input type="checkbox"/>	<input checked="" type="checkbox"/>	<input type="checkbox"/>	<input type="checkbox"/>
7	The opening and closing of the pump room door was interlocked with the indoor fan and lighting. The ventilation grille blades were not corroded, the fire damper handle was intact.	<input type="checkbox"/>	<input checked="" type="checkbox"/>	<input type="checkbox"/>	<input type="checkbox"/>
8	The fire separation between the pump room and the engine room was intact, the materials were not significantly damaged.	<input type="checkbox"/>	<input checked="" type="checkbox"/>	<input type="checkbox"/>	<input type="checkbox"/>

9	The paint on the pump body was intact without significant rust. The sealing of the pipeline flange was intact without significant gaps.	<input type="checkbox"/>	<input checked="" type="checkbox"/>	<input type="checkbox"/>	<input type="checkbox"/>
10	The sea chest hand-wheel screw in the pump room was well lubricated, and without corroded on the sea chest..	<input type="checkbox"/>	<input checked="" type="checkbox"/>	<input type="checkbox"/>	<input type="checkbox"/>
11	The checkered plate inside the pump room was free of oil stains, and no signs of leakage on the bottom edge of the wall. There is no a	<input type="checkbox"/>	<input checked="" type="checkbox"/>	<input type="checkbox"/>	<input type="checkbox"/>

amount of oil stains was found at the bottom of the room.				
12	The liquid cargo radar monitoring system in the cargo control room has no faults, and the computer system can clearly read the loading status and liquid level height.	<input type="checkbox"/>	<input checked="" type="checkbox"/>	<input type="checkbox"/>	<input type="checkbox"/>
13	The operation indicator light in the cargo control room has not faults. The pressure and temperature monitoring and the alarm system has not faults.	<input type="checkbox"/>	<input checked="" type="checkbox"/>	<input type="checkbox"/>	<input type="checkbox"/>
14	The doors and windows of the cargo control room, as well as the walls facing the cargo area, have a fire separation rating of A60.	<input type="checkbox"/>	<input type="checkbox"/>	<input type="checkbox"/>	<input type="checkbox"/>
15	The communication equipment in the cargo control room was intact, the liquid cargo pipeline was posted, and a damage control manual was provided.	<input type="checkbox"/>	<input checked="" type="checkbox"/>	<input type="checkbox"/>	<input type="checkbox"/>

Note: The above inspection items were found in "Fair to good" level overall.

During the inspection, the ship had just completed the tank cleaning and heavy oil pipeline cleaning project at the Haijiao shipyard, and was in the process of ventilation, making it impossible to enter for inspection.
